**TESORO HIGH PLAINS PIPELINE**

**CONSTRUCTION AS BUILT INSPECTION REPORT**

**Job Site As-Built Inspection  
Crop Review to Verify Proper Top Soil Replacement**

**Report Number:** PU-15-733

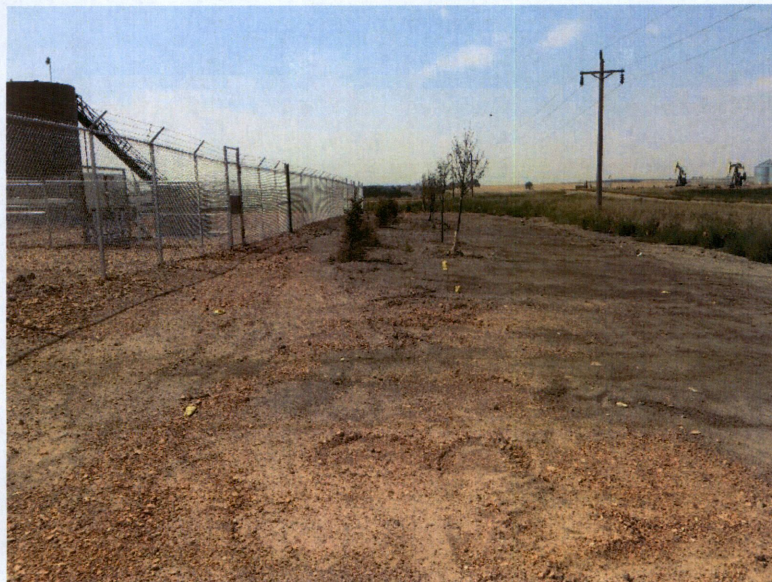
**Photo No. 2 Tesoro Pipeline Station 0+57 to 2+00  
PI #1 of Pipeline Project  
South of 40<sup>th</sup> Street NW  
July 31, 2017**

The above picture taken is looking west. The photograph represents the landscaping between the Tesoro property and the 40<sup>th</sup> Street NW right of way. Trees were planted to buffer the Tesoro fenced area. No action is necessary.

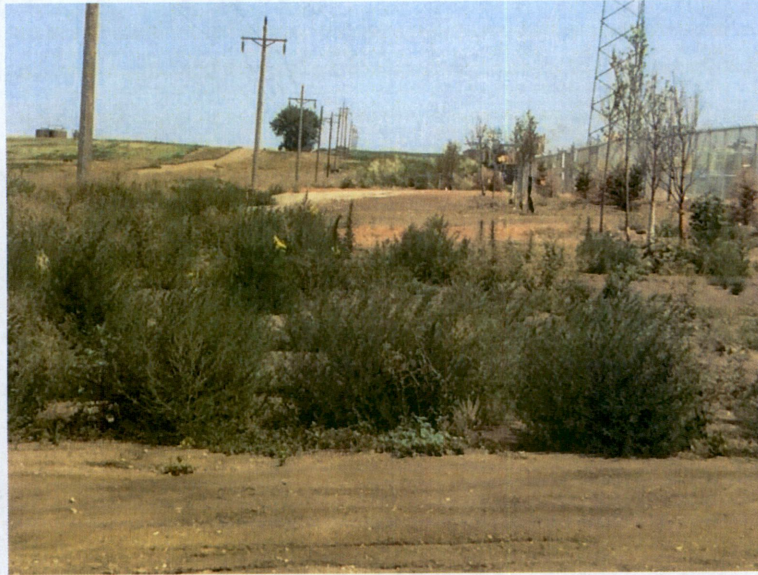
**Photo No. 3 Tesoro Pipeline Station 4+00 to 0+57  
PI #2 of Pipeline Project  
South of 40<sup>th</sup> Street NW  
July 31, 2017**

The above picture taken is looking east. The photograph represents the landscaping between the Tesoro property and the 40<sup>th</sup> Street NW right of way. Trees were planted to buffer the Tesoro fenced area. Ownership of disturbed area is Tesoro. No action is necessary.

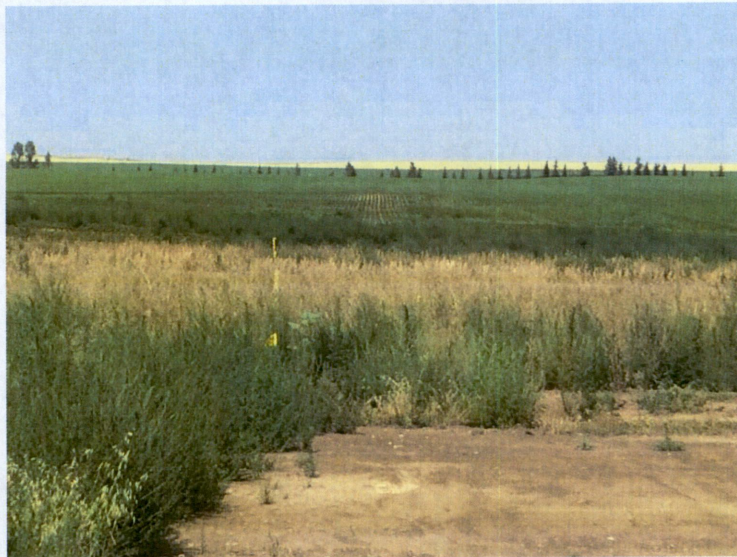
**Photo No. 4 Tesoro Pipeline Station 4+20 to 7+81  
PI #2 of Pipeline Project  
South of 40<sup>th</sup> Street NW  
July 31, 2017**

The above picture taken is looking north beyond 40<sup>th</sup> Street NW. The photograph represents the landscaping south of 40<sup>th</sup> Street NW and crops planted north of 40<sup>th</sup> Street NW. Ownership of disturbed area is Tesoro. No action is necessary.

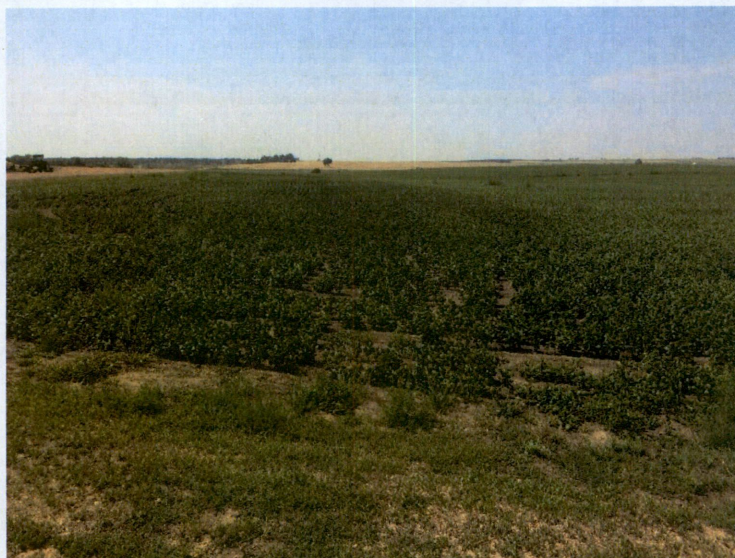
Photo No. 5 Tesoro Pipeline Station 4+20 to 7+81  
PI #3 of Pipeline Project  
South of 40<sup>th</sup> Street NW  
July 31, 2017

The above picture taken is looking north beyond 40<sup>th</sup> Street NW. The photograph represents the crops planted on the North side of 40<sup>th</sup> Street NW to PI #3. There is a good stand of crops, though this area has been under severe drought conditions. The land is owned by Kenneth A. Mogen. No action is necessary.

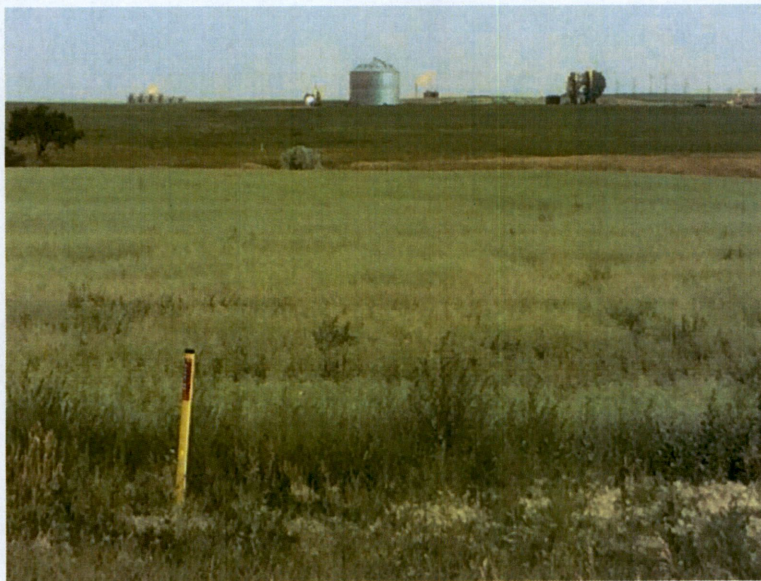
**Photo No. 7 Tesoro Pipeline Station 9+69 to 42+89  
Between PI #3 and PI #6 of Pipeline Project  
North of 40<sup>th</sup> Street NW  
July 31, 2017**

Picture taken is looking west towards PI #4 from gravel road. The photograph represents the crops planted on the North side of 40<sup>th</sup> Street NW and west of PI #3. There is a good stand of crops, though this area has been under severe drought conditions. The drainage draw can be seen and the horizon represents ND Hwy. 1806. The land is owned by Harvey O. and Elizabeth A. Thompson Trust. No action is necessary.

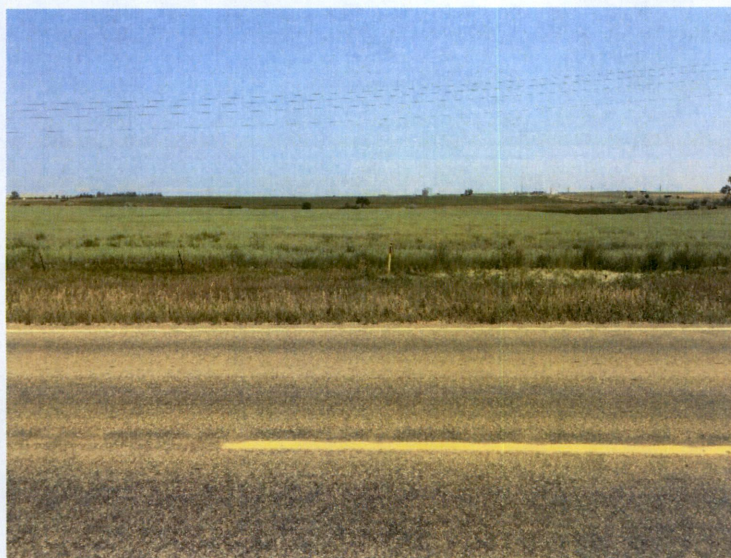
**Photo No. 8 Tesoro Pipeline Station 46+00 to 42+89  
Pipeline Bored under the Highway  
Looking East of ND Hwy 1806  
July 31, 2017**

Picture taken is looking east towards PI #7 from ND Highway 1806. The photograph represents the crops planted on the east side of the highway. There is a good stand of crops though this area has been under severe drought conditions. The land is owned by Harvey O. and Elizabeth A. Thompson Trust. No action is necessary.

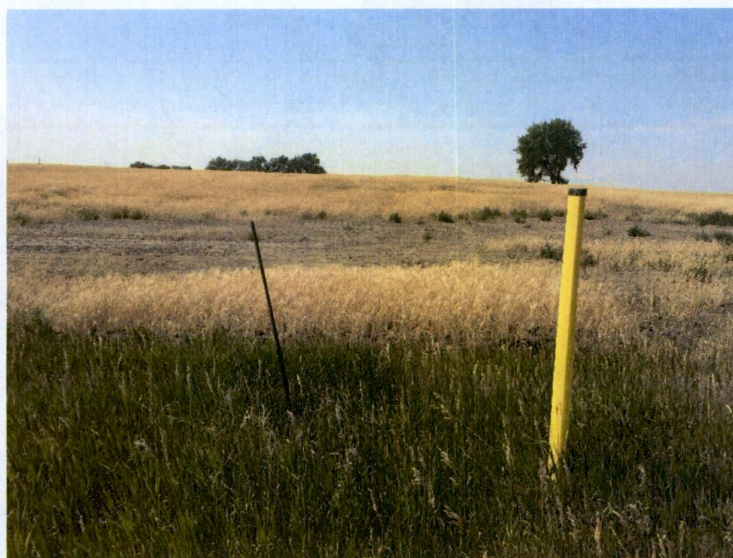
**Photo No. 9 Tesoro Pipeline Station 48+00 to 54+00**

**Pipeline west of Highway 1806  
Looking West towards PI #8  
July 31, 2017**

The above picture taken is looking west towards PI #8 from ND 1806. The photograph represents the crops planted on the West side of the Highway. There is a good stand of crops, though this area has been under severe drought conditions. The disturbed area was part of the boring operation, however, crops were not planted in the disturbed area this season. The pipe line goes past the trees on the horizon. The land is owned by Paul and Milo Wisness. No action is necessary.

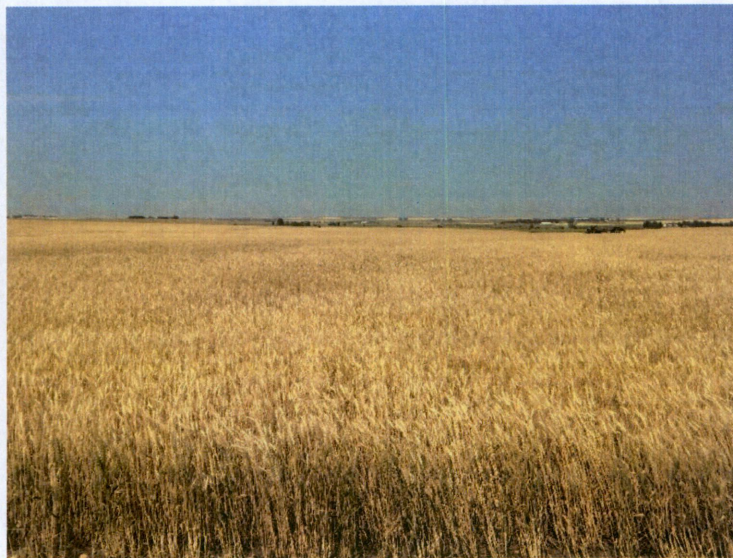
**Photo No. 10 Tesoro Pipeline Station 56+00 to 50+00  
Pipeline west of Highway 1806  
Looking East towards PI #7  
July 31, 2017**

The above picture taken is looking east of PI #8 towards ND 1806. The photograph represents the crops planted on the West side of the Highway. There is a good stand of crops, though this area has been under severe drought conditions. The land is owned by Paul and Milo Wisness. No action is necessary.

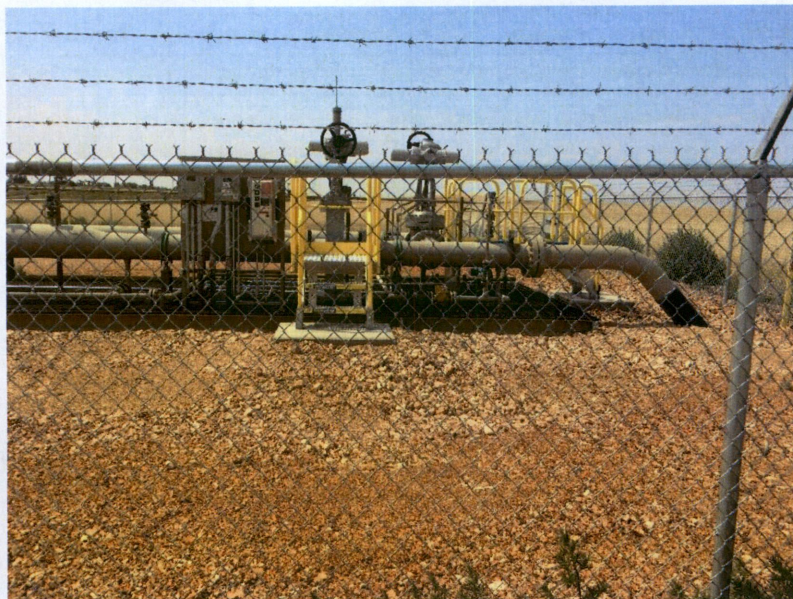
**Photo No. 11 Tesoro Pipeline Station 67+02  
End of Pipeline west of Highway 1806  
Looking West  
July 31, 2017**

**The above picture taken is located immediately south of PI #8. The photograph represents the Tesoro station. The land is owned by Tesoro. No action is necessary.**
