**Brady Transmission Line
Brady Wind, LLC
Stark County, North Dakota**

December 2015

Prepared by:
Tetra Tech, Inc.
350 Indiana Street, Suite 500
Golden, CO 80401

**Consolidated Application to the North Dakota Public Service
Commission for a Waiver or Reduction of Procedures and Time
Schedules and Certificate of Corridor Compatibility and Transmission
Facility Route Permit**

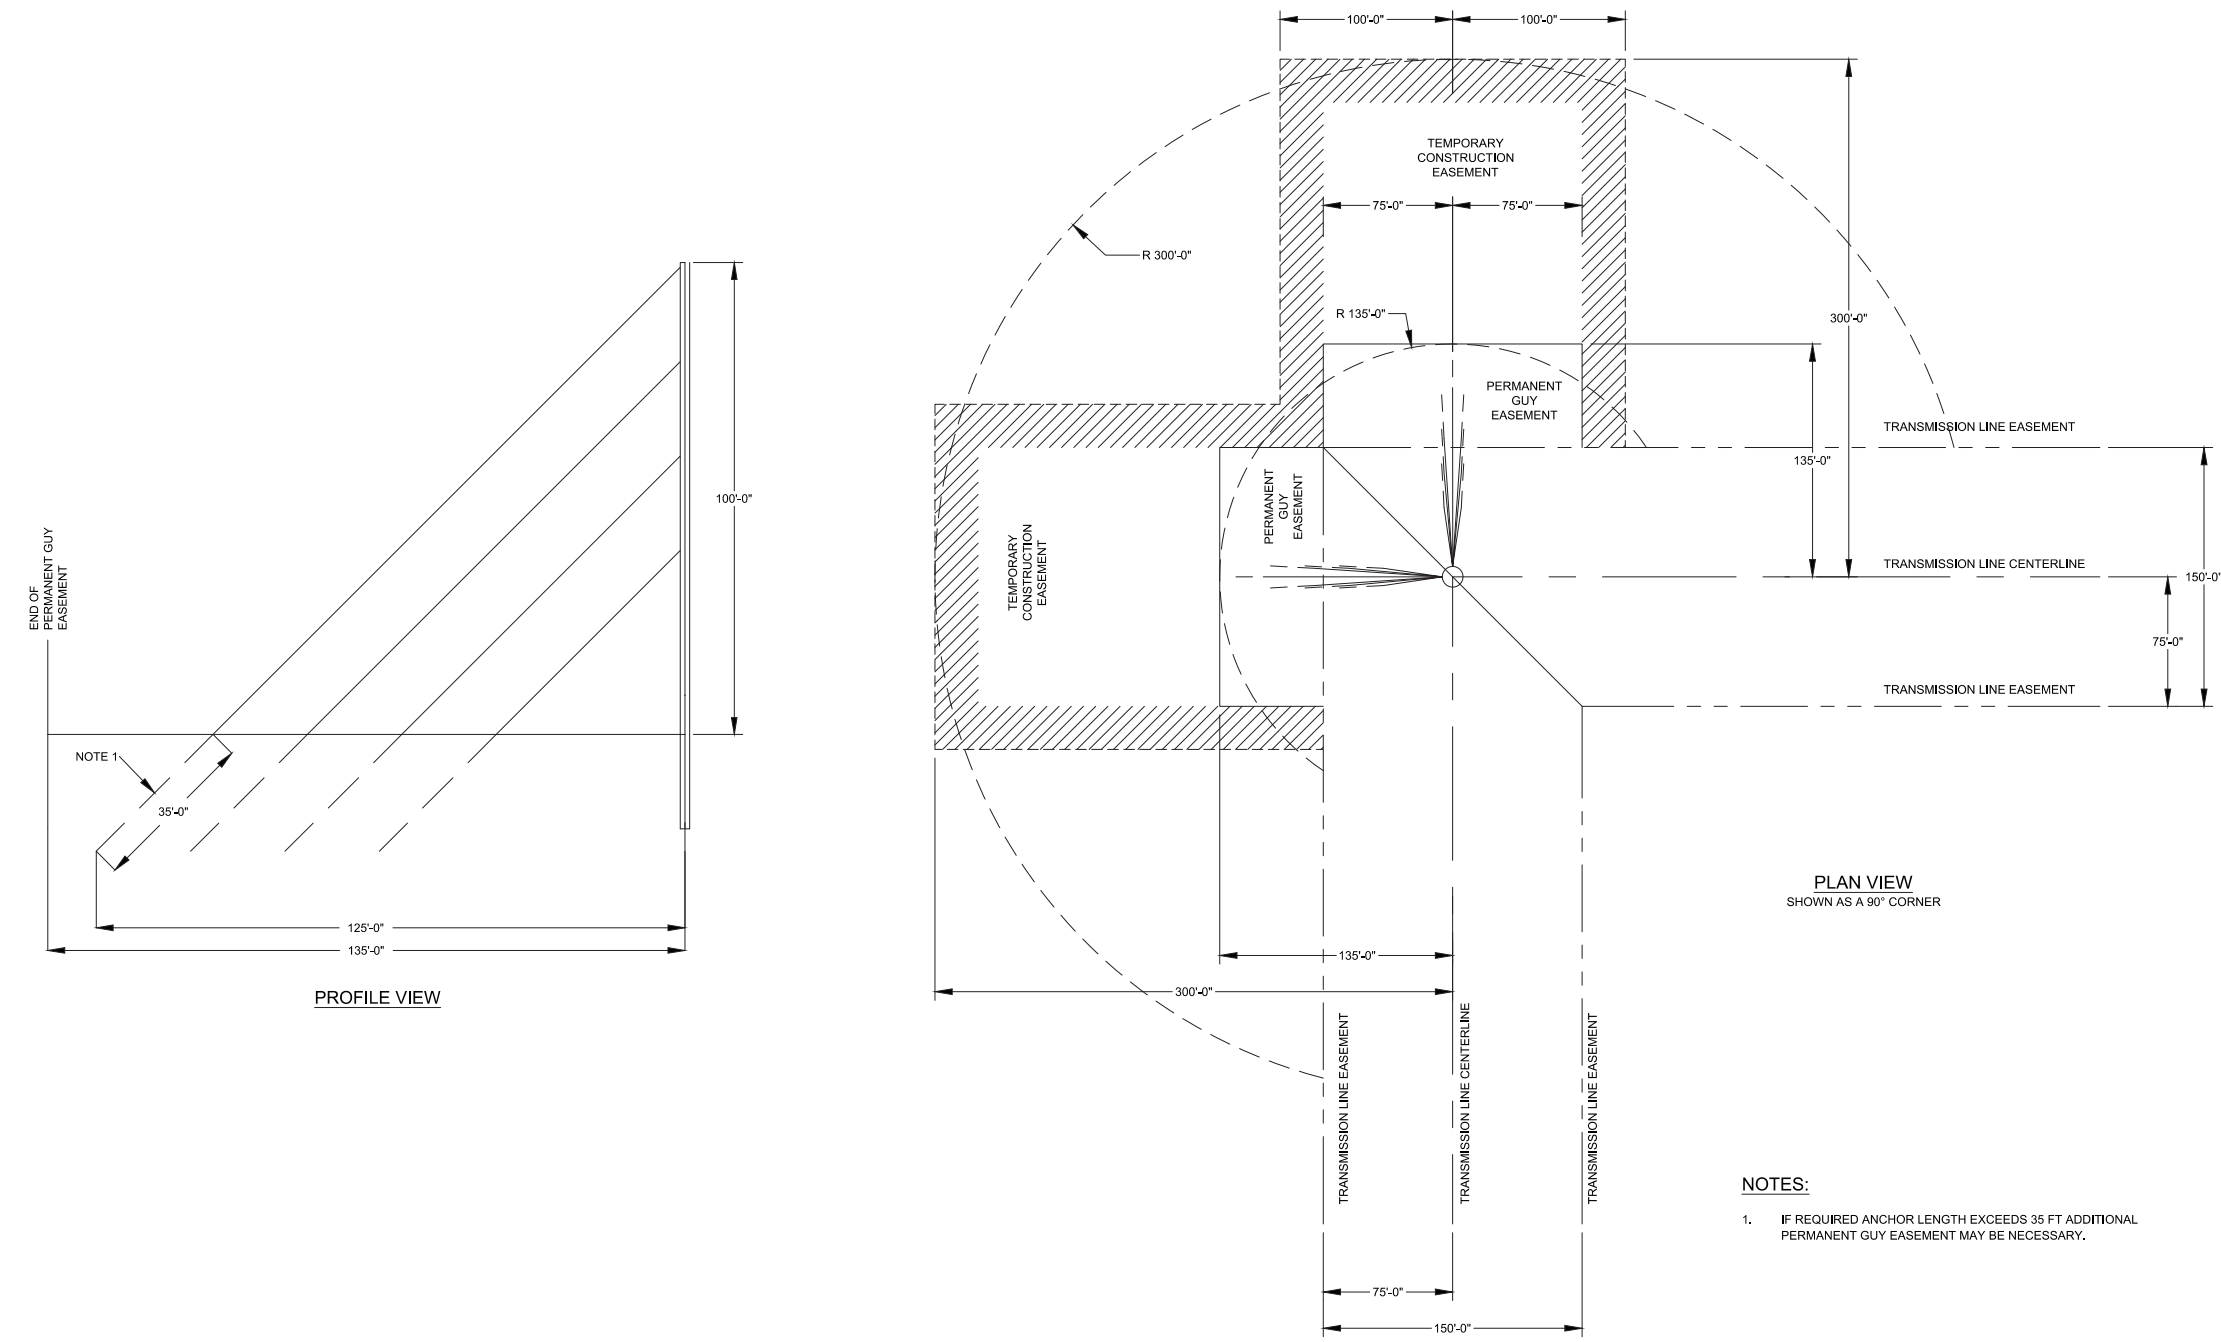
- NOTES:**
- IF REQUIRED ANCHOR LENGTH EXCEEDS 35 FT ADDITIONAL PERMANENT GUY EASEMENT MAY BE NECESSARY.

Guyed structures will be required at approximately 12 turns. Depending on the angle, up to 16 guy wires may be required per turn, each up to 135 feet from the pole structure (**Figure 5**). Specialty structures and foundations may be required in certain circumstances.

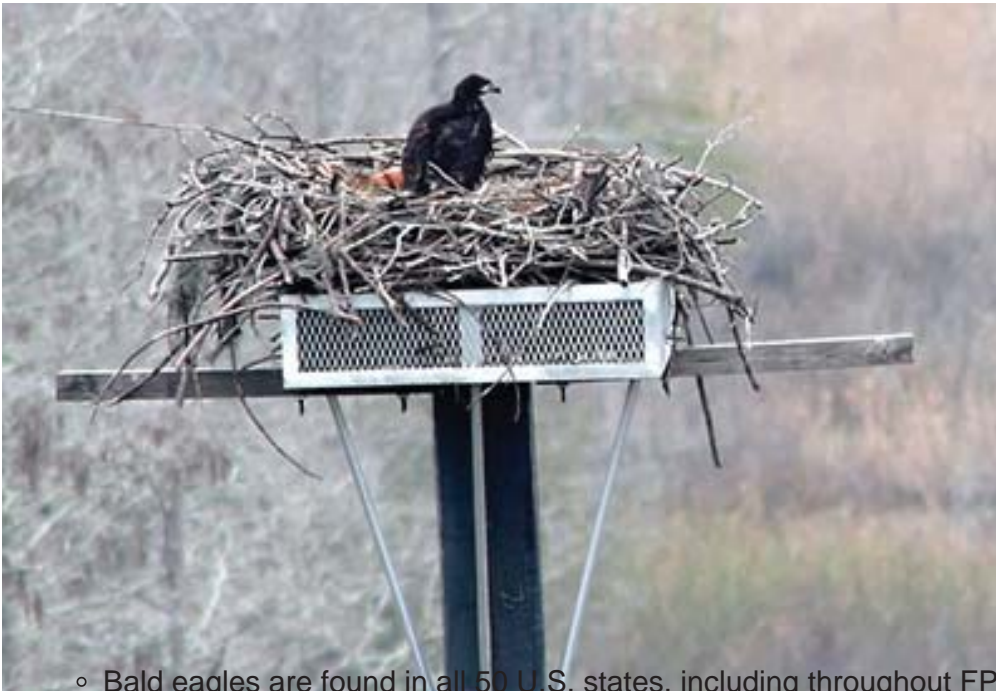
Nesting platform success in Florida

- Bald eagles are found in all 50 U.S. states, including throughout FPL's service territory in Florida.
- In the fall of 2013, a bald eagle built its nest on a 230-kV transmission line in Volusia County, Fla. To protect the nest and the eagles that would be raising their family in it, and because the surrounding area lacked viable nest trees, FPL for the first time ever constructed an independent pole and platform to provide the birds with a nearby nest location. With input from the Florida Fish and Wildlife Conservation Commission and

the U.S. Fish and Wildlife Service, the platform was designed to provide long-term support of the nest. Within 45 days of the nest transfer, a pair of eagles began to add onto and occupy the nest, and in 2014, a baby eaglet hatched in the nest!

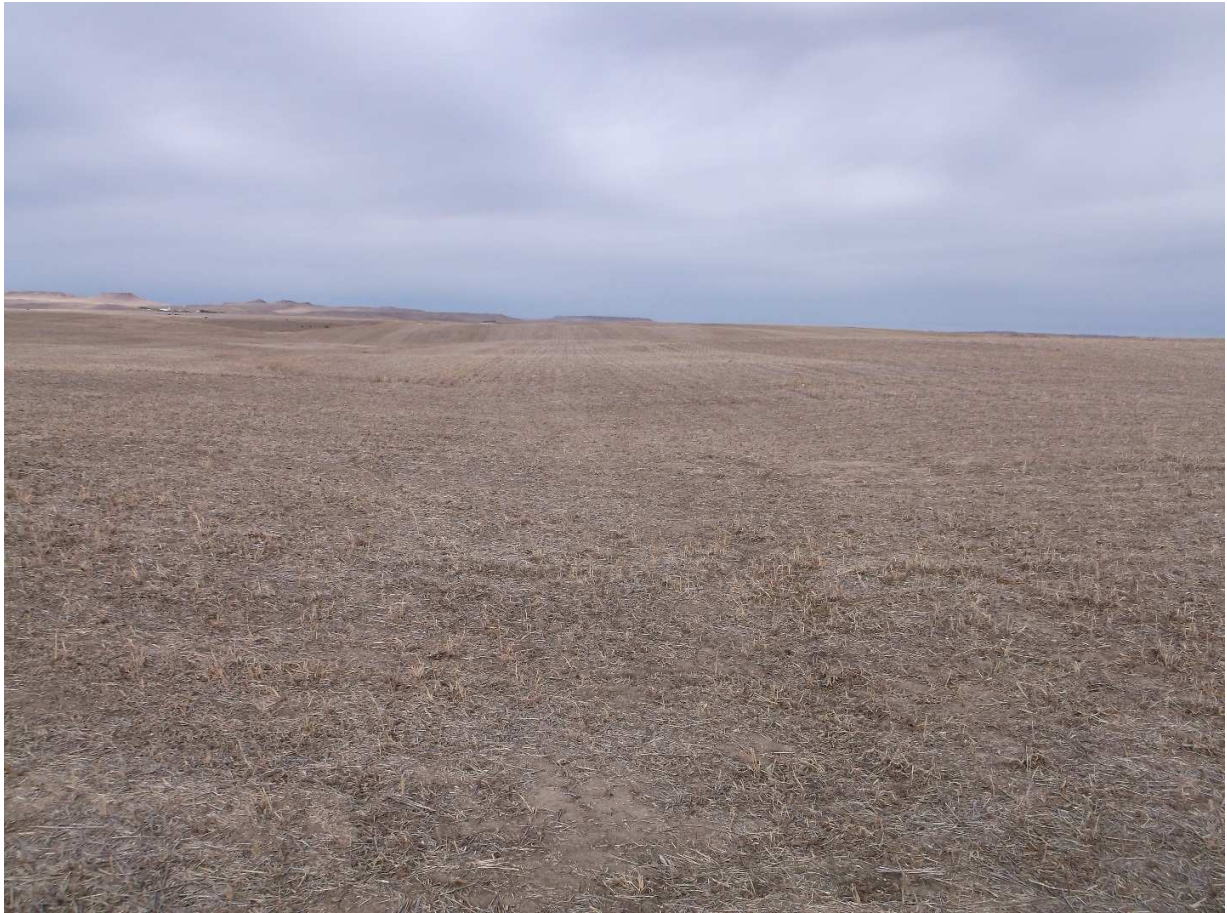
Photo 1: View to the typical swale. This feature has no defined bed or banks and no scoured channel, and is therefore not a wetland.

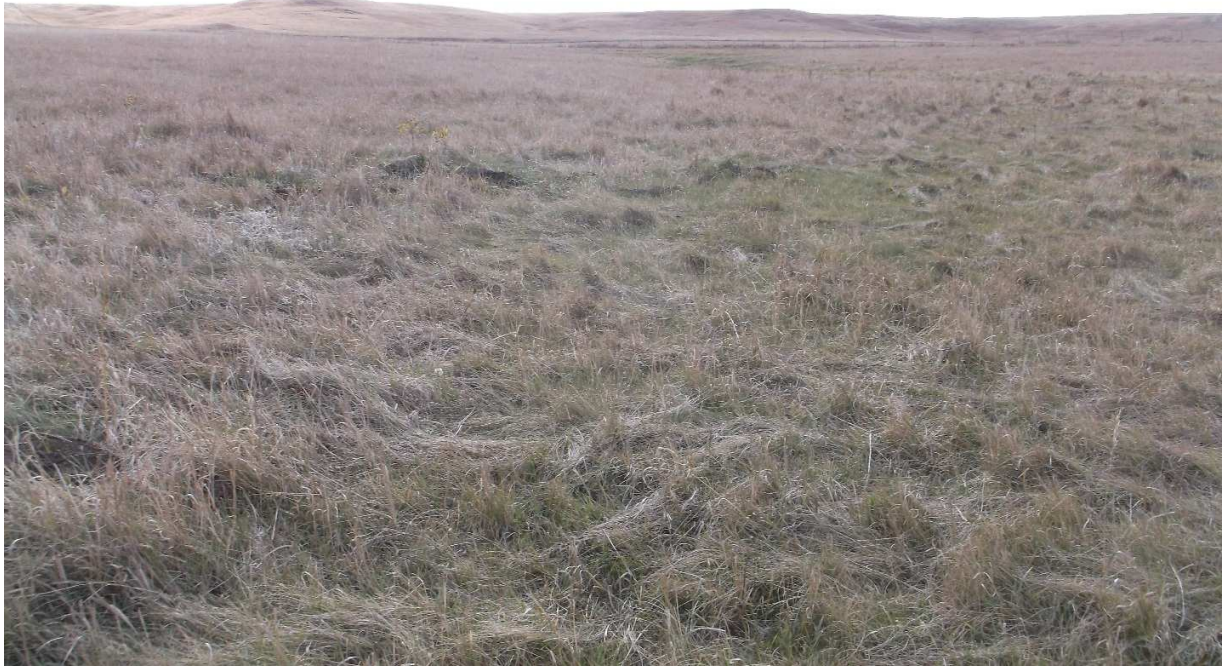
Photo 2: View to the southwest of typical upland. An NHD flowline was mapped in this location, but this feature has no channel that exhibits wetland or other WoUS traits.

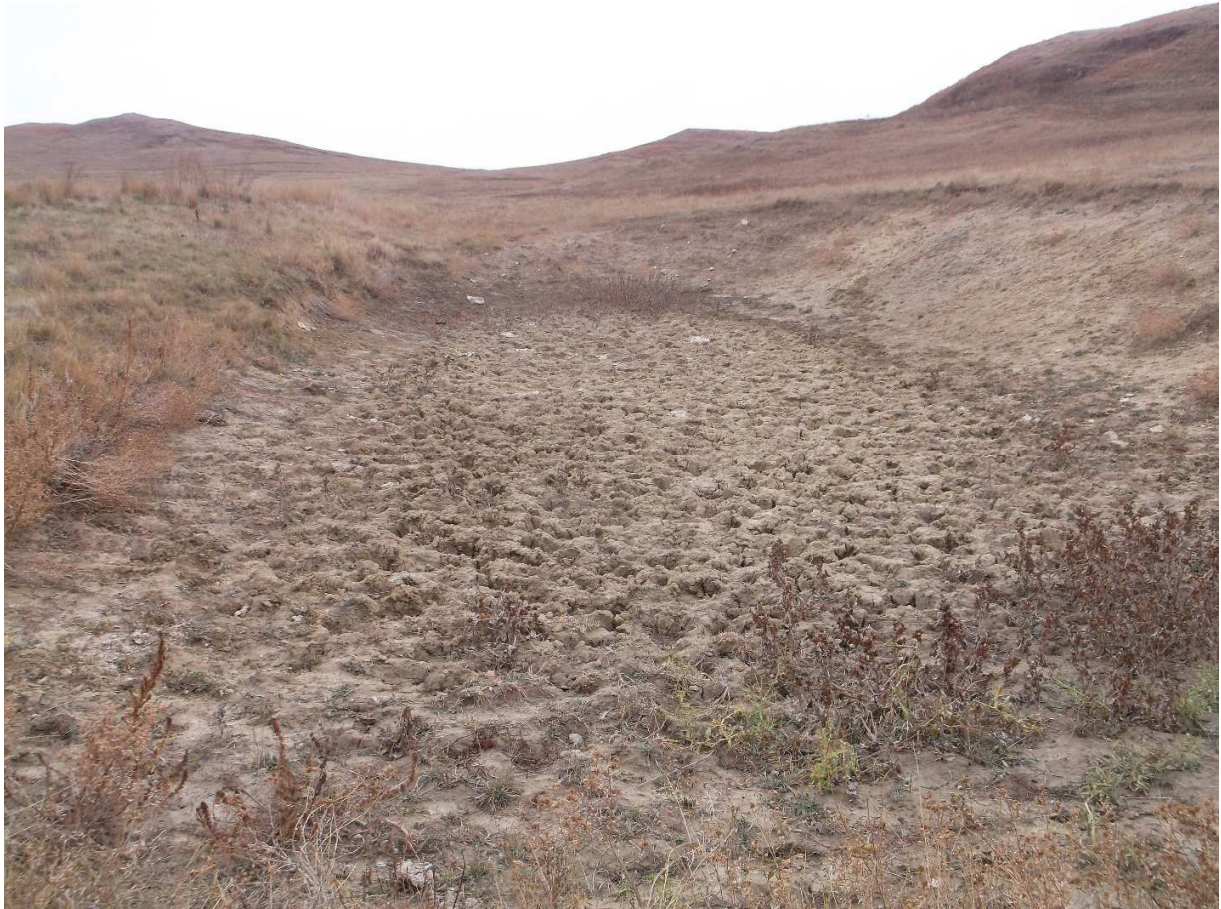
Photo 3: View to the south of Pond 2A. This feature likely collects several inches of water after seasonal precipitation events and should not be used for construction.

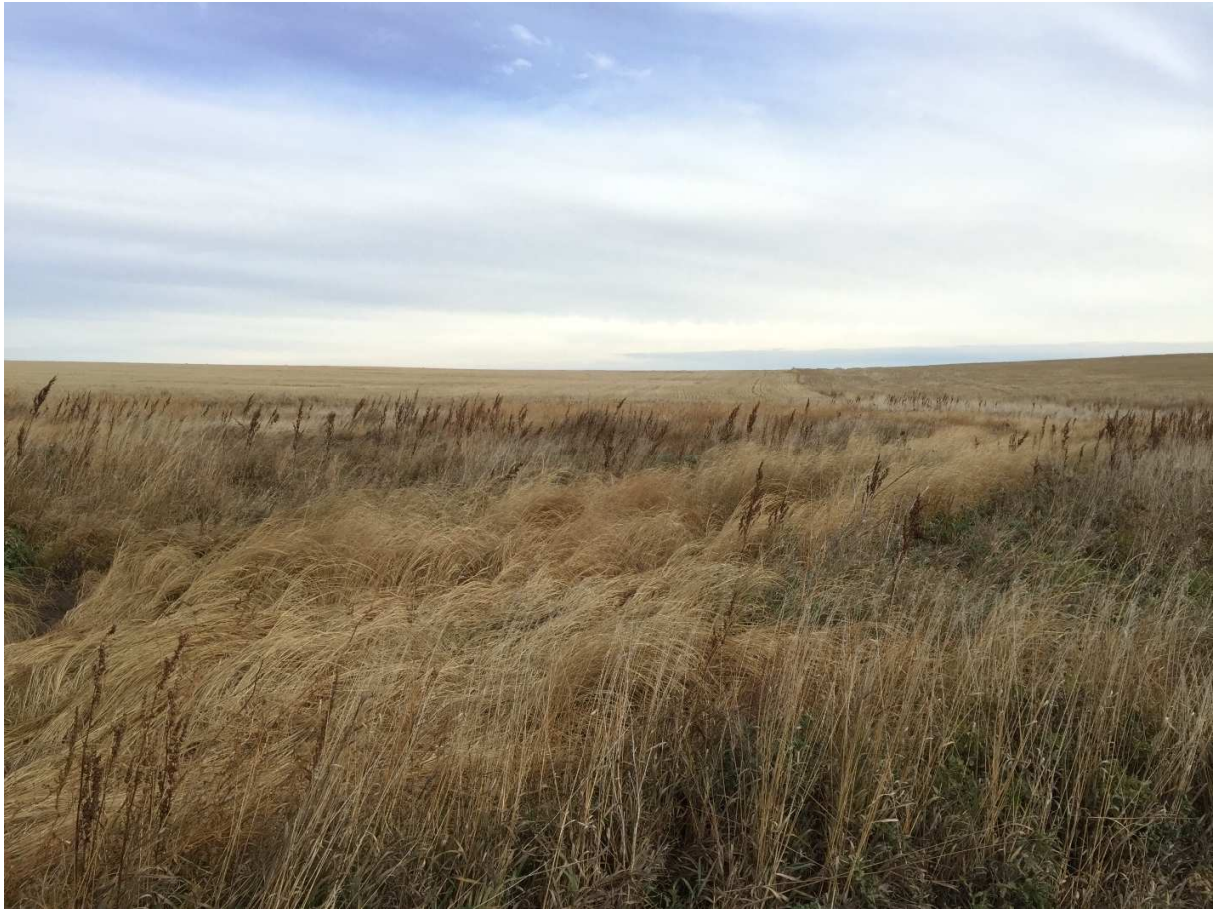
Photo 4: View to the northeast of Wetland 2A. This feature exhibited several patches of prairie cord grass and was saturated on aerial imagery. The wetland extends to the north and south of the survey area; however it is contained to the linear depressional area that runs north to south.

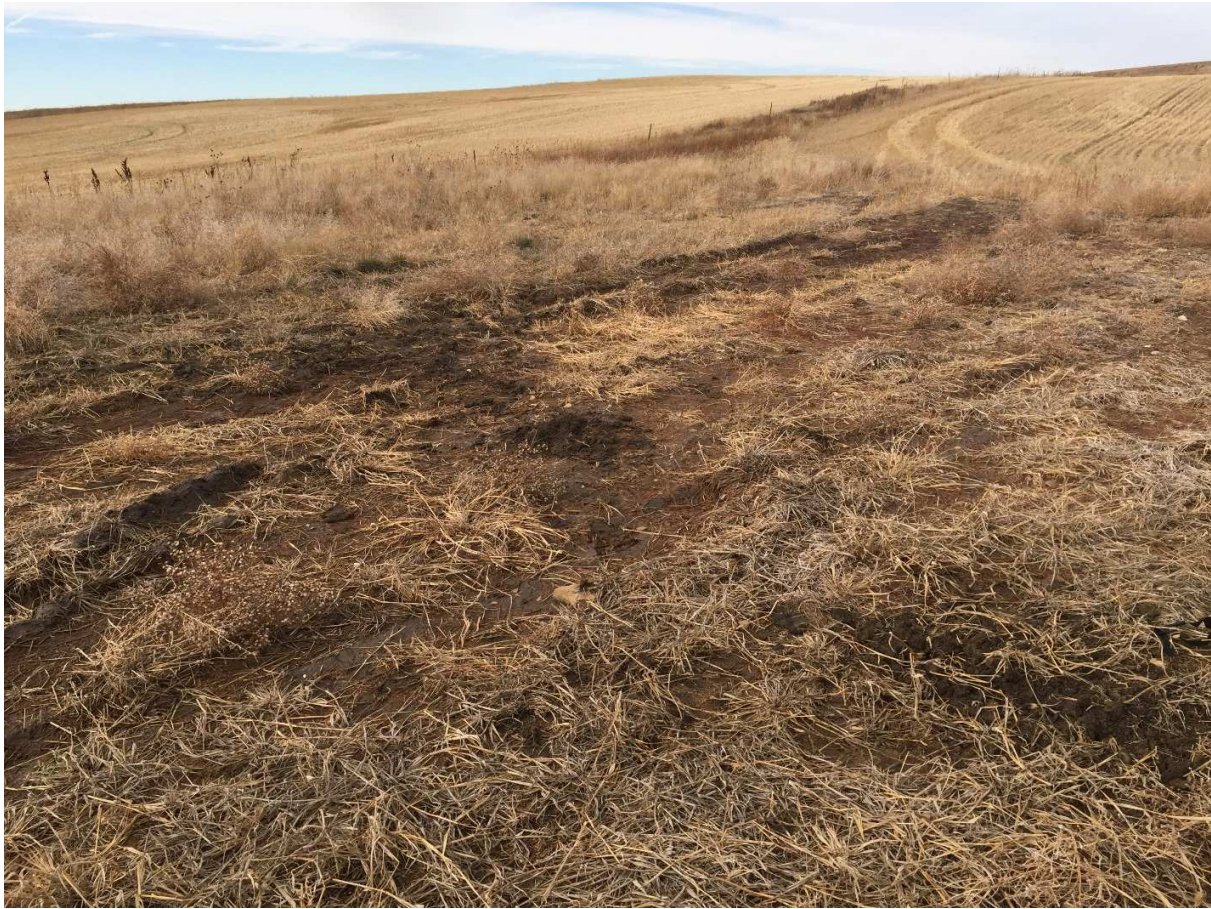
Photo 5: View to the northwest of Wetland 3A. This wetland is a small toe slope wetland located in an agricultural field. The wetland was observed to have problematic vegetation because the plant community had been altered. The wetland sample plot does meet the Hydric soil and wetland hydrology tests, and was therefore formally delineated and should be avoided for construction.

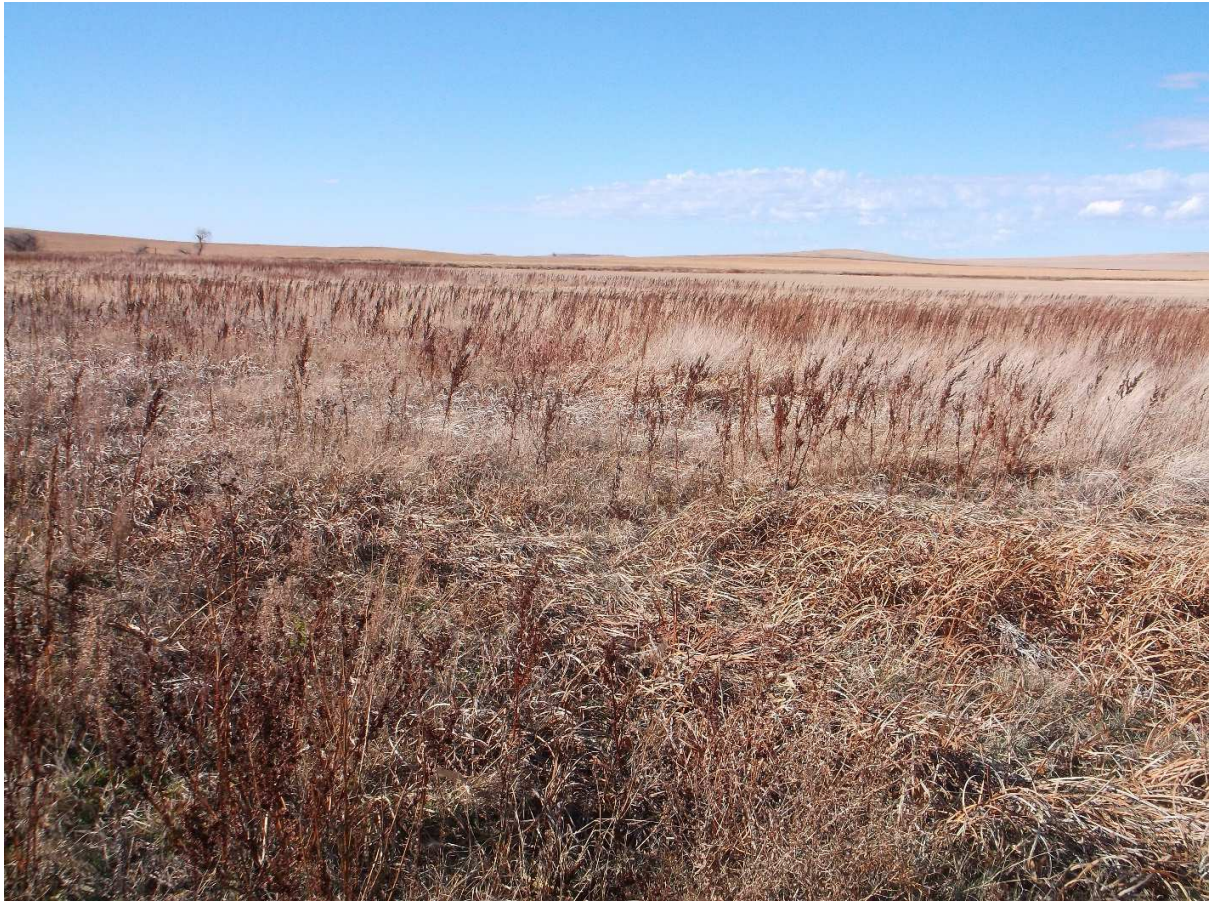
Photo 6: View to the northwest of Wetland 4A. This wetland is partially located in a soybean field and therefore exhibits problematic vegetation. The entire wetland is enclosed in a depression in an area that has been disturbed by agricultural practices.

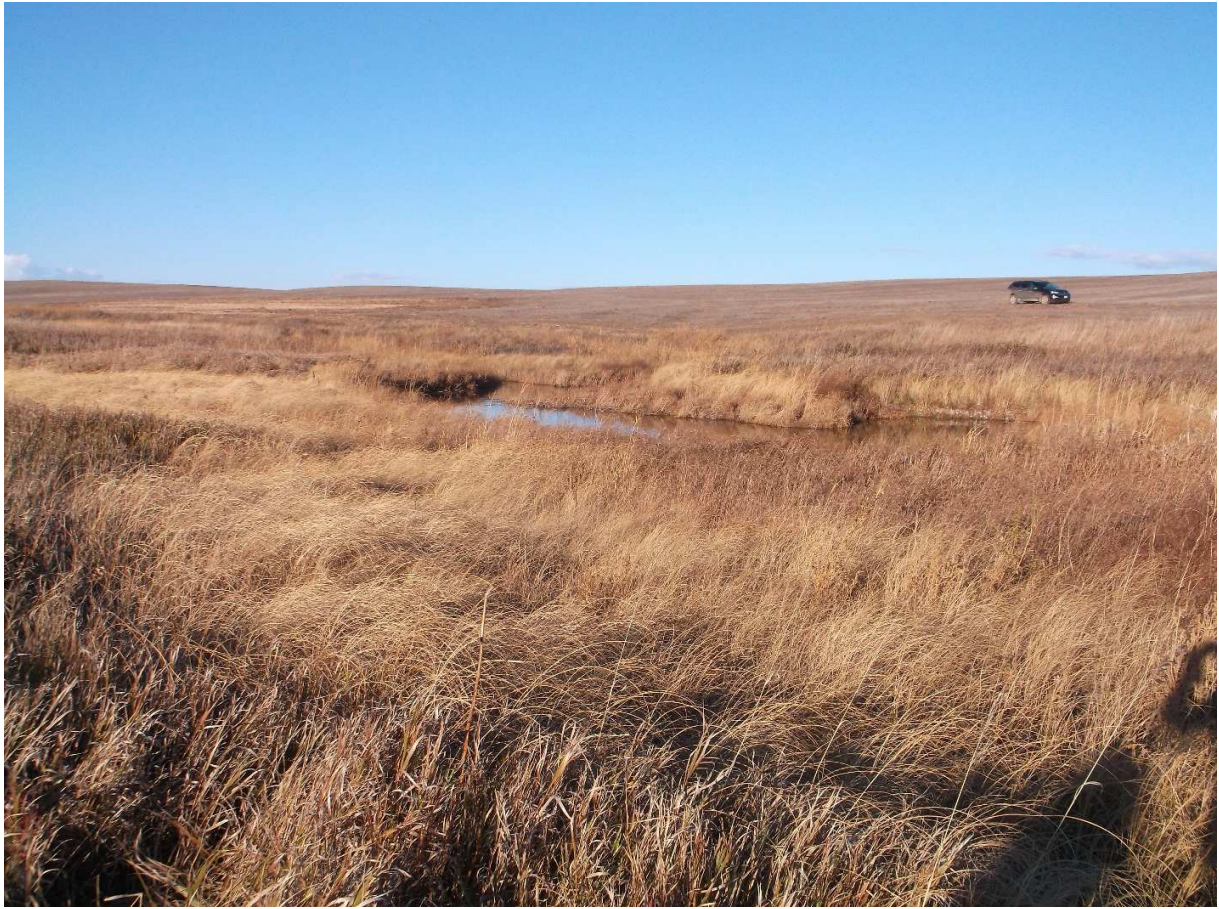
Photo 7: View to the northeast of Wetland 5A. Approximately 20 percent of the wetland had open water at the time of sampling. This entire area mapped as wetland likely collects substantial amounts of water during the rainy season, and should not be used for construction.

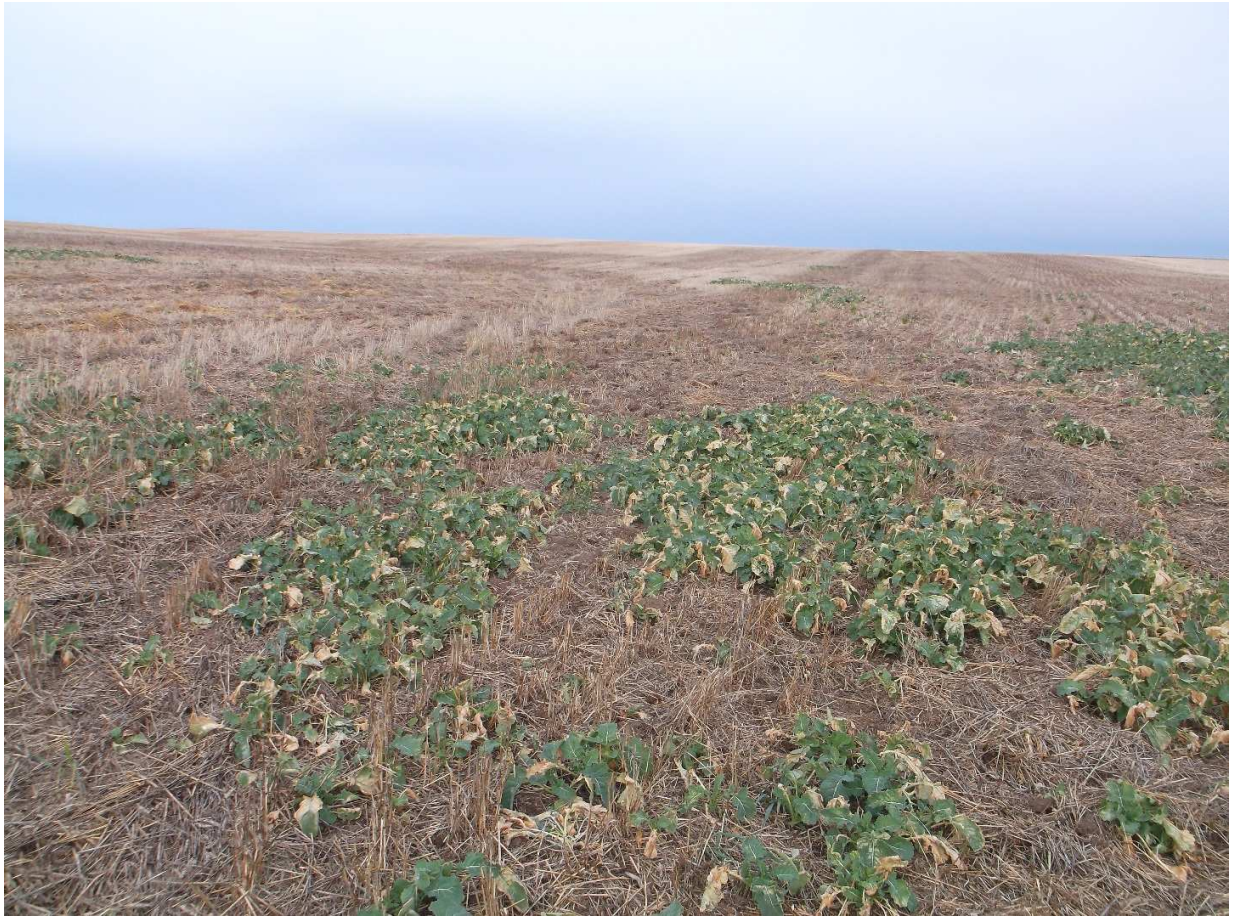
Photo 8: View facing northwest of Wetland 6A. This wetland is located in the topographical low point of a swale that runs through a plowed canola field.

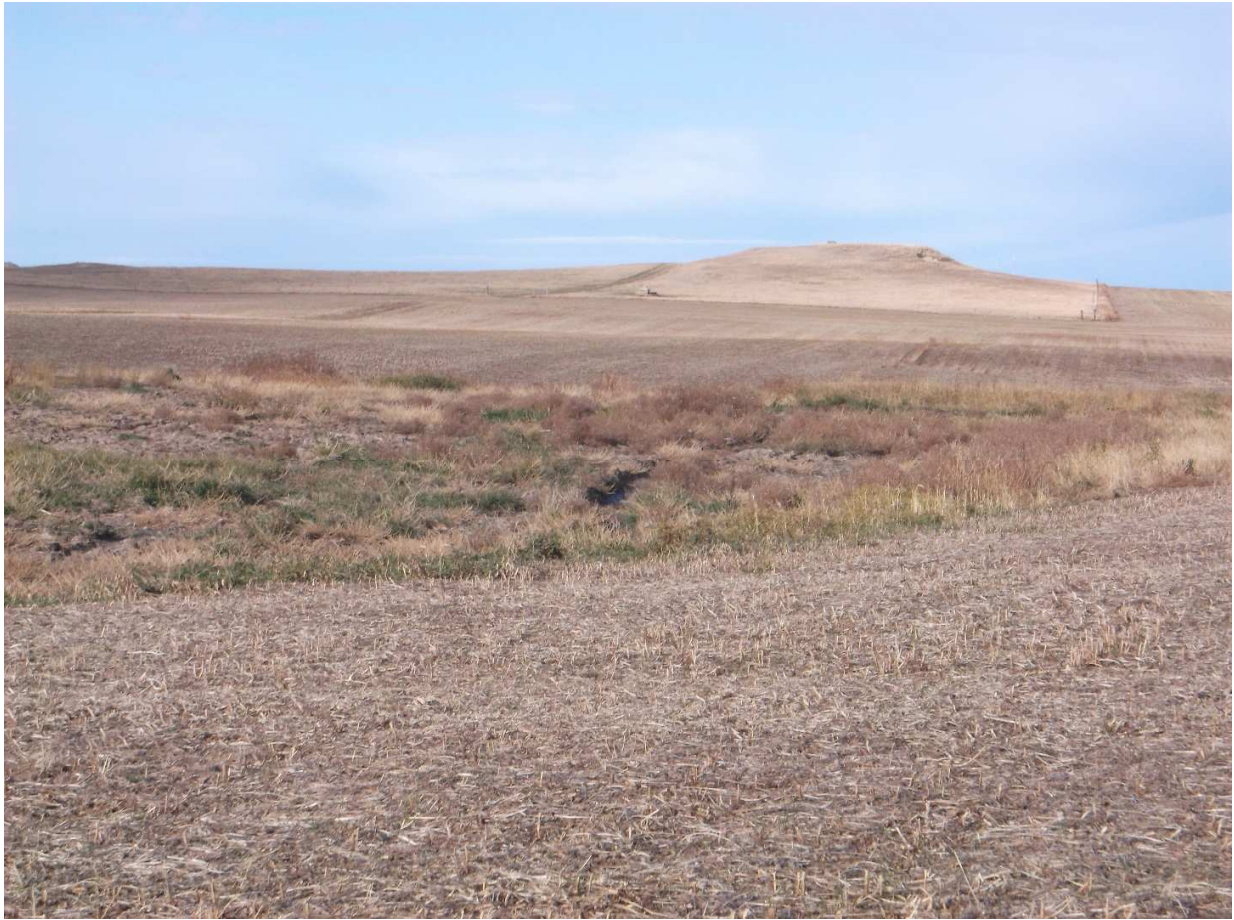
Photo 9: View facing North of Wetland 7A. The wetland was dominated by barnyard grass and was located in a linear depression. Wetland sampling determined that the area to the south of wetland was upland, and that the wetland was isolated to the north side of the transmission line survey corridor.

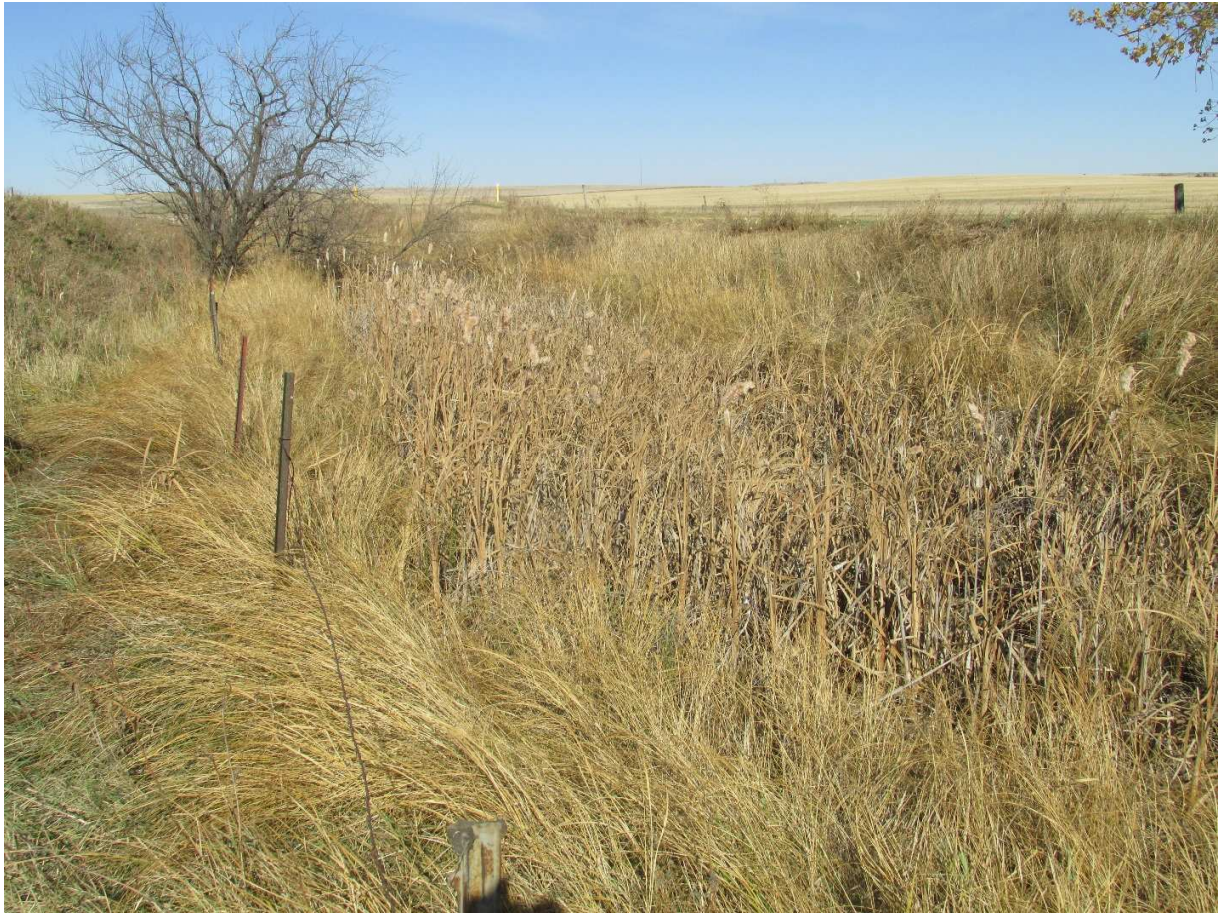
Photo 10: View to the northeast of Wetland 1B. This wetland is located in a roadside ditch. And continues outside the survey area on the other side of the road.

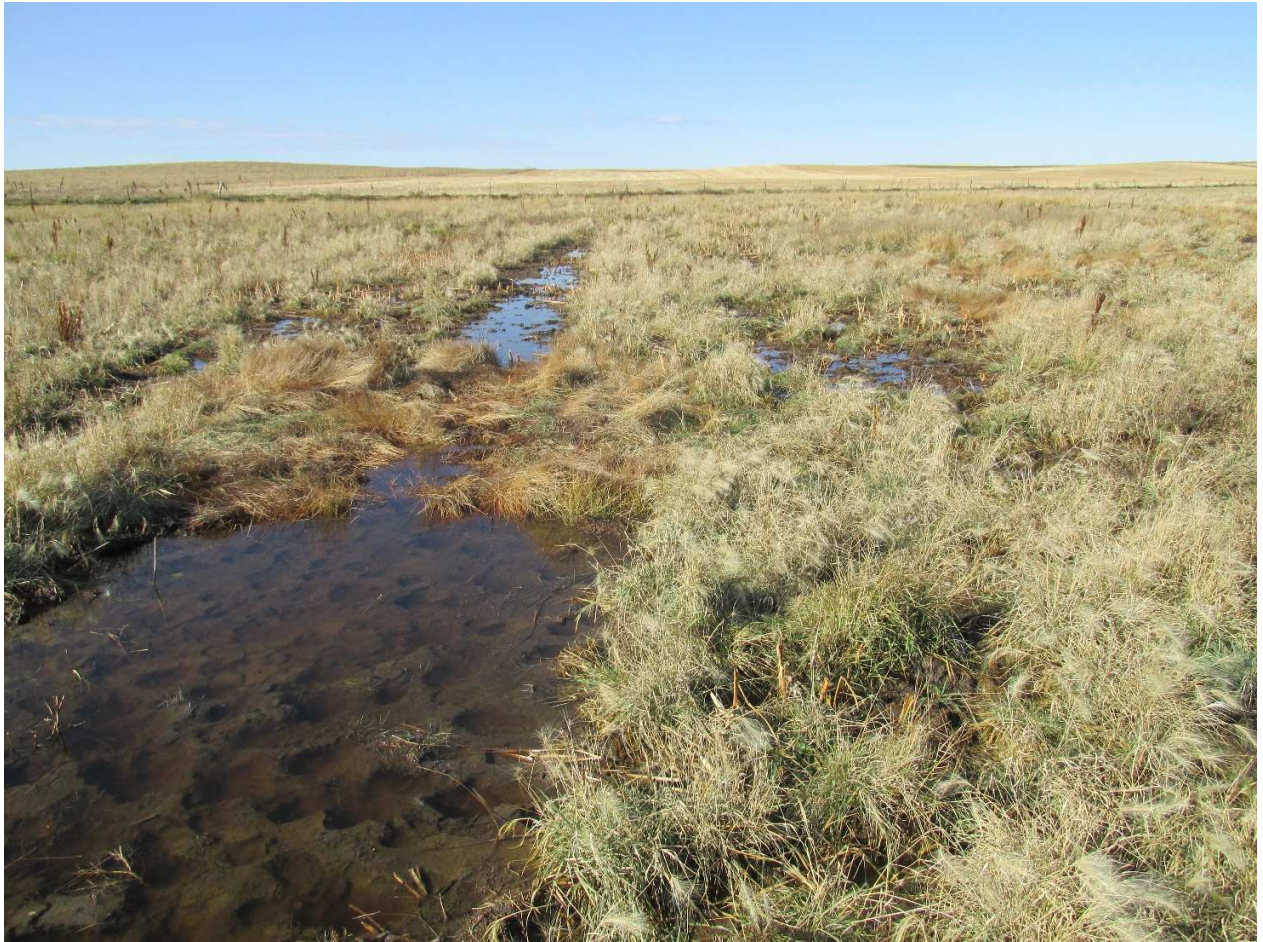
Photo 12: View to the southwest of Wetland 3B, with several inches of water in the center of the mapped wetland area.

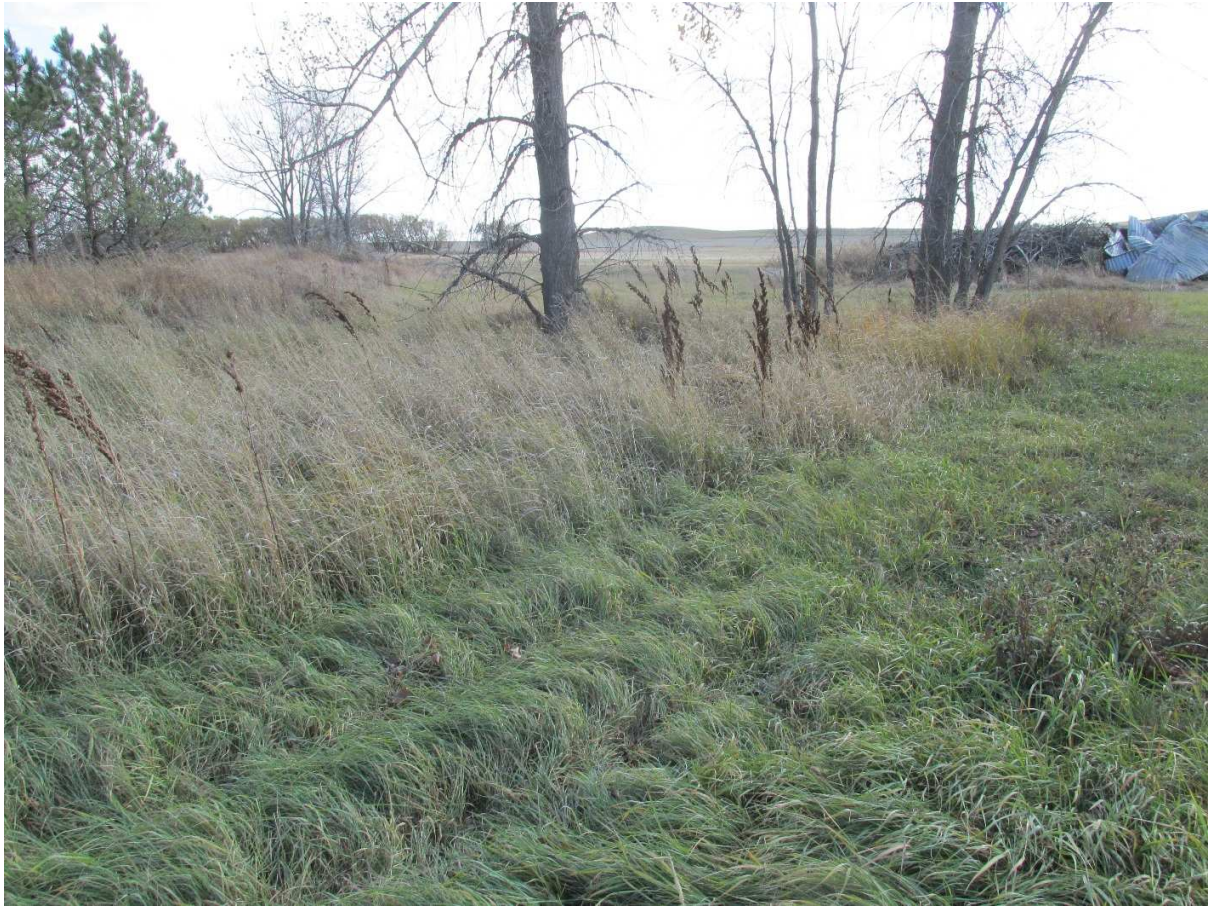
Photo 13: View to the north of Wetland 5B. This wetland was dominated by reed canary grass, a FACW plant.

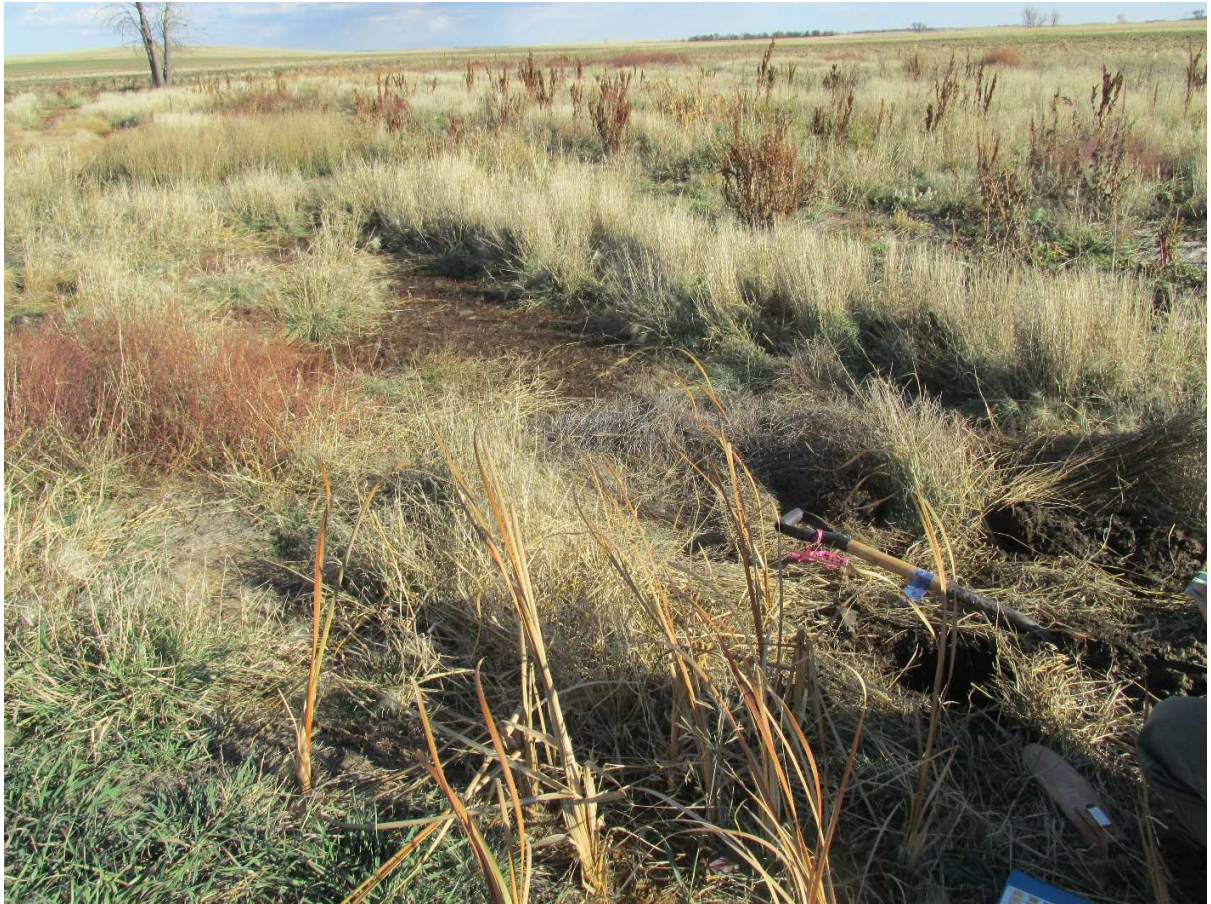
Photo 14: Wetland 6B. A slightly depressional wetland with a mix of native and non-native wetland plants.

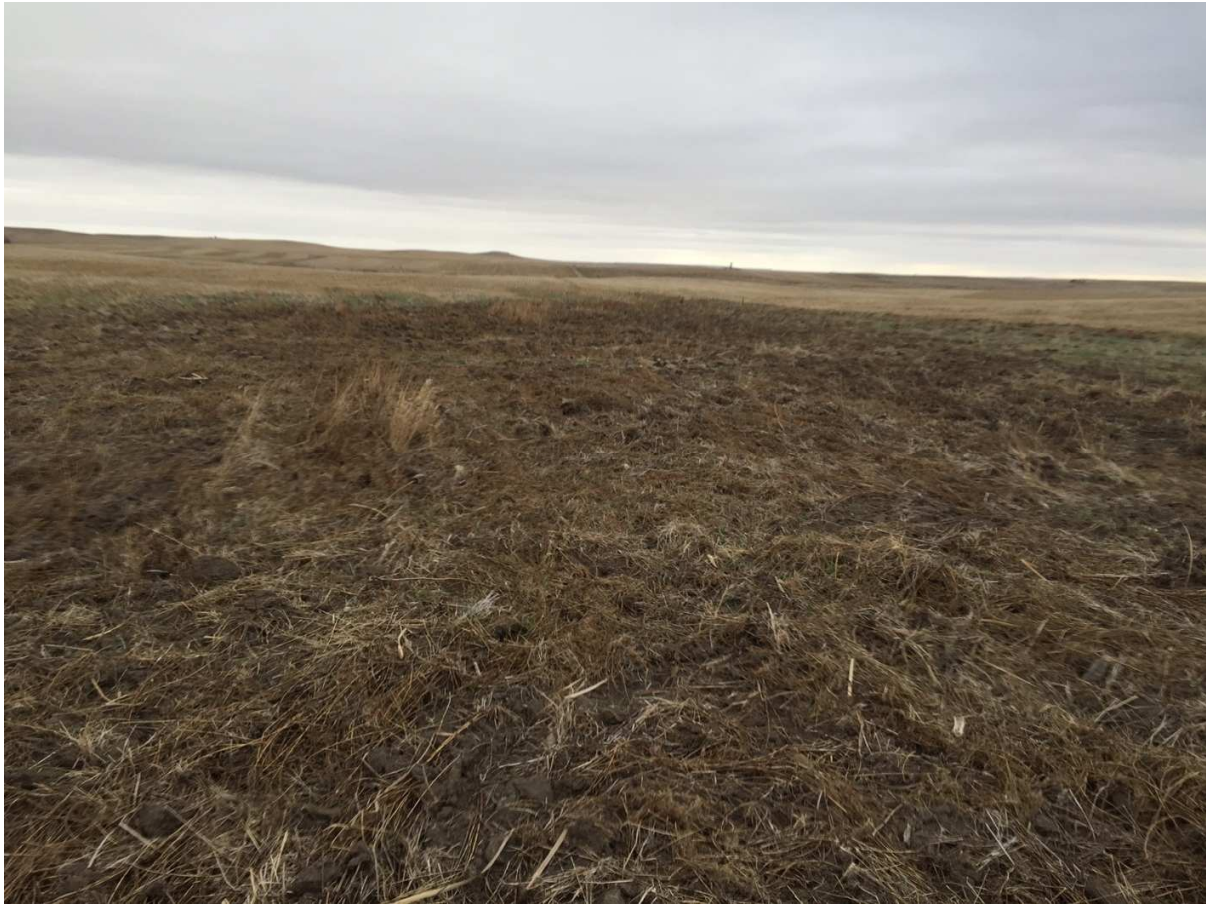
Photo 15: Wetland 1C. A depressional wetland in a recently plowed field.

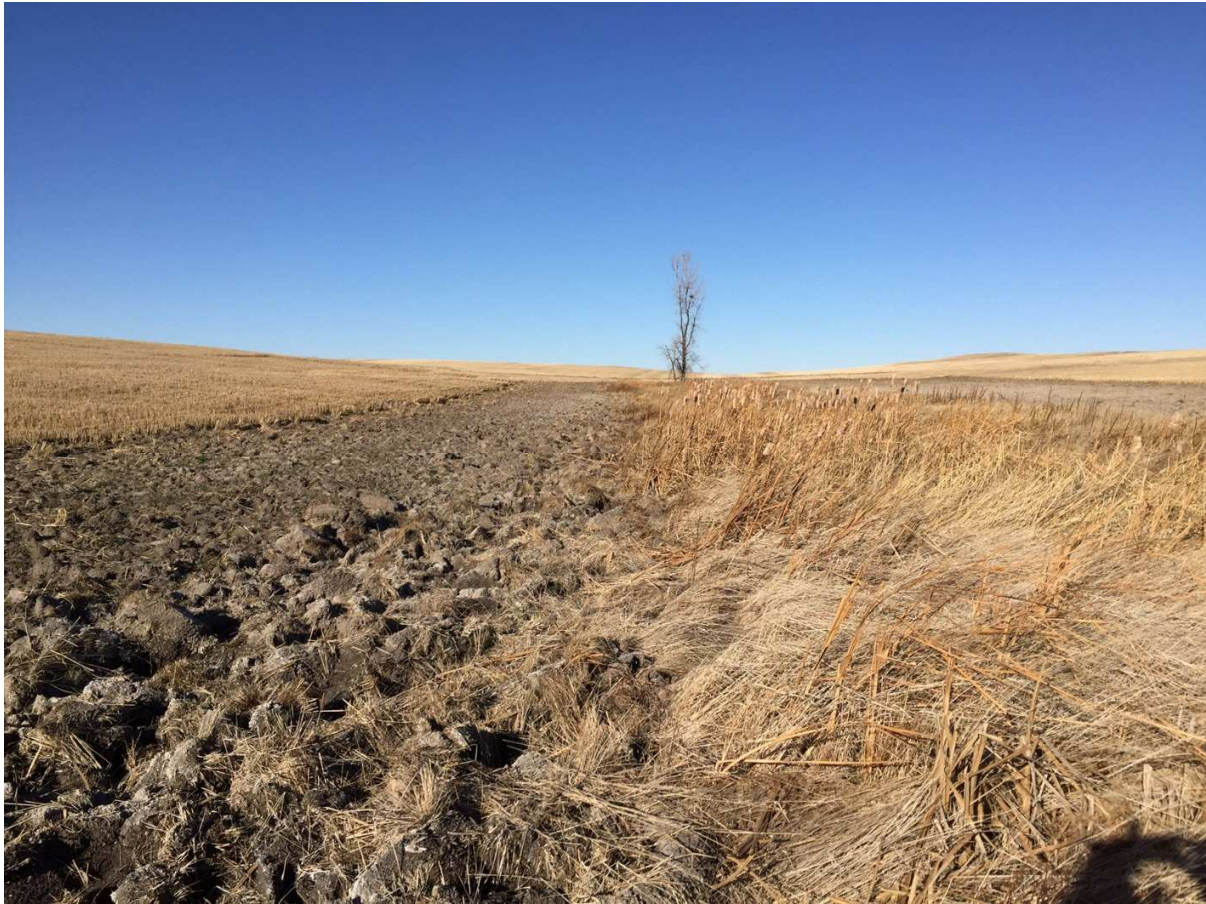
Photo 16: Wetland 3C. A depressional wetland in a recently plowed field. Cattails in the center-right of photo are obligate wetland plants.

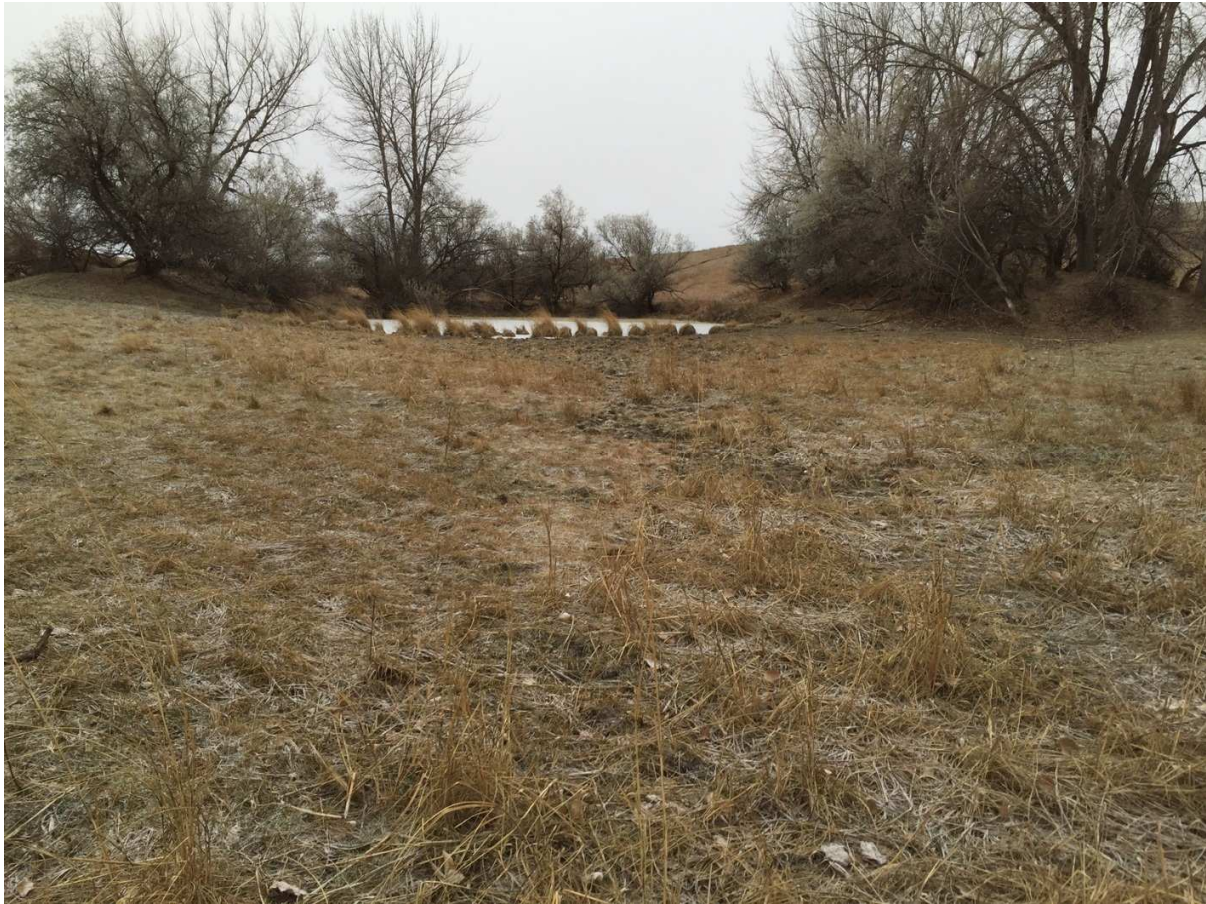
Photo 17: Wetland 5C. A wetland adjacent to Pond 1C.
