**Brady Transmission Line
Brady Wind, LLC
Stark County, North Dakota**

December 2015

Prepared by:
Tetra Tech, Inc.
350 Indiana Street, Suite 500
Golden, CO 80401

**Consolidated Application to the North Dakota Public Service
Commission for a Waiver or Reduction of Procedures and Time
Schedules and Certificate of Corridor Compatibility and Transmission
Facility Route Permit**

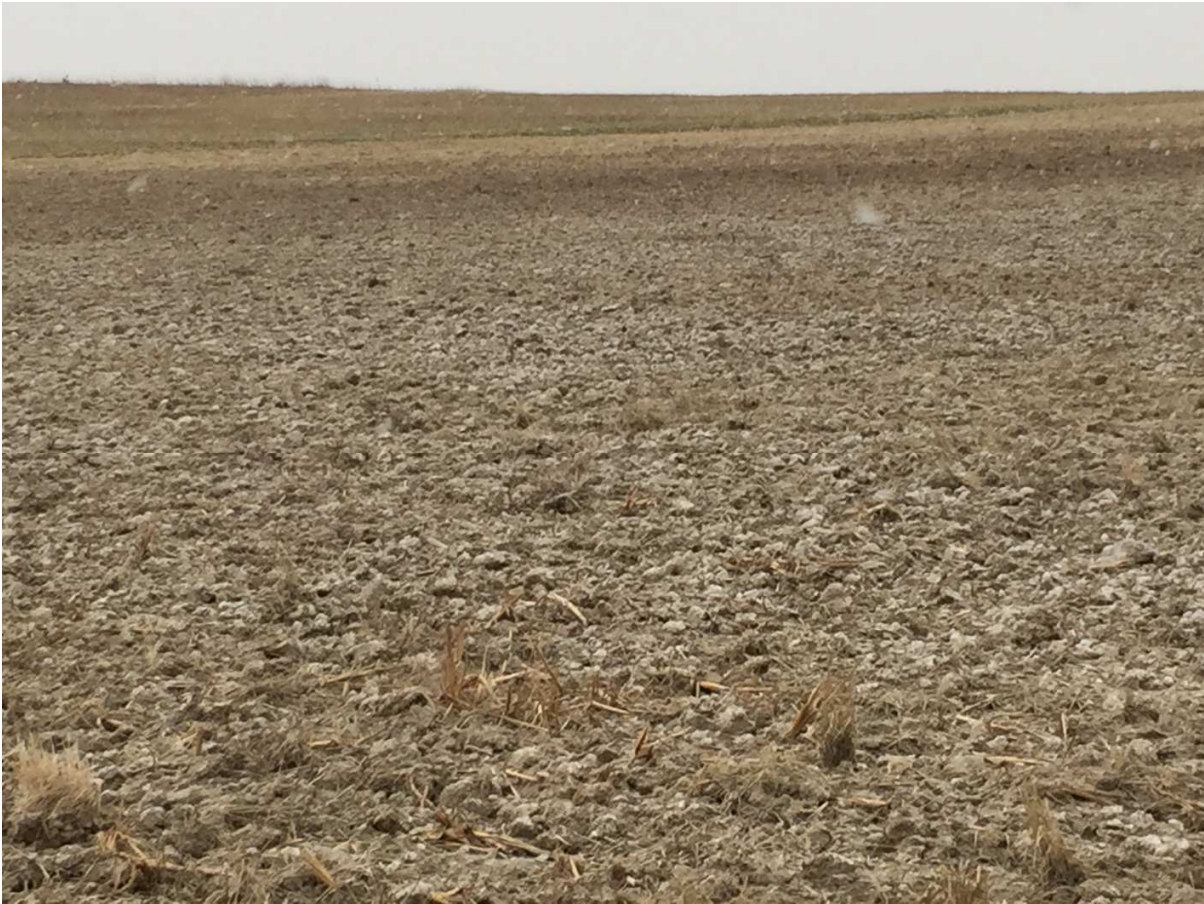
Photo 18: Wetland 7C. A depressional wetland in a recently plowed field. A distinct salt crust has formed on the surface of the soil which is a hydrology indicator.

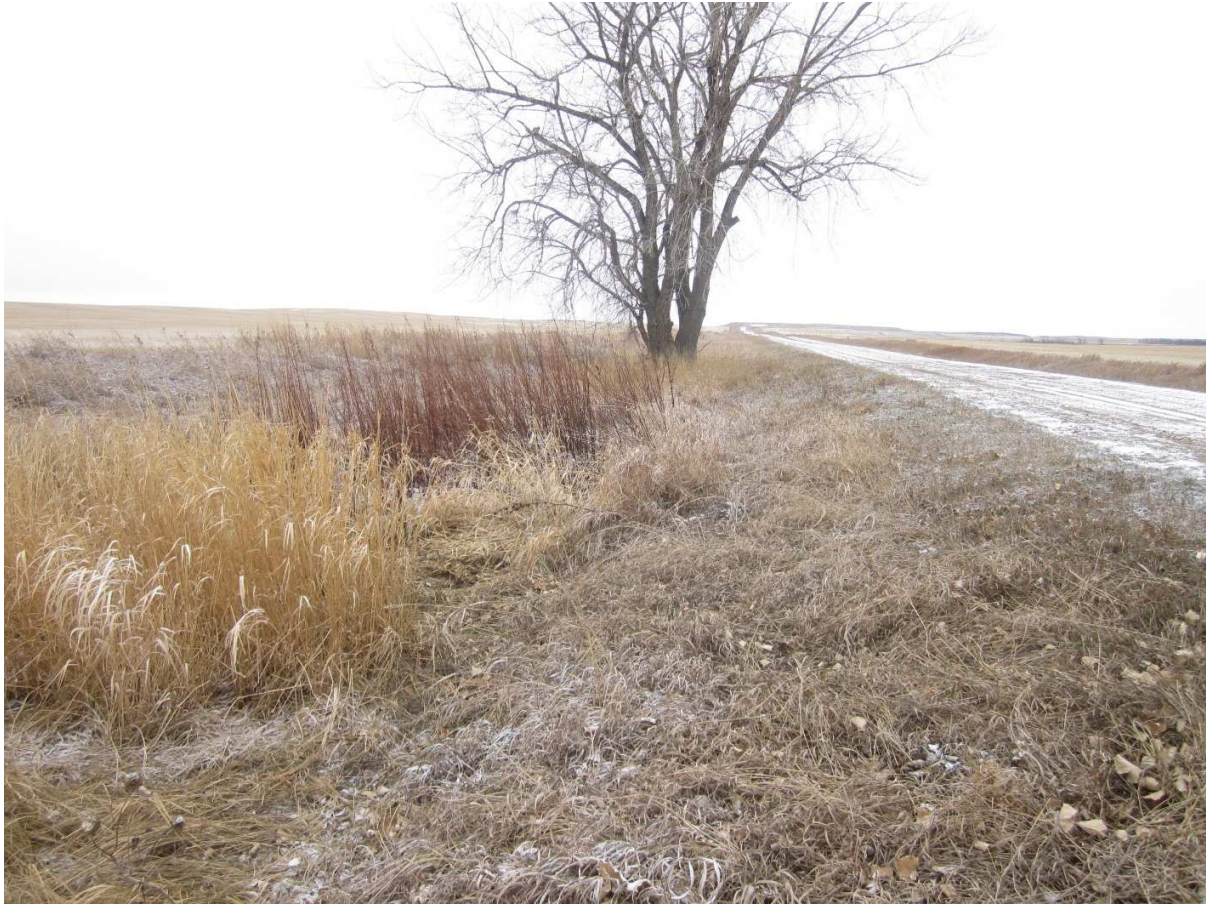
Photo 19: Wetland 1C. A depressional wetland in a recently plowed field.

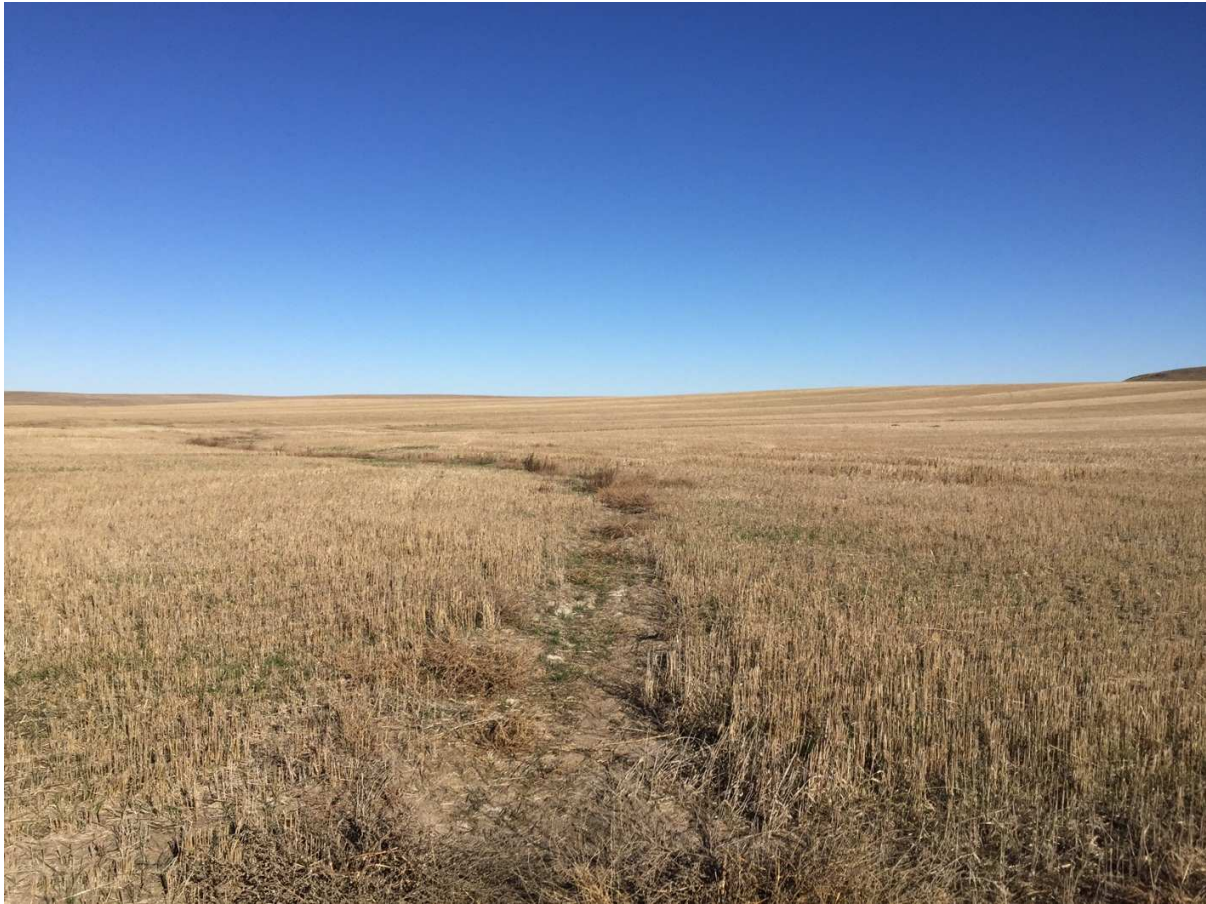
Photo 20: Stream 1C. A typical narrow ephemeral stream feature in an agricultural field. There is a distinct vegetation change from the fields and the channel.

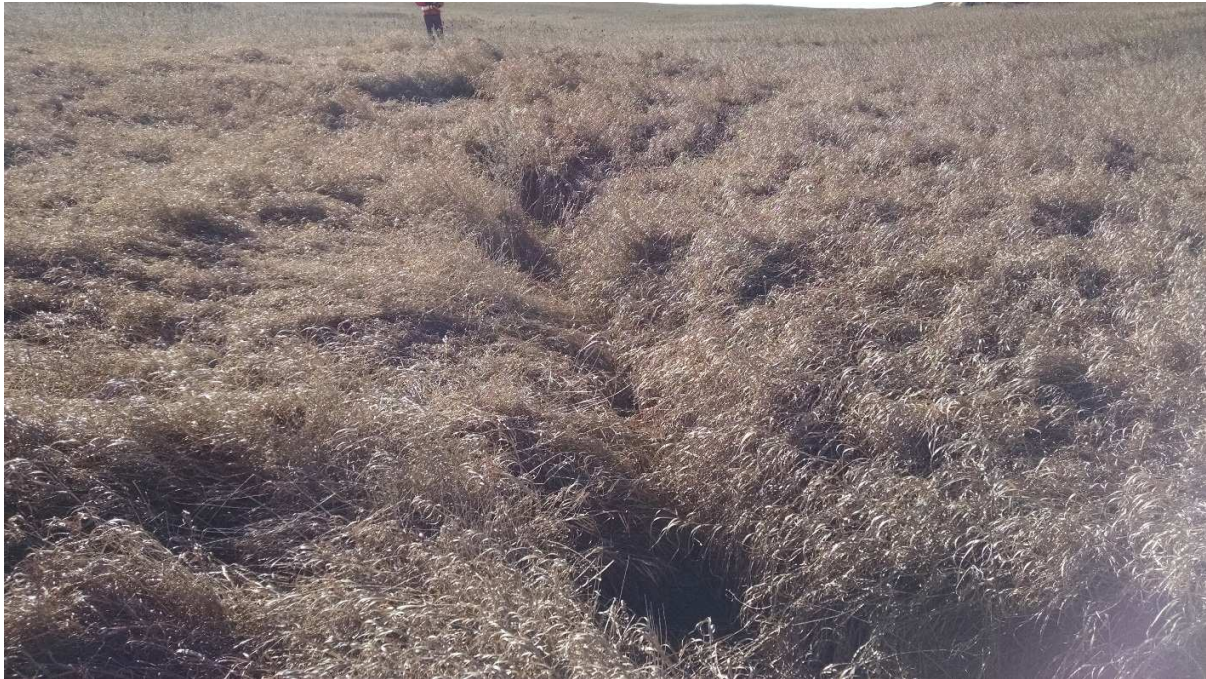
Photo 21: Stream 2D. A typical narrow ephemeral stream feature in a grassland. The stream channel is overgrown with the surrounding vegetation.

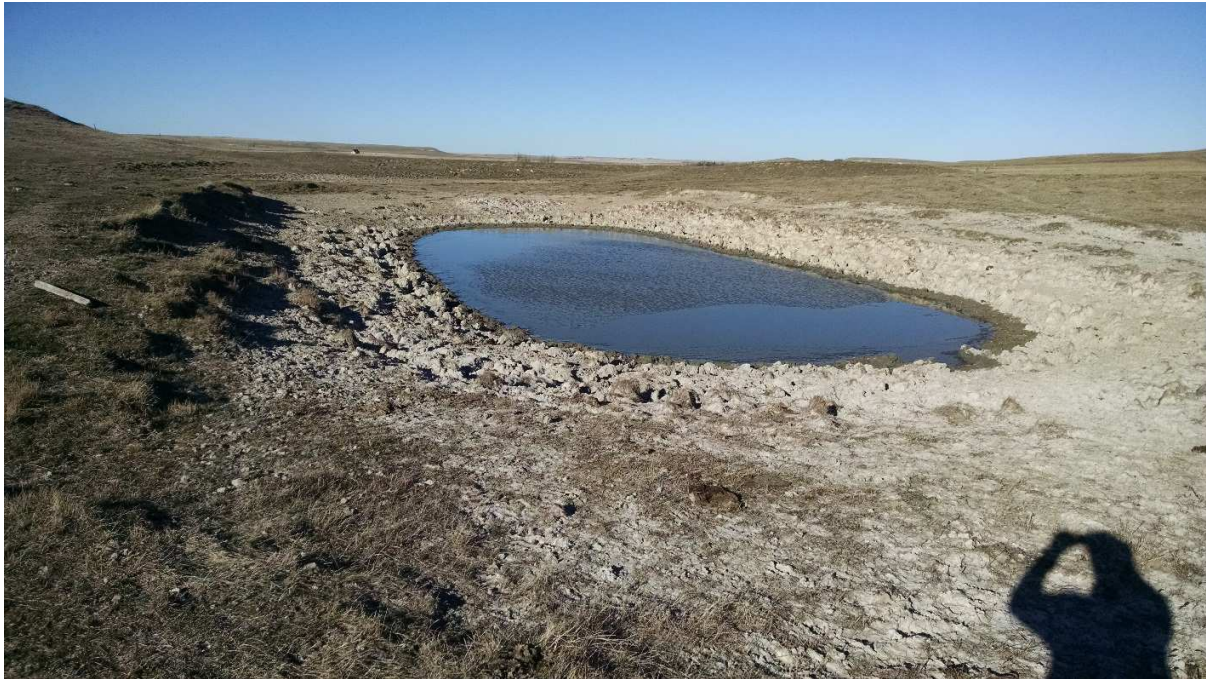
Photo 23: Pond 1D. A typical pond likely used for agricultural purposes.
