**Site/Project Location:** Brady Wind Transmission Line – Stark County **Date of Inspection:** 16 August 2016

Construction inspection of sites to focus on (1) confirming surface disturbance/work occurring within ND PSC-approved work corridor and/or route; (2) topsoil segregation occurring; (3) vegetation removal consistent with tree & scrub mitigation plan.

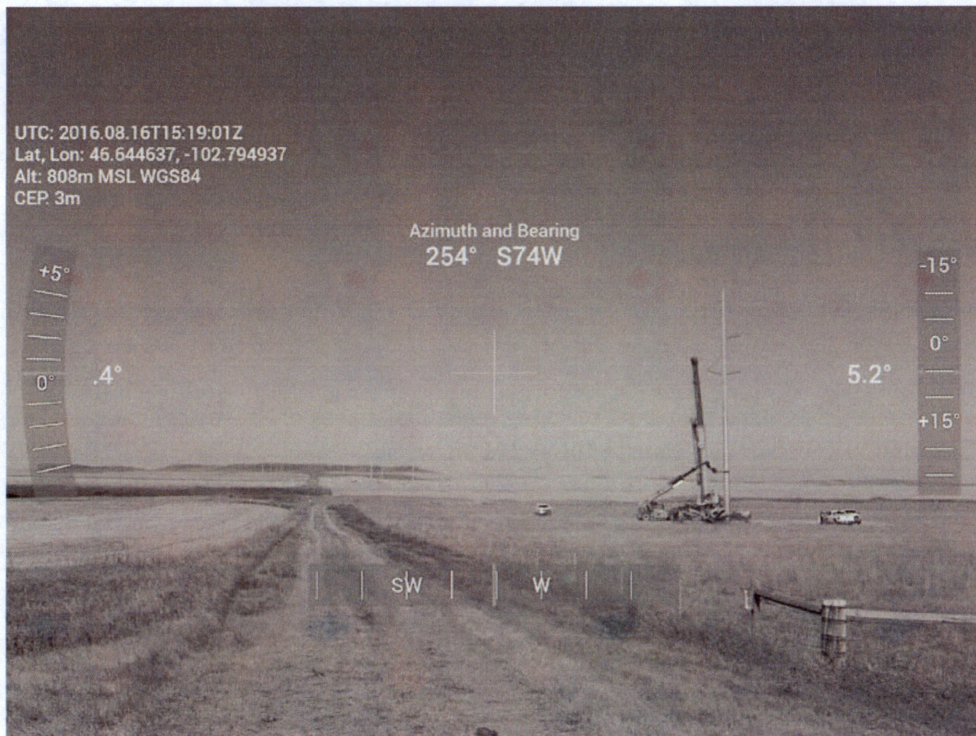
**Report Photo #1 "Final Pole West Of ND22"**

The area around poles where equipment was parked during construction does not look to be disturbed. Crews did not clear any topsoil or vegetation while constructing the poles. The hole was dug with an auger and the pole placed in the hole. Soil from auguring the hole is piled off to the side of the work area. The pole was braced with equipment; all crew members were wearing proper PPE. Crew was observed using mats to move equipment across roads. Minor compaction of soil was observed due to equipment around the poles.
