Site/Project Location: Brady Wind Transmission Line – Stark County **Date of Inspection:** 26 September 2016

Construction inspection of sites focused on (1) confirming surface disturbance/work occurring within ND PSC-approved work corridor and/or route; (2) topsoil segregation occurring; and (3) vegetation removal consistent with tree & scrub mitigation plan.

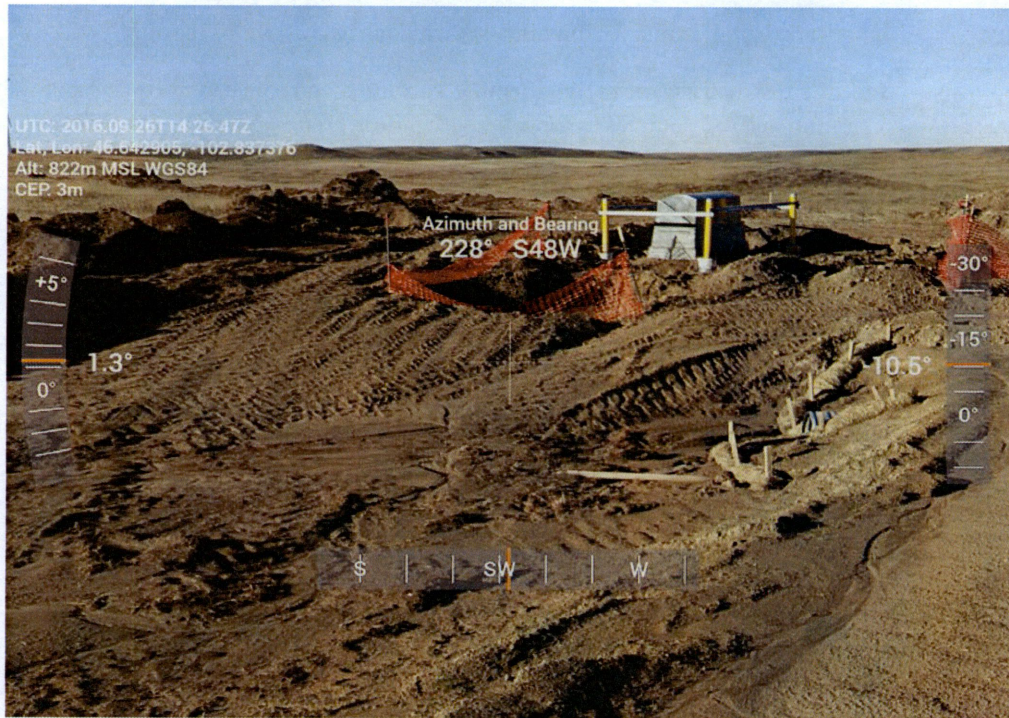
The Brady Wind Transmission Line project is at the final stages of construction. Crew has completed topsoil reclamation on most of the gathering lines currently in the ground and expect to seed on the buried lines in the spring to ensure seed growth.

The poles for the transmission line have been erected and transmission lines have been strung. The crew has buried gathering lines to current turbines and is working on laying gathering lines to the future turbines on the project. Crew has informed Keitu that topsoil will be replaced on disturbed areas on the gathering lines and the reclaim will most likely be finished in the spring when conditions are more suitable for seed regrowth.

Report Photo #1 "Gathering Line West of 112th Ave SW"

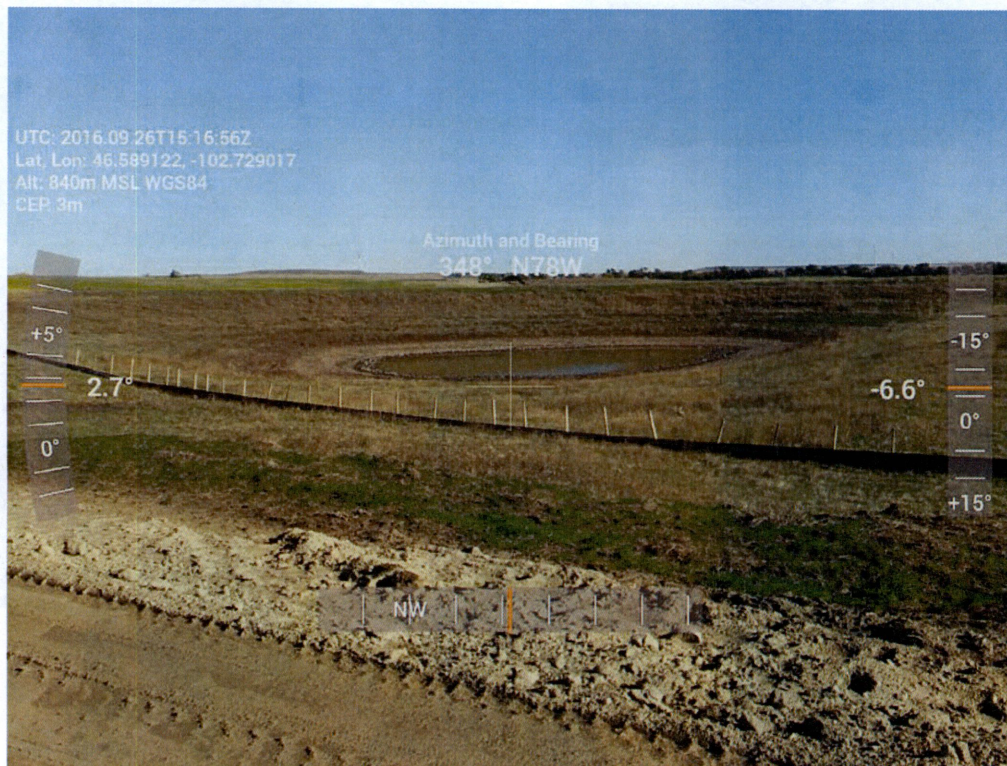
Weather conditions from the weekend have damaged a silt fence (see photo 2), Kyle McNab informed me the issue will be fixed by the end of the day

Report Photo #2 "Silt Fence At Wetland West of 112th Ave SW"
