ONEOK 8-inch Bear Creek Pipeline Project As-Built Inspection Report PU-15-801

1.0 Executive Summary

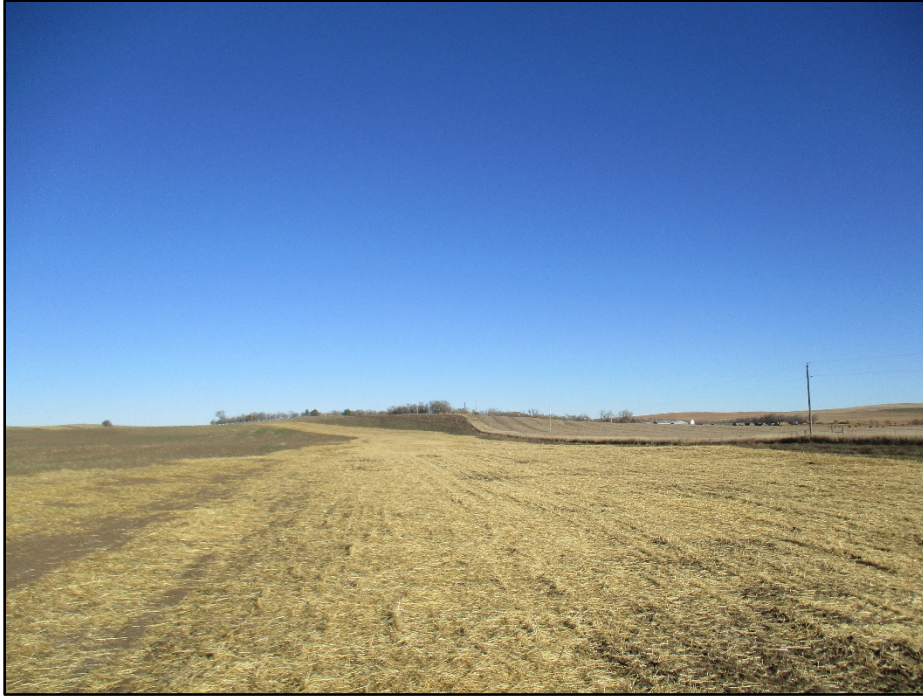
Photo 1. (near GPS Point #495) – Pipeline ROW, contours appear adequate. Area has been seeded and mulched. Direction: North.

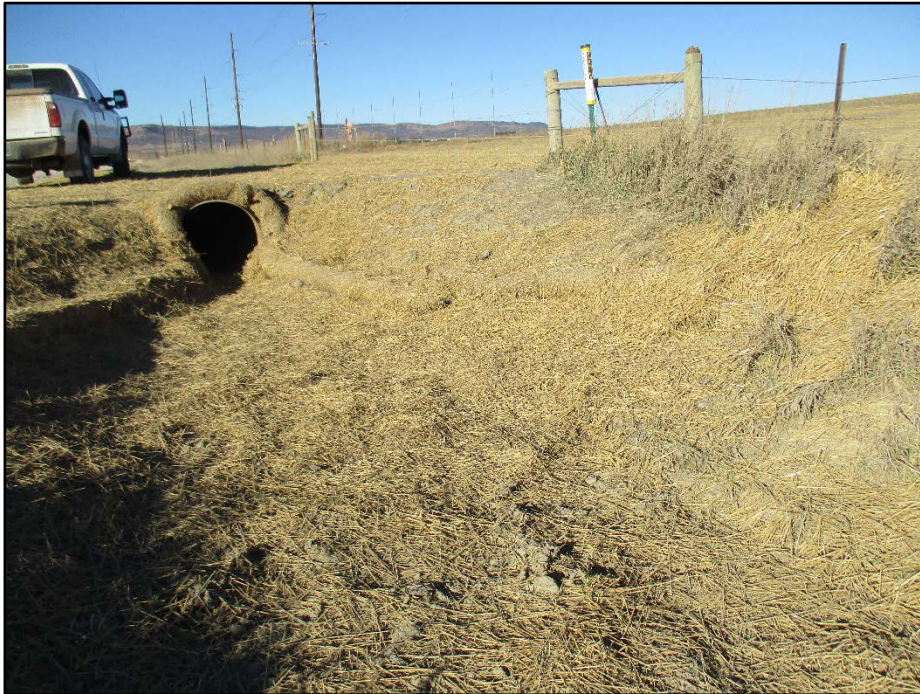
Photo 2. (GPS Point #495) – Approach to field/pipeline ROW from road. Area has fence with gate, pipeline marker, culvert, straw wattles, and mulch.

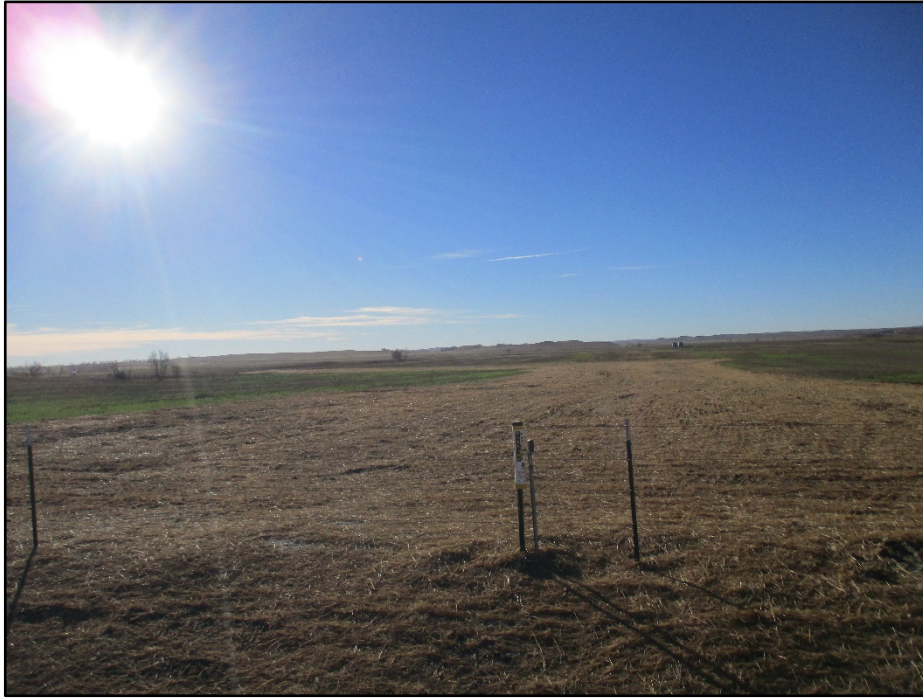
Photo 3. (GPS Point #496) – Pipeline ROW through field. Area has been mulched and seeded. Pipeline marker/sign (near center of photo) along fence line. Direction: East.

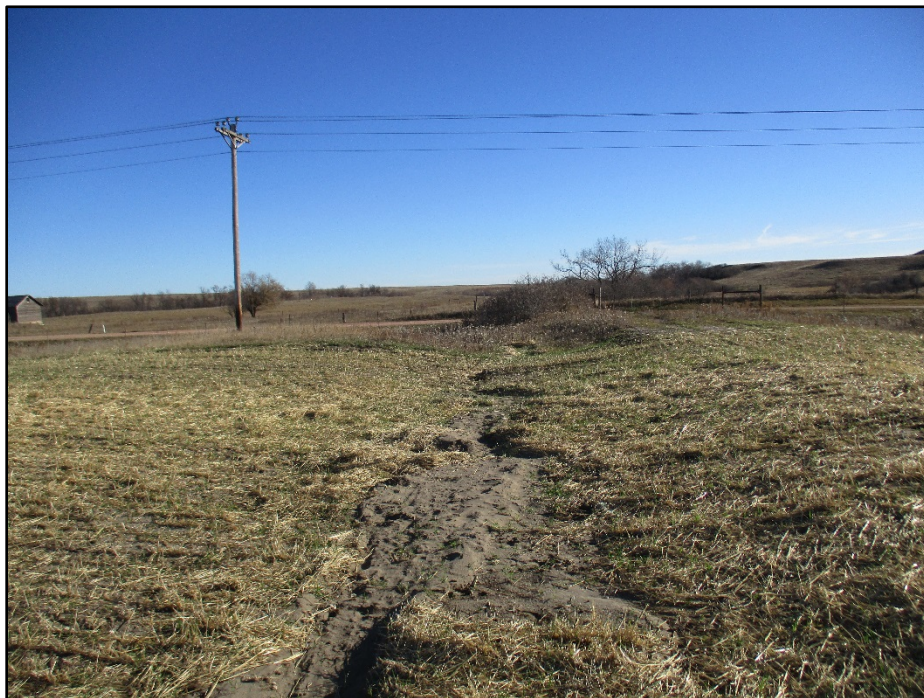
The Project Application states BMPs would be used during and after construction to minimize soil erosion and protect surface water. At the time of inspection there were two areas where some sedimentation and rills were starting to form (**Appendix A**, Photo 4). The ONEOK representative immediately called their reclamation department to come address the issue. During the site inspection it was evident that BMPs had and were being used to minimize erosion and maintain drainage because there were minimal to no erosion or drainage problems observed (**Appendix A**, Photo 2, 5, 6, 8, 19).

Photo 4. (GPS Point #497) – This area had some sedimentation and rills forming (erosional features) within the pipeline ROW. The area was sandy. While on-site the ONEOK representative called their reclamation team to come address the problem. Direction: East.

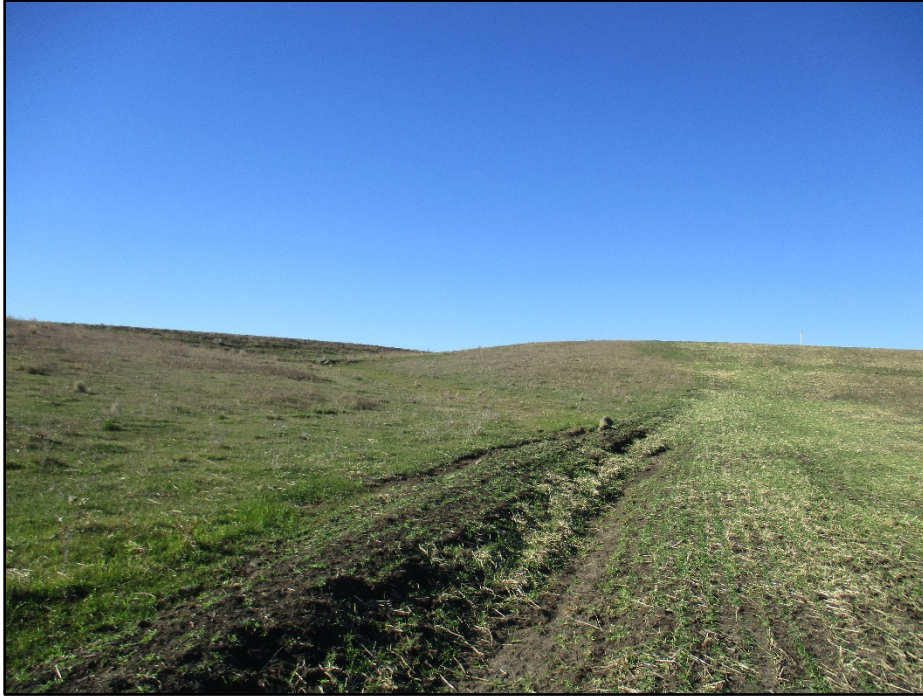
Photo 5. (GPS Point #498) –Grasses starting to grow within the pipeline ROW. The waterbar (shown to the left center of photo) helps divert or slow water from the drainage area away from the pipeline ROW. Direction: West.

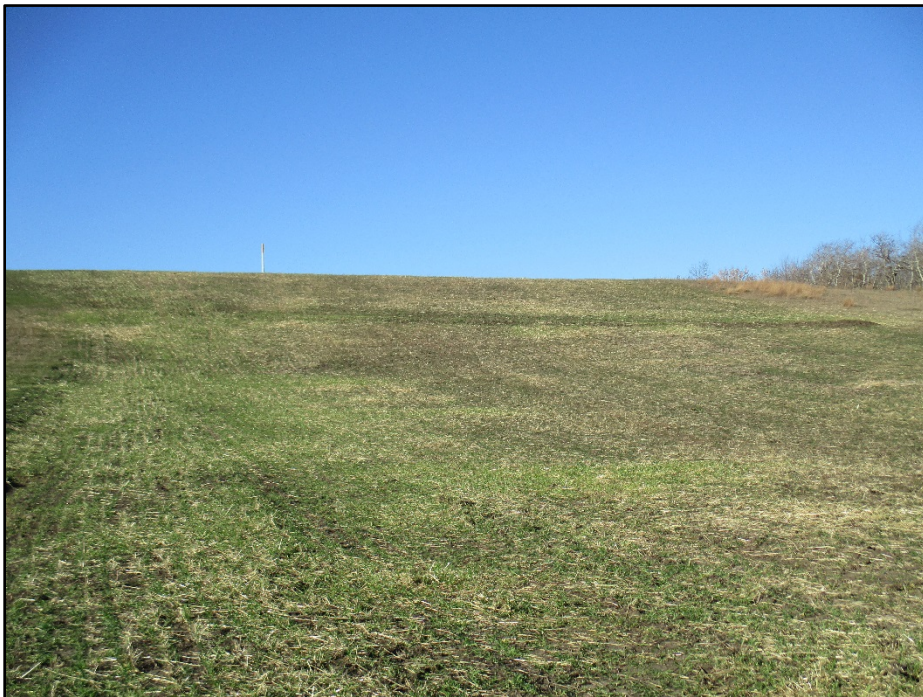
Photo 6. (GPS Point #498) – Grasses growing within the ROW. Shown above is a waterbar, near the top of the hill, and a pipeline marker at the top of the hill. Direction: West.

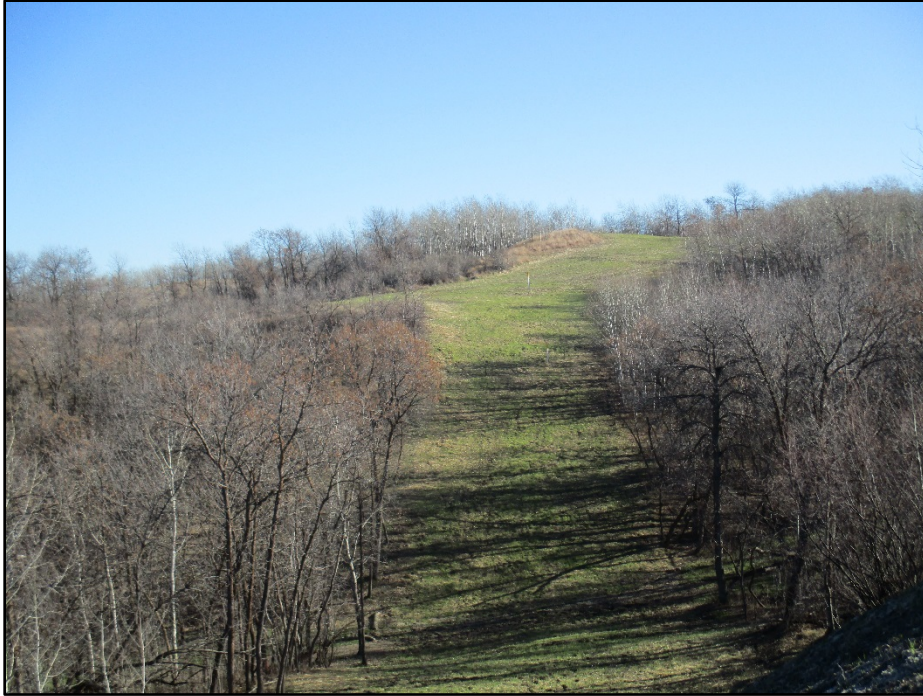
It appeared that in general, major woody areas were avoided through Project siting (**Appendix A**, Photo 7, 9). A tree and shrub count was done within the area expected to be impacted by construction (Docket #1, Consolidated Application, Appendix C). It was estimated that approximately 11,343 tree and shrubs would be disturbed by the 50-ft construction ROW and 22,686 saplings would need to be replanted to fulfill the 2:1 mitigation requirement (Docket #1, Consolidated Application). ONEOK states in their Application that replacement of trees and shrubs will be based upon actual impacts due to construction and will meet the 2:1 ratio specified and will be documented. A replacement plan or follow-up tree and shrub count report was not found in the documentation. It is recommended that the PSC follow up with ONEOK to ensure that tree mitigation efforts are in progress.

Photo 7. (GPS Point #499) – Ravine area, with pipeline markers. Trees and shrubs were removed. Direction: East.

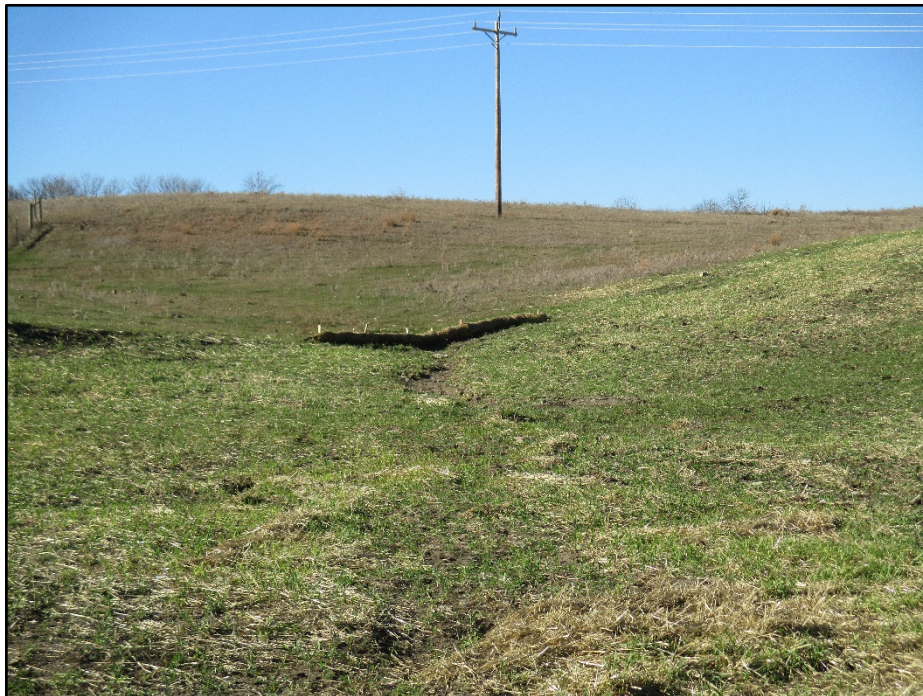
Photo 8. (GPS Point #500) – ROW through field. A straw wattle is shown above, with a small amount of erosion below it. Direction: Northwest.

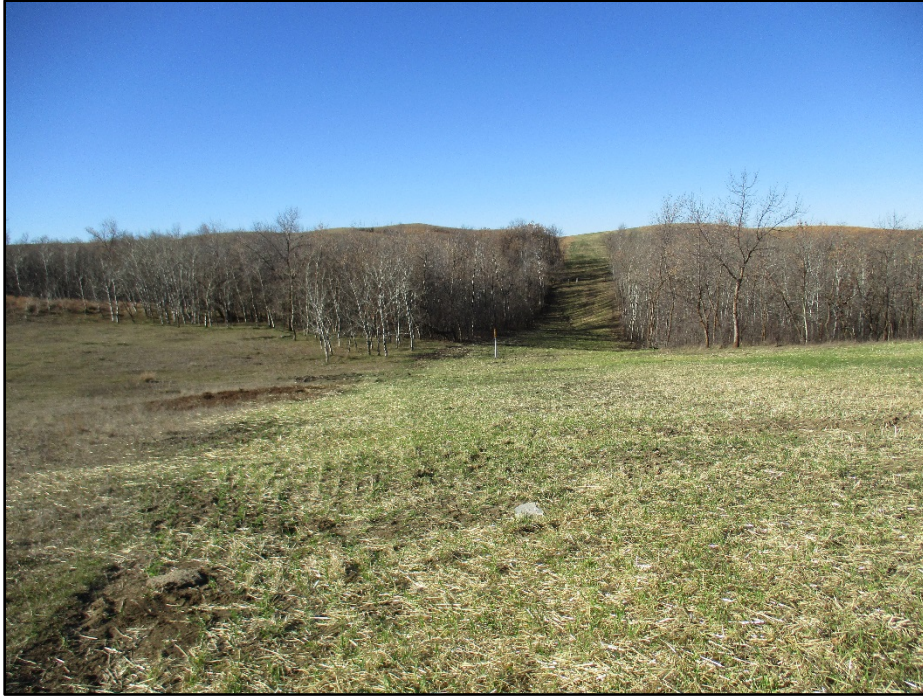
Photo 9. (GPS Point #501) – Ravine area with pipeline markers. Trees and shrubs were removed. Direction: West.

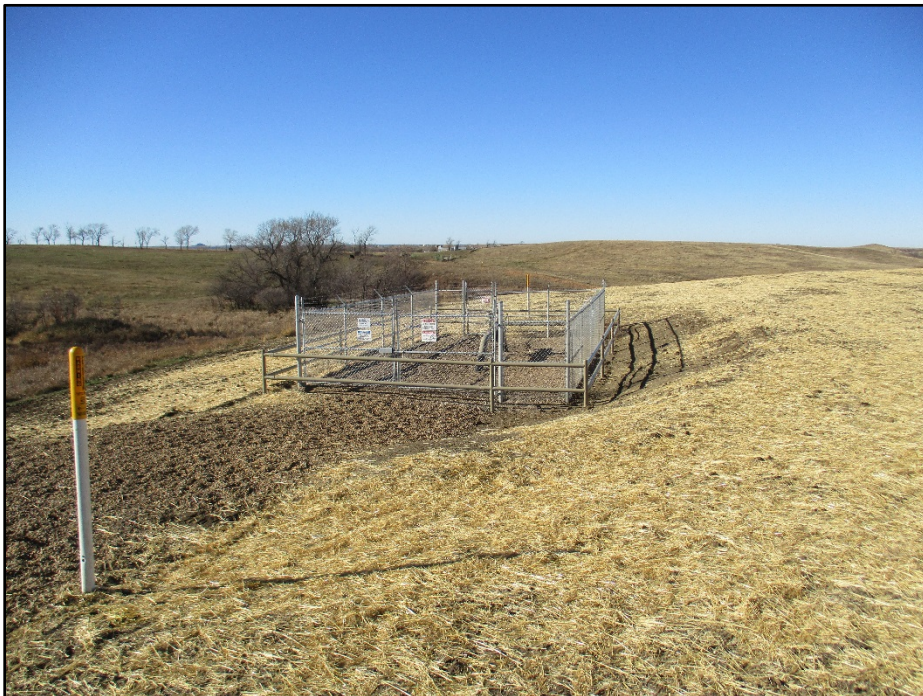
Photo 10. (GPS Point #502) – Pipeline ROW with fenced in block valve. Pipeline marker to the left of photo, area has been mulched and seeded. Direction: West.

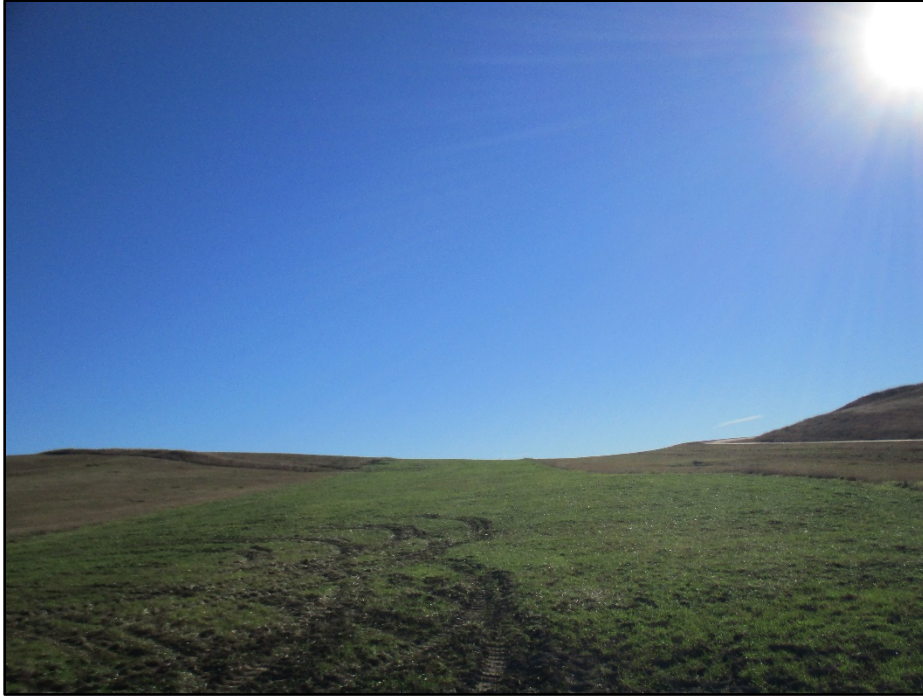
Photo 11. (GPS Point #502) – It appeared that the farmer had driven through the ROW (see tire marks on the lower left of photo). Area has been lightly grazed. Grasses are growing. Direction: East.

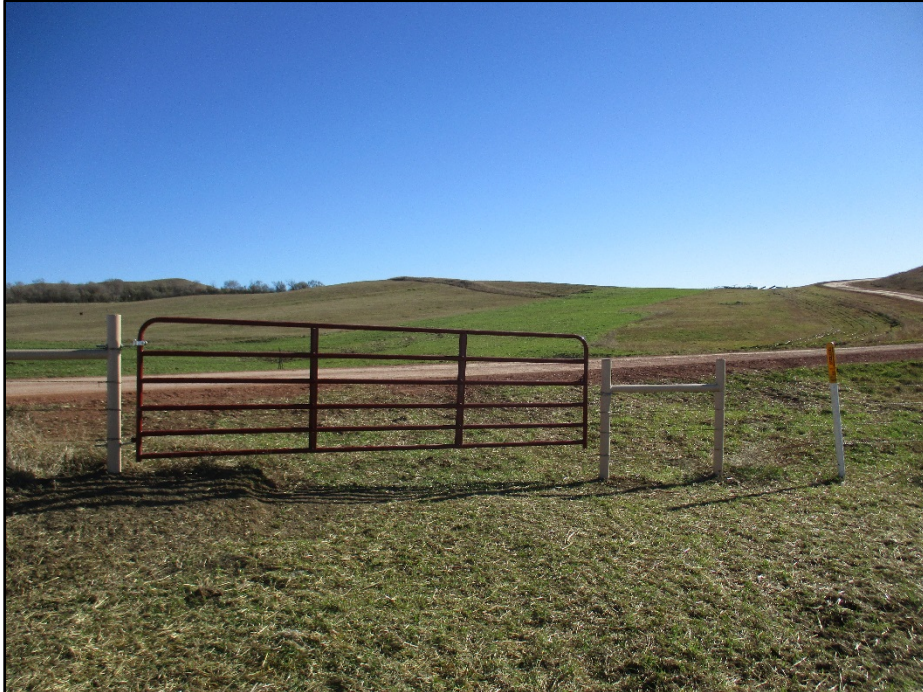
Photo 12. (GPS Point #502) – Pipeline ROW with fence gate and pipeline marker. Area was seeded and mulched. Grasses are growing. Direction: East.

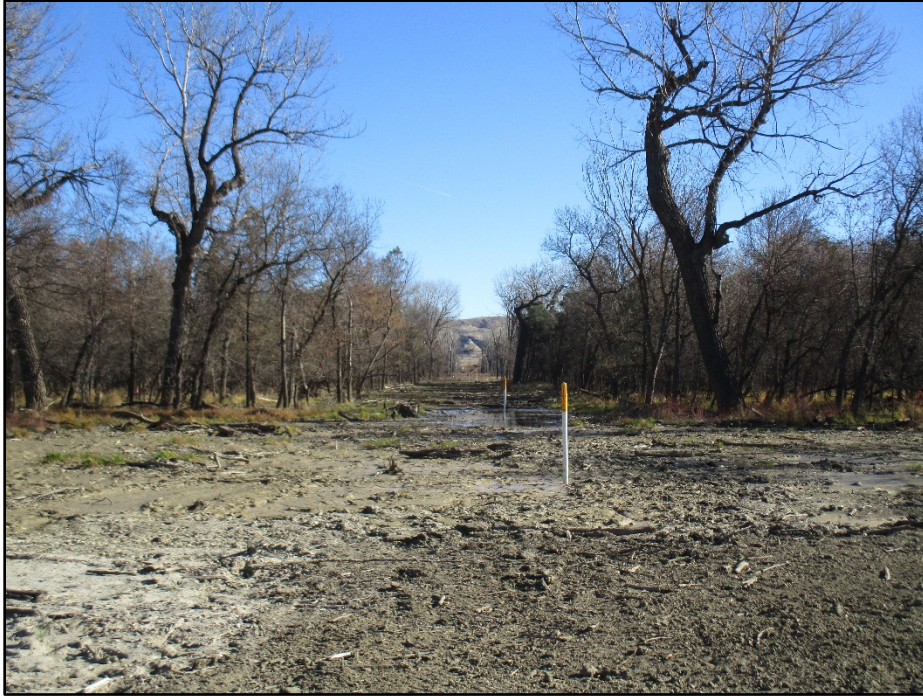
Photo 13. (GPS Point #503) – River bore location. Pipeline markers go through riparian area. Trees and shrubs were removed. Direction: East.

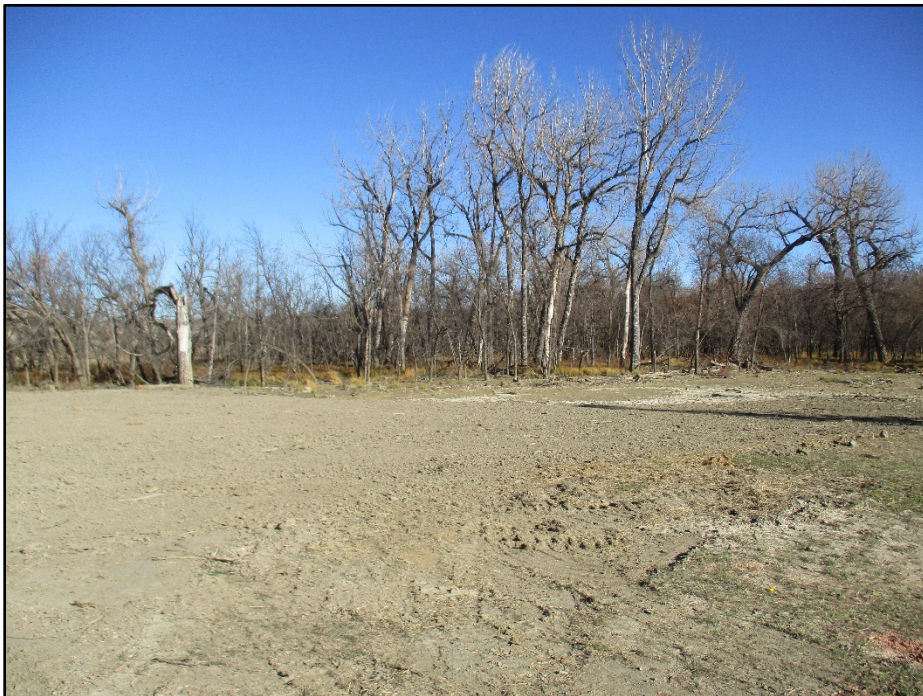
Photo 14. (GPS Point #503) – River bore location. This area has not been seeded and mulched yet, it was the only area during the inspection that had not yet had reclamation work completed on it. Reclamation work will be completed on this area very soon. Direction: Northeast.

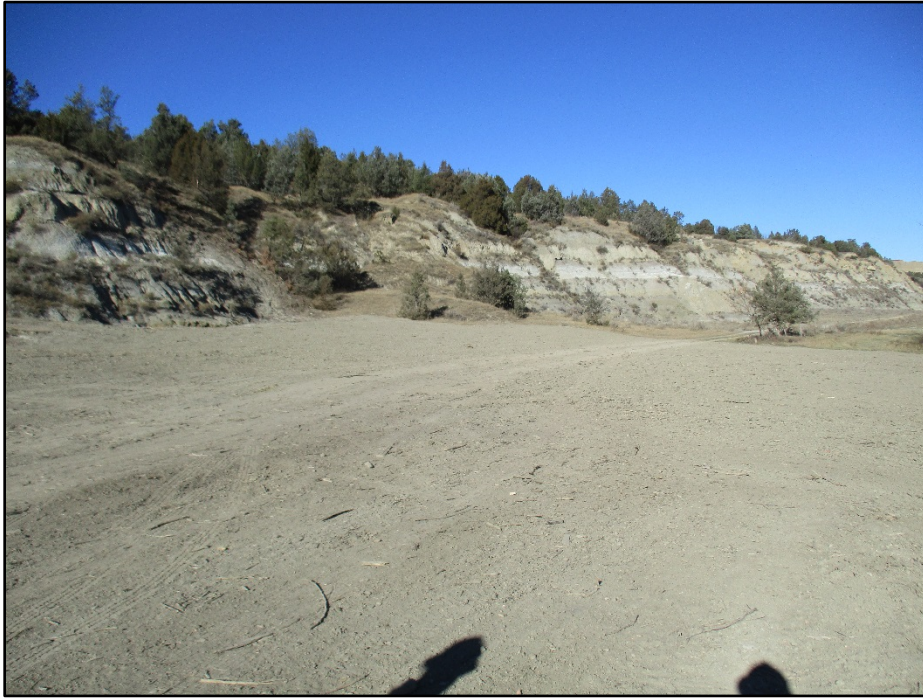
Photo 15. (GPS Point #503) – Bore location (river and cliff/hill bore, same area as above photo #14). Direction: Northwest.

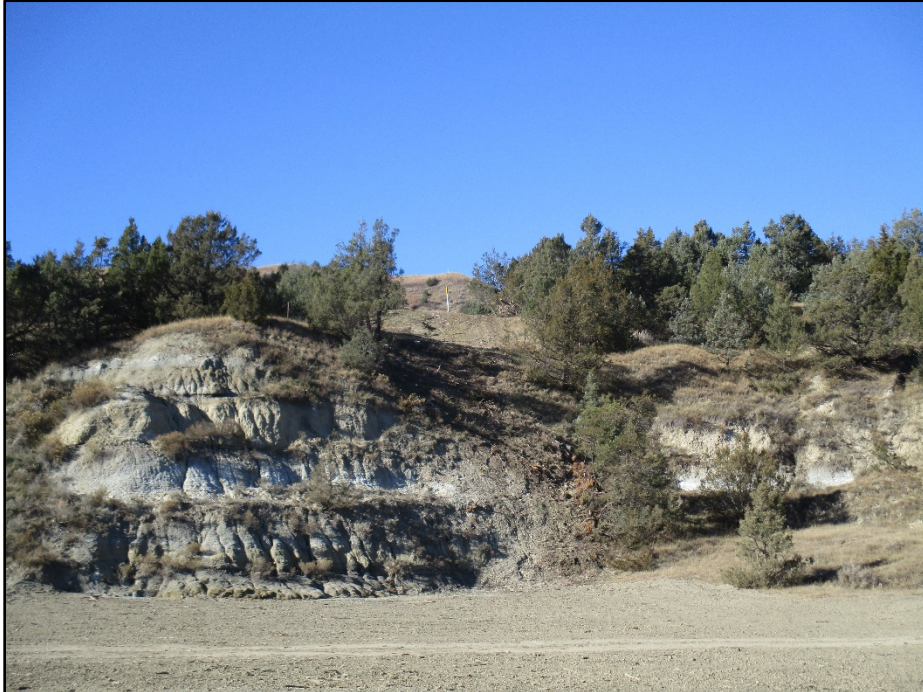
Photo 16. (GPS Point #503) – Pipeline ROW. Pipeline bored through hill/cliff area, bored with over 600 ft of elevation change. Pipeline markers were observed on hill tops. Direction: West.

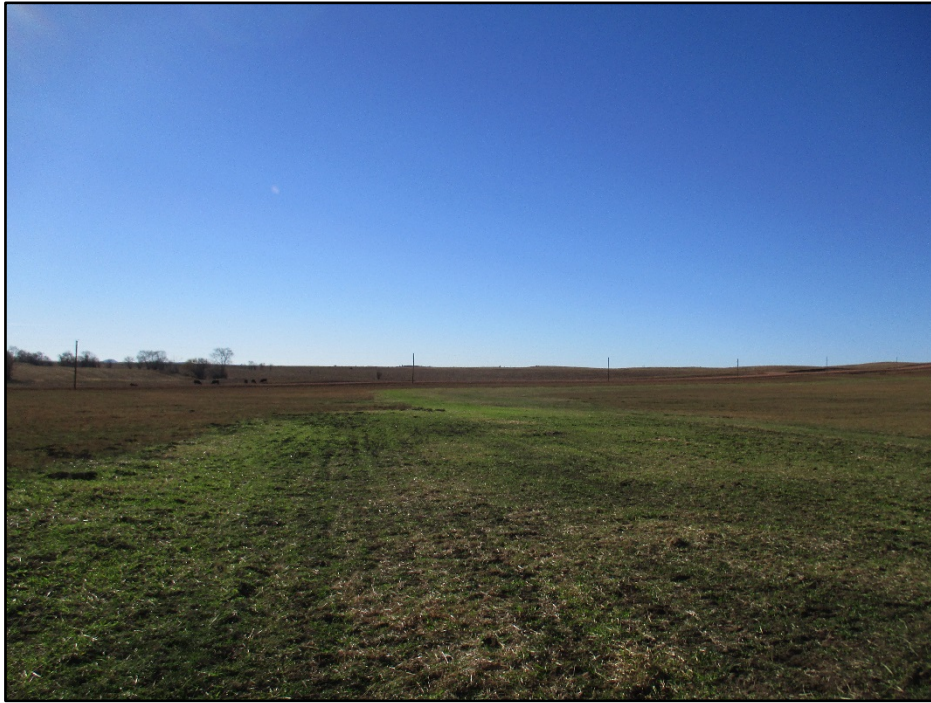
Photo 17. (GPS Point #504) – Pipeline ROW going through rangeland. Area was seeded and mulched, contours appear adequate. Area is being grazed. Direction: Southwest.

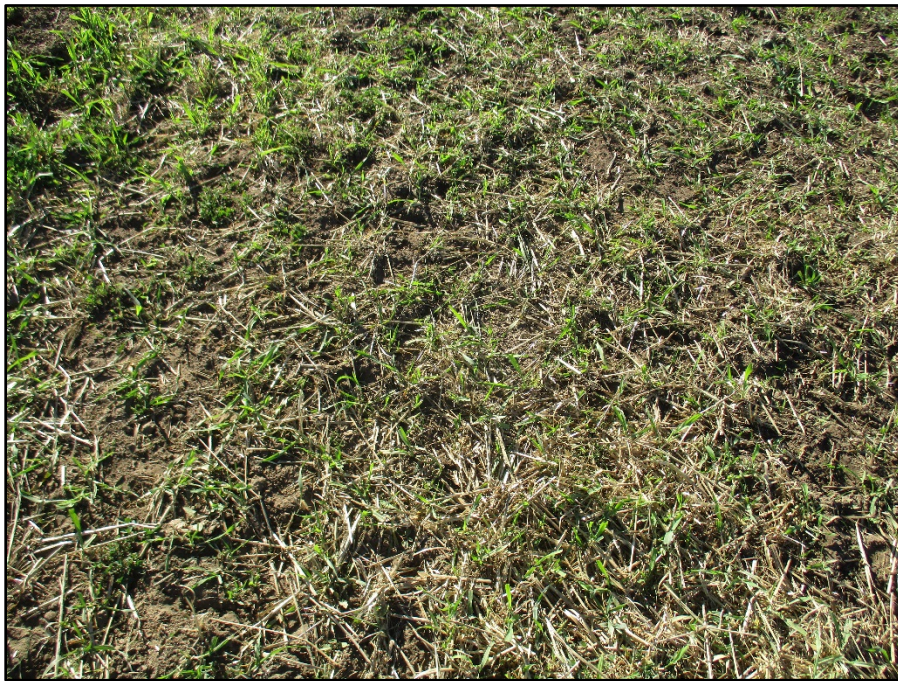
Photo 18. (GPS Point #504) – Pipeline ROW going through pasture. Grasses are growing.

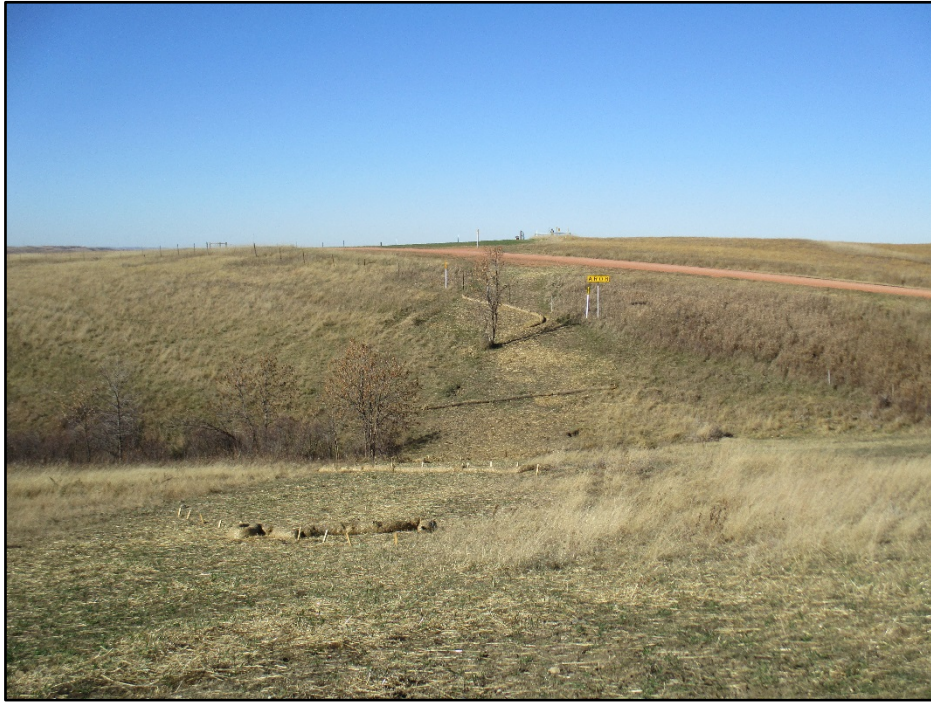
Photo 19. (GPS Point #505) – Pipeline ROW on state land with straw wattles for erosion control. Direction: Northwest.

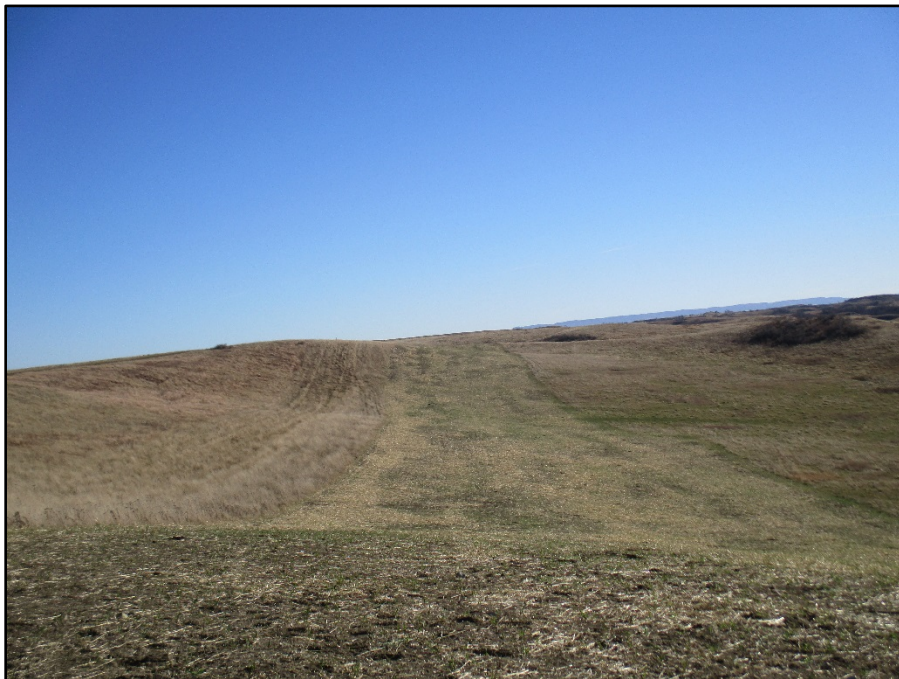
Photo 20. (GPS Point #505) – Pipeline ROW through state land. Contours appear adequate. Grasses are starting to grow. Direction: Southeast.

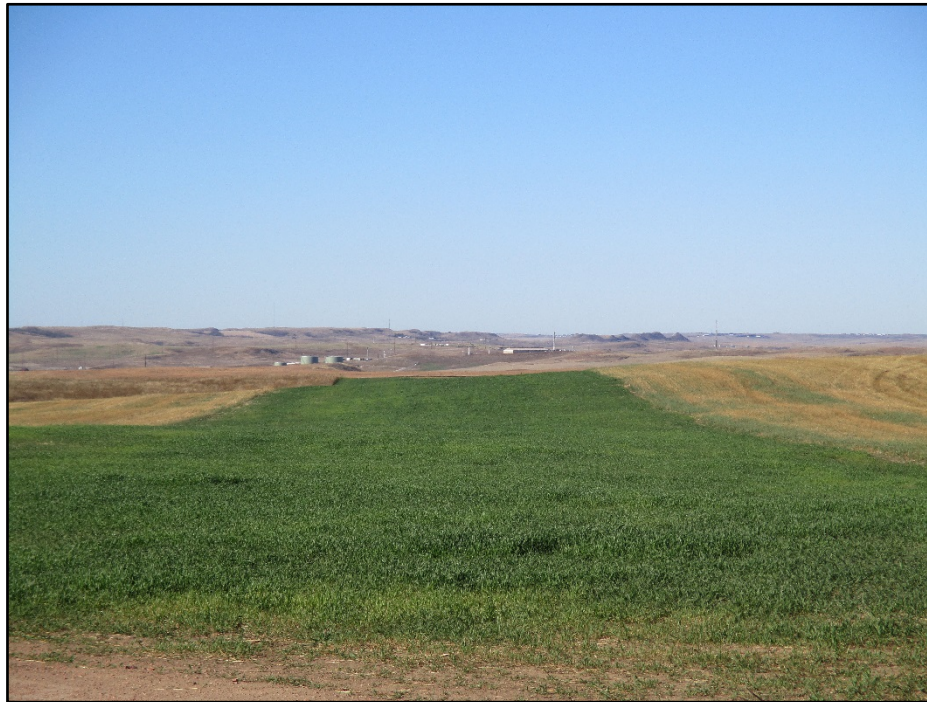
Photo 21. (GPS Point #506) – ROW through field. Grasses growing very well. Direction: Northwest.

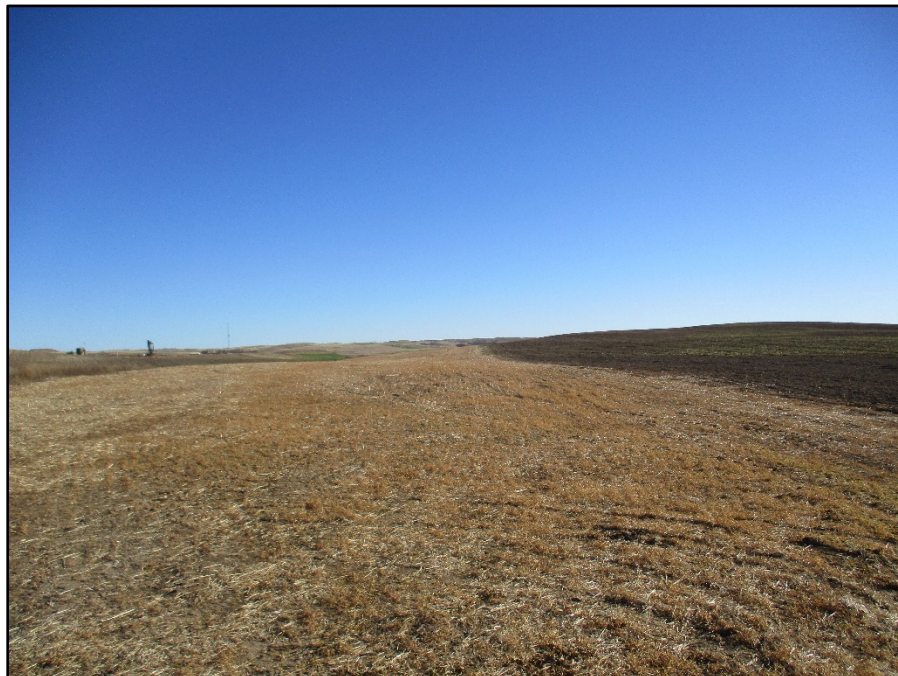
Photo 22. (GPS Point #506) – Pipeline ROW through field. Area mulched and seeded. The area did have grasses growing previously. It appears that it was potentially sprayed, or when the adjacent field was sprayed the wind carried the herbicide over to this area. Direction: Southeast.

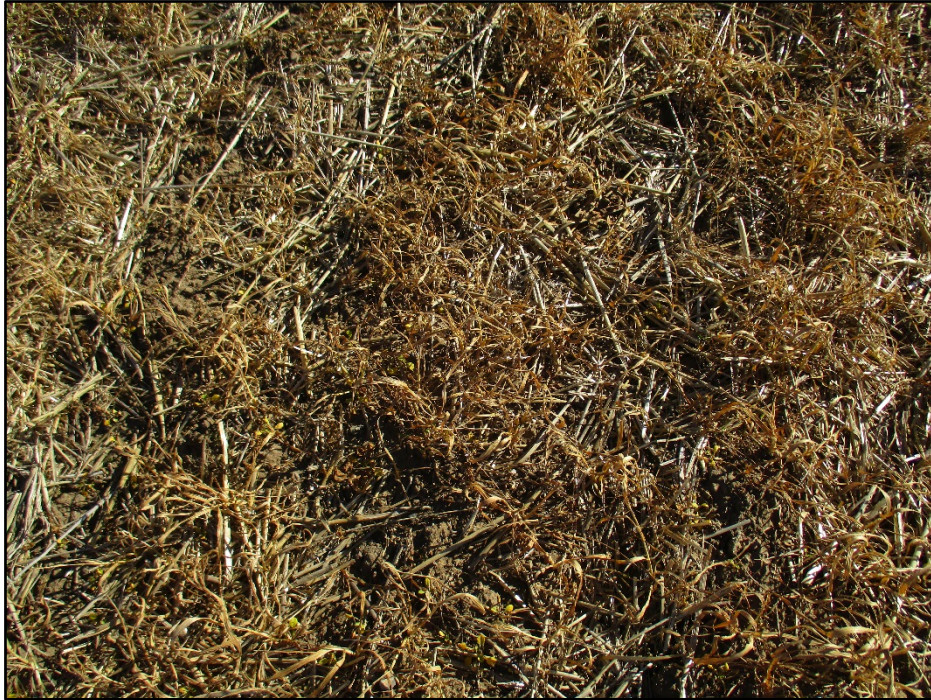
Photo 23. (GPS Point #506) – Pipeline ROW through field (same area as photo #22). Grasses had started to grow, now they are mostly dead and tan in color and blend in with the mulch.

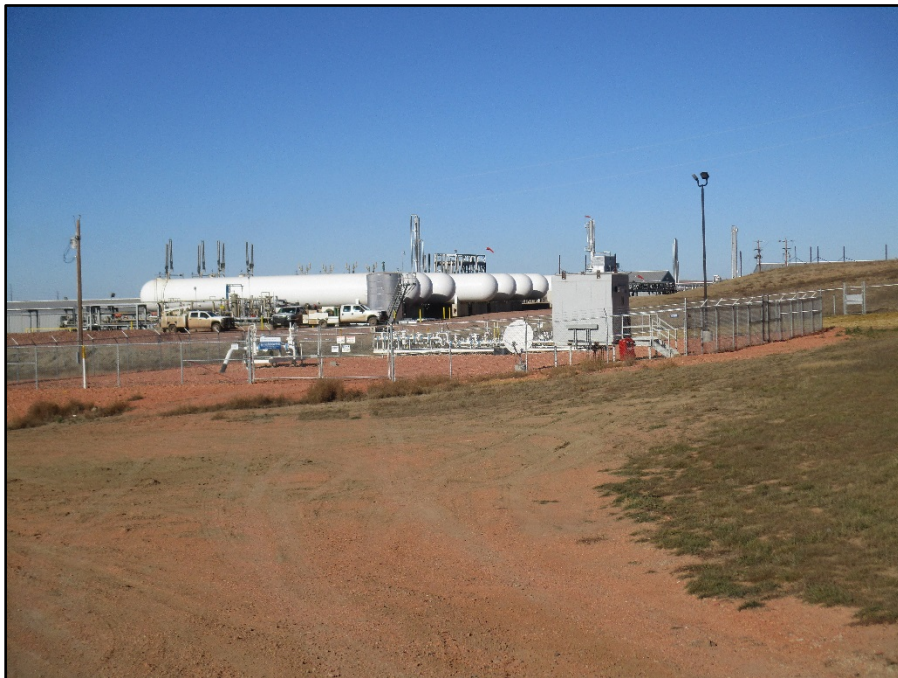
Photo 24. (GPS Point #507) – End of the pipeline, this is where it ties into the Targa NGL Pipeline. Direction: Northwest
