Re: Case No. 10,268

Figure 1
Designated Corridor (Case Number 10268, 1982);
Proposed Partial Pipeline
 Dakota Gasification Company: Pipeline Replacement Project

Dakota Gasification: Pipeline Replacement – A Class I & III Cultural Resources Inventory

**Dakota Gasification: Pipeline
Replacement – A Class I & III Cultural
Resources Inventory**

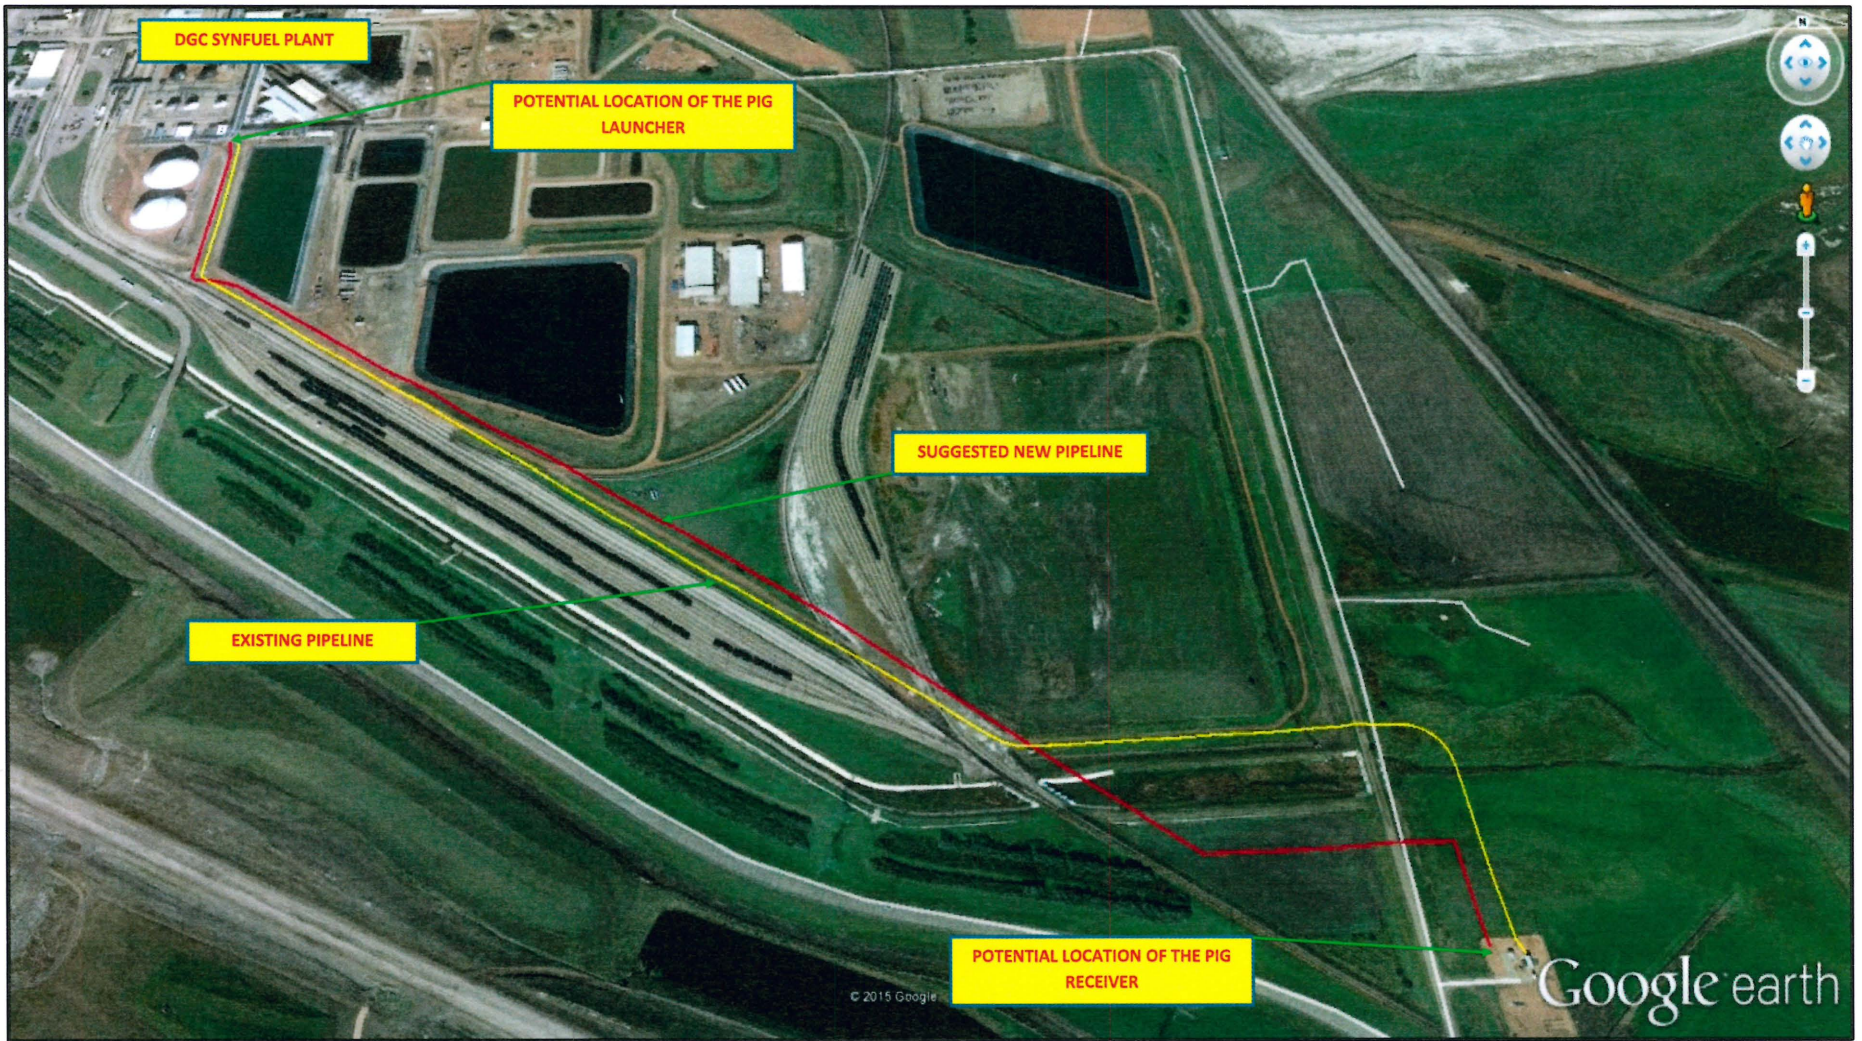
POTENTIAL LOCATION OF THE PIG LAUNCHER

SUGGESTED NEW PIPELINE

EXISTING PIPELINE

POTENTIAL LOCATION OF THE PIG RECEIVER

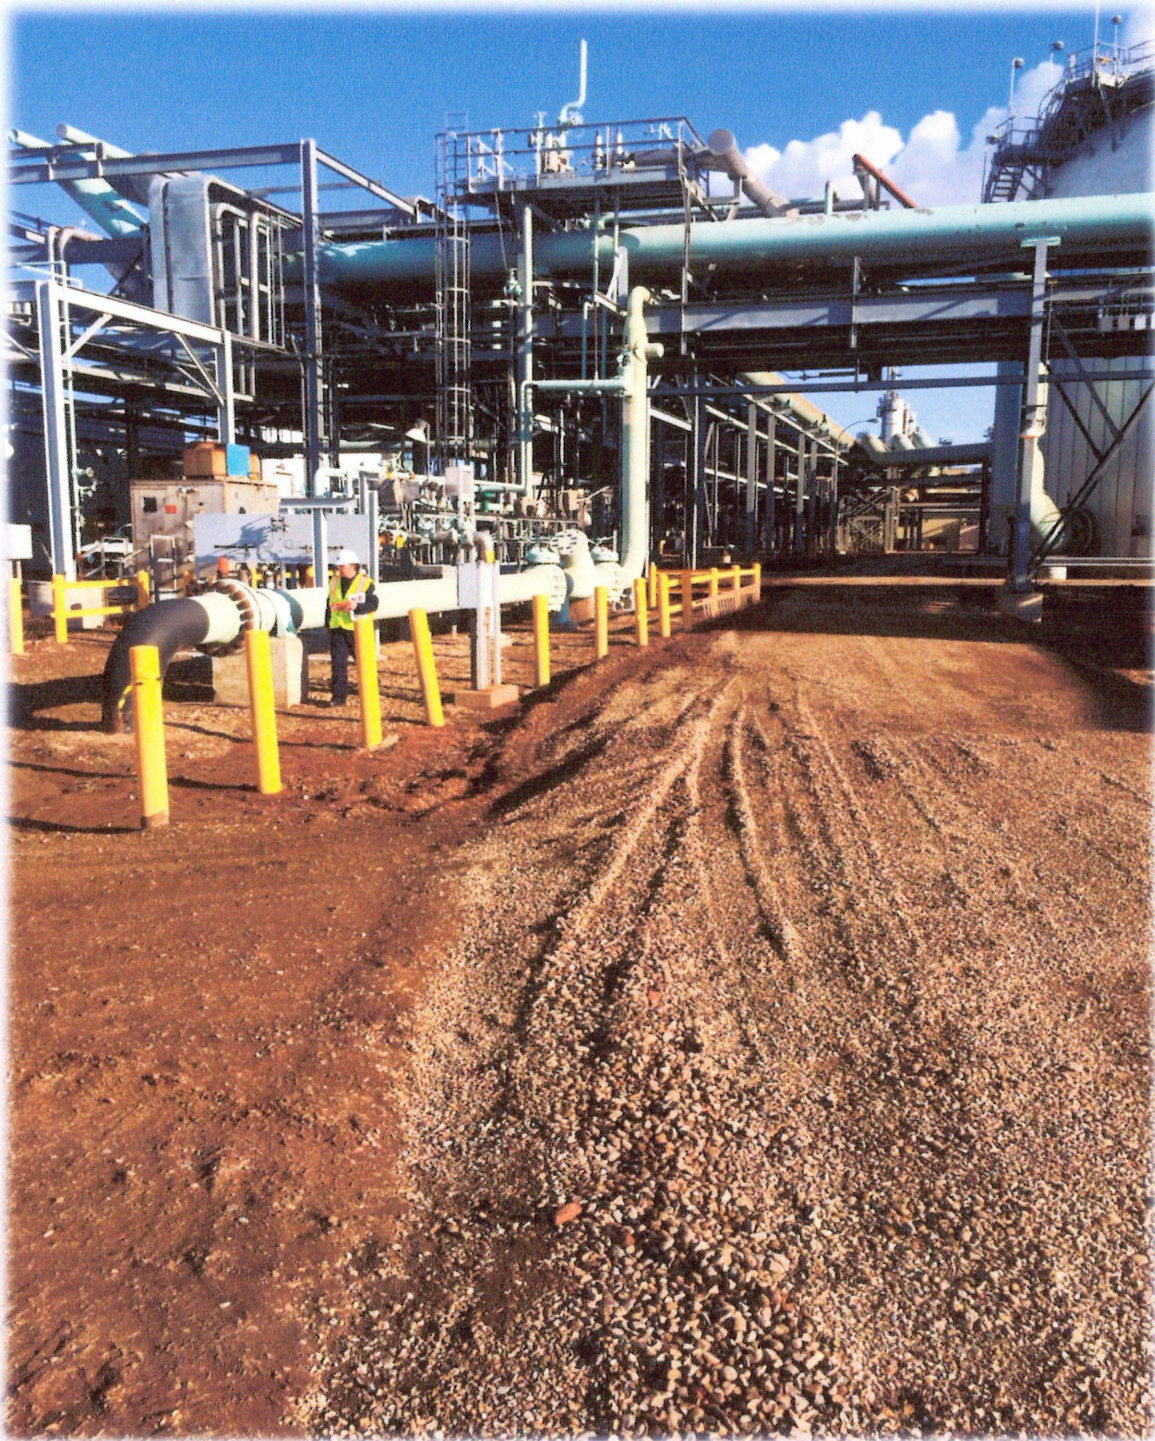
Figure 3: Section of the survey corridor located within the Plant. Note existing pipeline on the western side of the right-of-way. Photo taken from the center of the APE, view to the North.

The northernmost portion of corridor was located within the Dakota Gasification Plant (the Plant). This 0.82 miles of the survey area initially trended north-south following an existing pipeline (Figure 3 & 4). The survey corridor continued to follow the existing pipeline, turning northwest-southeast to run along the southern edge of the Plant.

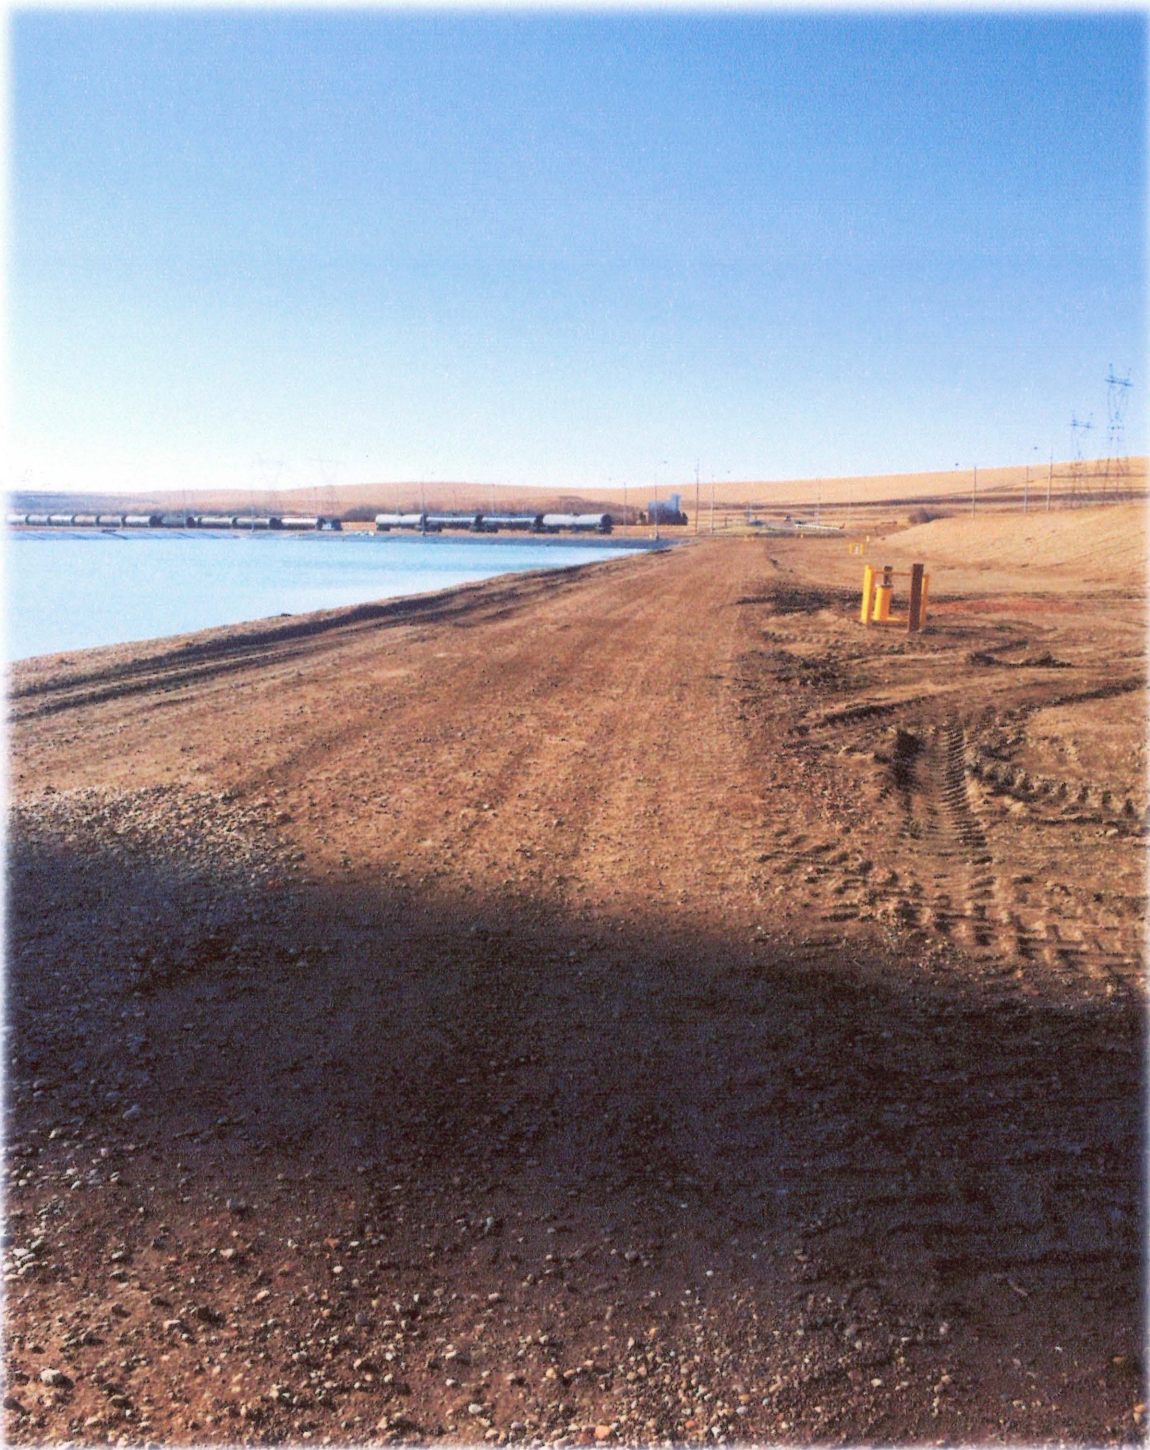
Figure 4: Overview showing the evaporation pond, existing pipeline, monitoring wells, and large berm which all intrude into the right-of-way. Photo taken from the center of the APE, view to the South.

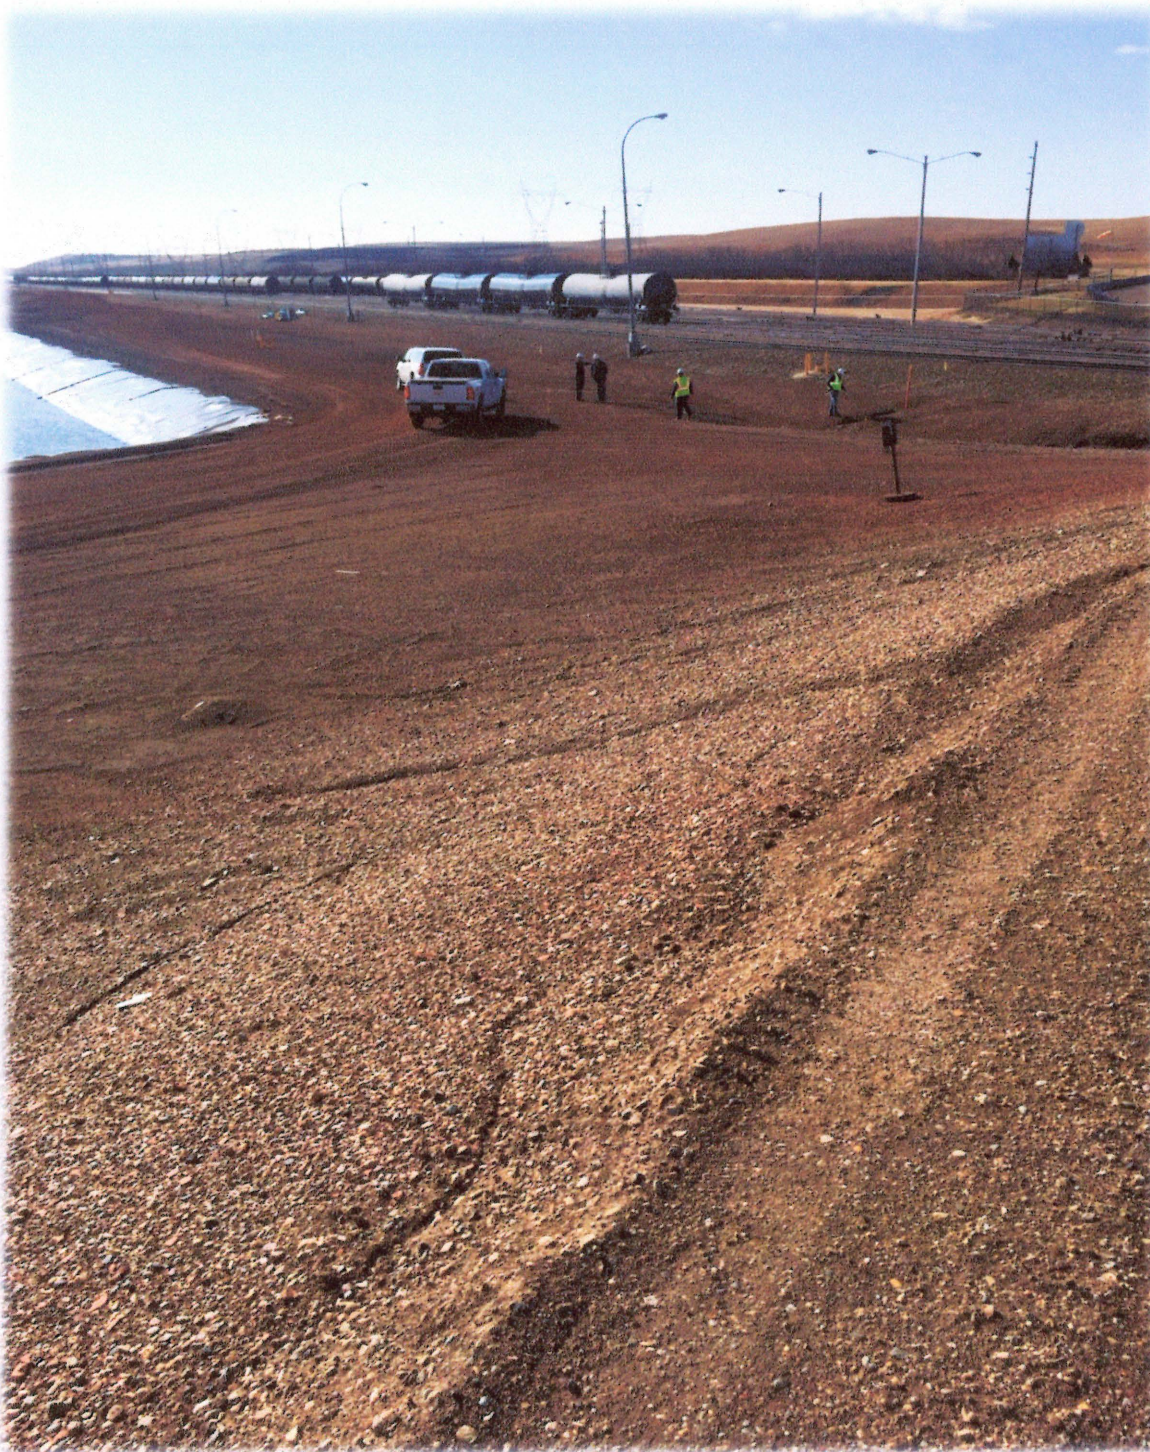
Figure 5: Overview of the area where the survey corridor turns from trending north-south to northwest-southeast. Photo taken from the western edge of the APE, view to the Southeast.

Along the southern edge of the Plant, the survey corridor on the southwestern side of the right-of-way parallels the Northern Pacific Railroad train yard (32ME2246) and its associated berms and drainage ditches (Figure 5 & 6). The northeastern side of the corridor encompasses the southern edge of the Plant, the existing pipeline corridor, a gravel road, and an equipment storage area (Figure 7 & 8). At the southern end of the train yard, the survey corridor crosses the Northern Pacific Railroad and continues to follow the existing pipeline, turning west-east for 0.23 miles, before once again trending north-south for 0.05 miles to connect to an existing meter station.

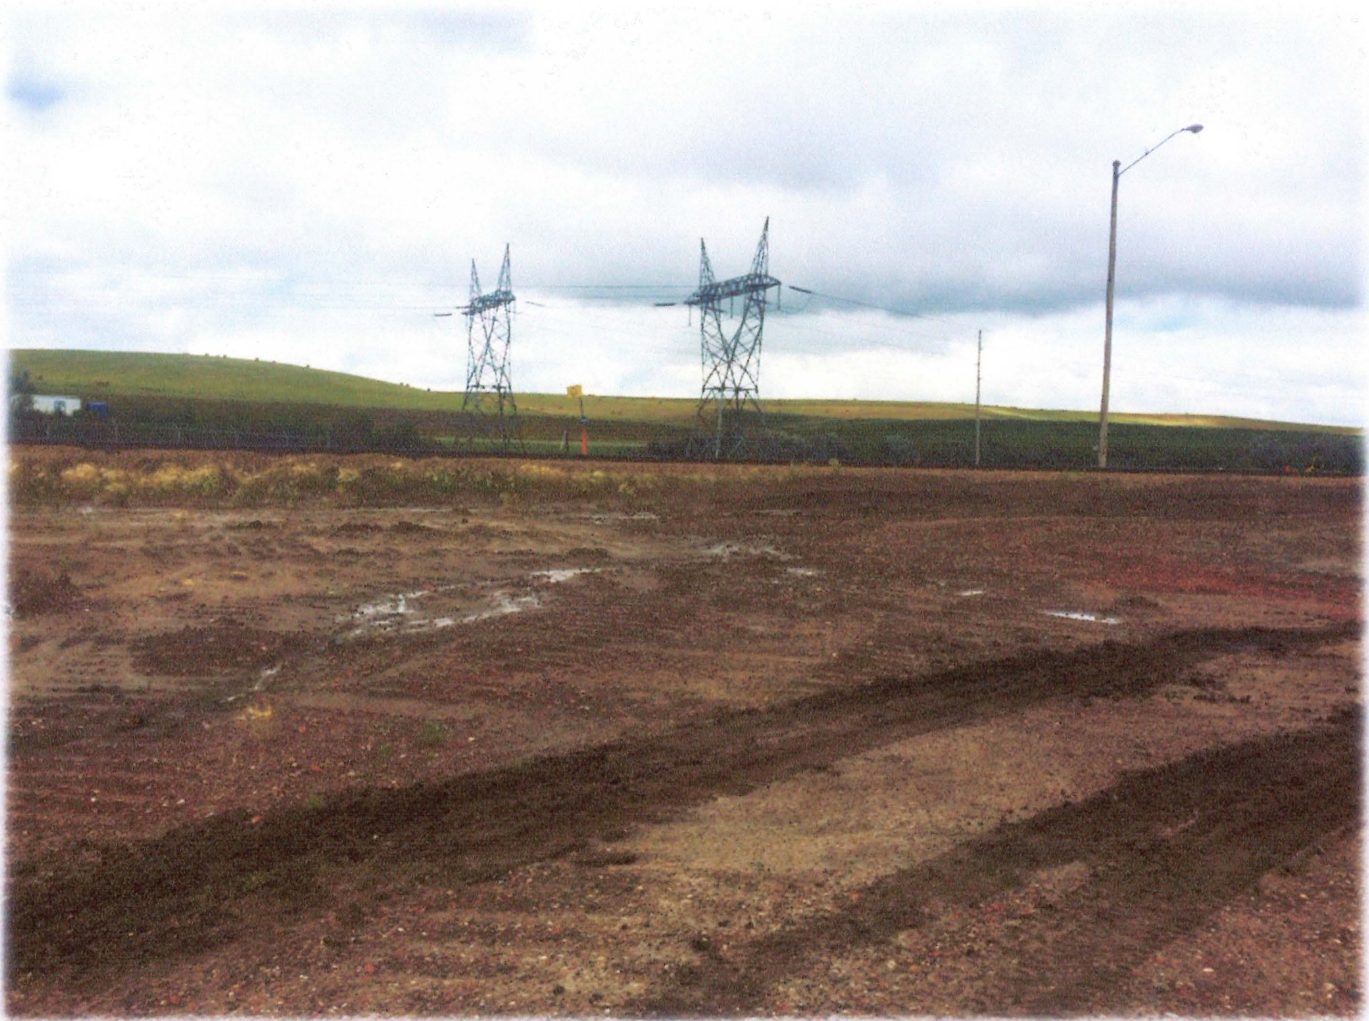
Figure 6: Area along the southern edge of the Plant showing heavy disturbance from the Northern Pacific Rail Road, roads, berms, and drainage ditches. Photo taken from the center of the APE, view to the Southwest.

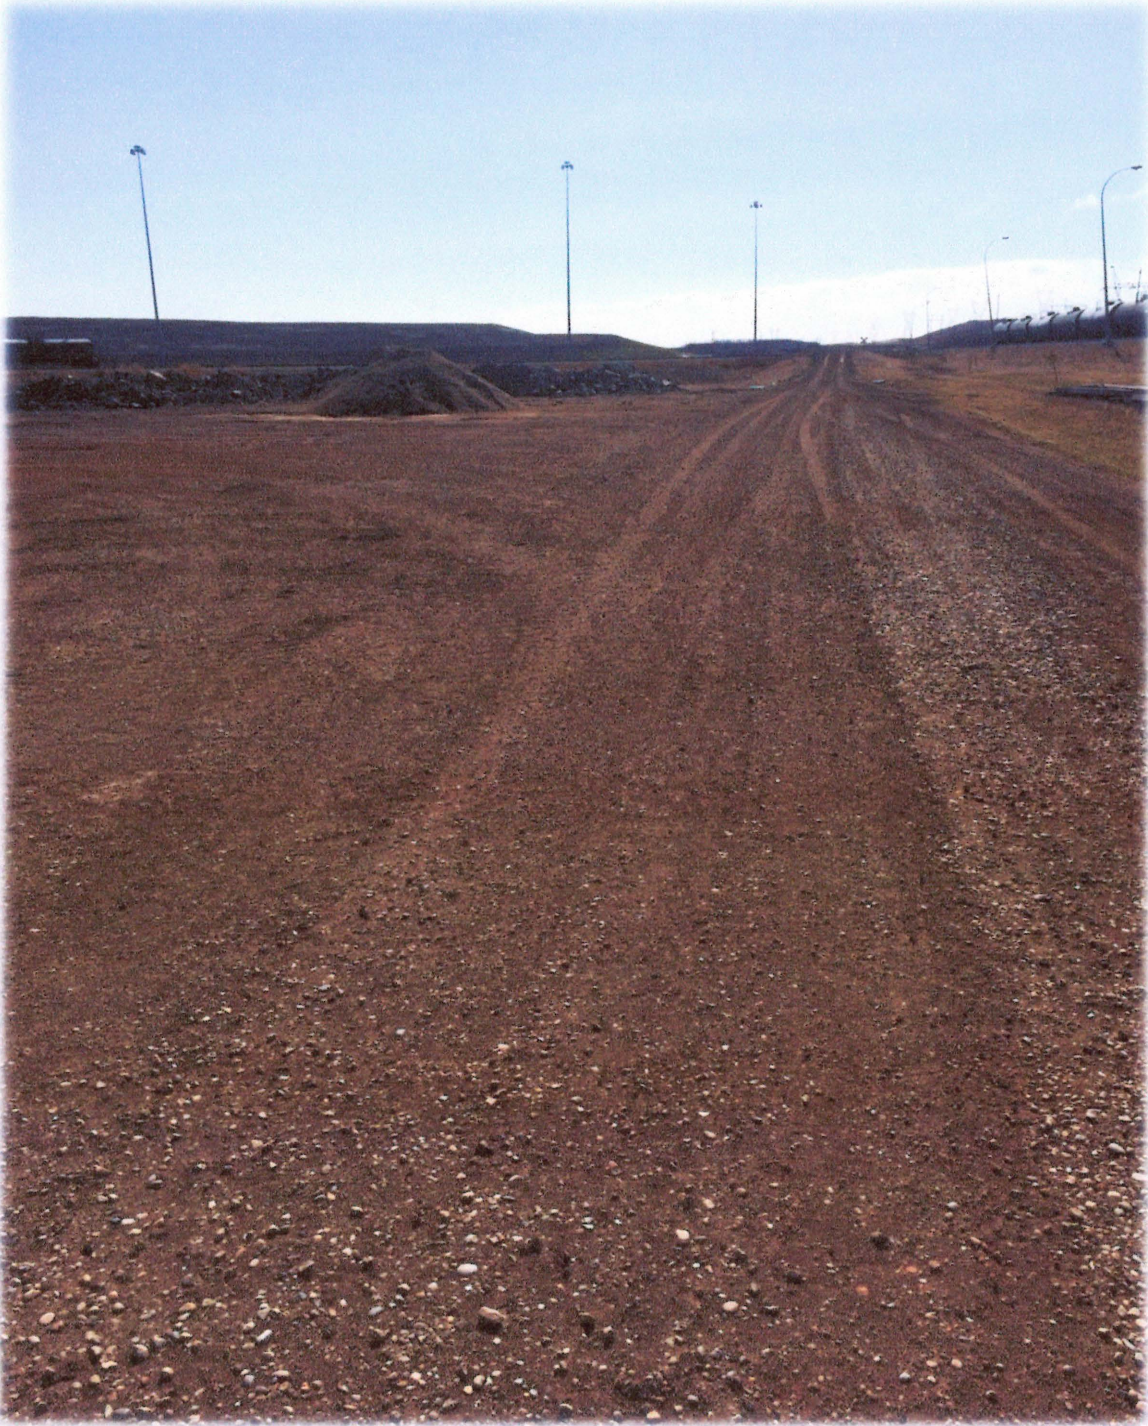
Figure 7: Overview of the survey corridor running along the southern edge of the Plant showing the work space (at left) and Northern Pacific Rail Road (at right). Photo taken from the center of the APE, view to the Southeast.

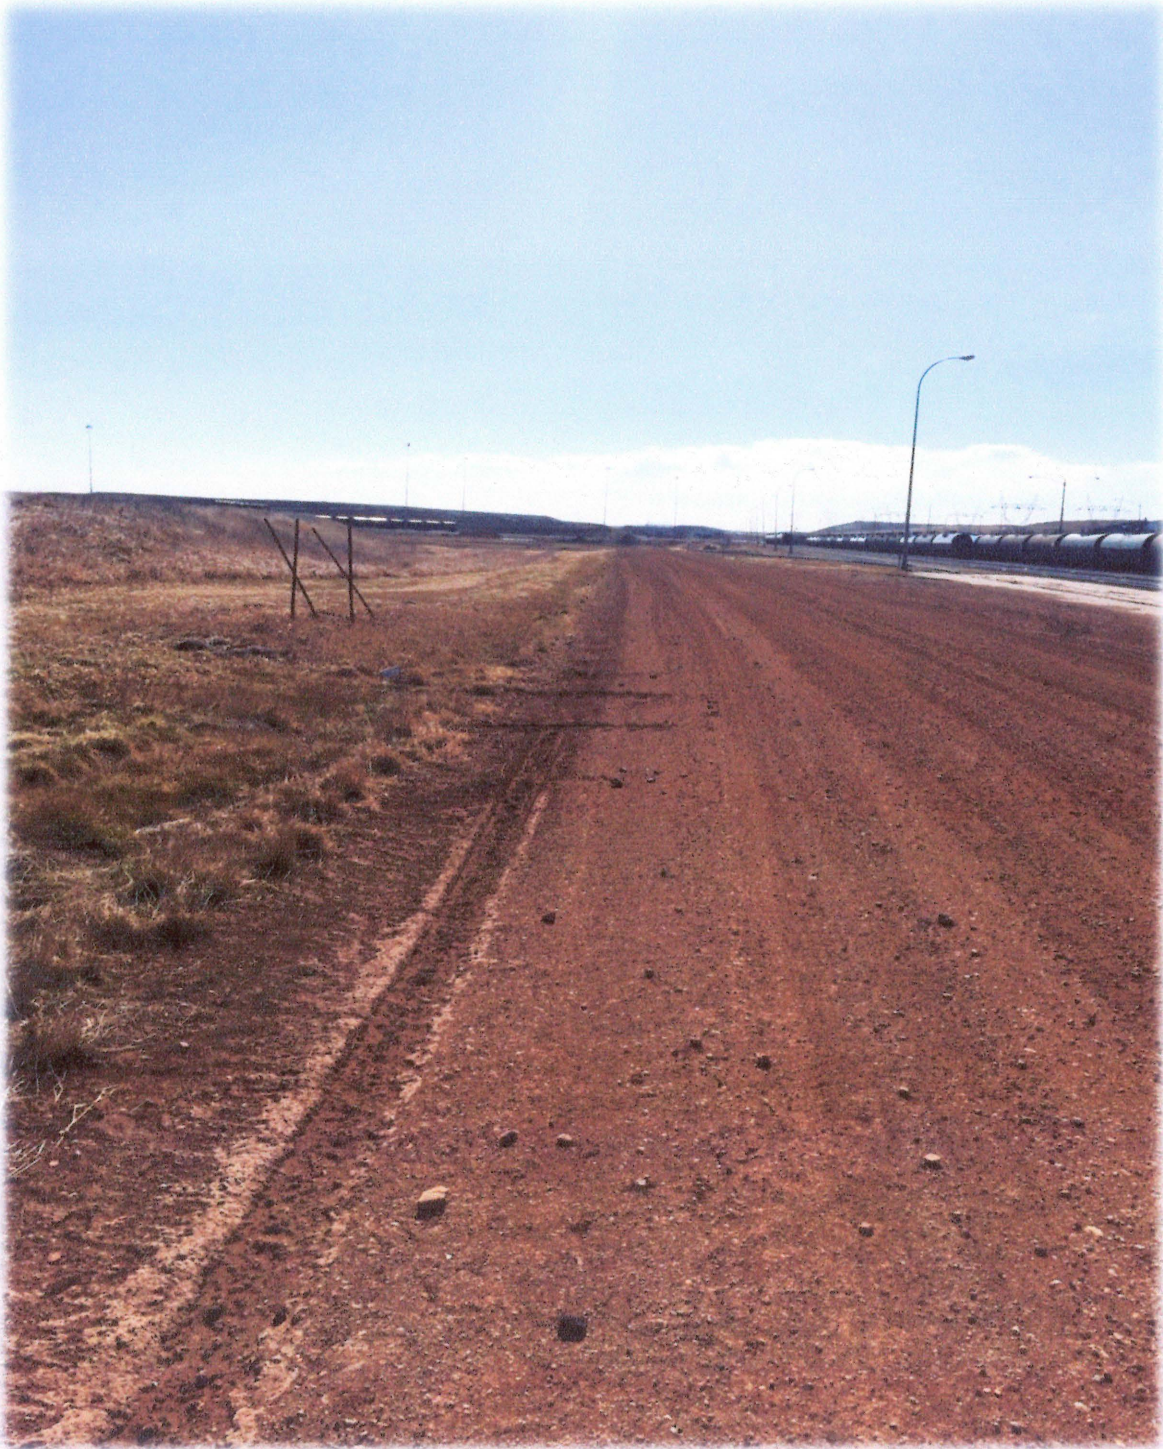
Figure 8: Survey corridor running along the southern edge of the Plant showing the existing pipeline (at left) and Northern Pacific Rail Road (at right). Photo taken from the western side of the APE, view to the Southeast.

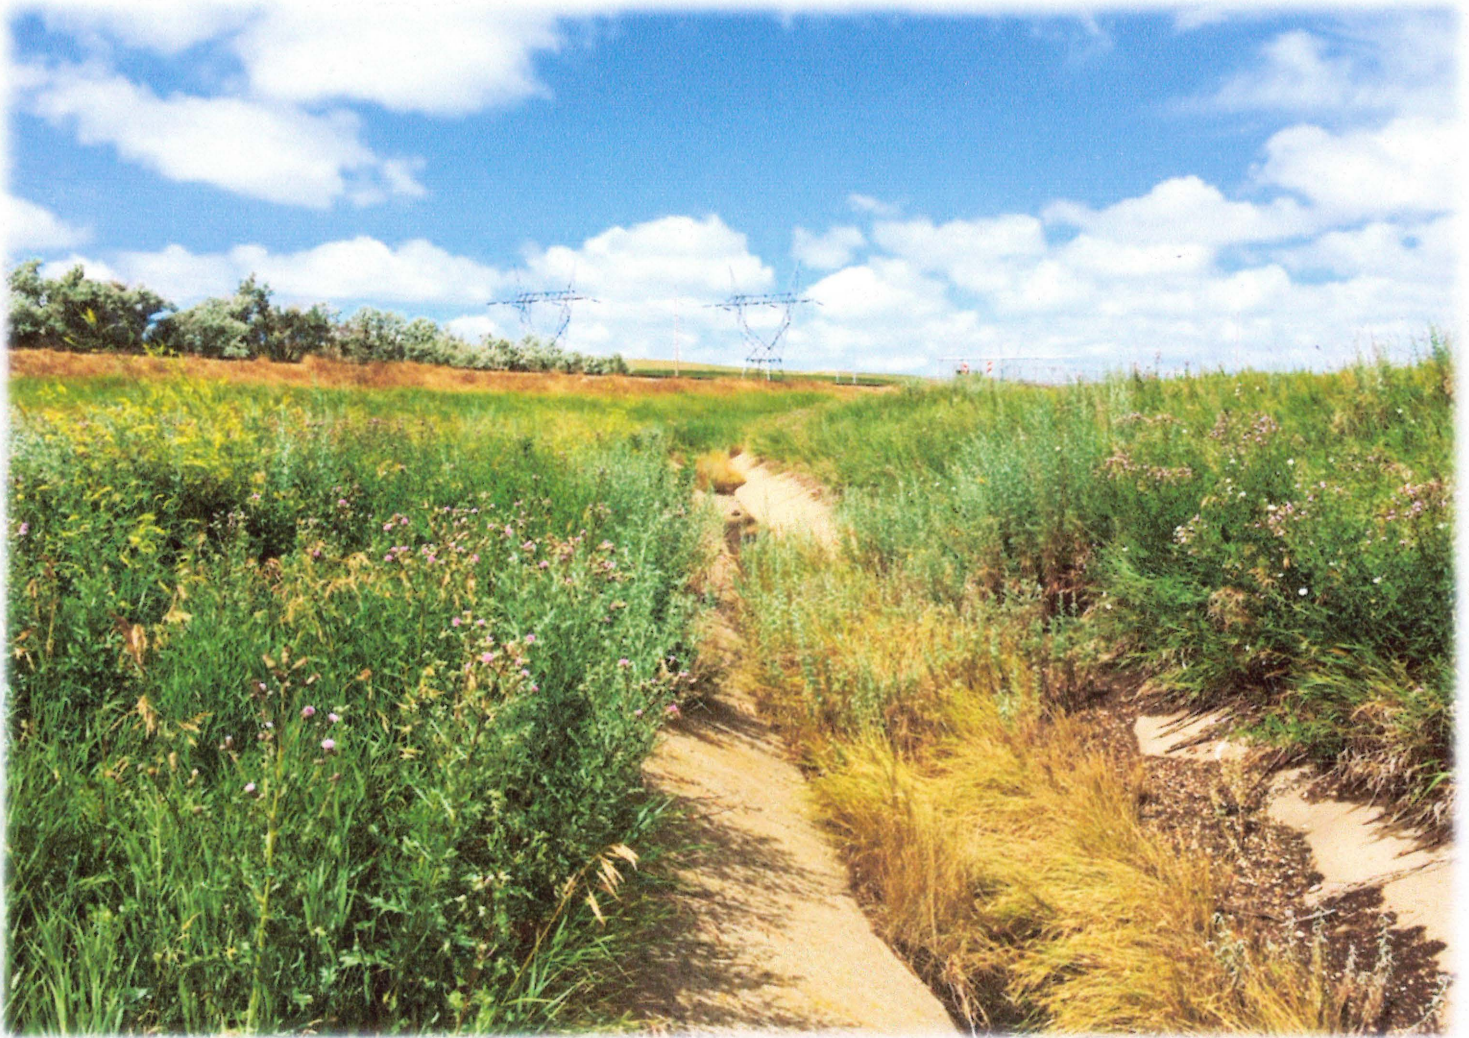
Figure 9: Overview of area where the survey corridor leaves the Plant and turns to runs east-west. Note concrete drainage with large berm (at right) and the Northern Pacific Railroad (at left). Photo taken from the center of the APE, view to the West.

The northern and eastern portions of this final 0.23 miles of corridor contain a concrete drainage, a berm with a gravel road, the existing pipeline, and two wetland areas (Figure 9 & 10). The southern and western portions are located within flat hay fields. Ground visibility within this area was approximately 30% and standing water was present in large sections of the fields (Figure 11).

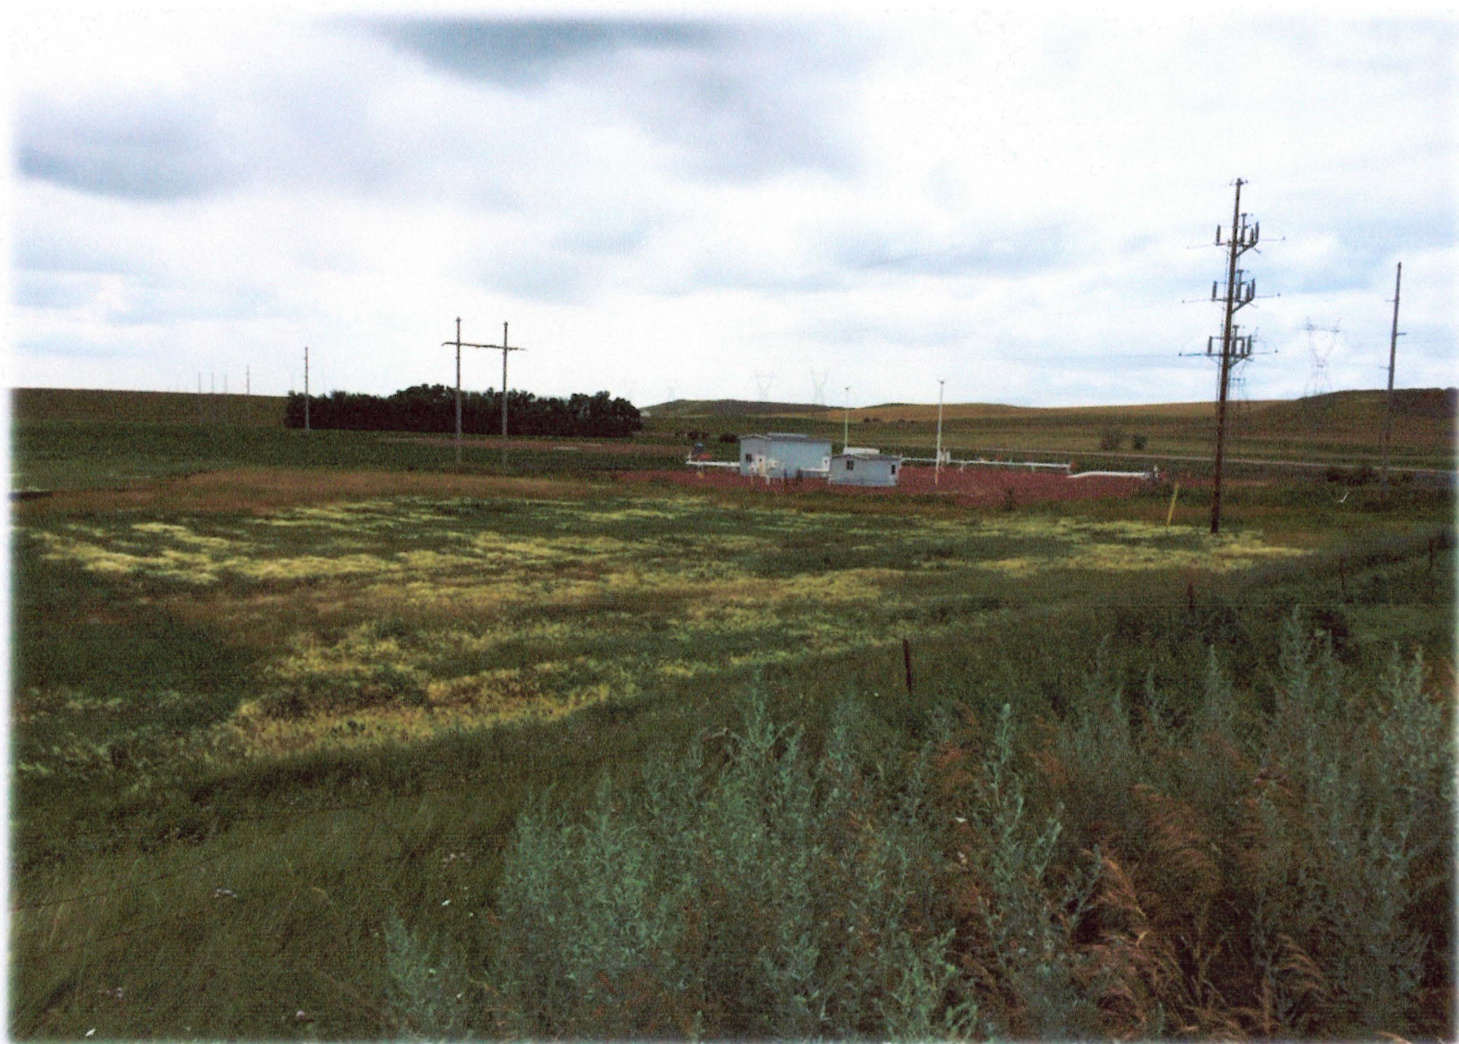
Figure 10: Overview of hay field and the meter station at the southern end of the survey corridor. Photo taken from the center of the APE, view to the southeast.

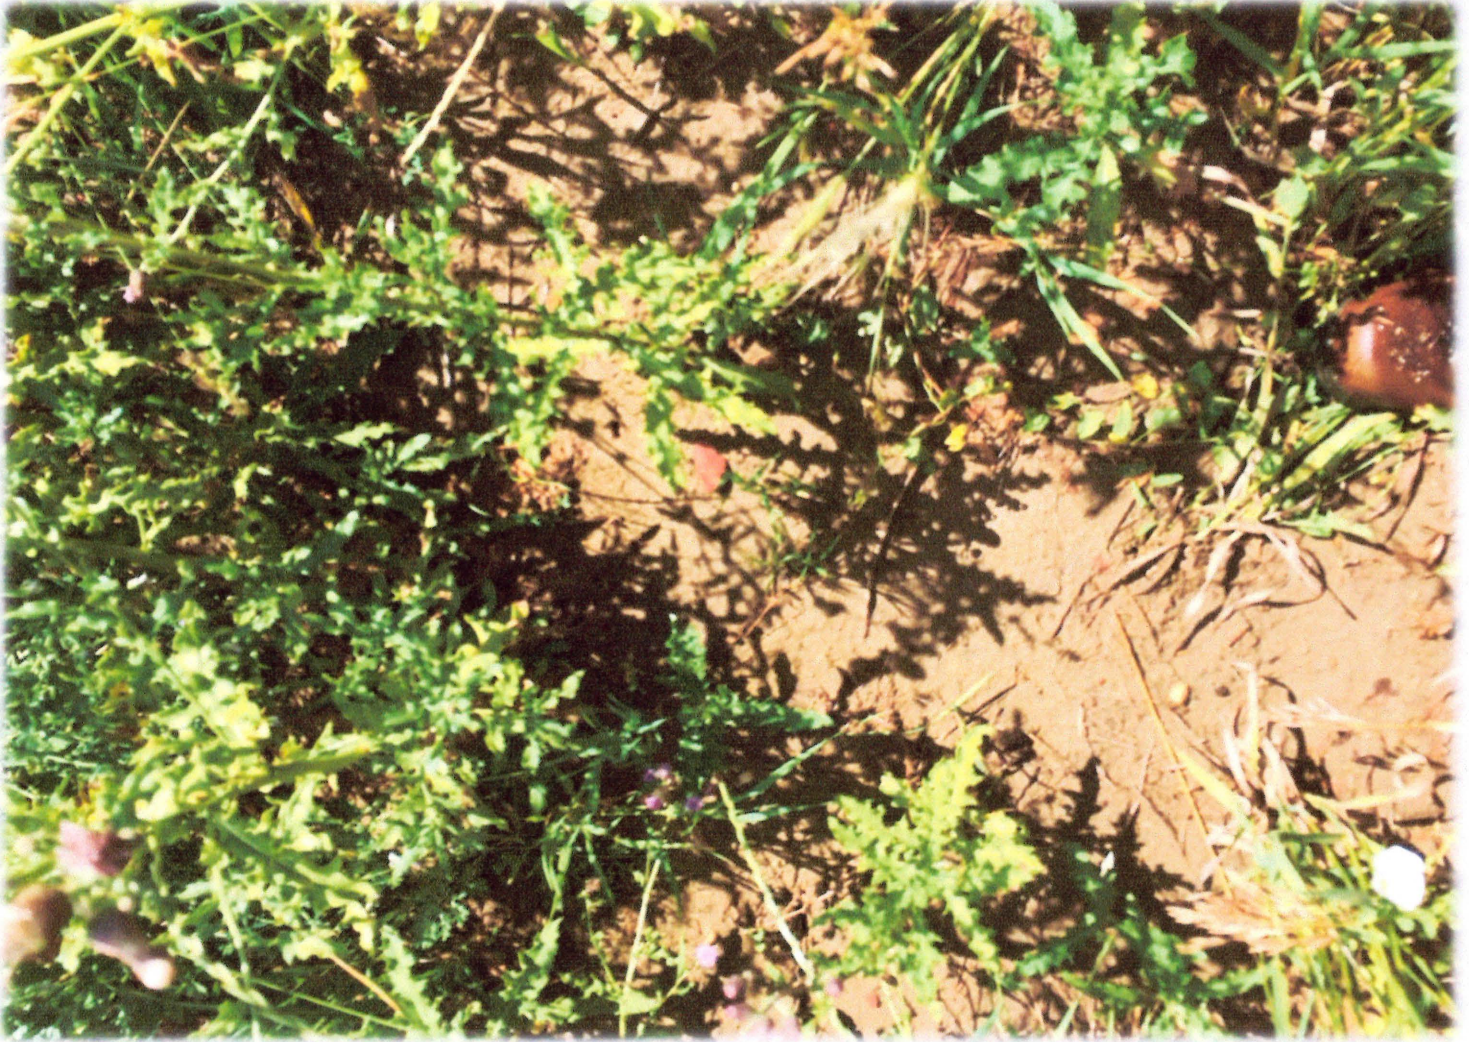
Figure 11: Ground surface visibility within the hay fields in the southern portion of the APE.
