Bat Acoustic Survey Report

Oliver III Wind Energy Center
Morton and Oliver Counties, North Dakota

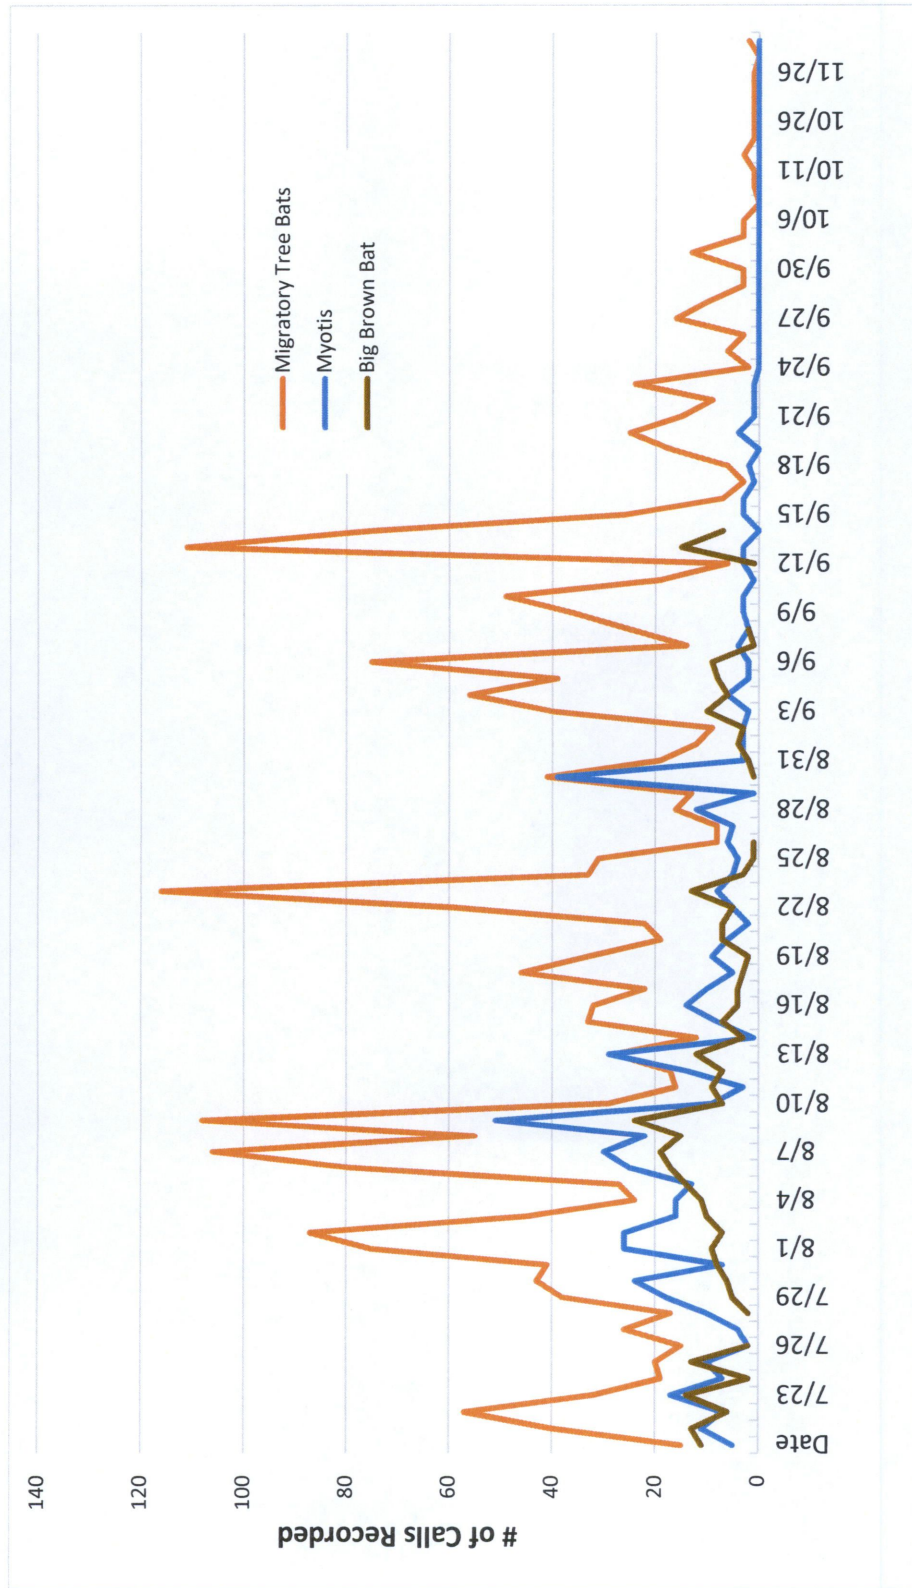
Figure 2. Total Number of Calls Recorded by Date and Species at all Detectors

Migratory tree bats (silver-haired, hoary, and eastern red bat) accounted for the majority of this activity throughout the duration of the survey period with an even higher proportion of the total activity in September (Figure 5).

Three species of migratory, tree-roosting bats (silver-haired bat, eastern red bat, and hoary bat), were detected throughout the summer period. Pulses in activity by silver-haired and hoary bat in August and September suggest these species may be migrating through the Project Area in brief, episodic movements. The hoary bat, silver-haired bat, and eastern red bat have been regularly documented as fatalities at wind projects across North America, most frequently in later summer and early fall during migratory periods (Arnett et al. 2008, Strickland et al. 2011). The most likely period of potential risk for this group is during migratory periods when individuals are moving across the landscape and are less closely associated with forested areas.

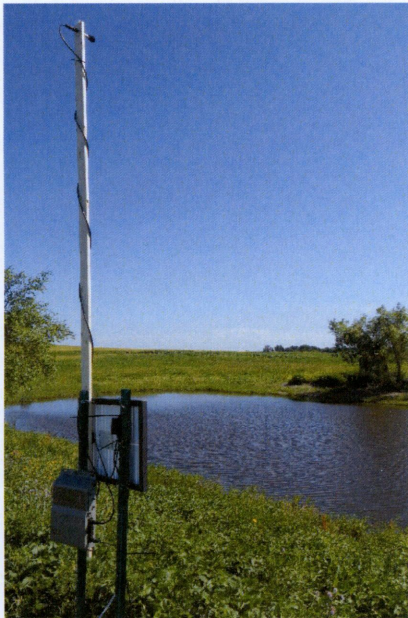
Site 2 was established adjacent to a ¼ acre stock pond amid pasture and crop lands. Another stock pond was located 250 to the east across the road. The nearest woodlands or shelterbelts were associated with farmsteads located between ¾ to one mile to the north, west, and south.

4) The detector setup oriented south over a stock pond. July 21, 2015.

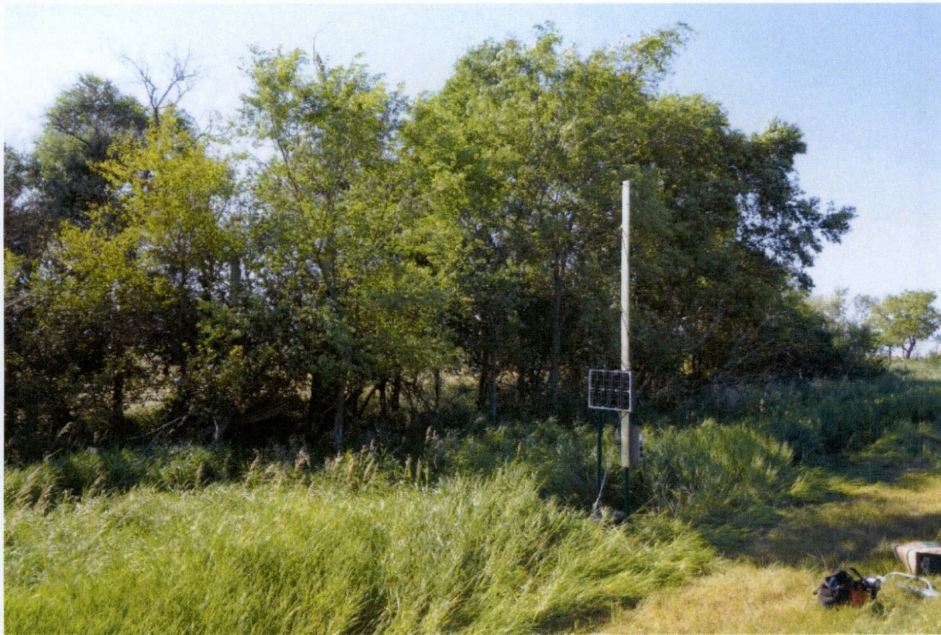
Site 3 was located adjacent to a mature shelter belt near a scrubby 4 acre patch surrounded by pastures and cropland.

7) Detector set up with microphone oriented along the shelterbelt edge. July 21, 2015. View to the north.

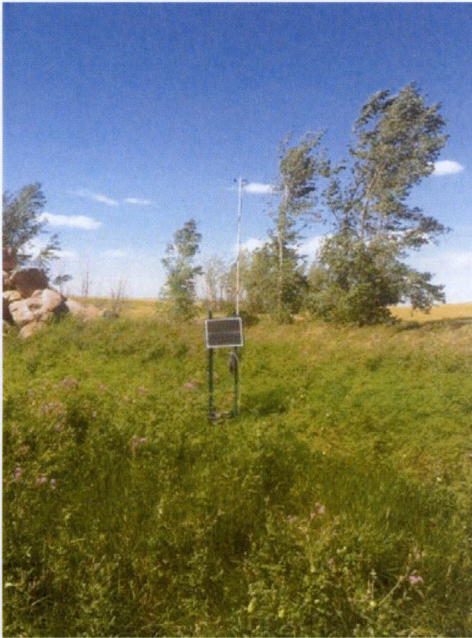
Site 4 was located adjacent to a forested patch near an abandoned farmstead. The site is surrounded by cropland.

10) Detector was positioned on edge of the forested patch with the microphone oriented over an ephemeral pond. View north.

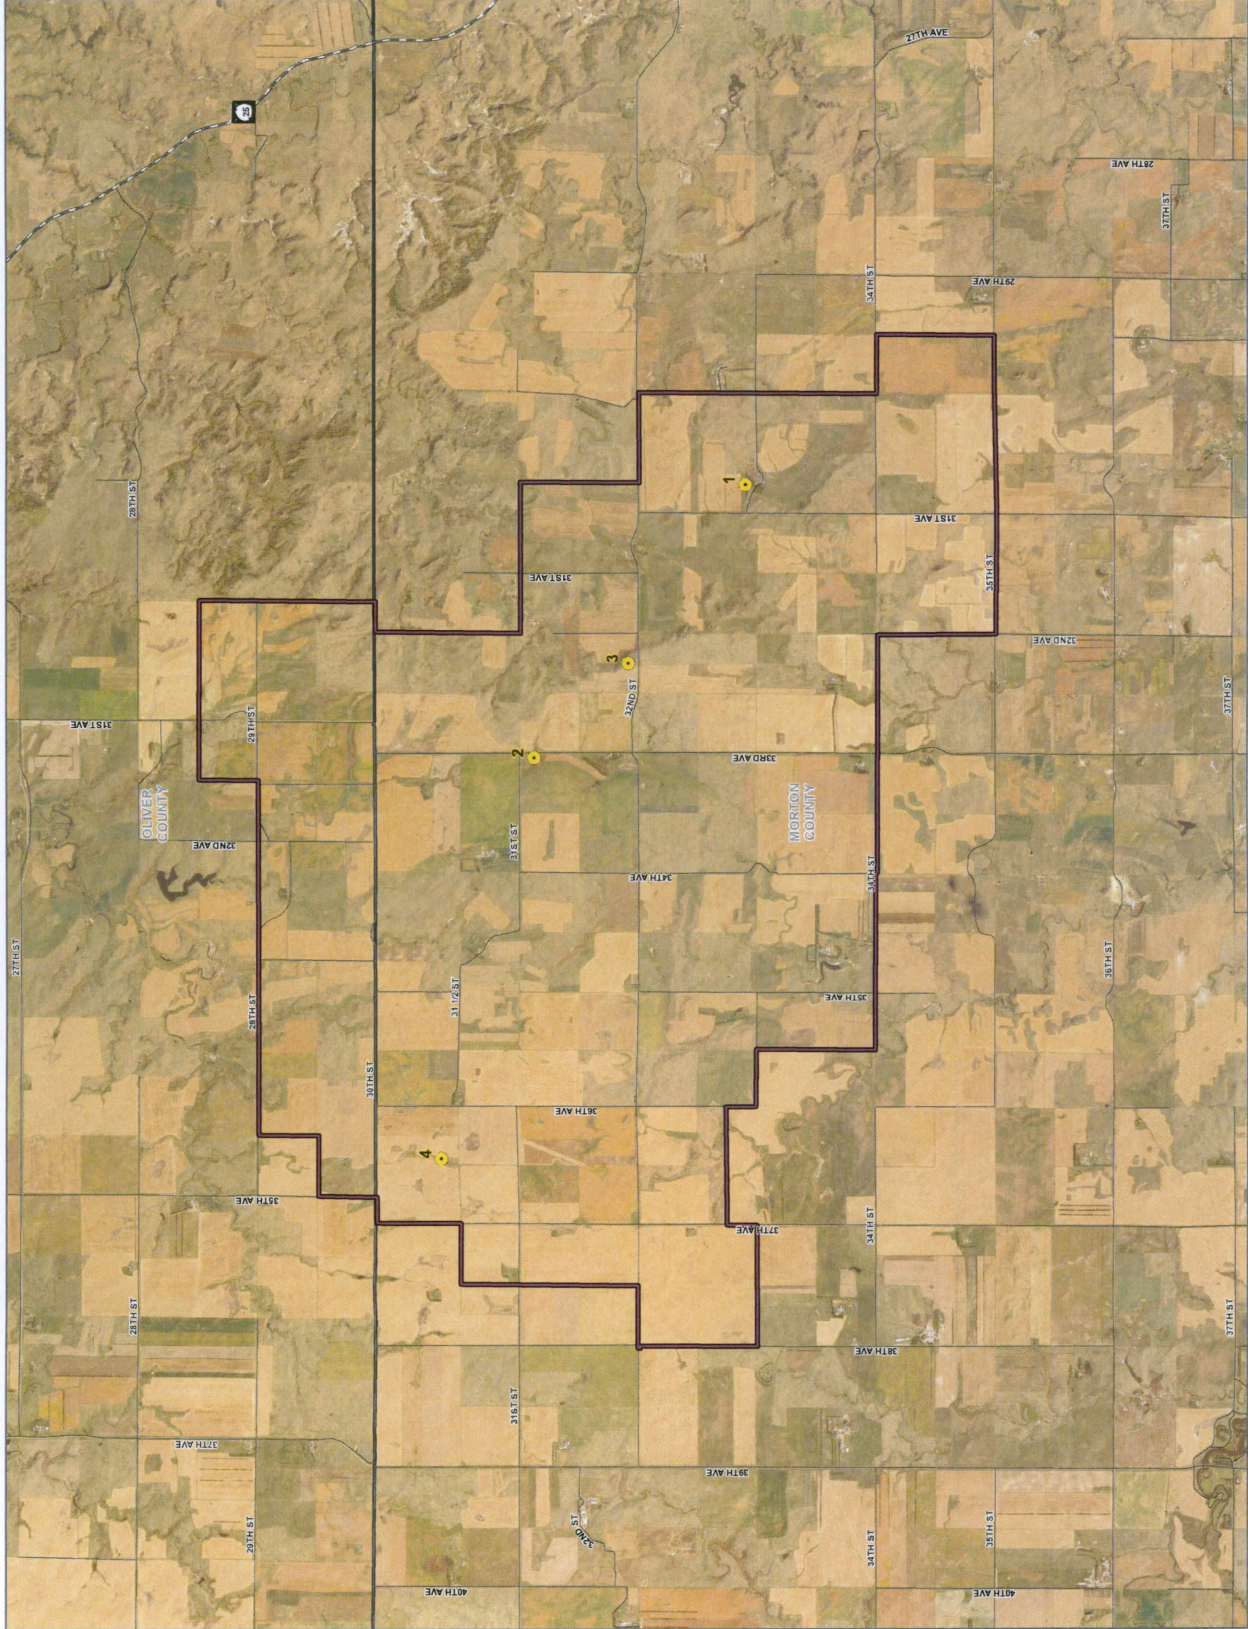
Figure 3
Bat Detector Locations

Bat Detector Location

Tetra Tech deployed four ground-based bat detectors within the Project Area in July 2015. Sampling sites were within representative habitats within the Project Area, areas with potential for high bat activity, and areas available for access under existing lease agreements (Figure 3). Site 1 was located between a six acre forested area and a shelter belt; Site 2 was located next to a stock pond amid pastures and cropland; Site 3 was located adjacent to a mature shelter belt near a scrubby one acre patch surrounded by pastures and cropland; and Site 4 was located adjacent to a forested patch near an abandoned farmstead (See Appendix A for photographs of detector locations and habitat descriptions). The microphone height of each of the ground-based bat detectors was approximately 2.5 meters. To ensure that the greatest period of bat activity was surveyed, bat detectors were programmed to begin recording at sunset and stop recording approximately at sunrise each day.
