Carlson McCain, Inc. (CMI) conducted a topsoil removal inspection at the Hess ETP Pipeline – Williams County (Case No. PU-16-189) on September 15, 2016, on behalf of the North Dakota Public Service Commission (PSC). The project consists of installing a 12-inch diameter, 1.1-mile crude oil pipeline.

43 **PU-16-189** Filed: 9/26/2016 Pages: 7
Topsoil Removal Inspection Report

Topsoil Removal Inspection
PSC Case No. PU-16-189

Figure 1
PSC Topsoil Inspection
 ETP Pipeline
 Hess Corporation

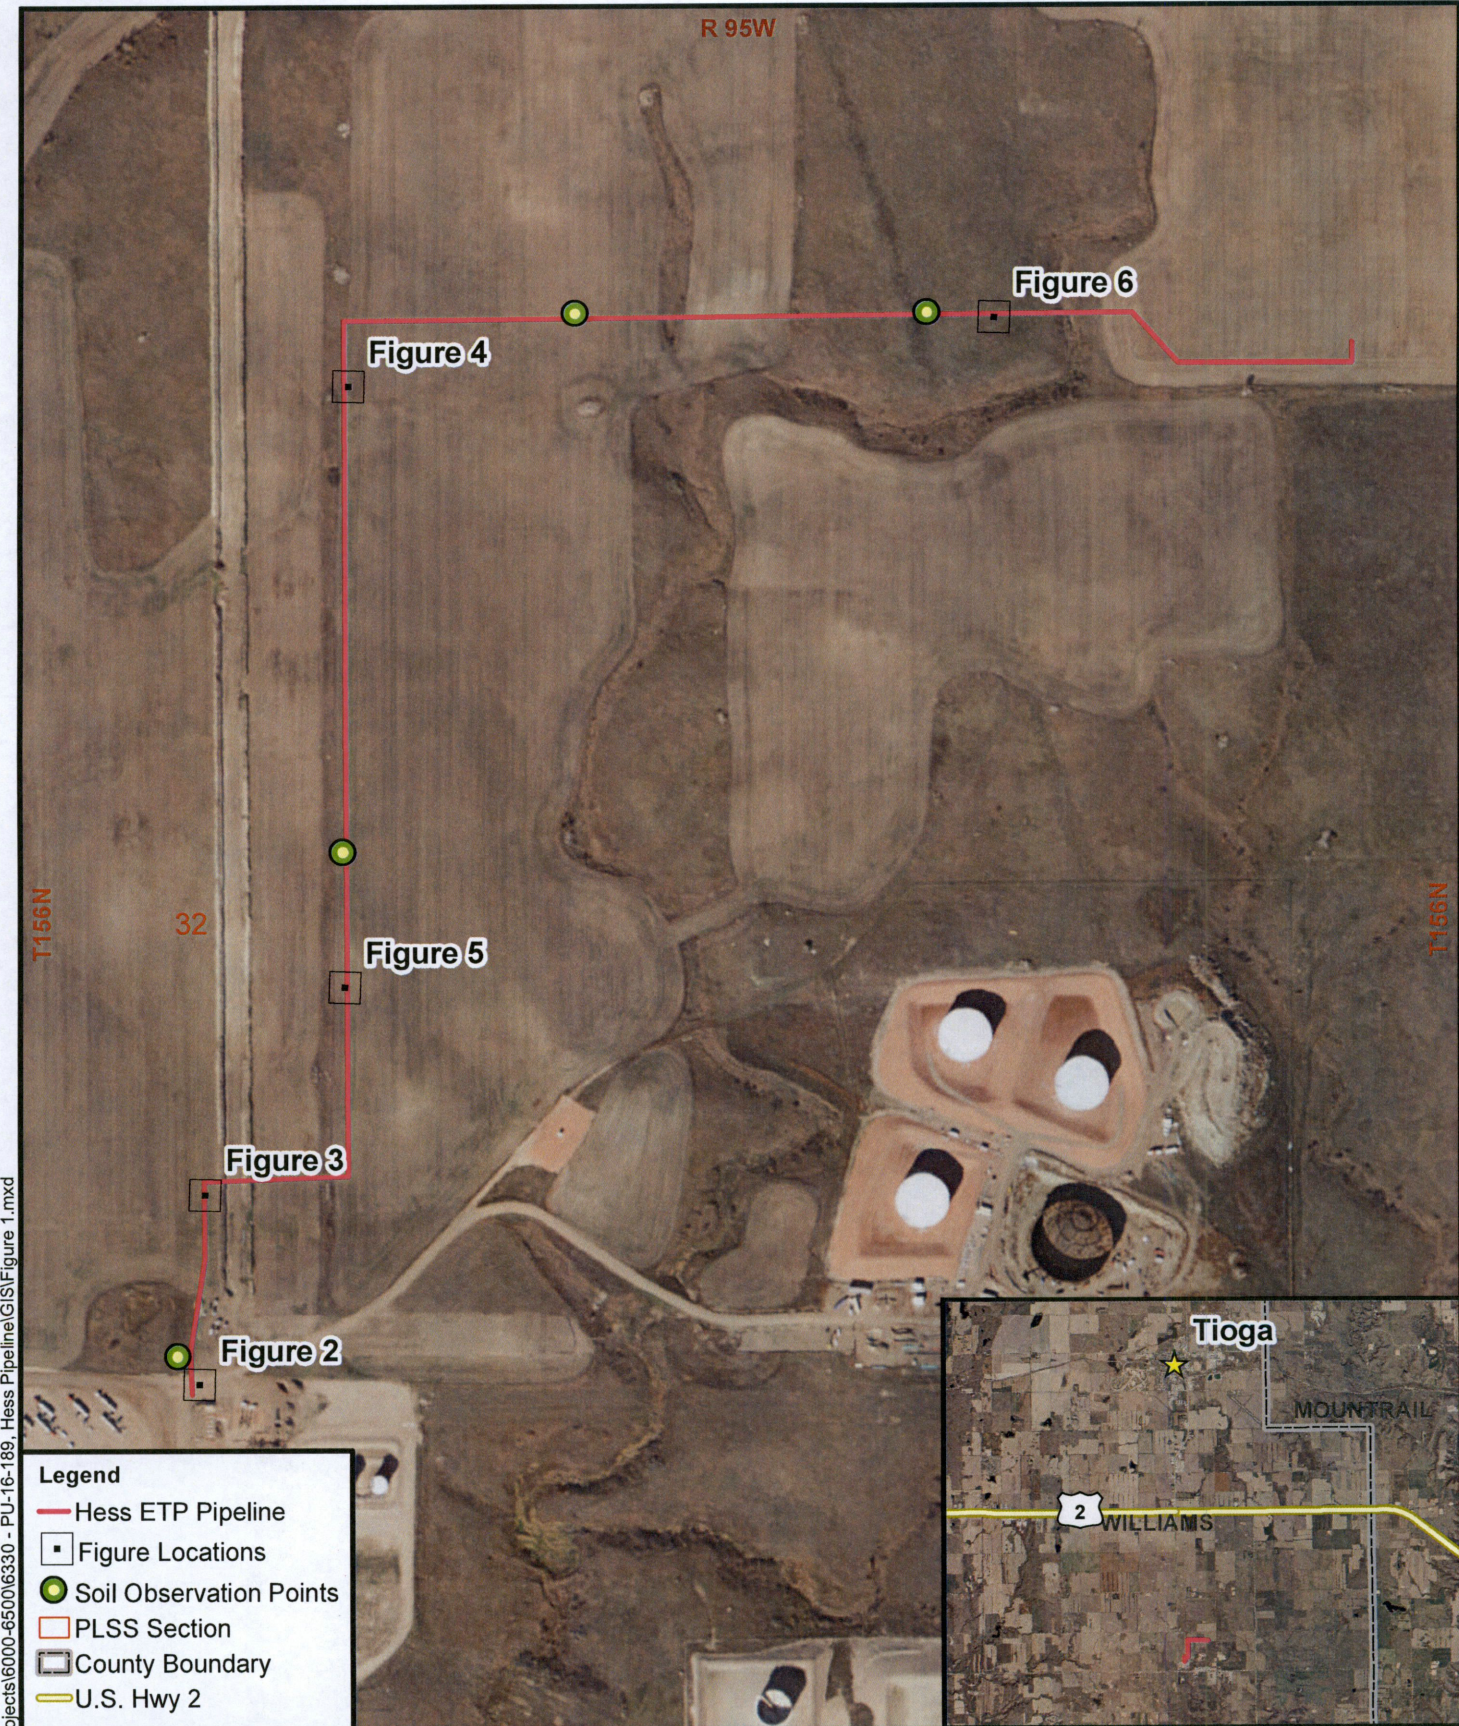
Potholes were dug to locate and mark existing underground lines and the holes were marked with orange snow fence. Matting was installed in low areas of the pipeline corridor to allow vehicle passage. Straw waddles were being installed for erosion control at the time of the inspection. Soil observation points and photo locations are documented on Figure 1.

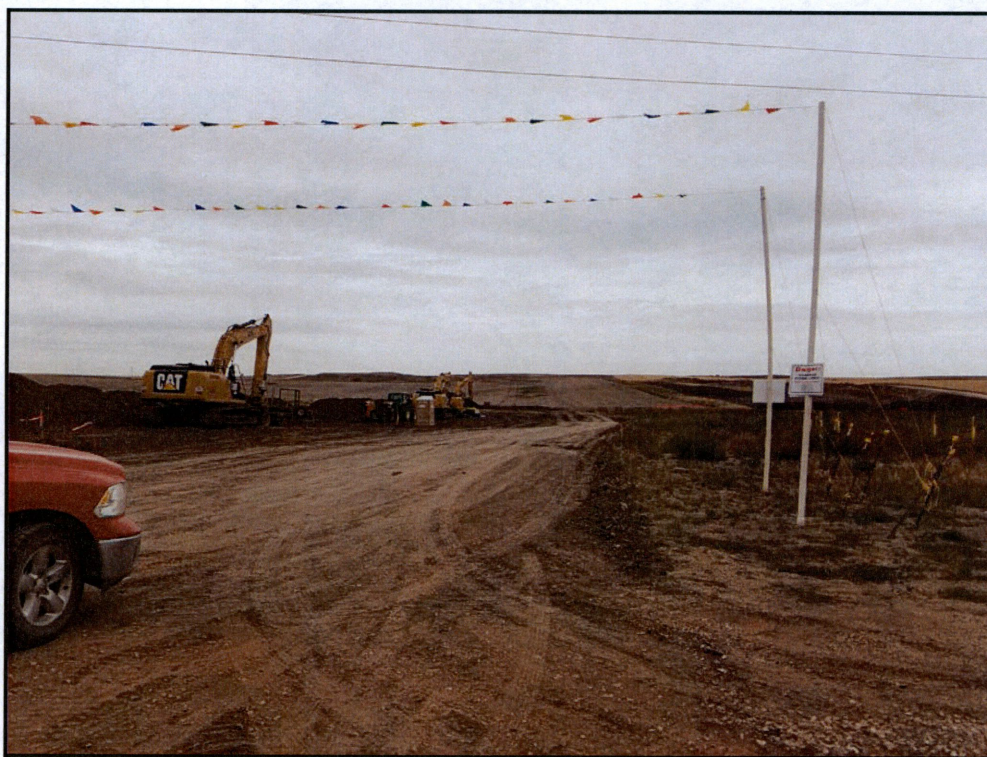
Figure 2. Photo taken facing north at the south end of the pipeline corridor. Overhead powerlines were marked.

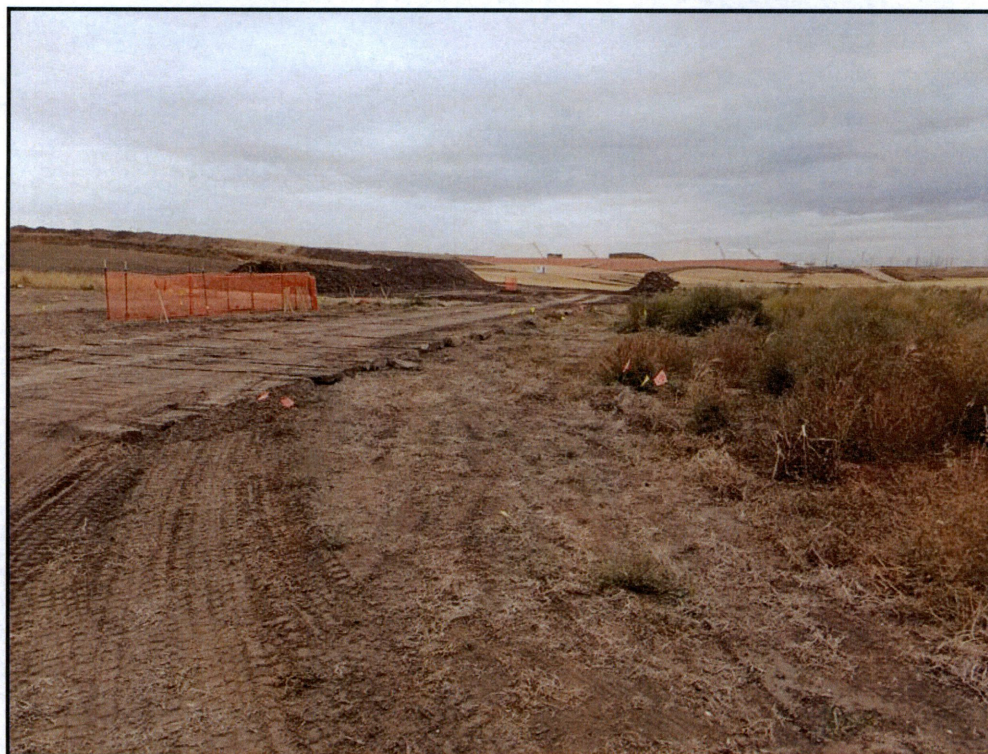
Figure 3. Photo taken looking north/northeast. Matting is in place and potholes are dug and marked with orange snow fence.

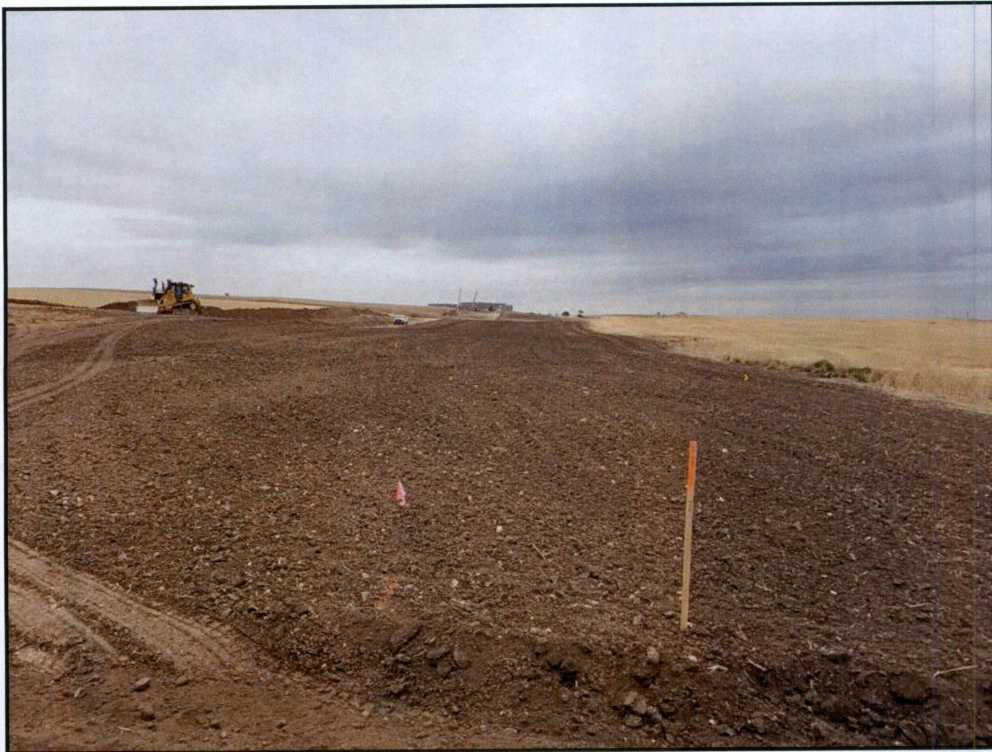
Figure 4. A portion of the pipeline runs parallel with the Dakota Access Pipeline (reclaimed area).

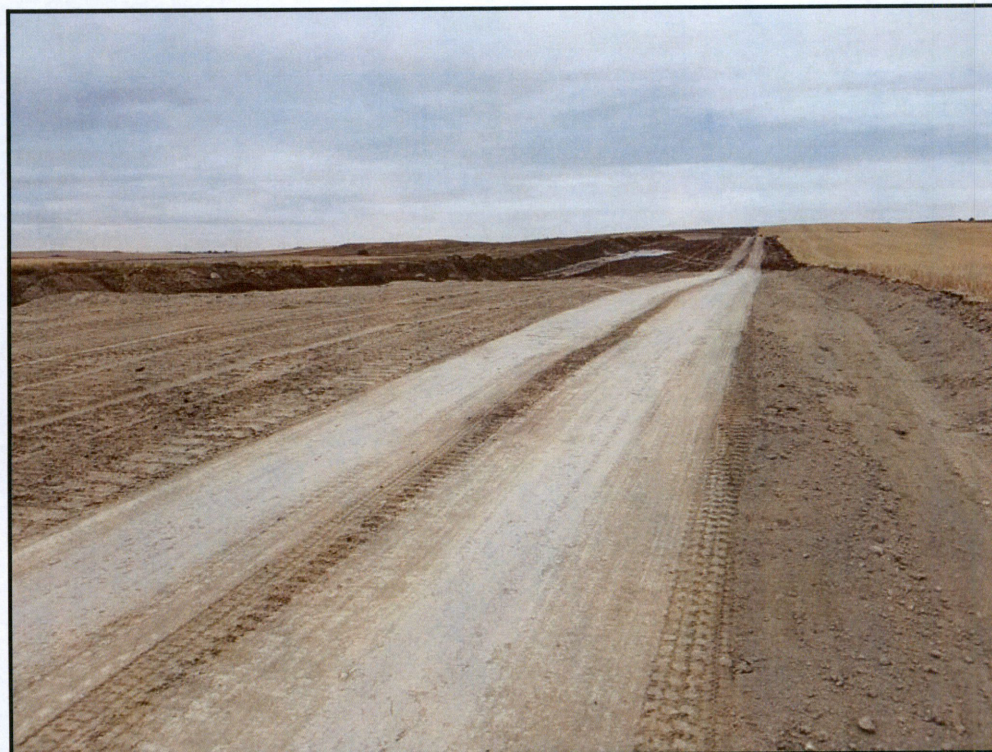
Figure 5. View looking east down the pipeline corridor.

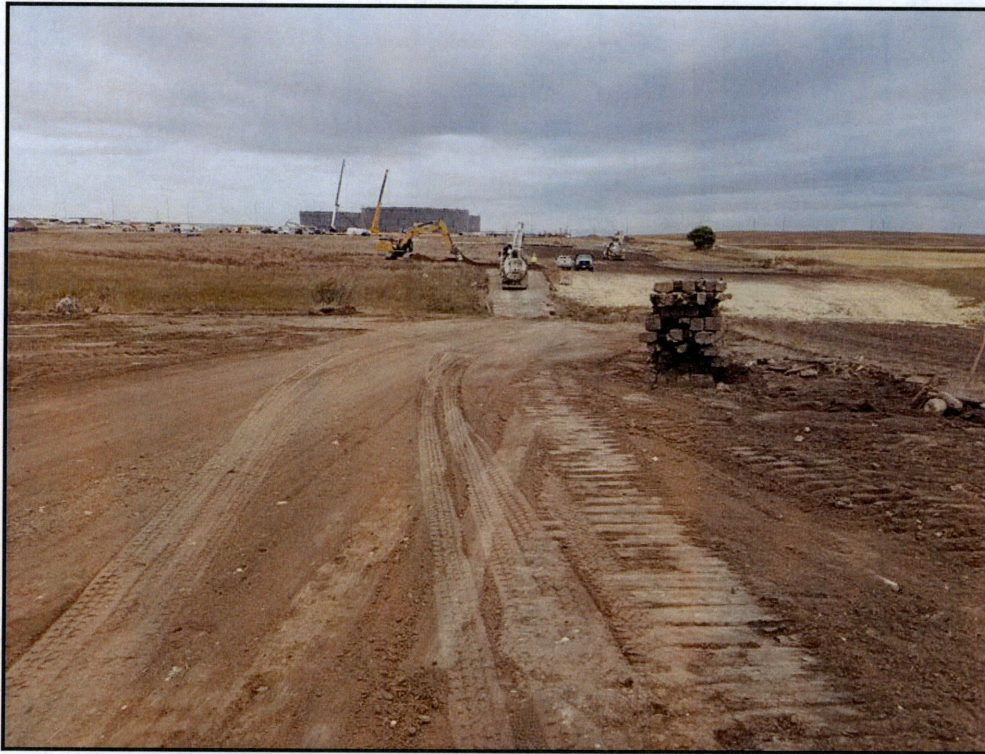
Figure 6. Photo showing the end of topsoil stripping on the north/east end of corridor.

* Small portion of line ~~not~~ not striped on N/E ^{EXIT} ~~side~~ of route due to DAPL.
