Caliber Bear Den Interconnect Pipeline Project As-Built Inspection Report PU-16-420

Prepared for:

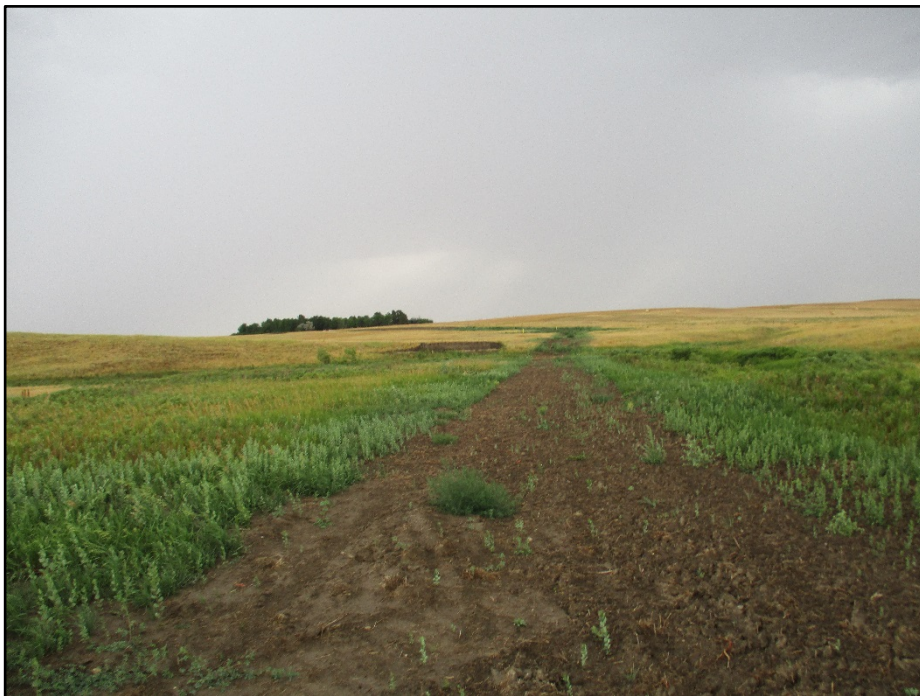
Photo 2. (GPS Point #520) – This area was used as an access road to get to the stream. There are few grasses and some weeds growing. Weeds are typical in the first year of re-seeding. Due to the drought conditions, most of the pipeline has a lack of vegetative growth. Direction: Northeast.

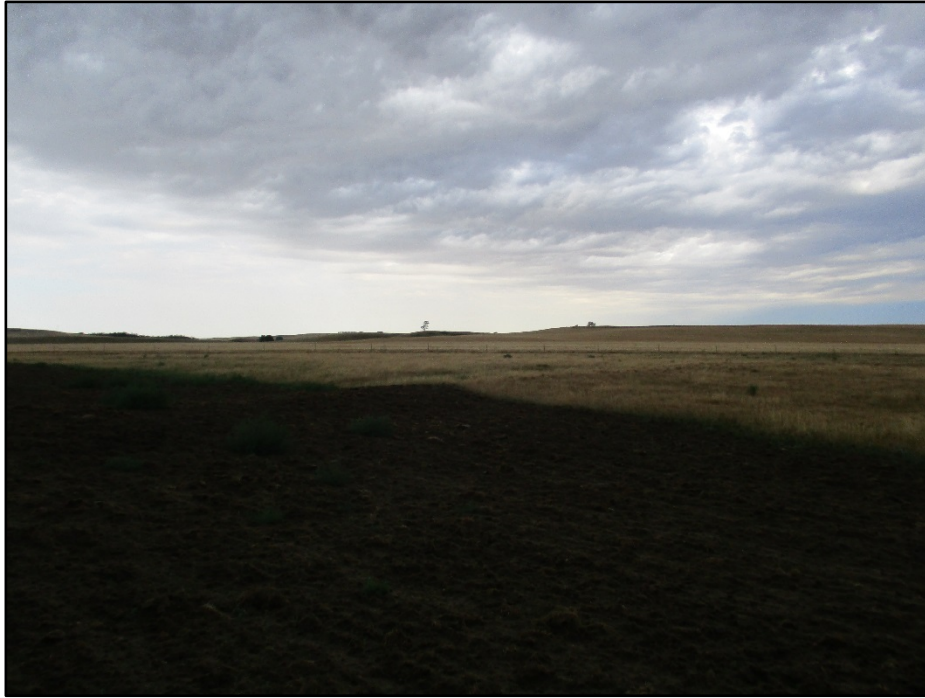
Photo 3. (GPS Point #521) – Pipeline ROW through grassland. There is a berm (near center of photo) from another pipeline crossing the area. Contours were matched. Direction: Southwest.

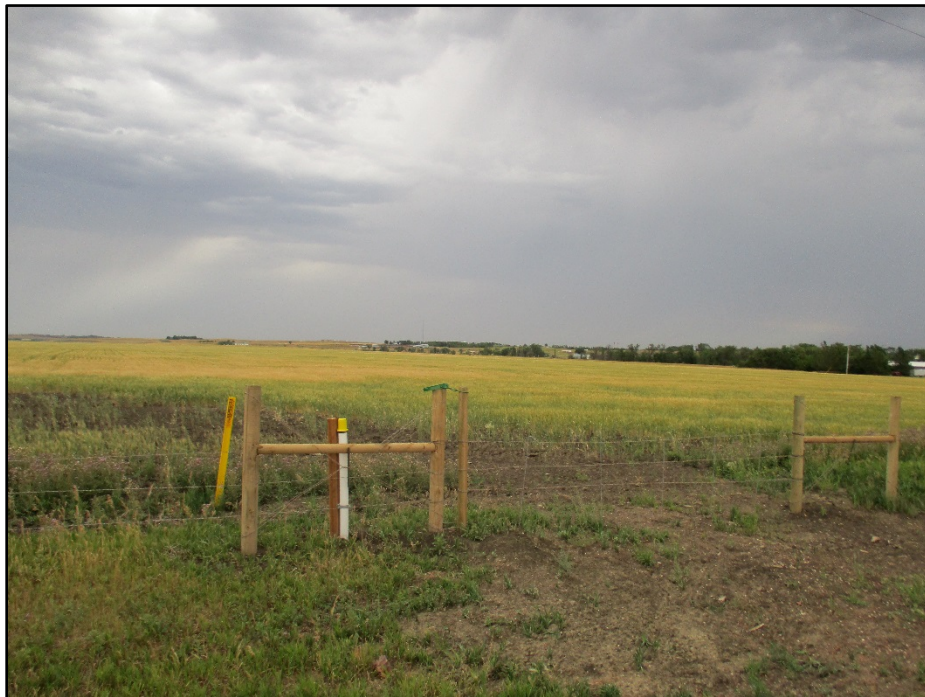
Photo 6. (GPS Point #524) – Caliber installed this fence/gate. Pipeline markers are observed near it. The wheat crop appears thin. Direction: Northwest.

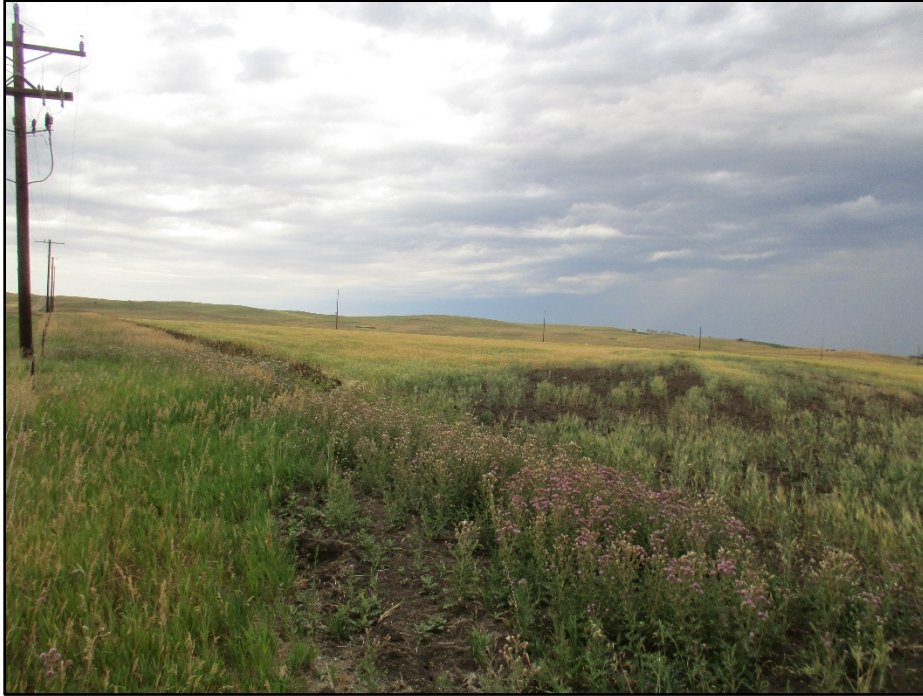
Photo 7. (GPS Point #524) – Canada thistle, a noxious weed, was observed along the edge of the ROW and in the nearby field and ditch. Caliber’s representative stated they are in contact with a company to make a weed plan and spray the noxious weeds. Direction: West.

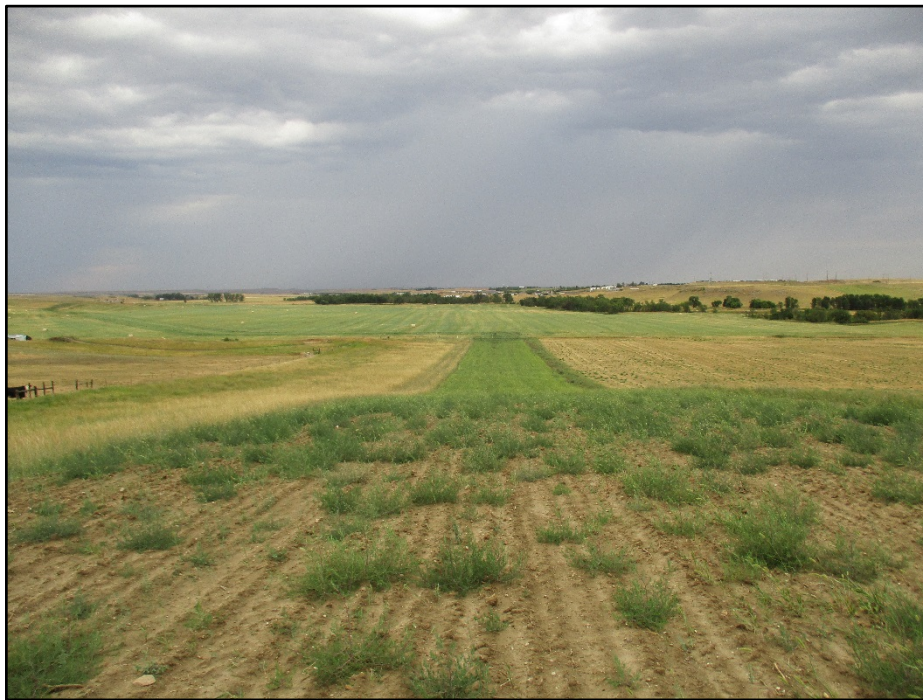
Photo 8. (GPS Point #526) – Pipeline ROW with a lot of bare ground, mostly annual weeds growing and very few grasses. Vegetation growth was poor, most likely due to drought conditions. Direction: South.

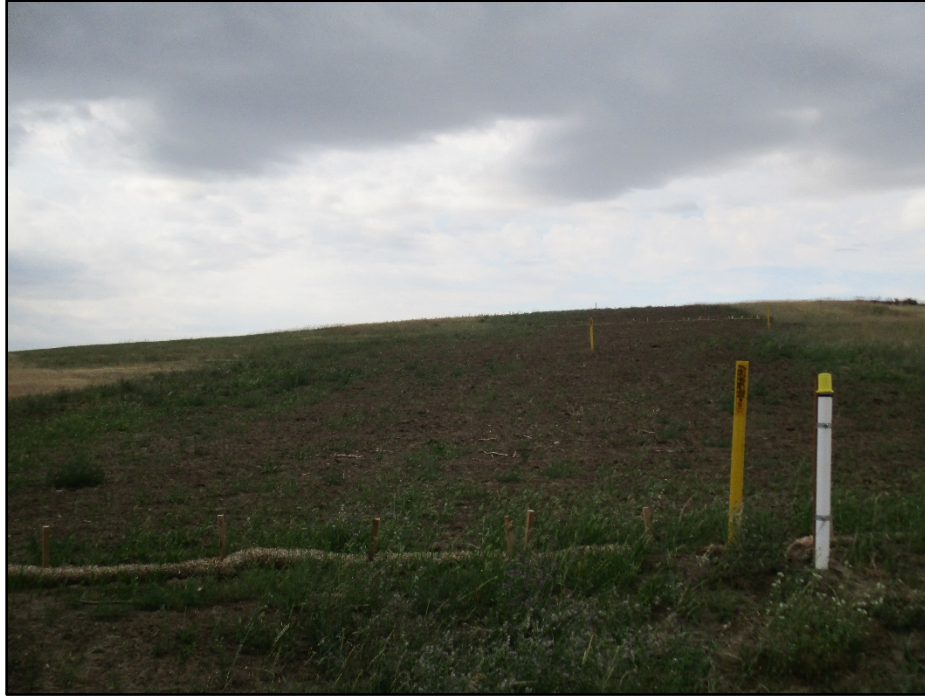
Photo 9. (GPS Point #527) – Pipeline ROW area with pipeline markers. Straw wattles were observed near the bottom and the middle of the hill. Direction: South.

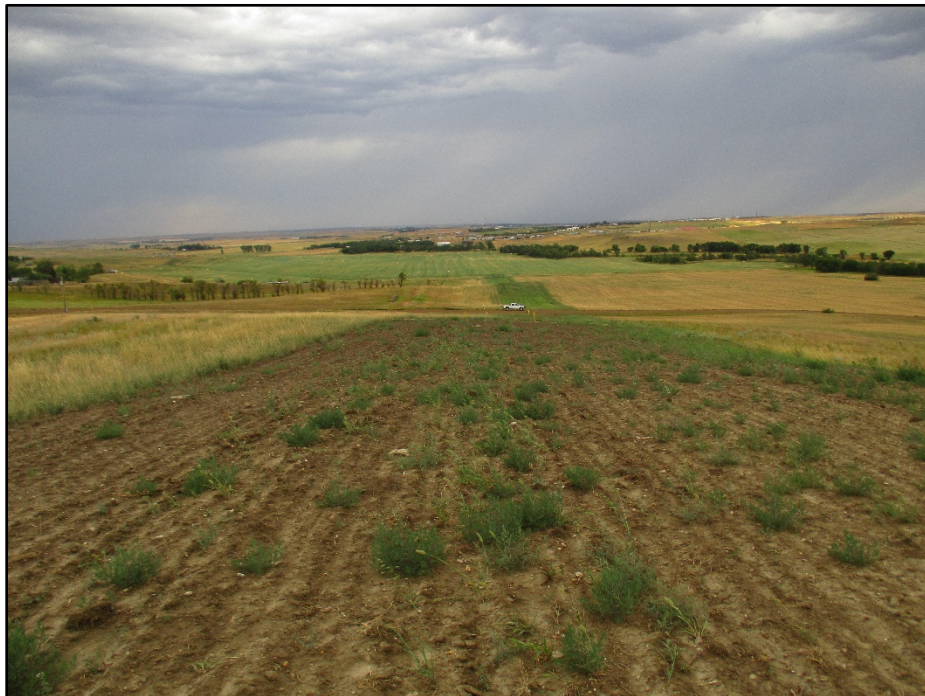
Photo 10. (GPS Point #528) – Pipeline ROW with bare ground, mostly annual weeds growing and few grasses. Vegetation growth from re-seeding was poor most likely due to drought conditions. Direction: North.

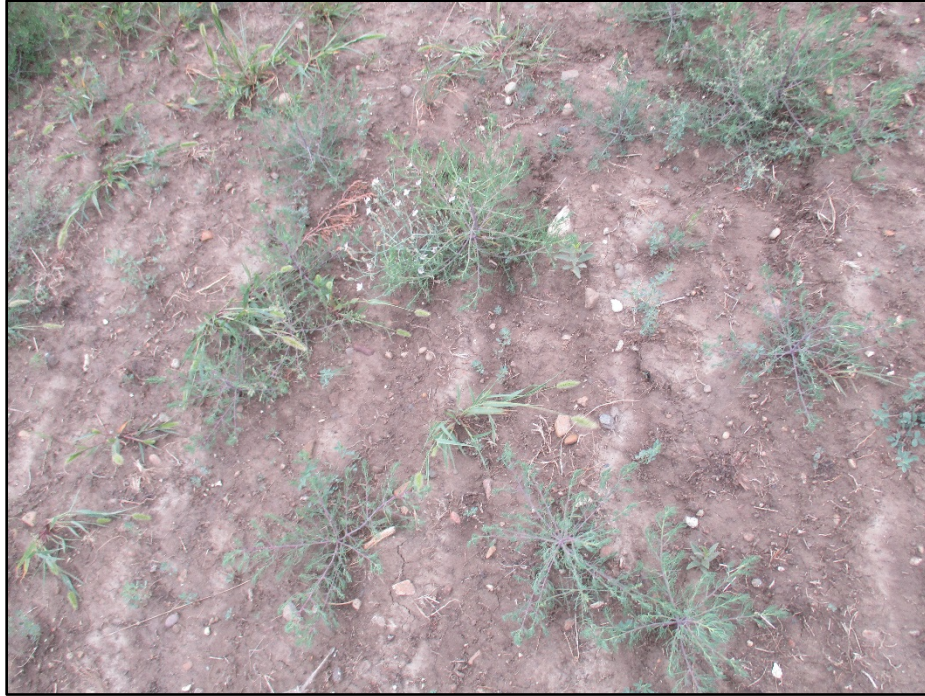
Photo 11. (GPS Point #502) – Pipeline ROW typical vegetative growth in this area. Bare ground with some annual weeds (Kochia, pigeon grass) and few grasses.

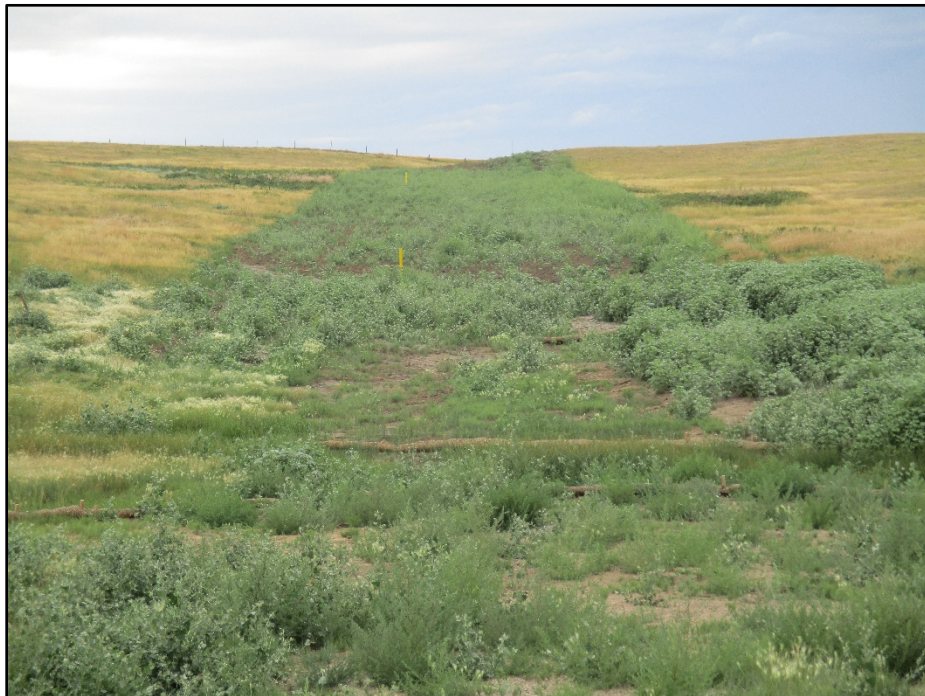
Photo 12. (GPS Point #529) – View of wetland area that was double ditched. Width of pipeline disturbance was necked down to cross wetland. Straw wattles were observed. Pipeline markers are along the ROW. Direction: West.

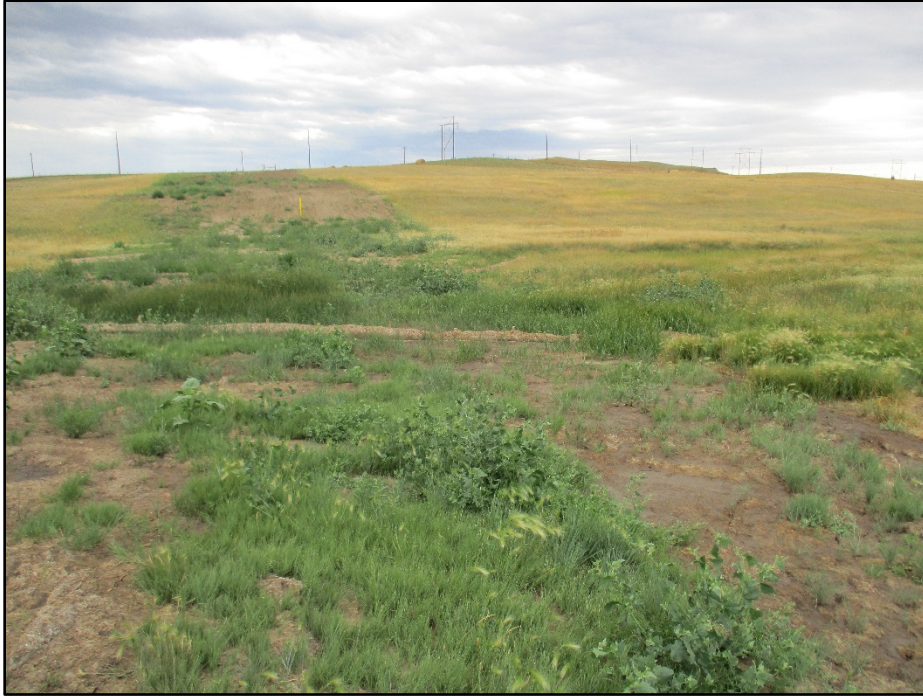
Photo 13. (GPS Point near #529) – View of wetland area above. Area is poorly vegetated, with weeds and some non-planted species growing in from nearby area such as foxtail barley (observed to the left of photo outside of ROW). Direction: East.

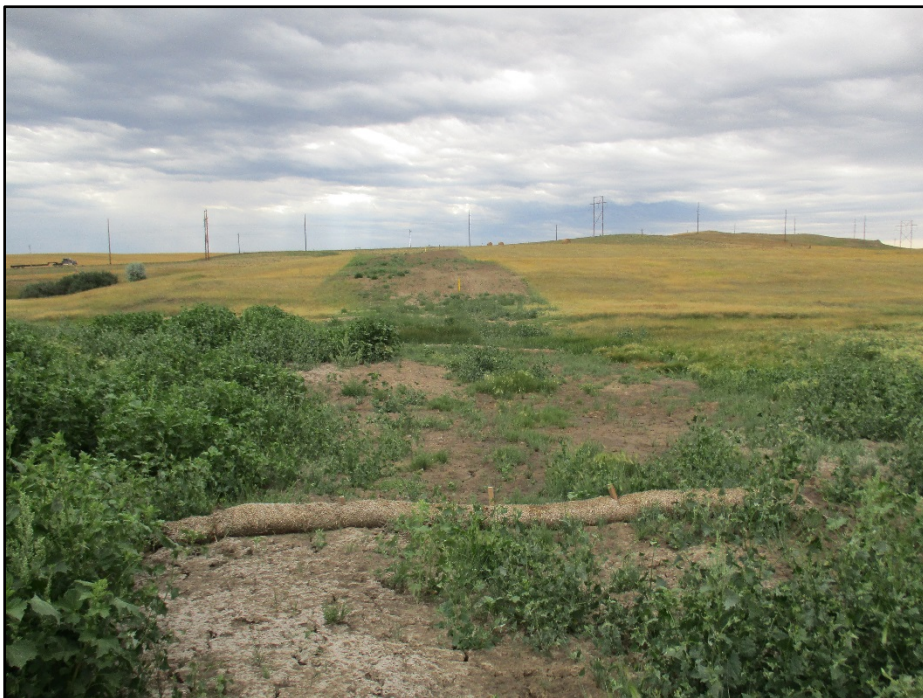
Photo 14. (GPS Point near #529) – View near wetland area. Straw wattles were observed. Area is poorly vegetated, with weeds and some native plants along the lower portion of the wetland. Poor vegetation most likely due to drought conditions. Direction: East.

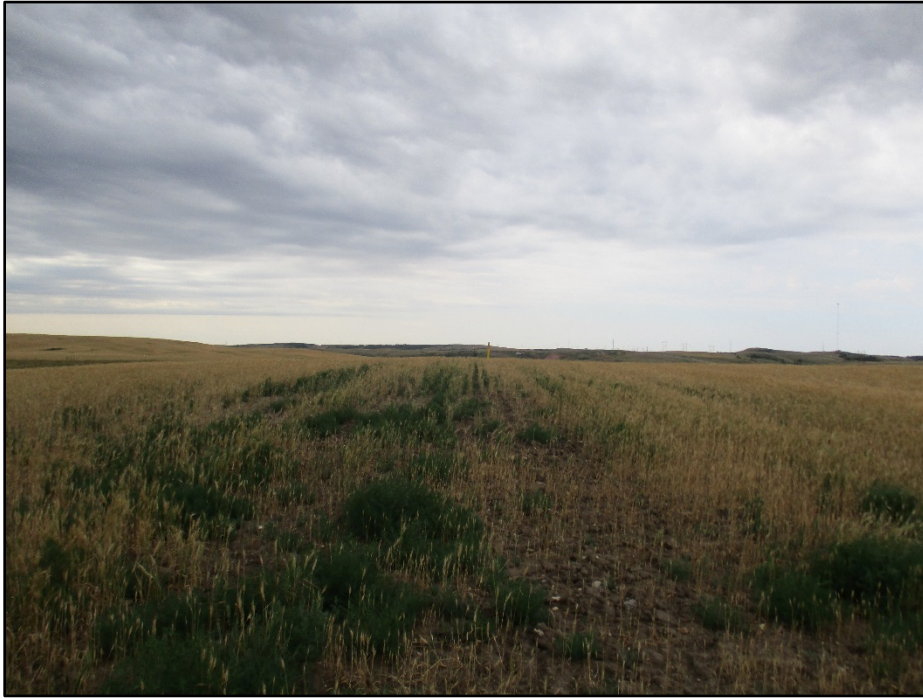
Photo 15. (GPS Point #530) – Pipeline ROW going through cropland, with pipeline marker in the distance. Direction: South.

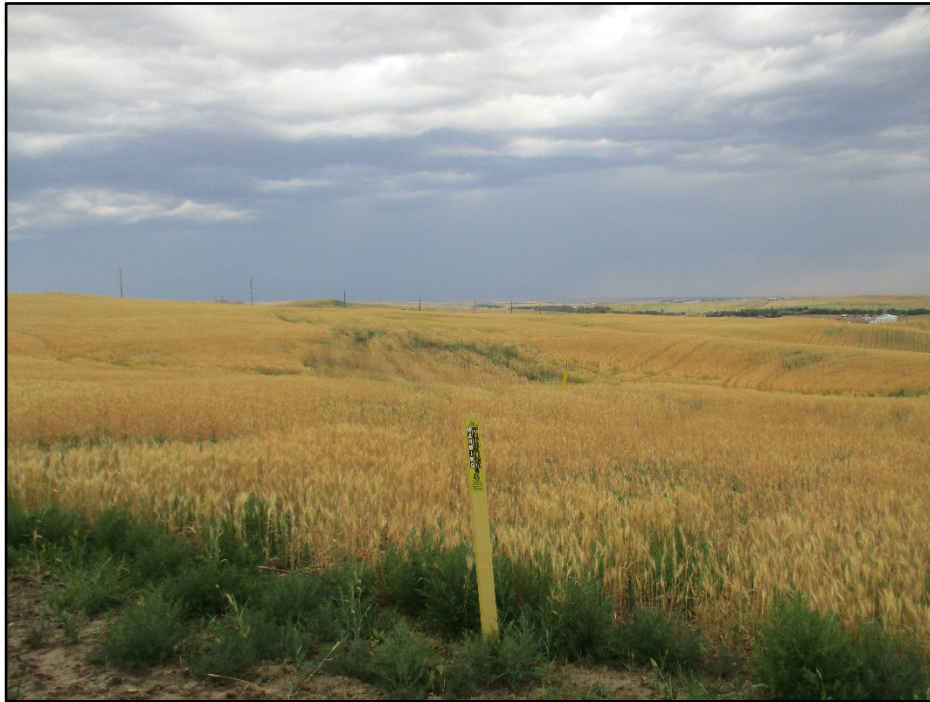
Photo 17. (GPS Point #531) – Pipeline ROW going through cropland, with good vegetative growth and few weeds. Pipeline marker observed and contours appear adequate. Direction: North-northwest.
