STATE OF NORTH DAKOTA
PUBLIC SERVICE COMMISSION

Savage Bakken Connector, Inc.
10-Inch Crude Oil Pipeline – McKenzie County
Savage Bakken Petroleum Hub Connector

Short Elliott Hendrickson Inc.
CONSTRUCTION INSPECTION REPORT

Project: Savage Bakken Petroleum Hub Connector - 10" Crude Oil Pipeline

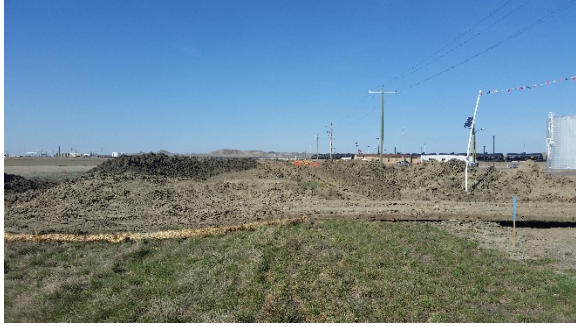
- * Between STA 4+30 - STA 8+90, topsoil was stockpiled LT of centerline and subsoil from trench excavation was stockpiled RT of centerline (see pictures #1 & 2). Topsoil was kept segregated and no erosion or transposition of soils were observed.

#1 - STA 4+30 AH, topsoil storage and subsoil storage	
#2 - STA 9+00 BK, pipeline backfill and trench depth	
#3 - STA 17+00, topsoil storage near easement

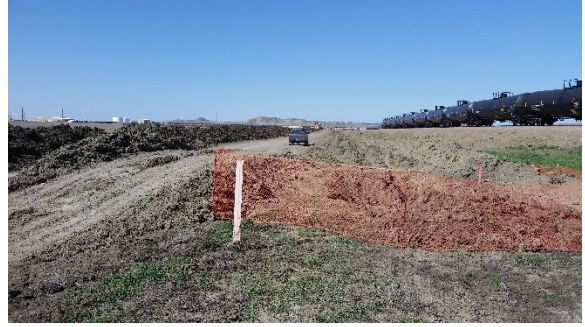
- * Between STA 14+76 - STA 28+06, topsoil was stockpiled in windrows on the LT of centerline and subsoils from trench excavation were stockpiled on RT. (see pictures #3-6).

#4 - STA 14+76 AH, trenching and removed topsoil area	
#5 - STA 18+00 AH, backfilled pipeline with remaining 2 ft of trench.	
#7 - STA 28+00 BK, existing and removed topsoil

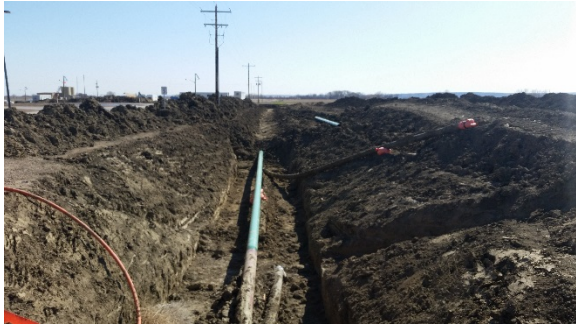
* Trenching operations into subsoils were excavated to depths ranging between 4 ft - 5 ft from top of subsoil. Trenching operations were complete between STA 4+30 - STA 77+30. (See pictures #2 & #13).

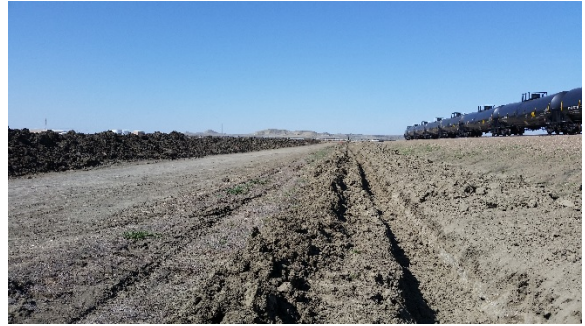
* Laid pipeline was being covered with approximately 2 ft - 3 ft of subsoil, and compacted by excavator. This cover left approximately 2 ft of open trench to top of subsoils. This was done due to Savage having a private fiber optic line installed over pipeline. Once fiber optic line is installed, remaining 2 ft of subsoil to be placed and compacted for a total of 48" - 60" of subsoil cover over pipeline (not including topsoil depth). (See pictures #5 & #12). Pipeline was backfilled to these depths between STA 4+30 - STA 8+00, STA 40+90 - STA 33+00, and STA 73+50 - STA 75+25.

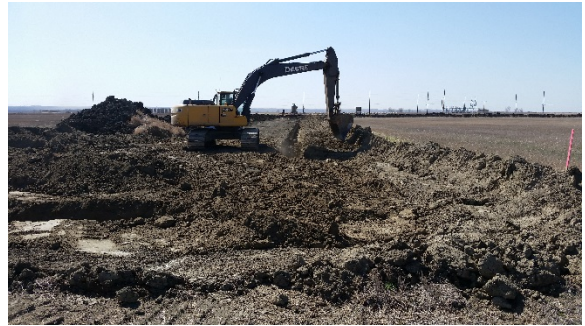
#9 - STA 28+00 RT AH, subsoil replacement	
#10 - STA 28+00 LT AH, continued topsoil windrow w/subsoil on RT of centerline	
#11 - STA 28+00 LT AH, no evident topsoil sediment deposition from windrow

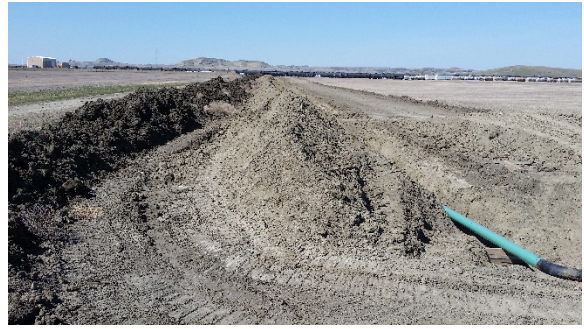
#12 - STA 32+00 AH, backfilled pipeline compacted with remaining 2 ft of trench	
#13 - STA 34+00 BK, pipeline	
#14 - STA 34+00 AH, topsoil and subsoil windrow LT

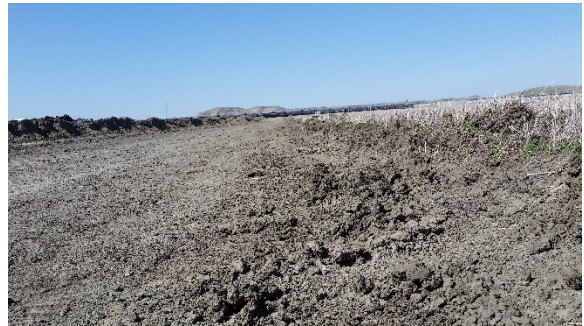
- * At STA 34+50, topsoil removal depth was checked. It was observed that removal depth measured approximately 10"-12". (See picture #15).
- * Between STA 34+00 - STA 41+20, topsoil and subsoils windrow stockpiles were stored on the LT of centerline. Windrows were kept segregated with toe of each stockpile being separated by 1ft-3ft. (See photo #16). No transposition of soil from windrows observed.

#15 - STA 34+50 AH, Depth Check RT	
#16 - STA 35+25 BK, topsoil and subsoil windrows LT	
#17 - STA 41+40 AH, touching windrows	
#18 - STA 41+40 AH, touching windrows

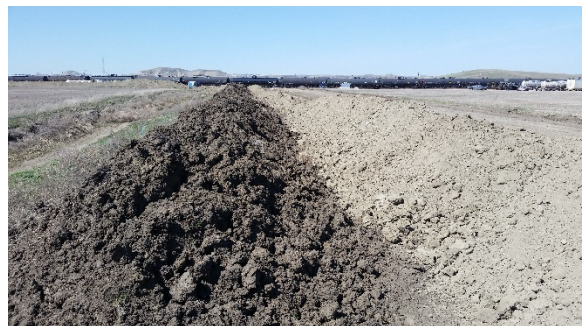
#18

- * Between STA 41+20 - STA 46+25, the toe of topsoil and subsoil were touching in areas, but no mixture of soil types was evident per color and soil type. (See picture # 17 & 18).

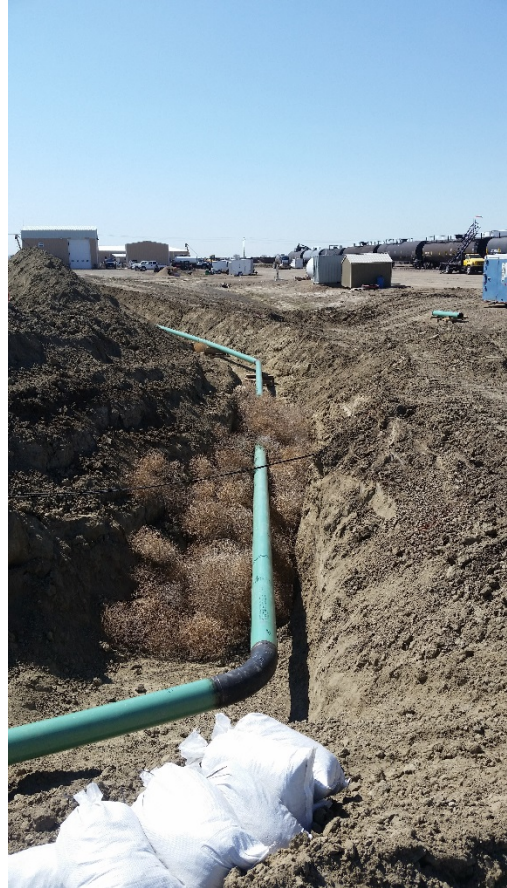
- * Between STA 46+25 - STA 73+06 no topsoil was removed or stockpiled due to existing surfacing being composed of gravel and sand. This area was existing stockyard and rail storage facility. An effort was made by contractor to keep gravel surfacing separated from subsoils. (See pictures #21-26).

#19 - STA 46+25 BK, covered end of topsoil windrow (5' covered)	
#20 - STA 46+25 AH, covered end of topsoil windrow	
#21 - STA 46+40 AH, no topsoil removal, exist. gravel surface

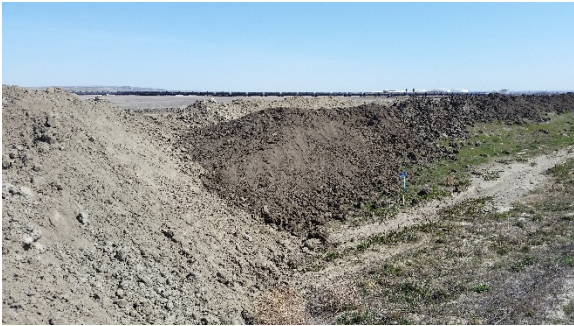
#19

Identified Issues (non-threatening of compliance):
STA 46+25 LT - end 5 feet of topsoil windrow was covered by subsoil. This resulted in a minute amount of topsoil mixing and is insignificant to amount of topsoil stockpiled for area.
STA 103+50 - STA 108+00 - No topsoil stripped and current construction mats in place. Savage and ProPipe foremen made aware that this area needs topsoil stripped prior to trenching for pipeline or construction of pump pad with gravel surfacing over centerline of pipeline. See attached Inspection Report for further observations of area and correspondence.

- * At STA 46+25, it was observed that topsoil windrow end was covered by subsoil and was not segregated. This was at the end of a topsoil windrow due to pipeline trenching continuing on through Savage gravel surfaced stockyard. Approximately 5ft of topsoil had been covered by subsoils. (See pictures #19-20).

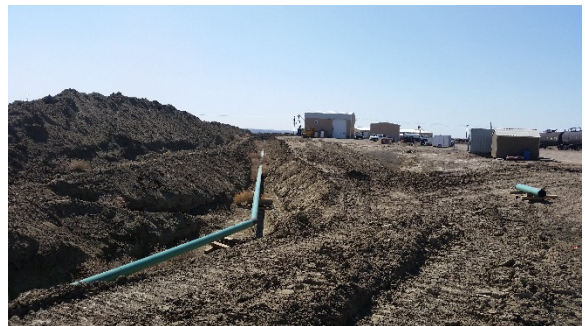
* Depth of trench and pipe installation was checked at STA 8+20, STA 15+25, STA 26+00, and STA 33+00. Remaining pipeline was resting on blocks at bottom of trench between STA 33+00 - STA 77+10. (see pictures #22, 25, 27, & 31).

#22 - STA 46+45 AH, trenching depth with pipeline on blocks, subsoil storage LT	
#23 - STA 59+60 BK, rail stockyard	
#24 - STA 60+00 AH, rail stockyard	
#25 - STA 73+00 BK, stockyard trenching depth 5 ft, no topsoil

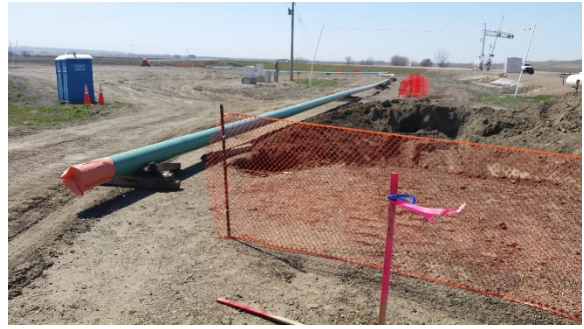
- * Between STA 77+30 - STA 83+78, no topsoil removal or trenching had taken place. Existing surfacing was mixture of sand and gravel with clay. Minimal vegetation. (See pictures #27-28). 12" Fiber Roles were in place at ditch flowline along 149th Ave NW.

#26 - STA 73+00 BK, rail stockyard trenching	
#27 - STA 77+30 AH, no topsoil removed currently prior to bore under highway	
#28 - STA 83+76 BK, unstripped topsoil area next to highway

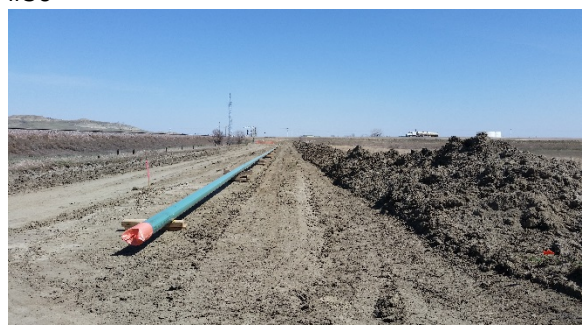
* Between STA 87+28 - STA 103+50, topsoil was stockpiled LT of pipe centerline. No trenching had taken place and no subsoils had been stockpiled at this time. (See pictures #30-31).

#30 - STA 94+15 BK, topsoil windrow storage			
#31 - STA 94+15 AH, topsoil windrow storage and pipeline blocking			
#32 - STA 87+50 RT, topsoil removal depth check

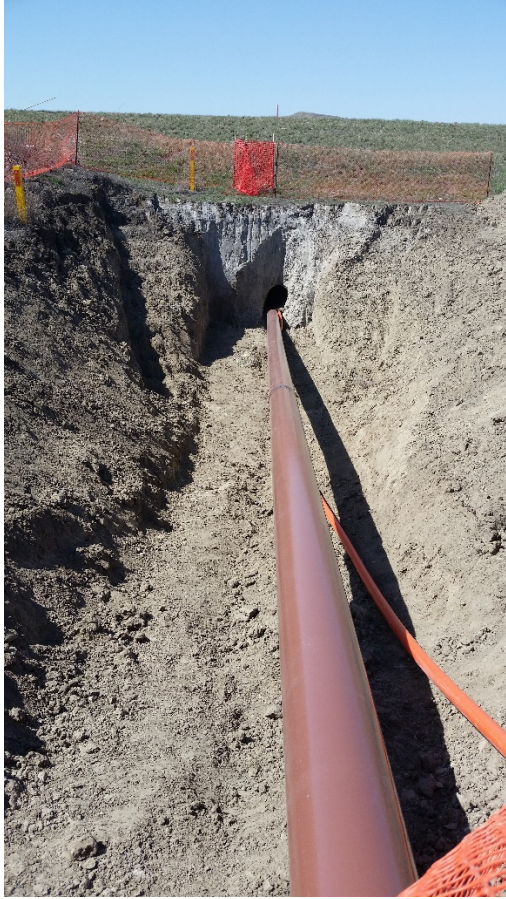
#29 - STA 83+78 AH, bore under highway	
*See attached map with location of each photo, and attached pages of photo's

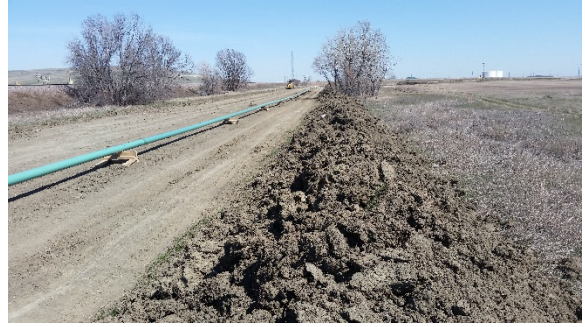
* Between STA 101+00 - STA 103+50, topsoil removal depth appeared to be between 10"-12", and remaining soil appeared to be continual topsoil. This could be due to the lowlands and presence of vegetative cover and wetlands. (See pictures #33-34).

#33 - STA 102+00 BK, topsoil storage			
#34 - STA 103+00 BK, topsoil removal depth showing vegetation still present			
#35 - STA 103+64 AH, Clearing & Grubing area/construction mats

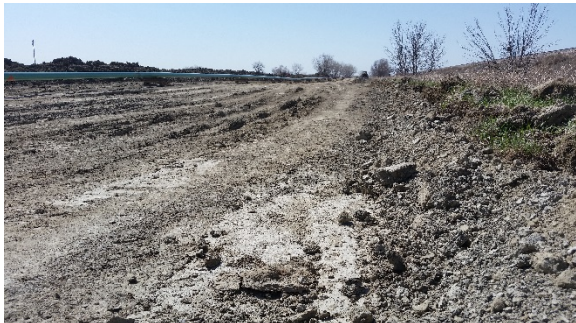
#32

* At STA 87+50, a topsoil removal depth check was performed. The average removal depth was measured to be 12". (See picture # 32).

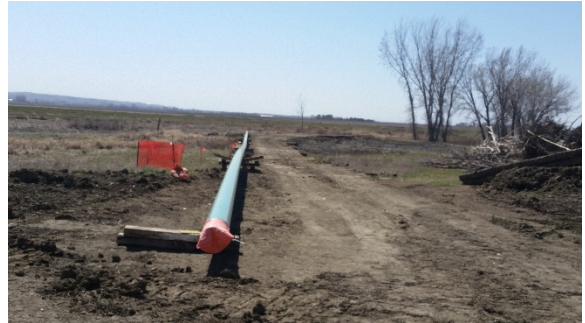
#35

* Between STA 103+64 - STA 108+00 no topsoil had been stripped. This area was Clear & Grubbed, and construction mats had been placed between STA 103+90 - STA 107+64. Construction mats had pushed into native soils. (See pictures #35-40). Matt Schaible consulted with ProPipe and Savage personnel regarding this site (see Contractor Correspondence section on pg 1).

Other Remarks: * Tyler Newman of Savage Services was made aware of the need for topsoil stripping between STA 103+64 - STA 108+00 prior to any construction of earthen pad with graveling services. Tyler said topsoil would be stripped and kept segregated from subsoils along with an area to the NE that will be a soil borrow site. Topsoil that is not spread over the area the pad is being constructed will be used over other areas of the pipeline.

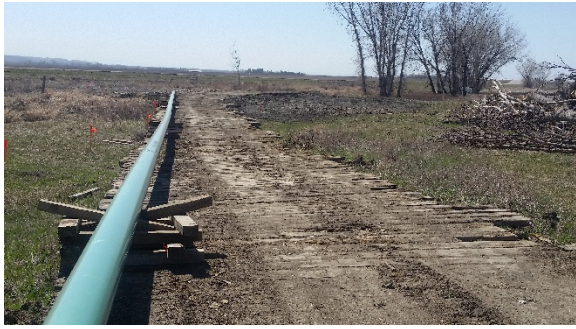
#36 - STA 103+80 AH, construction mats over topsoil			
#37 - STA 105+00 AH, pipeline centerline with no topsoil removed			
#38 - STA 105+00 AH, non-stripped topsoil, construction mats, pipeline

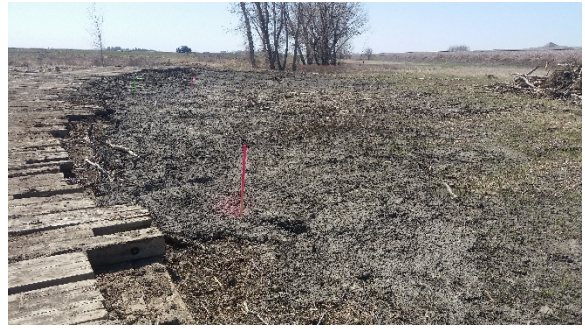
#39 - STA 105+50 AH, Clearing & Grubing area (topsoil not removed)			
#40 - STA 104+00 AH, overview of non-stripped topsoil area			
*See attached map with location of each photo, and attached pages of photo's			
*(AH=Ahead Stationing, BK=Back Stationing)
