PU-17-97
Cenex Pipeline, L.L.C.
10" Refined Fuels Pipeline
As-Built Inspection Report

May 2021

**North Dakota Public Service
Commission**
600 E. Boulevard Avenue
Bismarck, ND 58505-0480

Stantec Consulting Services Inc.
3303 Fiechtner Drive, Ste 100
Fargo, ND 58103

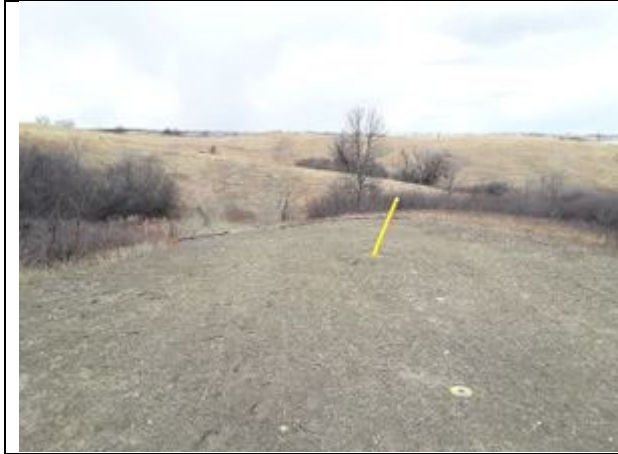
Observation Point: 1
Date Taken: April 19, 2021 2:37 PM
Direction Photo is Taken: North
Spread: 2

Photo Description: Appropriate tree clearing width.

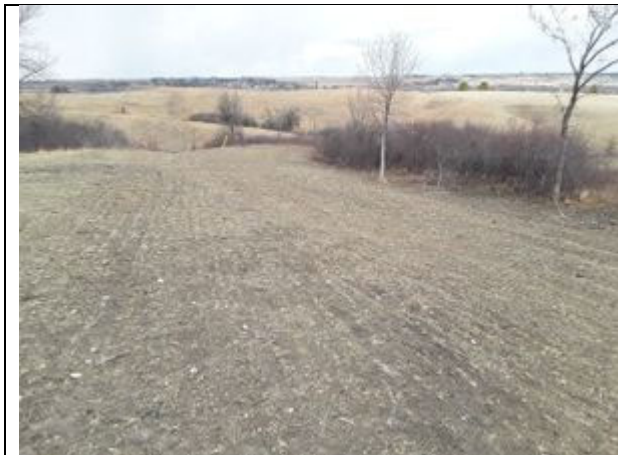
Observation Point: 2
Date Taken: April 19, 2021 2:40 PM
Direction Photo is Taken: North
Spread: 2

Photo Description: Lack of BMPs for erosion and sediment control on slopes.

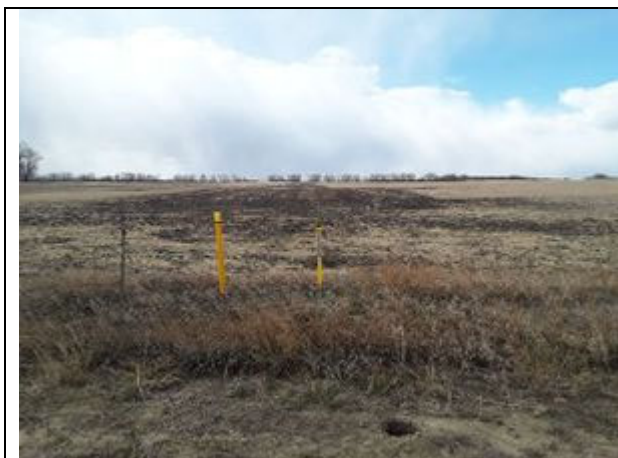
Observation Point: 3
Date Taken: April 19, 2021 3:13 PM
Direction Photo is Taken: West
Spread: 2

Photo Description: Overview of well graded and decompaction plowed pipeline ROW. Unclear as to why the ROW is seemingly recently plowed.

Cenex submitted Docket 31: Construction Environmental Program; detailing restoration and mitigation practices. At the time of the site inspection, the pipeline trench had been backfilled, soils had been recontoured, and topsoil replaced. The majority of the ROW appeared recently plowed and/or seeded. In crop land, the plowing was inconsistent with adjacent field conditions, and no evidence of previous cropping. Non-cropland generally lacked any vegetation at all (**Photo Observation Point: 5, 6, 28, 29, 30, 34, and 44**). Stantec recommends actions in the weed management plan be implemented from now and throughout the reclamation phase (**Photo Observation Points 3 and 35**).

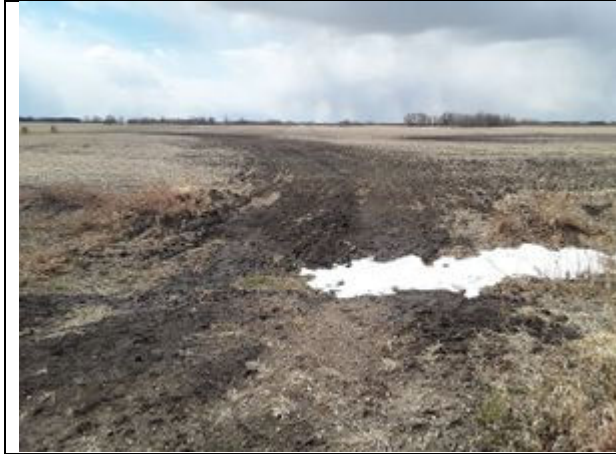
Observation Point: 4

Photo Description: Construction access not graded well, also utilized by landowner, not clear if grading and compaction issues present are Cenex or landowner caused.

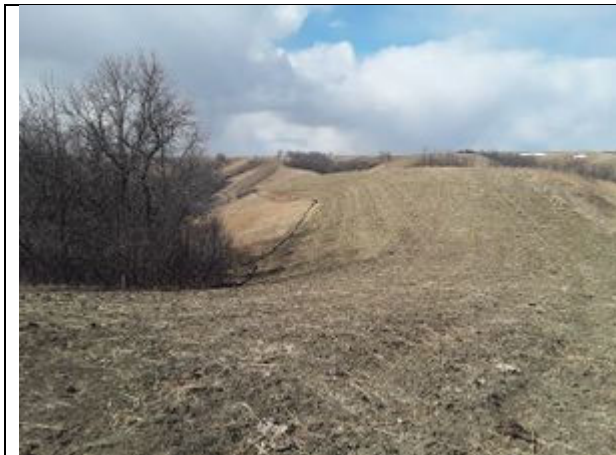
Observation Point: 5

Photo Description: BMPs not maintained. No vegetation growing. Lack of construction industry standard and Cenex SWPPP implementation of BMPs.

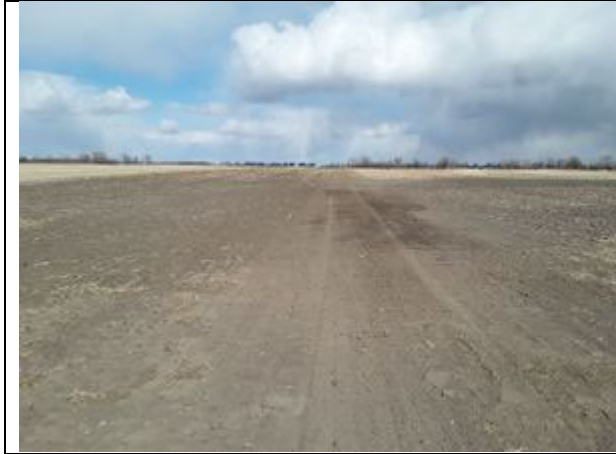
Observation Point: 7
Date Taken: April 19, 2021 4:14 PM
Direction Photo is Taken: East
Spread: 2

Photo Description: Compaction in ROW along access path, may be utilized by landowner, unsure if Cenex or landowner caused issue.

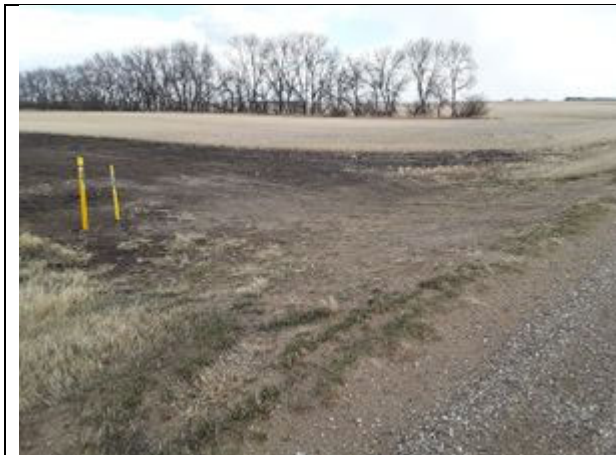
Observation Point: 8
Date Taken: April 19, 2021 4:33 PM
Direction Photo is Taken: Southeast
Spread: 2

Photo Description: Roadway ROW construction access in ditch. Substandard reclamation, both sides. Unclear as to why the ROW is seemingly recently plowed.

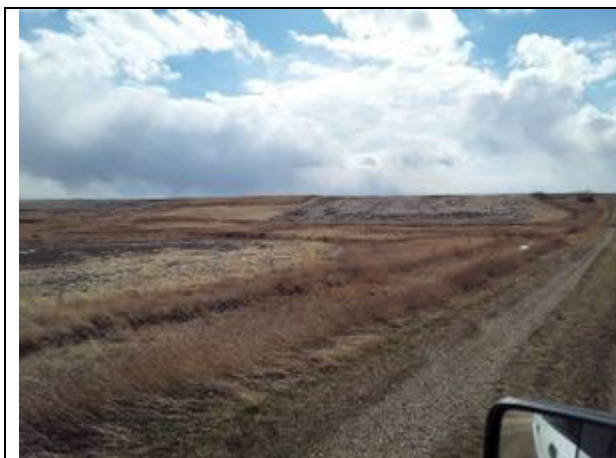
Observation Point: 9
Date Taken: April 19, 2021 4:45 PM
Direction Photo is Taken: Southwest
Spread: 2

Photo Description: Proof of HDD crossing methods through wetland drainage.

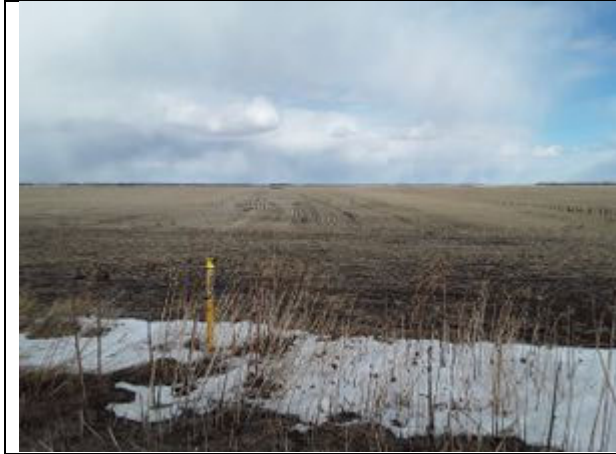
Observation Point: 10

Photo Description: Overview of pipeline ROW, successfully cropped field.

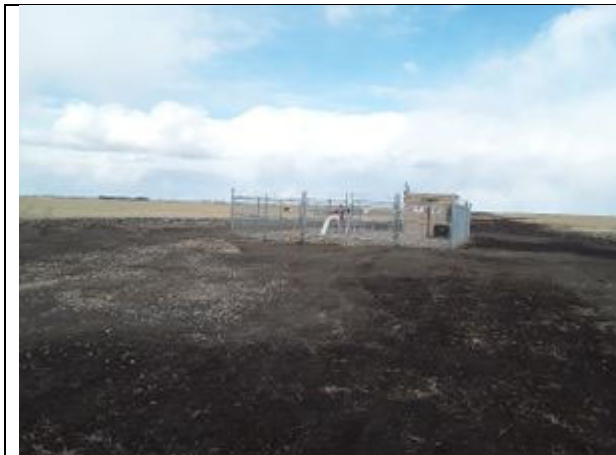
Observation Point: 11

Of aboveground infrastructure pad templates Stantec observed, all appeared to be a loose assortment of rocks with little to no relief provided from native soil ground surface. This condition allows for pad materials at the edges of the template to mix with surrounding native soils and also will allow for the emergence of weeds through the pad template. Areas where pad materials were stockpiled prior to use and loading/unloading/construction areas were not cleaned up properly and have resulted in the surrounding areas of the pad template to be mixed with an abundance of pad materials. Small stockpiles of pad materials were left adjacent to the pads in many instances. Stantec cannot be sure of landowner

Photo Description: Block valve pad. Unkempt and strewn pad material. Unclear as to why the ROW is seemingly recently plowed.

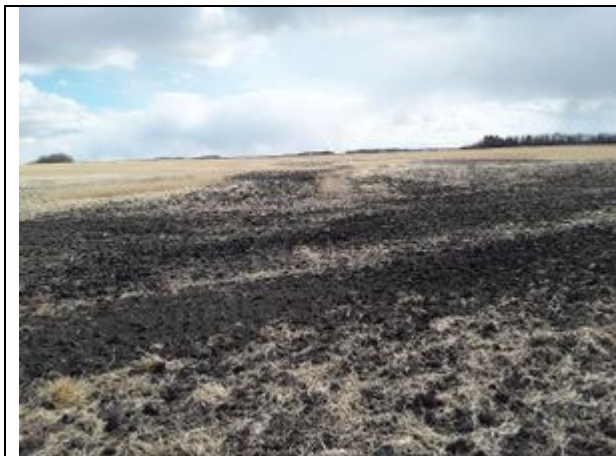
Observation Point: 12

Photo Description: Drainageway not graded back to original conditions. Large clods and topsoil present with mixed subsoil. Unclear as to why the ROW is seemingly recently plowed.

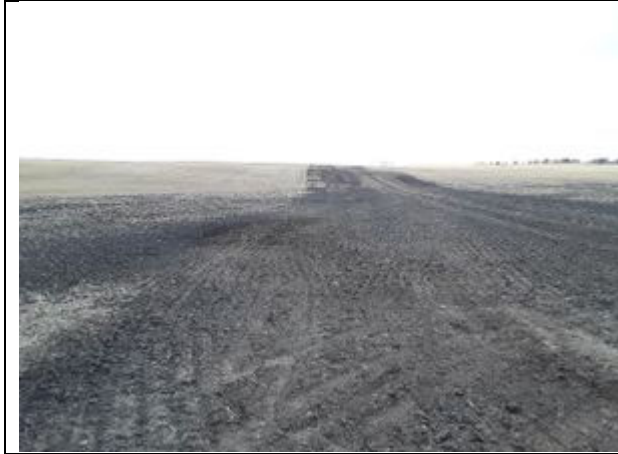
Observation Point: 13

Photo Description: Construction inspection revisit of HDD area. Significant subsoil mixing present. Unclear as to why the ROW is seemingly recently plowed.

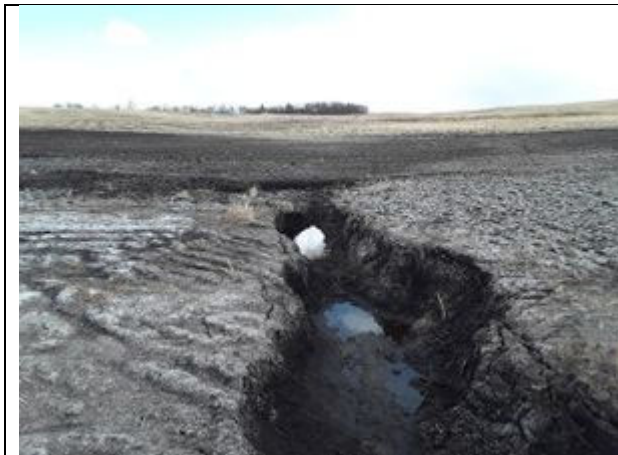
Observation Point: 14

Photo Description: Minor wetland outlet drainageway filled. Alteration of surface drainage patterns. Unclear as to why the ROW is seemingly recently plowed.

- Status of reclamation activities, re-grading of poorly graded areas, maintenance of BMPs, and potential need for additional BMPs
- Status of filled wetland drainageway and other poorly graded drainageways
- Status of recent plowing and/or seeding evidenced by soil disturbance and lack of vegetation, including annual weeds; determine final reseeding dates
- Status of SWPPP related deficiencies
- Status of rockpiles with significant soil fractions
- Status of roadway ROW reclamation of access points
- Status of potential compaction issues
- Status of temporary approach
- Status of area of subsidence
- Status of missing fencing
- Status of temporary approach

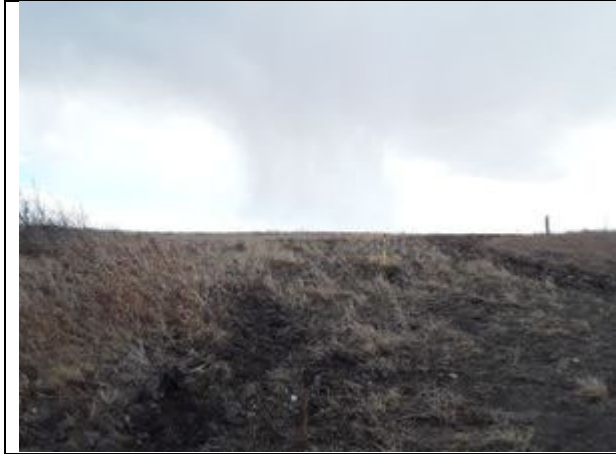
Observation Point: 16
Date Taken: April 19, 2021 5:59 PM
Direction Photo is Taken: Southwest
Spread: 2

Photo Description: Fence not replaced.

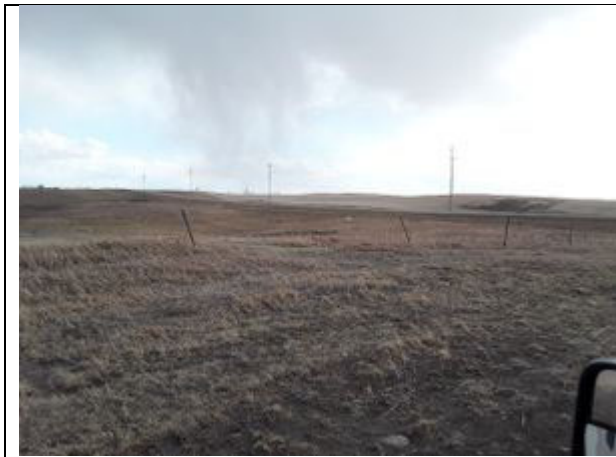
Observation Point: 17
Date Taken: April 19, 2021 6:01 PM
Direction Photo is Taken: Southwest
Spread: 2

Photo Description: Fence not replaced.

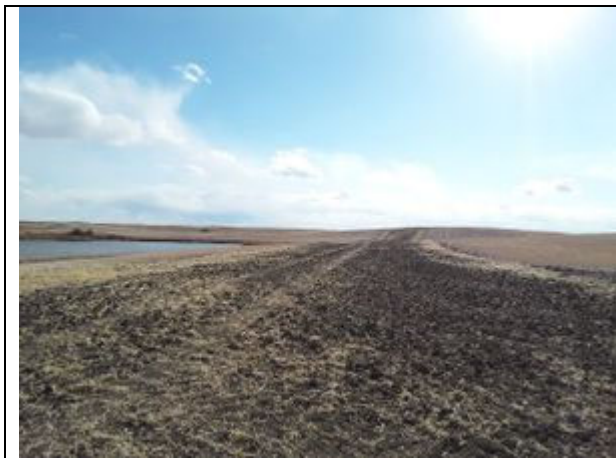
Observation Point: 18
Date Taken: April 19, 2021 6:09 PM
Direction Photo is Taken: West
Spread: 2

Photo Description: Overview of well graded, no mixing, and no compaction of pipeline ROW. Unclear as to why the ROW is seemingly recently plowed.

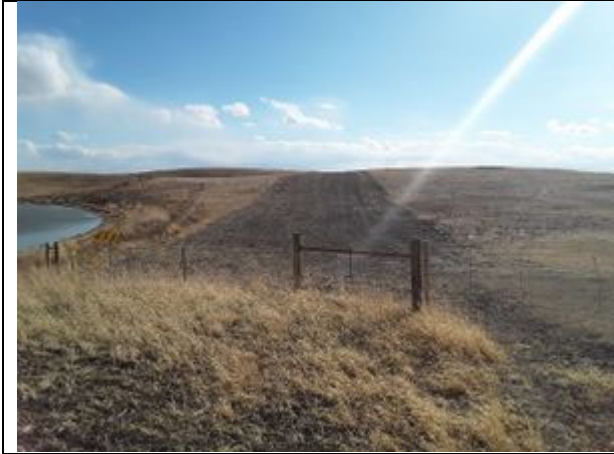
Observation Point: 19

Photo Description: Fence replaced.

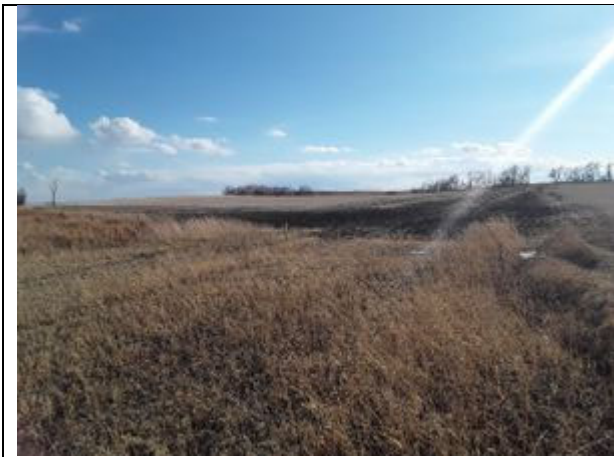
Observation Point: 20

Photo Description: Fence not replaced.

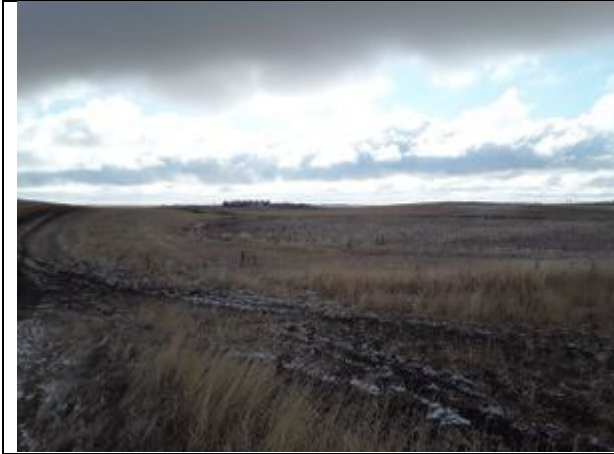
Observation Point: 22

Photo Description: Proof of HDD crossing wetland.

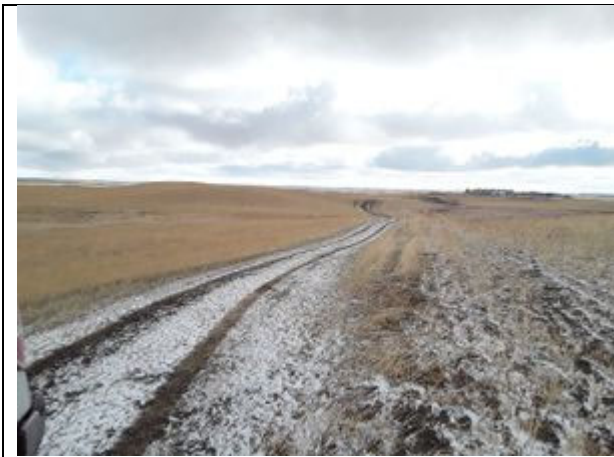
Observation Point: 23

Photo Description: Construction access not reclaimed and compaction present.

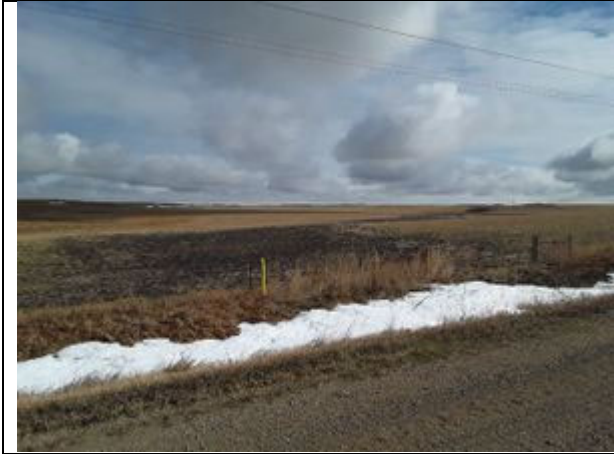
Observation Point: 25
Date Taken: April 20, 2021 10:42 AM
Direction Photo is Taken: Northeast
Spread: 2

Photo Description: Fence replaced.

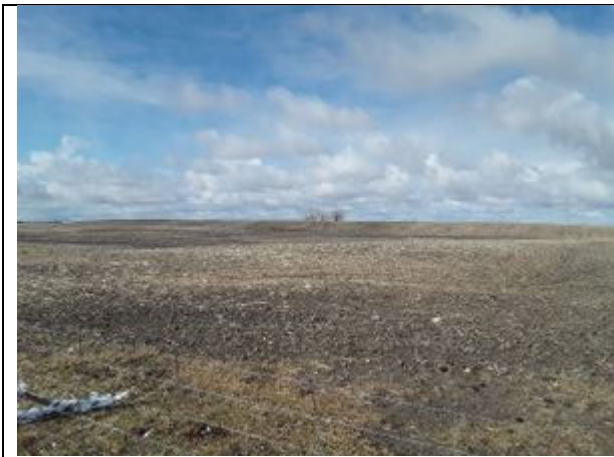
Observation Point: 26
Date Taken: April 20, 2021 11:10 AM
Direction Photo is Taken: Southwest
Spread: 2

Photo Description: Overview of well graded topography.

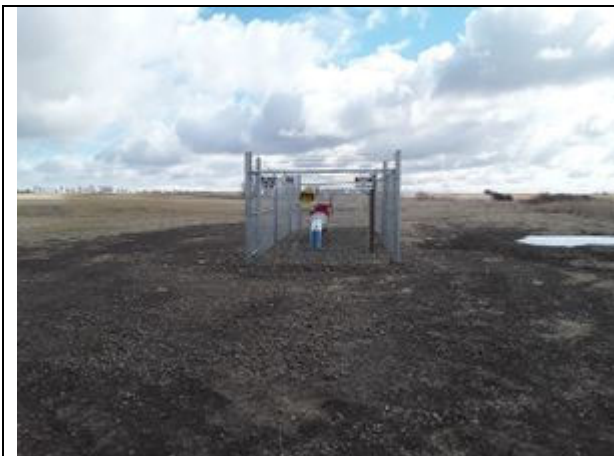
Observation Point: 27
Date Taken: April 20, 2021 11:25 AM
Direction Photo is Taken: East
Spread: 2

Photo Description: Block valve pad. Pad materials in strewn and unkempt.

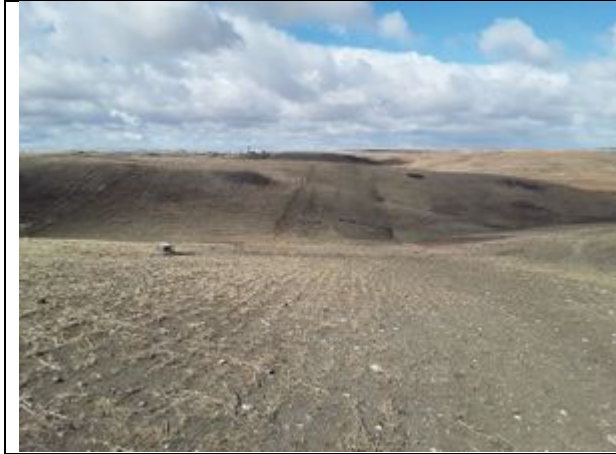
Observation Point: 28

Photo Description: BMPs not maintained. No vegetation growing. Lack of construction industry standard and Cenex SWPPP implementation of BMPs.

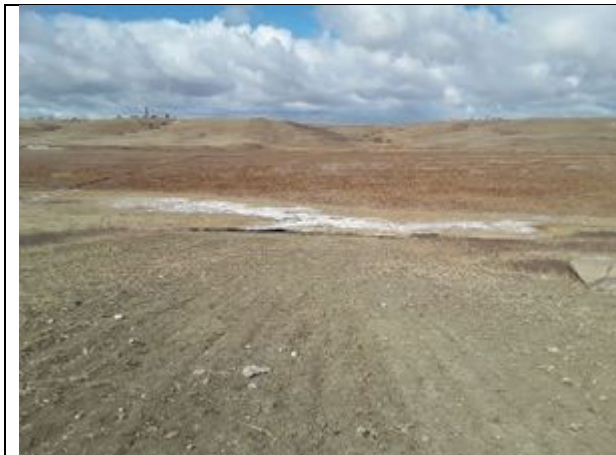
Observation Point: 29

Photo Description: BMPs not maintained. No vegetation growing. Lack of construction industry standard and Cenex SWPPP implementation of BMPs.

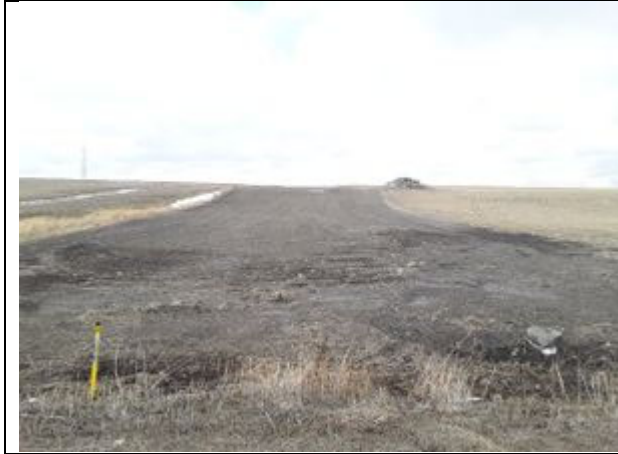
Observation Point: 31

Photo Description: Overview of well graded and plowed ROW. Unclear as to why the ROW is seemingly recently plowed.

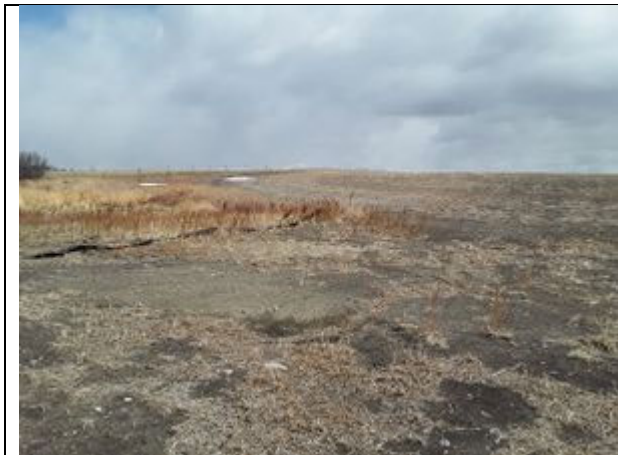
Observation Point: 32

Photo Description: Poor grading in drainageway. Improper BMP placement. Silt fence perpendicular to drainageway is not industry standard. Failure to maintain BMPs.

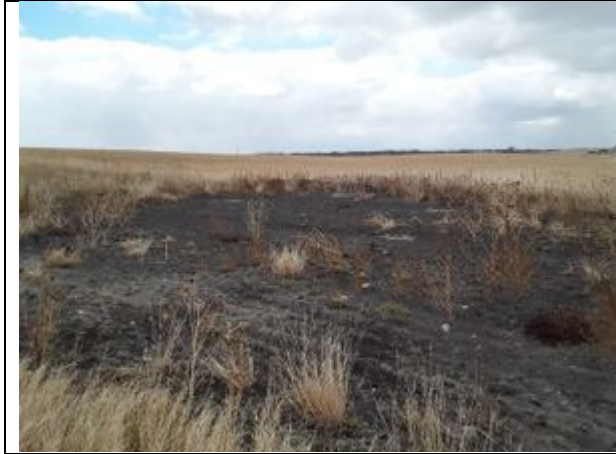
Observation Point: 34

Photo Description: BMP maintenance required. Poor vegetation abundance and quality, multitude of weeds.

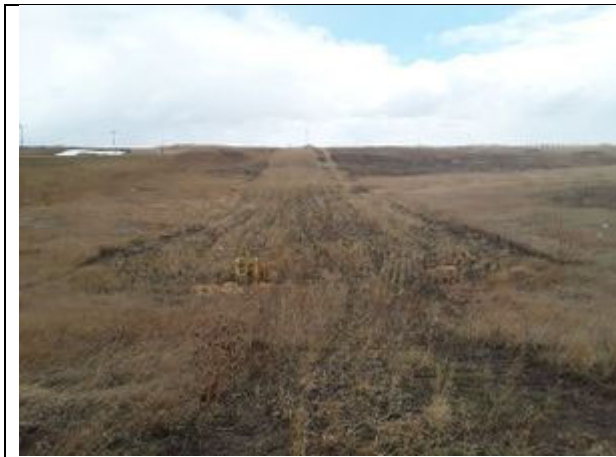
Observation Point: 35

Photo Description: Vegetation actively growing, weedy.

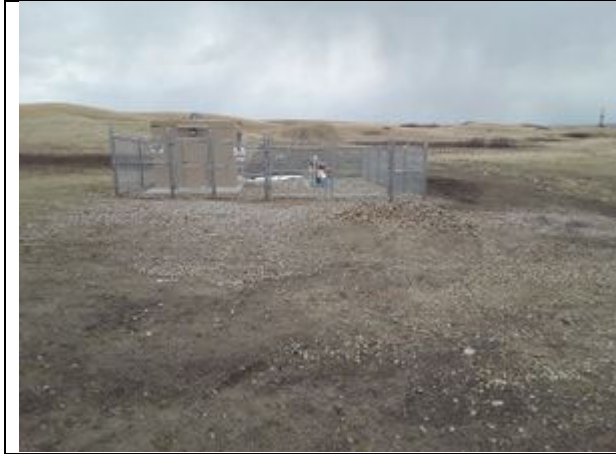
Observation Point: 37

Photo Description: Pad materials strewn and stockpile left. Unclear as to why the ROW is seemingly recently plowed.

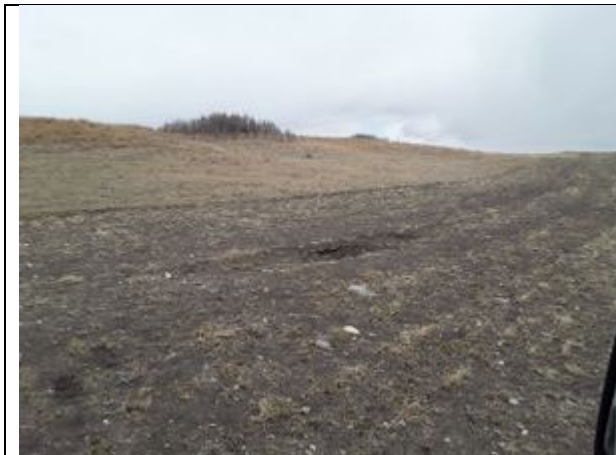
Observation Point: 38

Photo Description: Minor subsidence. Unclear as to why the ROW is seemingly recently plowed.

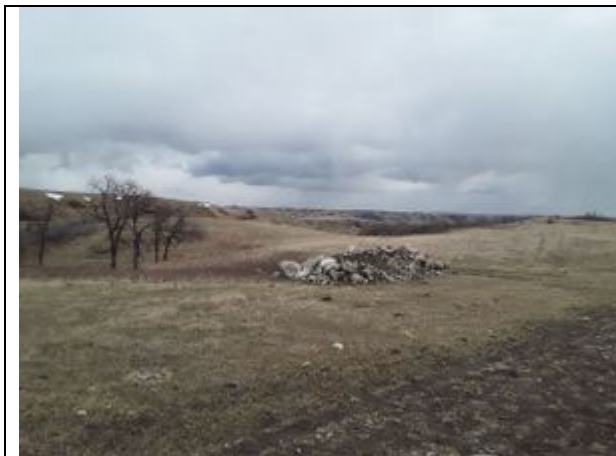
Observation Point: 39

Stantec observed rock piles with significant fractions of topsoil placed out of the ROW and one near the head of a drainageway (**Observation Points 39 and 41**).

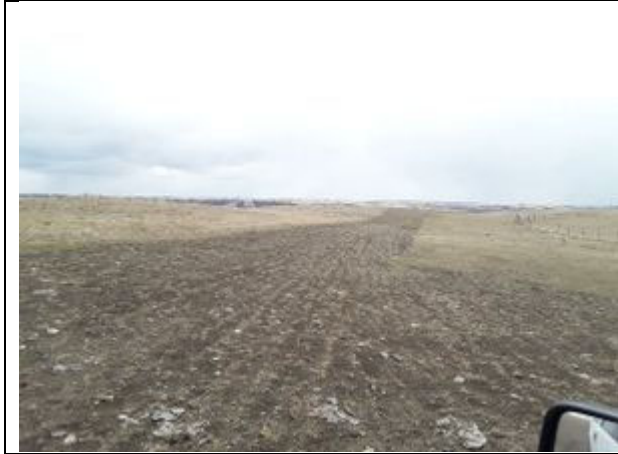
Observation Point: 40

Photo Description: Construction inspection revisit. Winter stripping does not differ from other areas. Unclear as to why the ROW is seemingly recently plowed.

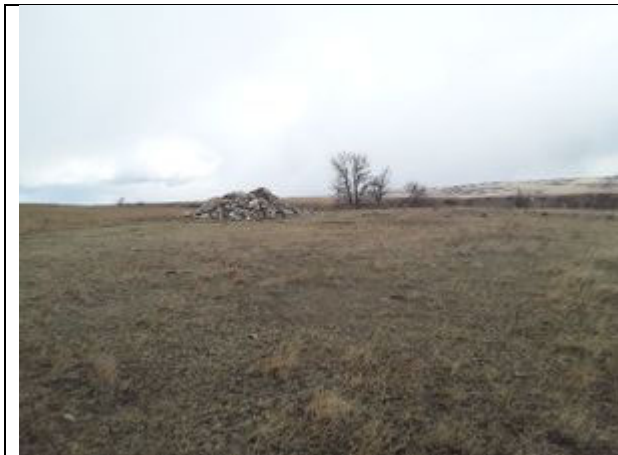
Observation Point: 41

Photo Description: Rock pile with significant soil fraction located off row.

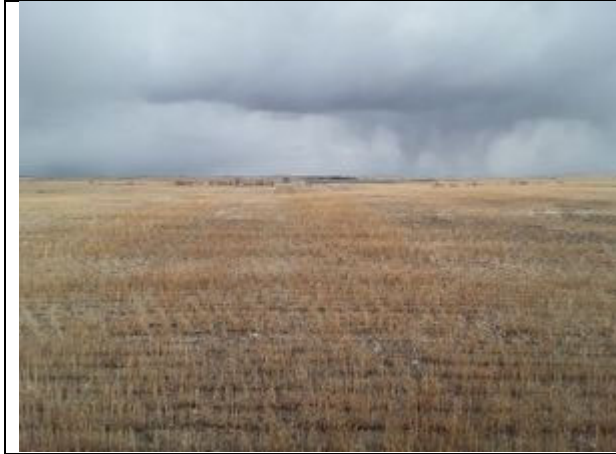
Observation Point: 43

Photo Description: Overview of well graded ROW with no growth difference.

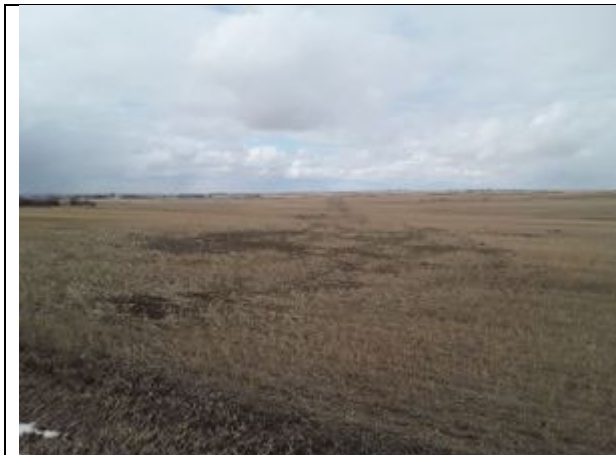
Observation Point: 44

Photo Description: Overview of ROW with contrasting vegetative success indicative of potential compaction.

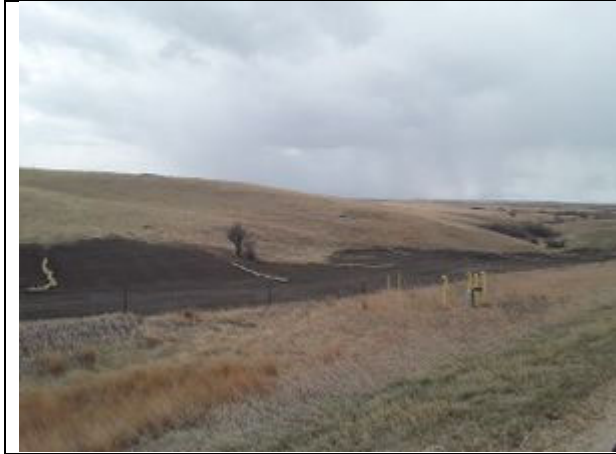
Observation Point: 46

Photo Description: Evidence of BMPs placed relatively recently. Unclear as to why the ROW is seemingly recently plowed.

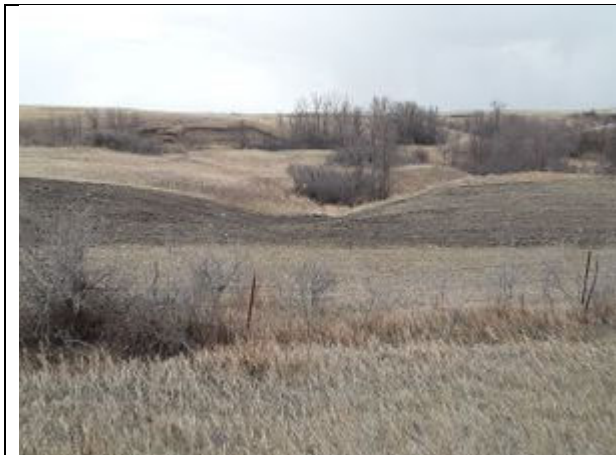
Observation Point: 47

Photo Description: Failure to maintain BMPs. Unclear as to why the ROW is seemingly recently plowed.

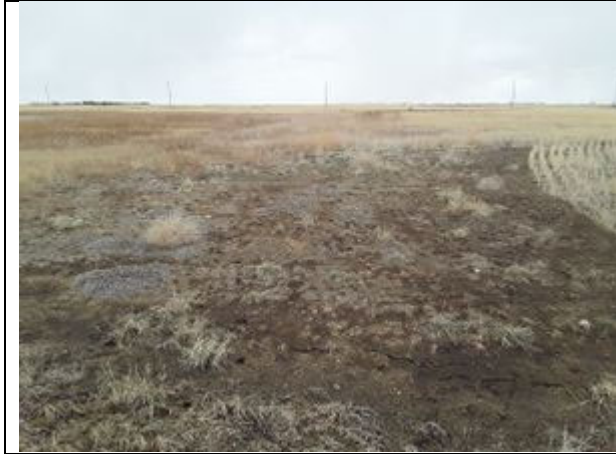
Observation Point: 49

Photo Description: Evidence of soil mixing and no desired vegetation present.

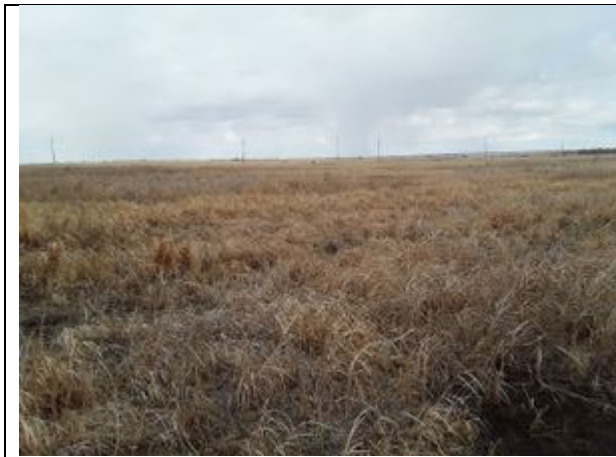
Observation Point: 50

Photo Description: Construction inspection soil segregation issue revisit. 2020Vegetation growth seems adequate.

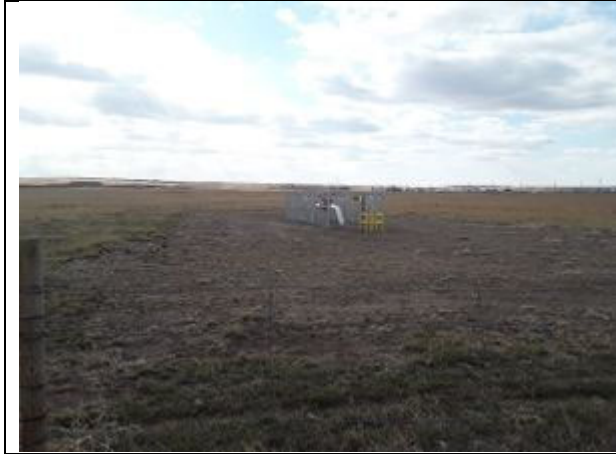
Observation Point: 52

Photo Description: Block valve. No vegetation.

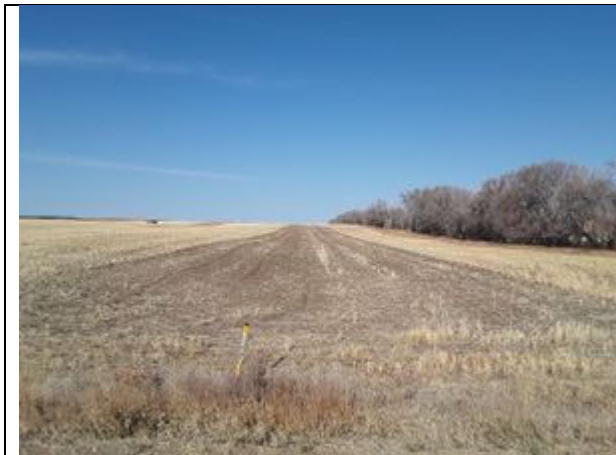
Observation Point: 53

Photo Description: Overview of well graded and plowed ROW. Unclear as to why the ROW is seemingly recently plowed.

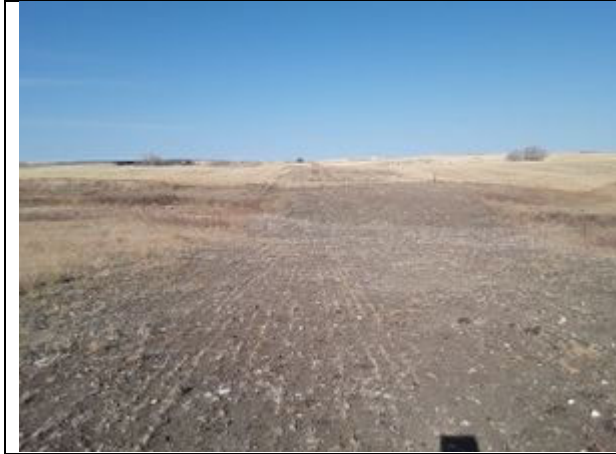
Observation Point: 55

Photo Description: ROW trenched through NHD blue line waterway. Closer inspection reveals area is not a wetland or waterway.

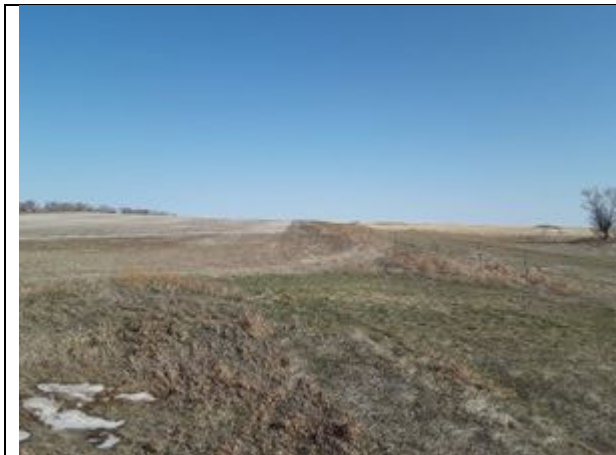
Observation Point: 56

Photo Description: Overview of well graded and plowed ROW. Unclear as to why the ROW is seemingly recently plowed.

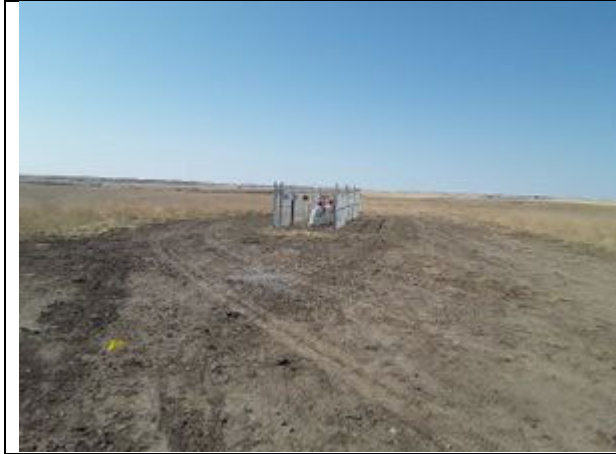
Observation Point: 58

Photo Description: Pad materials strewn, compaction present, and no vegetation.

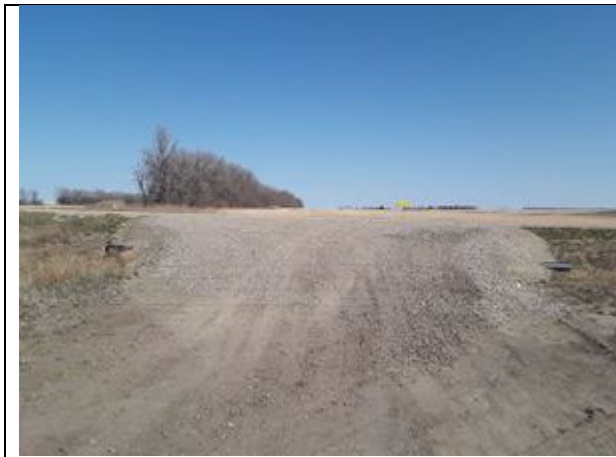
Observation Point: 59

Photo Description: Apparent temporary approach left intact.

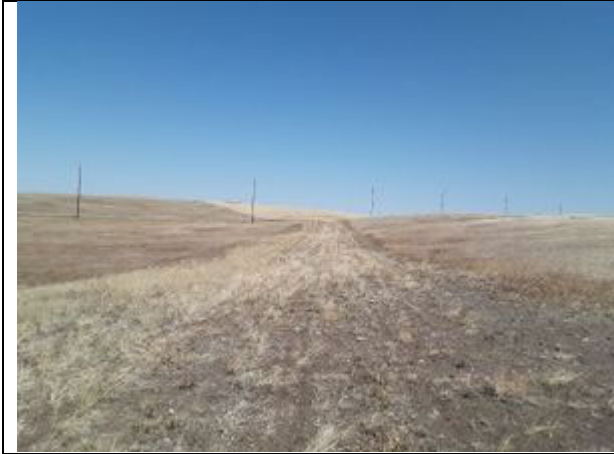
Observation Point: 61

Photo Description: Vegetation growing.

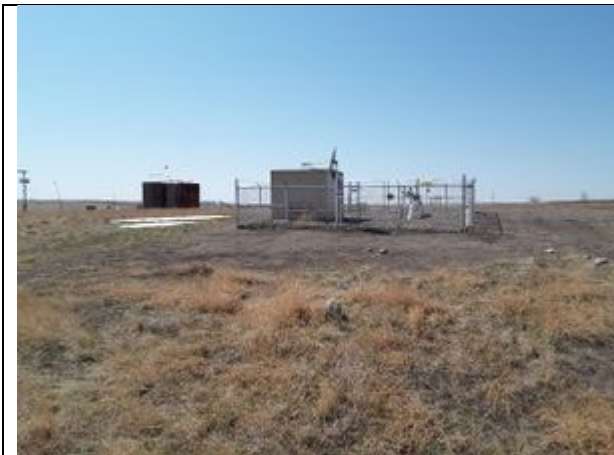
Observation Point: 62

Photo Description: Construction inspection revisit. Winter tie in area. Conditions are acceptable.
