**In re: Cenex Pipeline, LLC
10" Refined Fuels Pipeline
Case No. PU-17-097
Our File No. 020836-000001**

Date: 6/18/2021
To: North Dakota Public Service Commission
Copy to: Mike Stahly, Cenex Pipeline, LLC; Robb Schwend, Cenex Pipeline, LLC; Casey Furey, Crowley-Fleck
From: Grady Wolf - KLJ
RE: Cenex Pipeline, LLC. Liquid Petroleum Pipeline
Summary of the Status of Restoration Activities
Case No. PU-17-97

As a condition of the Order, paragraph 12 stipulated that one year after the project is placed in service, Cenex shall file with the PSC a summary of the status of restoration activities related to the project, including any restoration-related issues raised by landowners or identified by Cenex. A field inspection focused on the success of reclamation efforts was conducted May 22, 2021 through May 26, 2021.

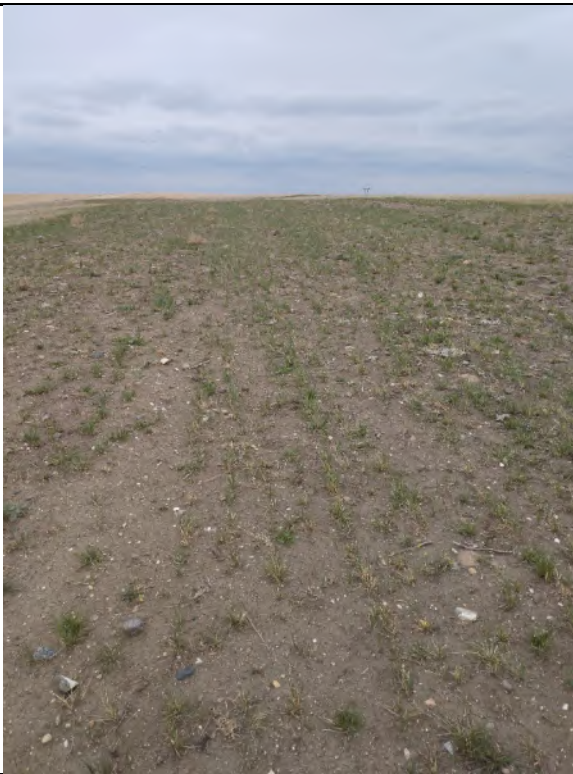
Photograph #1	CENEX Sidney to Minot Spread 1	Station 2198+50
Date Taken:	May 26, 2021

Direction:	South	
Description:	Grasses and forbs establishing, sparse areas.

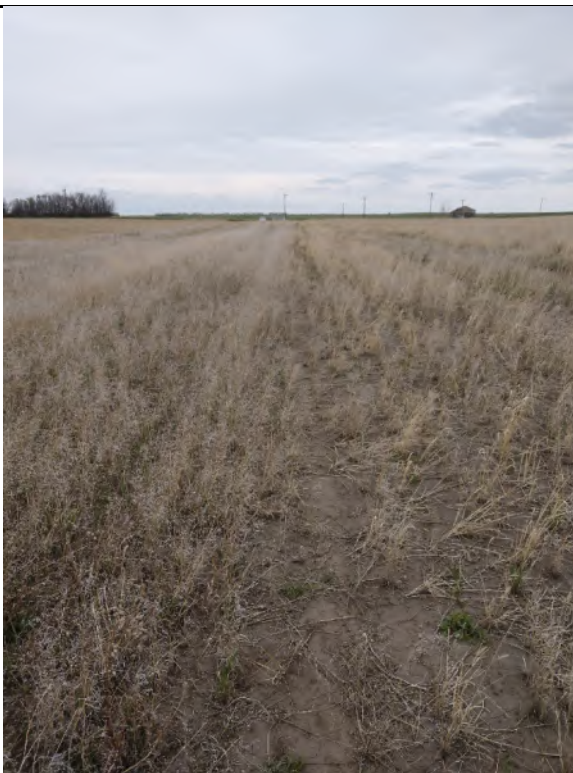
Photograph #2	CENEX Sidney to Minot Spread 1	Station 2624+00
Date Taken:	May 26, 2021

Direction:	Northeast	
Description:	Establishing grasses and forbs mixed with annual weeds.

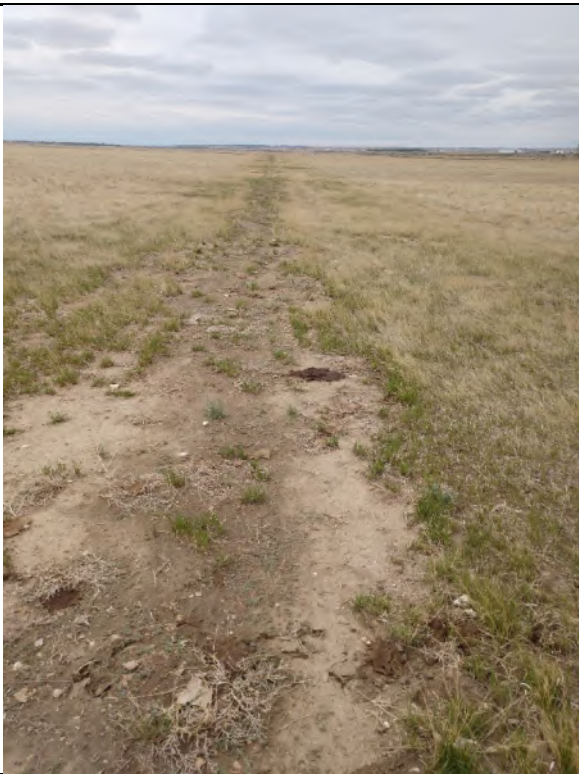
Photograph #3	CENEX Sidney to Minot Spread 1	Station 3637+00
Date Taken:	May 26, 2021

Direction:	Southwest	
Description:	Sparse vegetative growth over pipeline, preservation of surrounding vegetation within ROW.

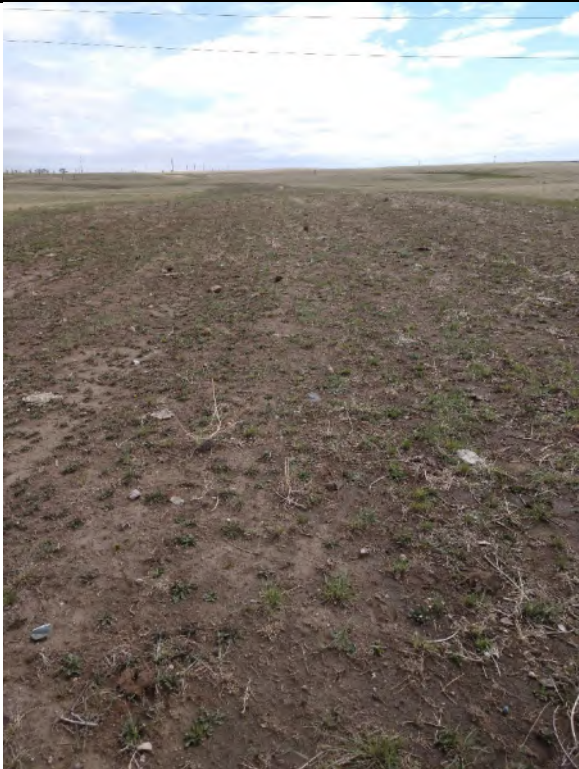
Photograph #4	CENEX Sidney to Minot Spread 1	Station 3709+50
Date Taken:	May 26, 2021

Direction:	East	
Description:	Weedy vegetative growth, sparse vegetative cover in areas, grasses beginning to establish.

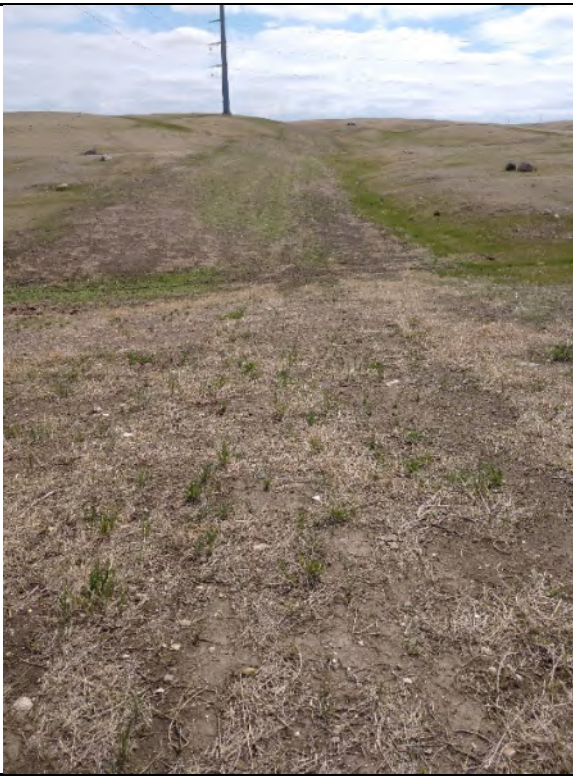
Photograph #5	CENEX Sidney to Minot Spread 1	Station 3770+00
Date Taken:	May 26, 2021

Direction:	East	
Description:	Area treated for weeds 2020. Sparse areas of grasses establishing as well as weeds.

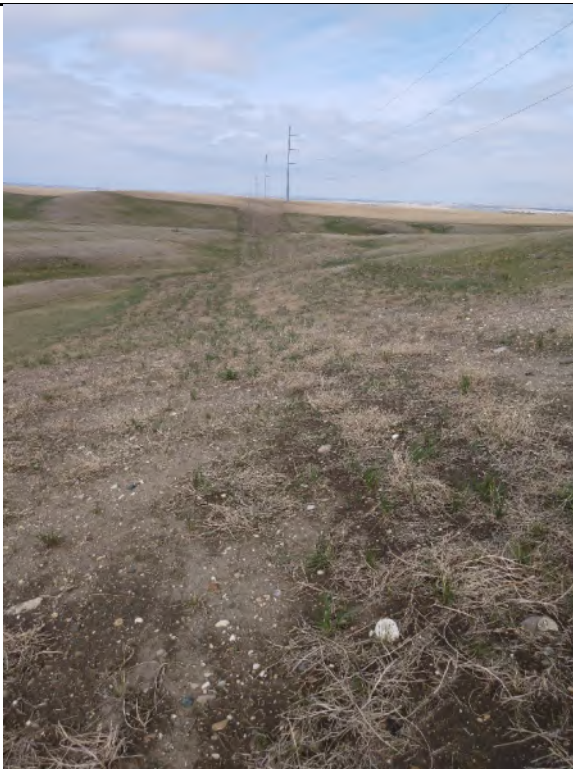
Photograph #6	CENEX Sidney to Minot Spread 1	Station 3779+50
Date Taken:	May 26, 2021

Direction:	West	
Description:	Area treated for weeds 2020. Sparse areas of grasses establishing as well as weeds.

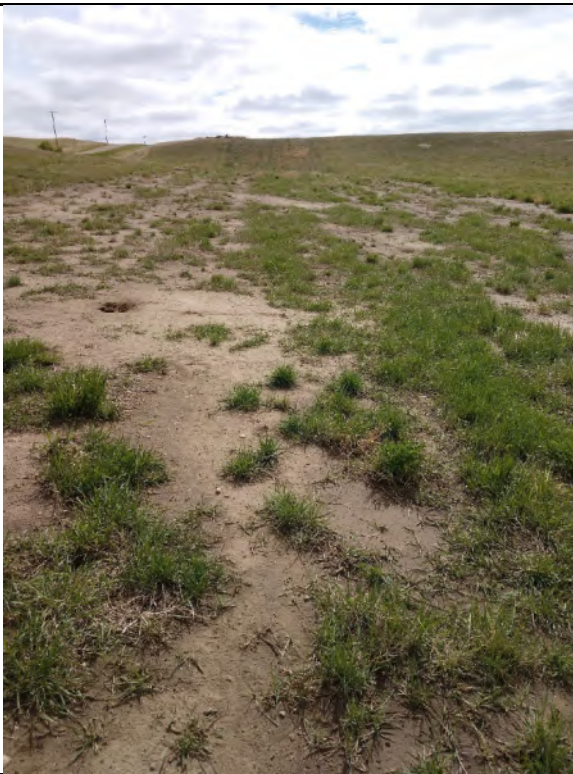
Photograph #7	CENEX Sidney to Minot Spread 1	Station 4074+00
Date Taken:	May 26, 2021

Direction:	East	
Description:	Grasses establishing, weeds present. Location impacted by prairie dog village.

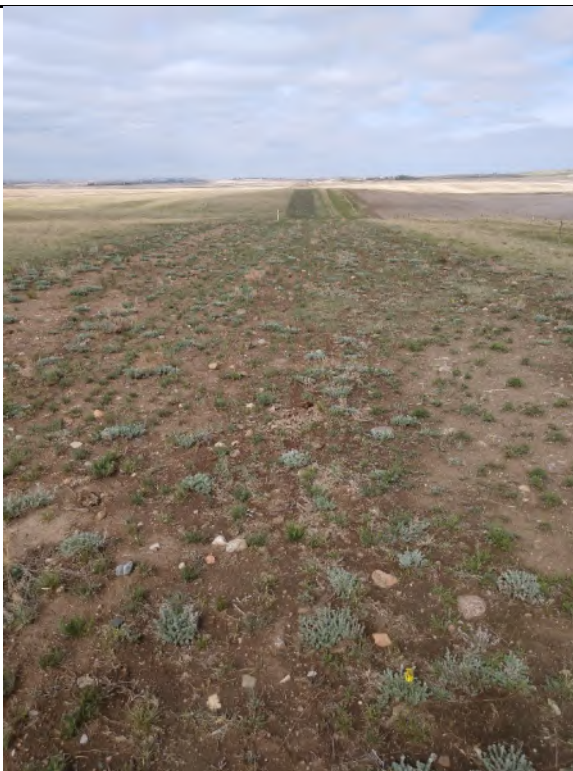
Photograph #8	CENEX Sidney to Minot Spread 1	Station 4183+00
Date Taken:	May 25, 2021

Direction:	West	
Description:	Grasses and forbs establishing, sparse veg, North Dakota State Lands.

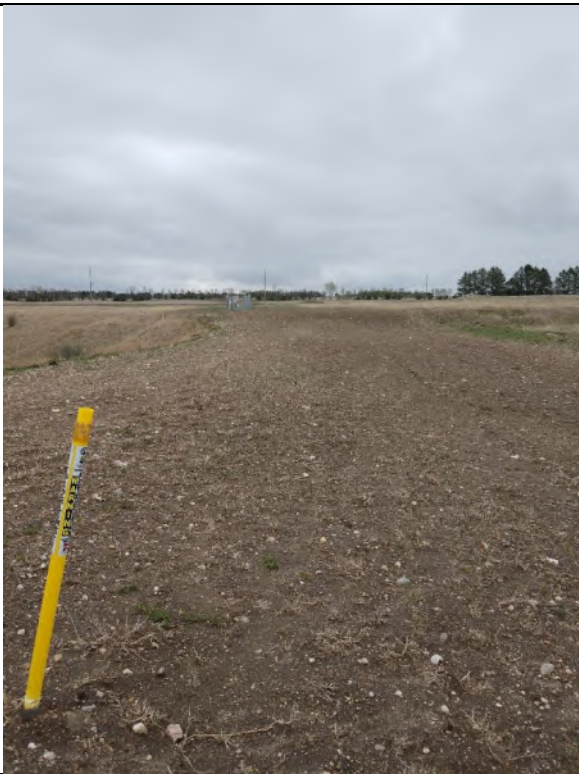
Photograph #9	CENEX Sidney to Minot Spread 2	Station 4976+50
Date Taken:	May 25, 2021

Direction:	East	
Description:	Very sparse vegetation

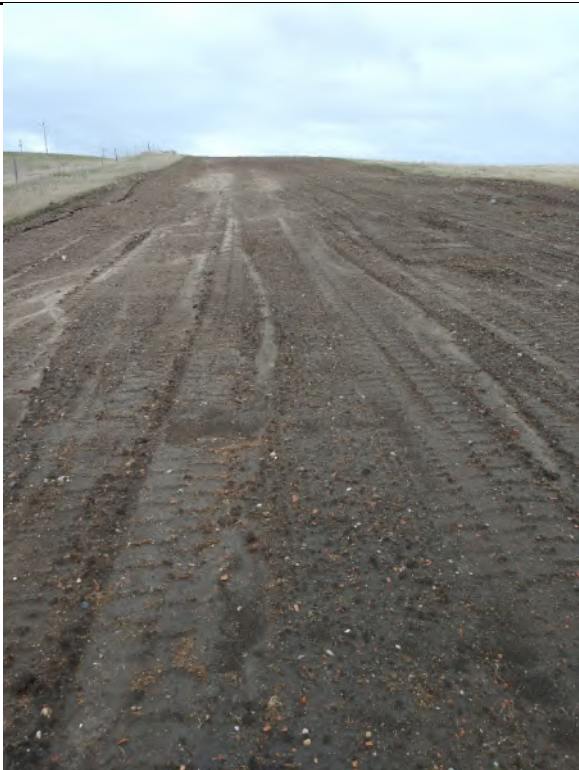
Photograph #10	CENEX Sidney to Minot Spread 2	Station 5068+50
Date Taken:	May 25, 2021

During the survey, rangeland areas identified with extremely sparse to virtually no vegetative growth were identified between pipeline stationing 5065+50- 5076+00 (photo 10), 5548+00 - 5585+00 (photo 15), 5660+00 - 5711+00 (photo 16), 5911+00 - 5923+00 (photo 18), 6955+00 - 6983+00 (photo 26-27), 7202+00 - 7213+00 (photo 28), and 7675+00 - 7730+00 (photo 33). These areas will continue to be monitored throughout the year during monthly SWPPP inspections for grass species establishment as well as invasive and noxious weed species presence. A large area of leafy spurge, located in Section 7, Township 154N, Range 86W, was noted during the field inspection (Photo 37). The infestation was not identified preconstruction. Cenex will coordinate with the landowner in Section 7 regarding timing and control methods. Spot spraying for weeds will be conducted as necessary on all rangeland and pasture lands and fall or spring seeding will occur where necessary in accordance with Natural Resources Conservation Service (NRCS) guidelines for the appropriate seed mixes.

Direction:	East	
Description:	ROW devoid of vegetation due to recent construction of pipeline adjacent to ROW.

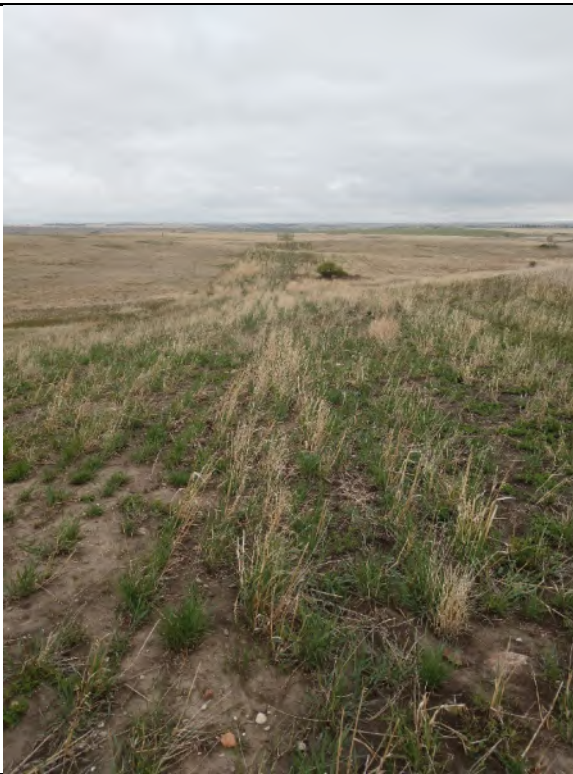
Photograph #11	CENEX Sidney to Minot Spread 2	Station 5284+00
Date Taken:	May 25, 2021

Direction:	East	
Description:	Grasses and forbs developing nicely.

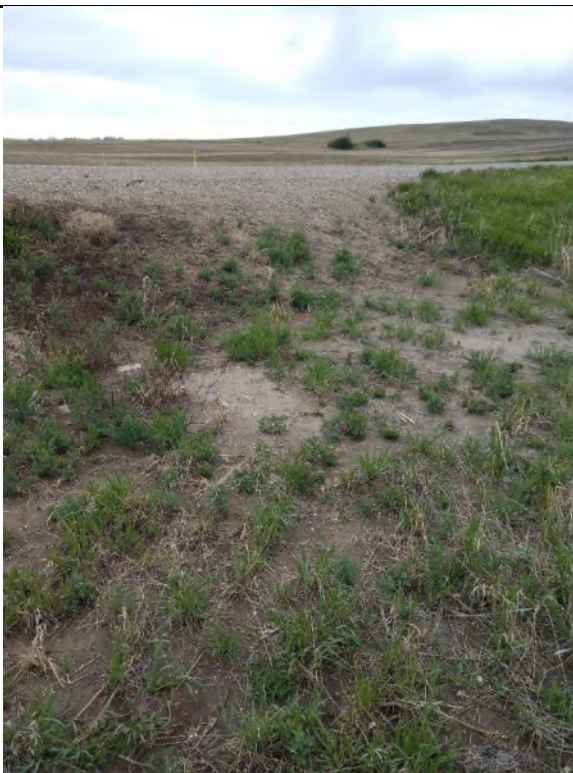
Photograph #12	CENEX Sidney to Minot Spread 2	Station 5299+50
Date Taken:	May 25, 2021

During the survey it was noted that many of the access locations throughout Spread 2 had diminished vegetative success and were dominated by weedy species. Accesses will continue to be monitored during the growing season and if necessary, spot sprayed for weeds and reseeded when appropriate. If grass establishment continues to be impacted and it appears compaction may be a contributing factor, tillage followed by reseeding may be necessary.

Direction:	Northwest	
Description:	Example of vegetative growth at access, relatively common throughout spread 2.

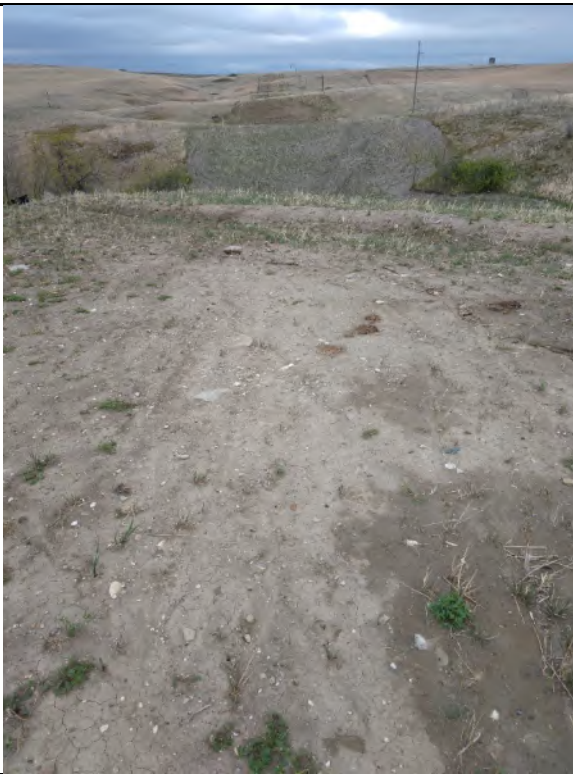
Photograph #13	CENEX Sidney to Minot Spread 2	Station 5452+50
Date Taken:	May 25, 2021

Direction:	East	
Description:	Sparse vegetated hilltops, developing grasses on hillslopes and in drainages.

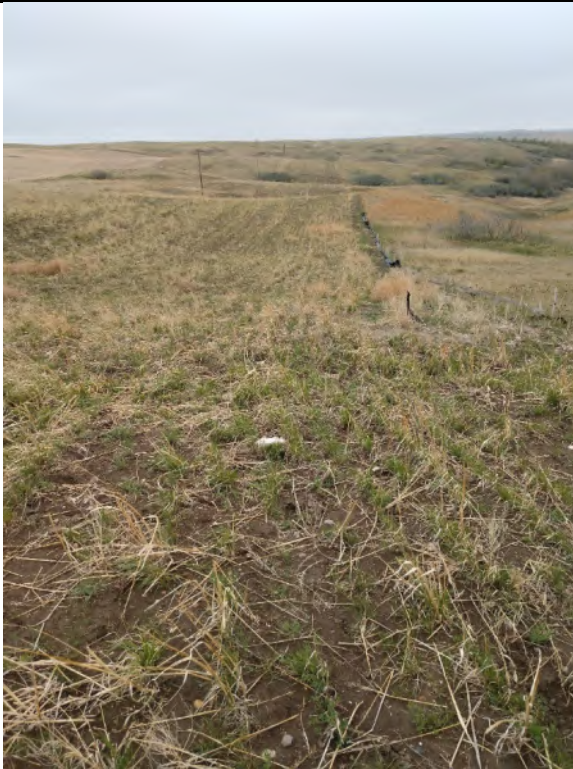
Photograph #14	CENEX Sidney to Minot Spread 2	Station 5471+00
Date Taken:	May 25, 2021

Direction:	West	
Description:	Grasses and forbs establishing.

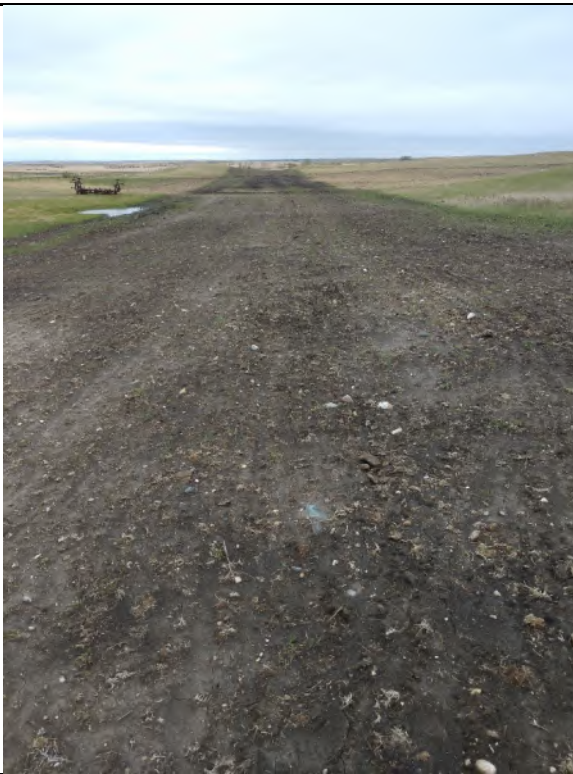
Photograph #15	CENEX Sidney to Minot Spread 2	Station 5577+50
Date Taken:	May 25, 2021

Direction:	West	
Description:	Very sparse vegetation.

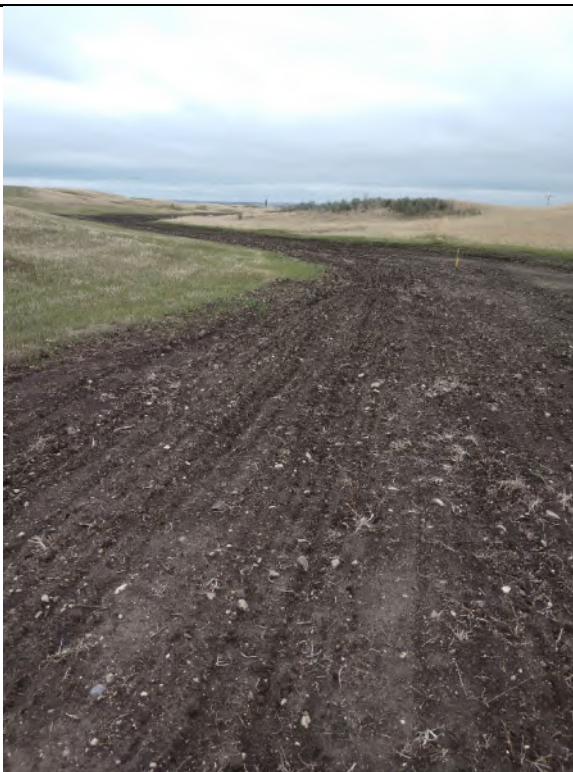
Photograph #16	CENEX Sidney to Minot Spread 2	Station 5678+00
Date Taken:	May 25, 2021

Direction:	South	
Description:	Very sparse vegetation

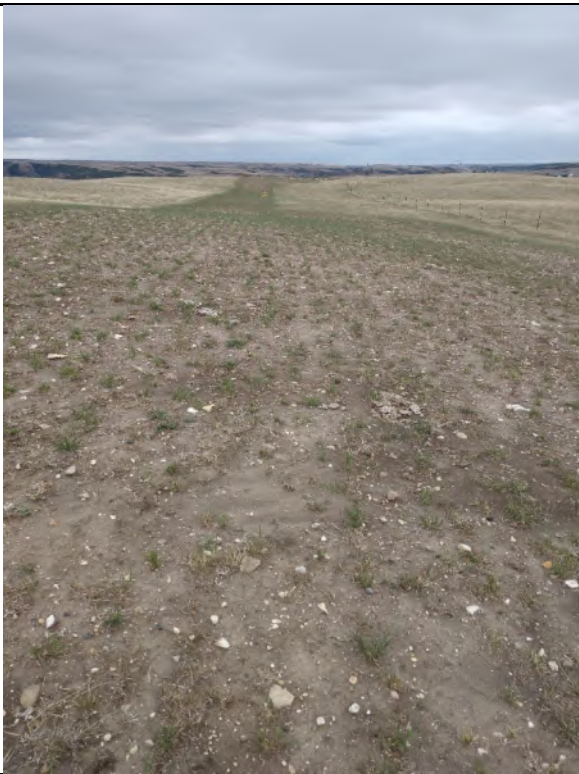
Photograph #17	CENEX Sidney to Minot Spread 2	Station 5770+00
Date Taken:	May 25, 2021

Direction:	Southeast	
Description:	Sparse vegetation on hilltops, grasses establishing

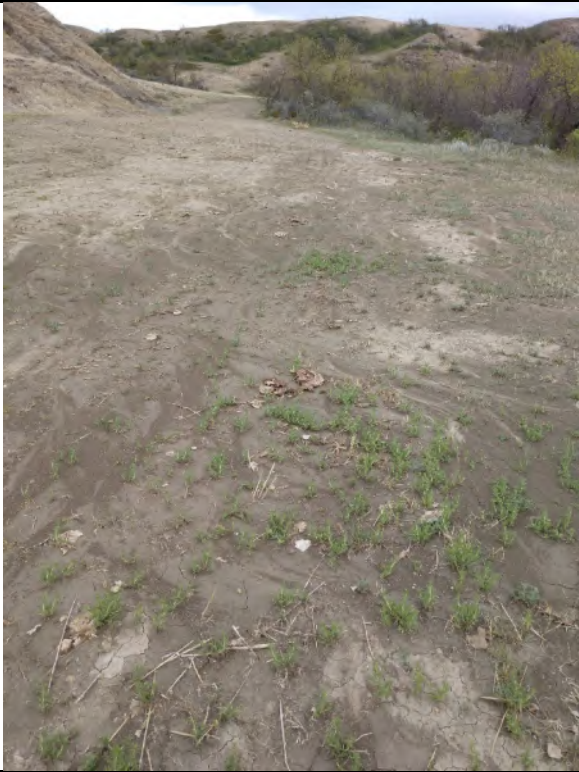
Photograph #18	CENEX Sidney to Minot Spread 2	Station 5919+50
Date Taken:	May 25, 2021

Direction:	East	
Description:	Very sparse vegetation, erosion occurring as a result

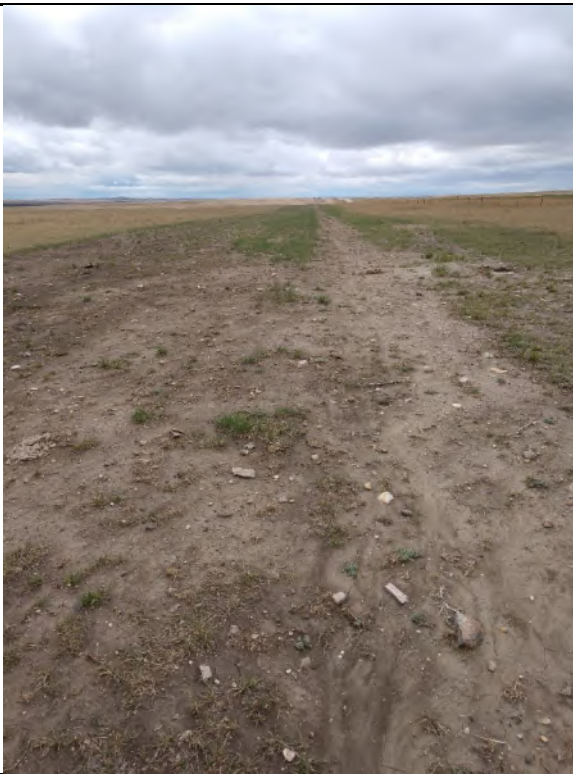
Photograph #19	CENEX Sidney to Minot Spread 2	Station 6012+00
Date Taken:	May 25, 2021

Direction:	West	
Description:	Sparse vegetation over pipeline and throughout ROW, State of North Dakota lands.

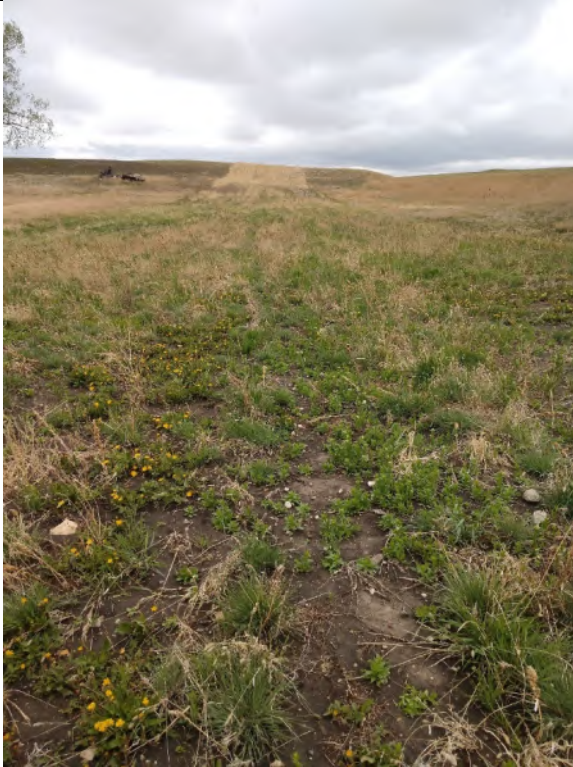
Photograph #20	CENEX Sidney to Minot Spread 2	Station 6082+50
Date Taken:	May 25, 2021

Direction:	West	
Description:	Grasses establishing along with weeds.

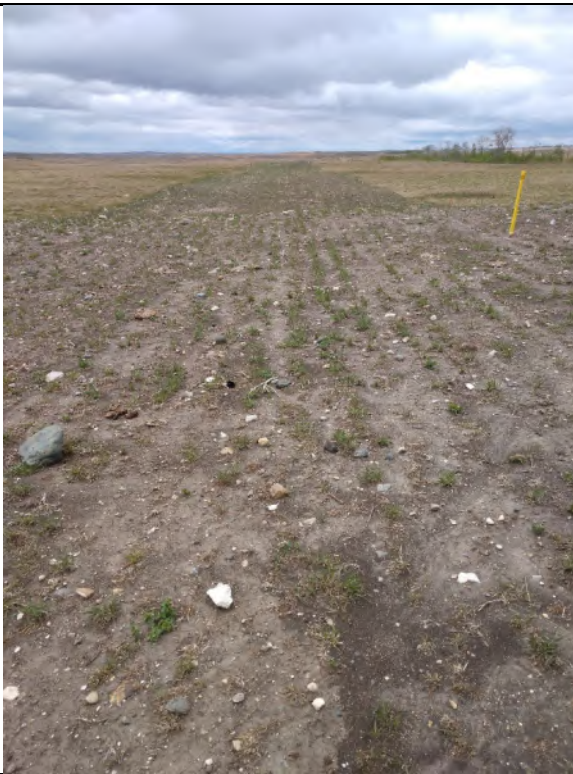
Photograph #21	CENEX Sidney to Minot Spread 2	Station 6144+00
Date Taken:	May 25, 2021

Direction:	West northwest	
Description:	Grasses establishing, sparse, rocks throughout ROW, weeds.

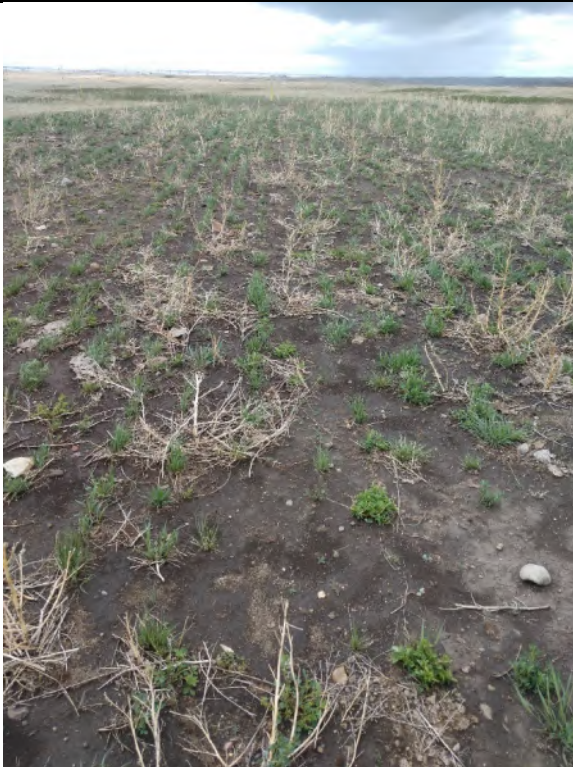
Photograph #22	CENEX Sidney to Minot Spread 2	Station 6381+50
Date Taken:	May 25, 2021

Direction:	East	
Description:	Non native grasses, weeds, throughout ROW.

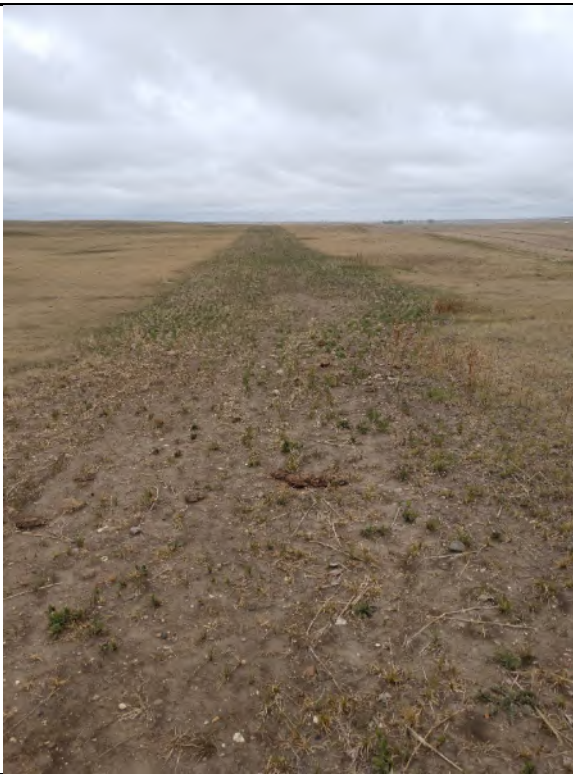
Photograph #23	CENEX Sidney to Minot Spread 2	Station 6672+50
Date Taken:	May 24, 2021

Direction:	West	
Description:	Grasses and forbs establishing, State of North Dakota Land.

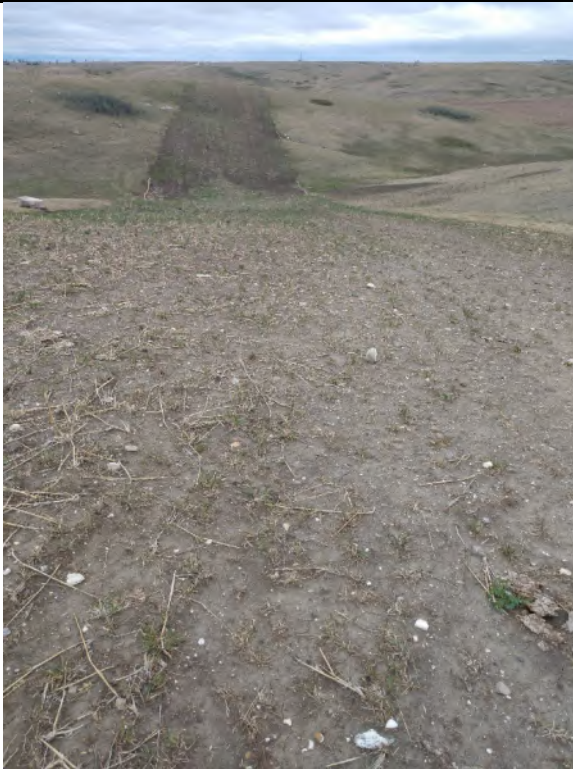
Photograph #24	CENEX Sidney to Minot Spread 2	Station 6782+00
Date Taken:	May 24, 2021

Direction:	Northwest	
Description:	Grasses establishing, sparse hilltops.

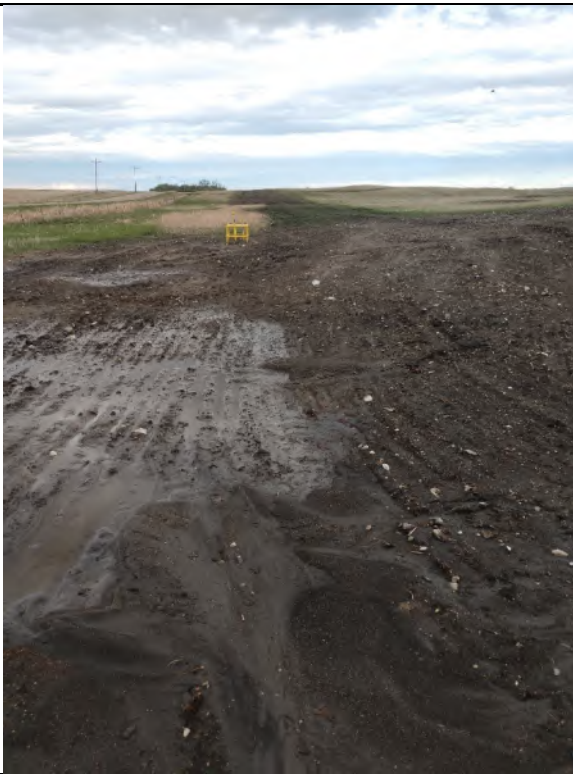
Photograph #25	CENEX Sidney to Minot Spread 2	Station 6956+00
Date Taken:	May 24, 2021

Direction:	East	
Description:	Very sparsely vegetated, weeds, North Dakota State Lands.

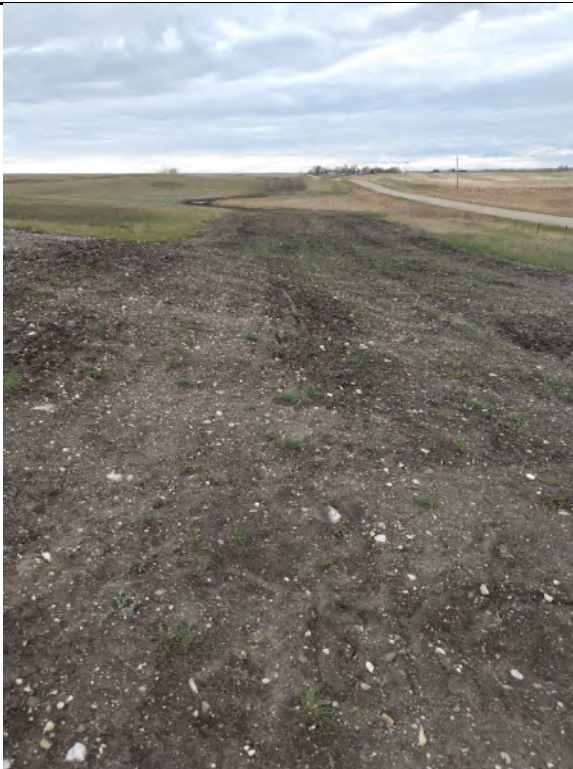
Photograph #26	CENEX Sidney to Minot Spread 2	Station 6978+50
Date Taken:	May 24, 2021

Direction:	East	
Description:	Very sparsely vegetated, weeds, North Dakota State Lands.

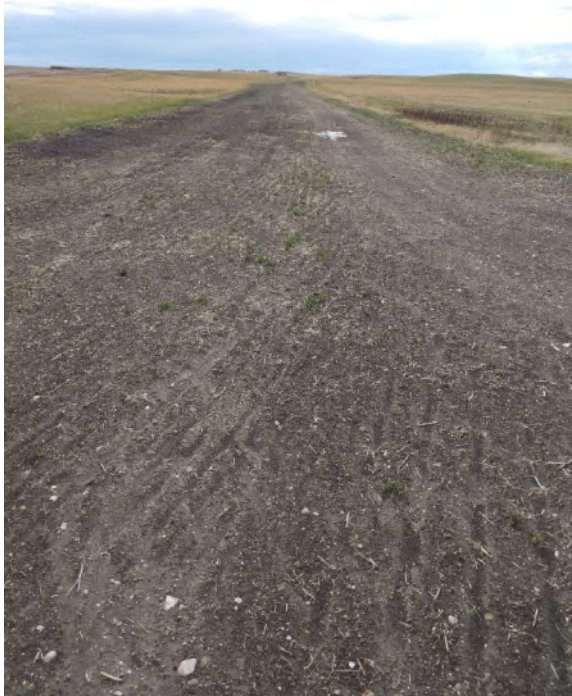
Photograph #27	CENEX Sidney to Minot Spread 2	Station 7213+00
Date Taken:	May 24, 2021

Direction:	West	
Description:	Sparse vegetation.

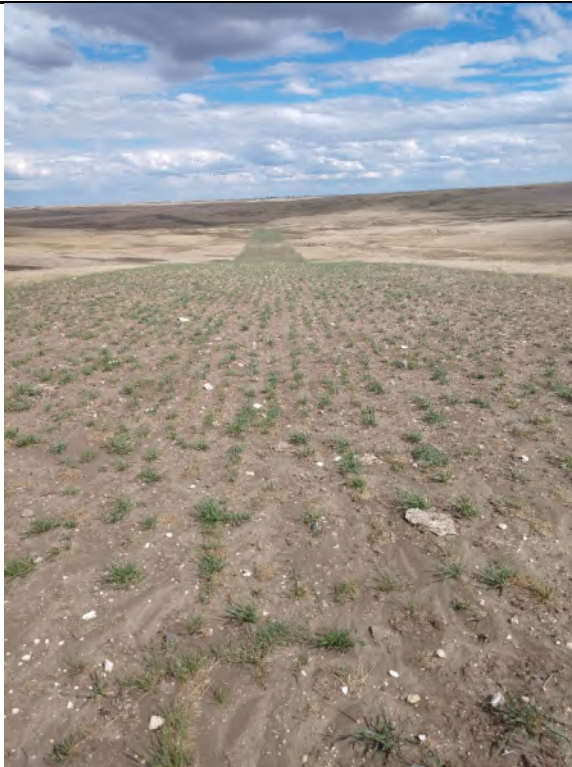
Photograph #28	CENEX Sidney to Minot Spread 2	Station 7359+00
Date Taken:	May 24, 2021

Direction:	East	
Description:	Grasses establishing, sparse vegetation

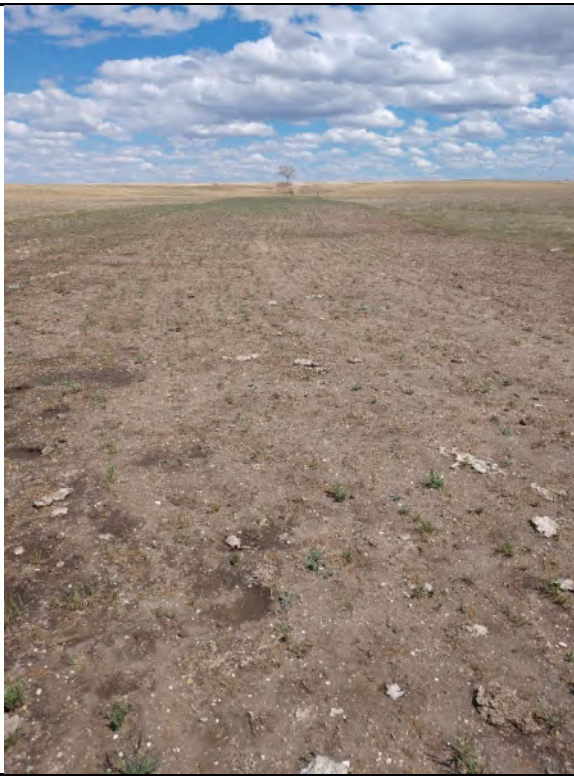
Photograph #29	CENEX Sidney to Minot Spread 2	Station 7442+50
Date Taken:	May 24, 2021

Direction:	East	
Description:	Grasses establishing, sparse in areas.

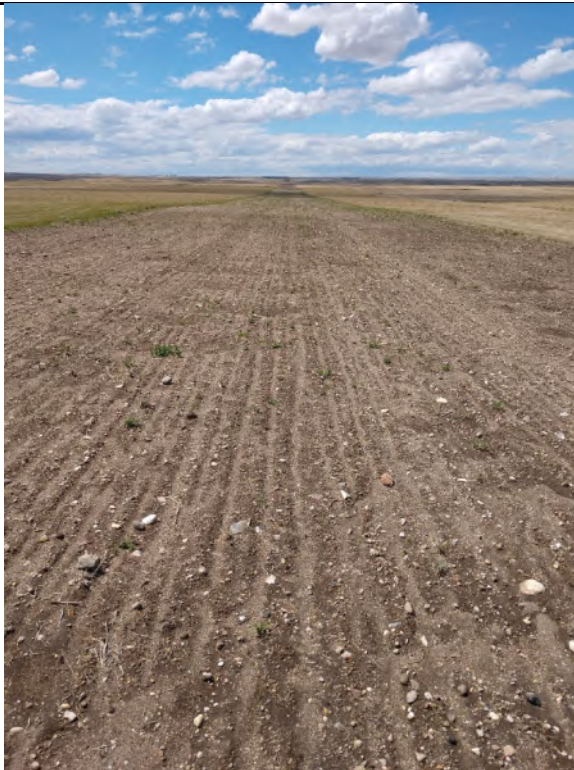
Photograph #30	CENEX Sidney to Minot Spread 2	Station 7508+00
Date Taken:	May 25, 2021

Direction:	West	
Description:	Sparsely vegetated, some grasses establishing.

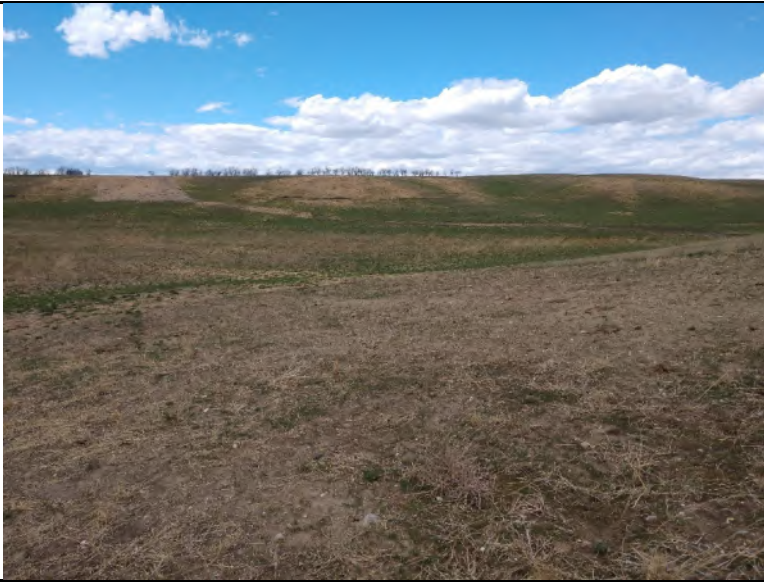
Photograph #31	CENEX Sidney to Minot Spread 2	Station 7604+50
Date Taken:	May 24, 2021

Direction:	East southeast	
Description:	Stunted vegetative growth potentially as a result of compaction on access.

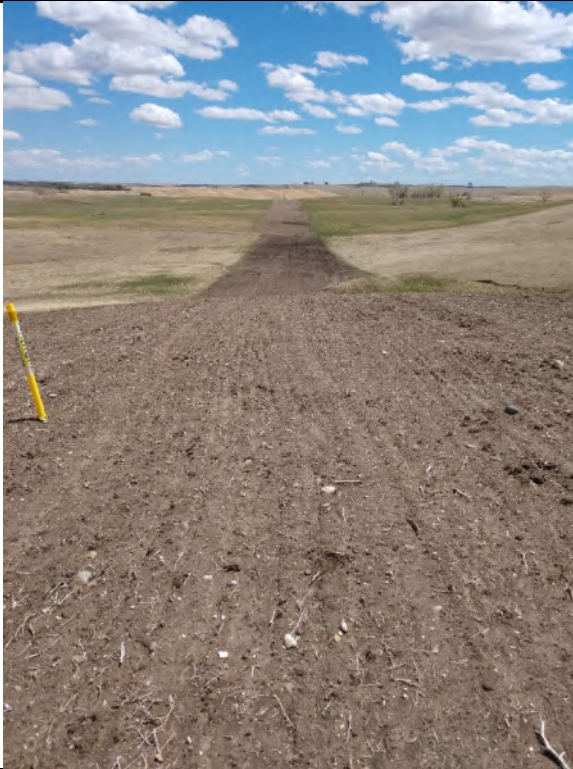
Photograph #32	CENEX Sidney to Minot Spread 2	Station 7706+00
Date Taken:	May 24, 2021

Direction:	East southeast	
Description:	Very sparse vegetation.

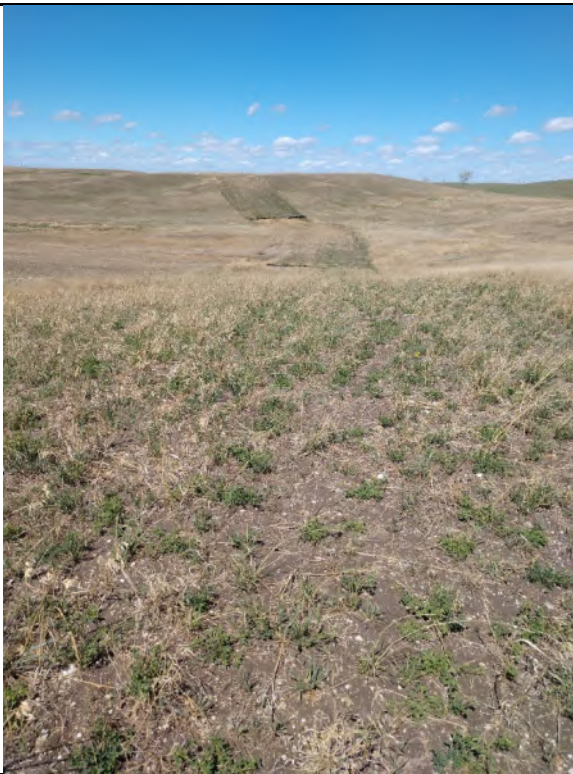
Photograph #33	CENEX Sidney to Minot Spread 2	Station 7925+00
Date Taken:	May 24, 2021

Direction:	Northwest	
Description:	Grasses establishing, annual weeds intermixed.

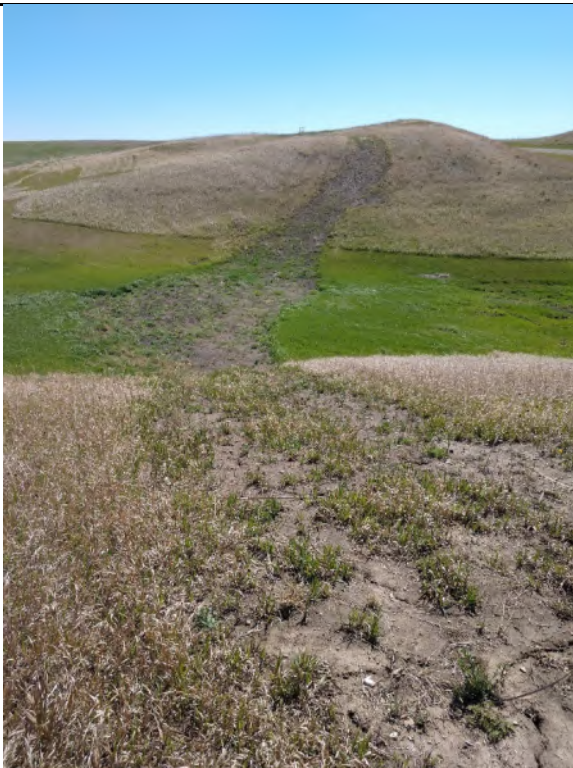
Photograph #34	CENEX Sidney to Minot Spread 2	Station 8080+50
Date Taken:	May 24, 2021

Direction:	East	
Description:	Stunted vegetative growth.

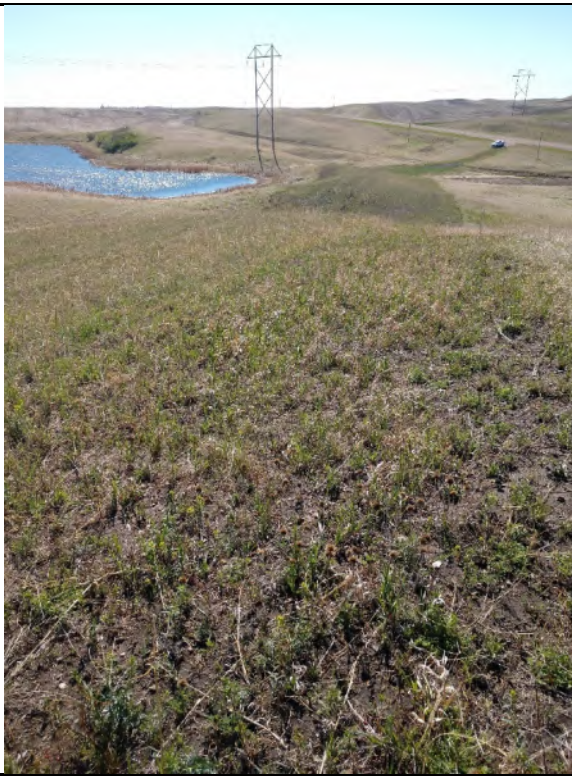
Photograph #35	CENEX Sidney to Minot Spread 2	Station 8357+00
Date Taken:	May 24, 2021

Direction:	southeast	
Description:	Grasses and forbs establishing.

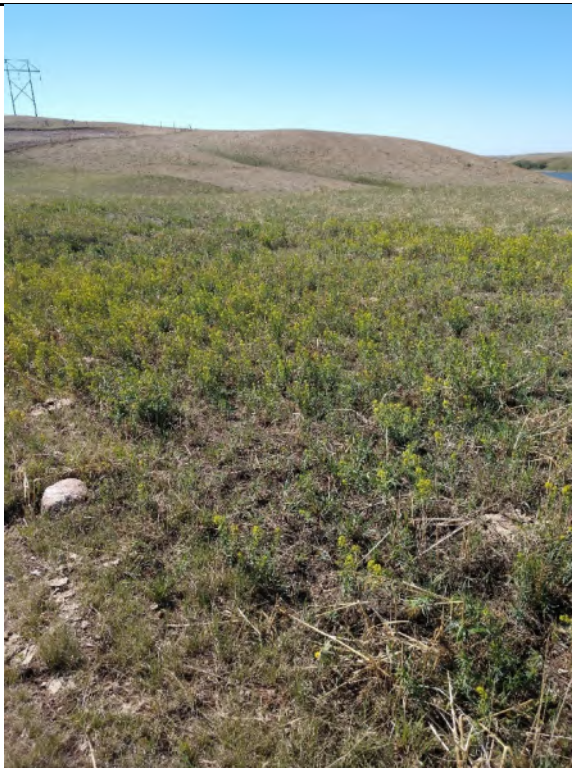
Photograph #36	CENEX Sidney to Minot Spread 2	Station 8370+00
Date Taken:	May 24, 2021

Direction:	South	
Description:	Leafy spurge infestation.

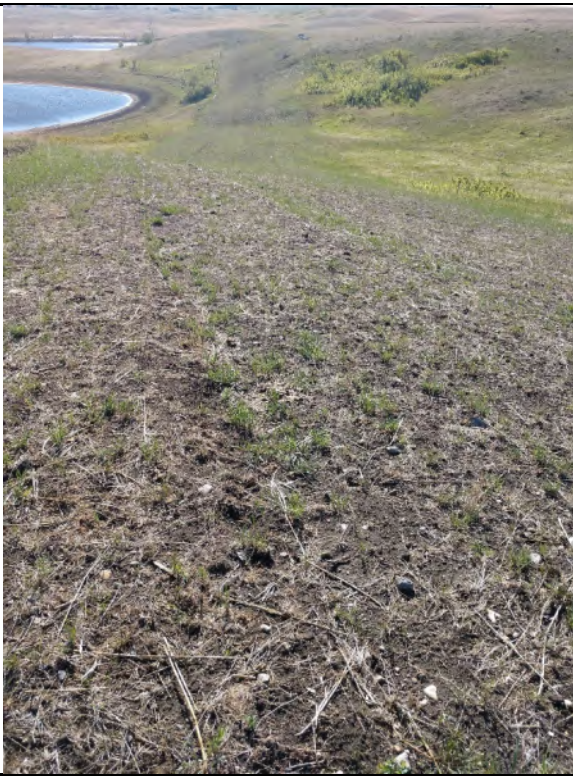
Photograph #37	CENEX Sidney to Minot Spread 2	Station 8506+00
Date Taken:	May 24, 2021

Direction:	East	
Description:	Grasses and forbs establishing.

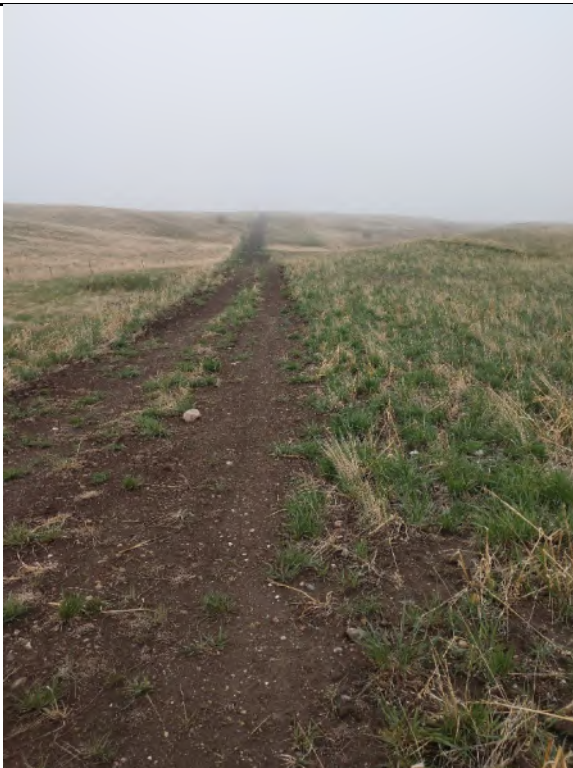
Photograph #38	CENEX Sidney to Minot Spread 2	Station 8691+00
Date Taken:	May 23, 2021

Direction:	West southwest	
Description:	Poor vegetative growth establishing grasses elsewhere.

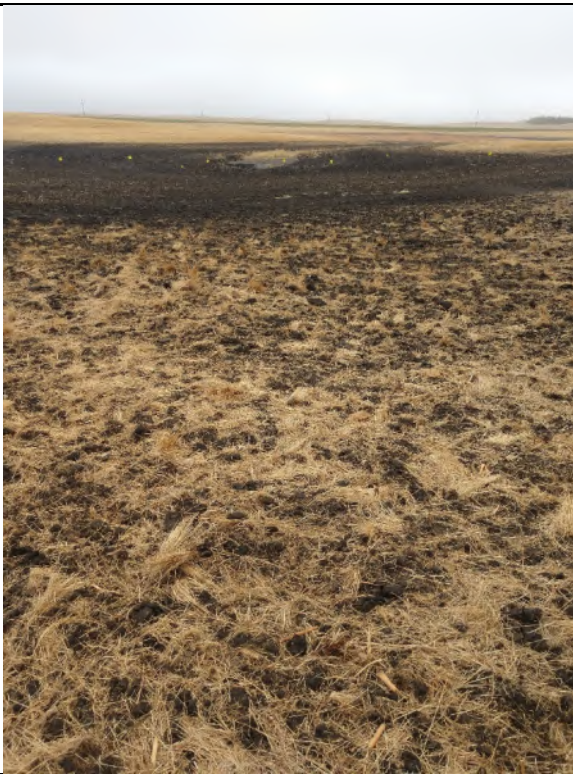
Photograph #39	CENEX Sidney to Minot Spread 2	Station 8962+00
Date Taken:	May 23, 2021

Direction:	North	
Description:	Contoured agricultural field adjacent delineated aquatic feature. Photo taken outside of ROW.

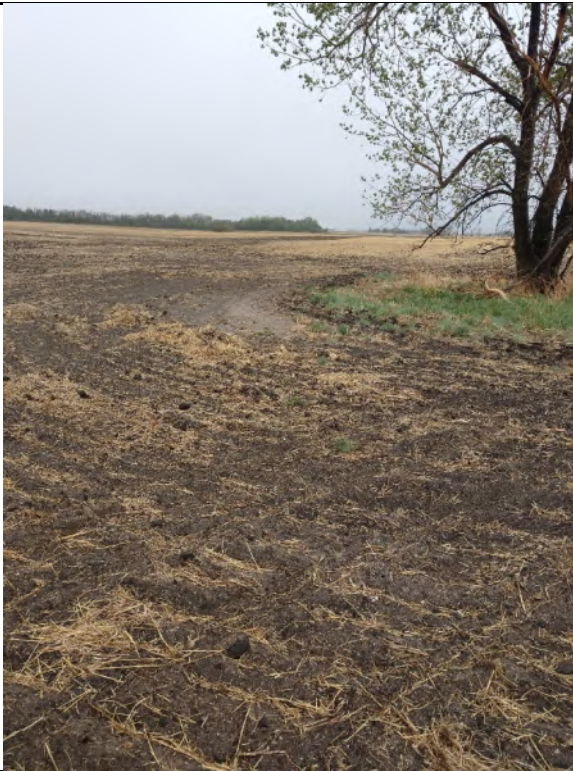
Photograph #40	CENEX Sidney to Minot Spread 2	Station 9056+50
Date Taken:	May 23, 2021

Direction:	South southwest	
Description:	Contours of drainage in agricultural field, sandy subsoil material. Photo outside ROW.

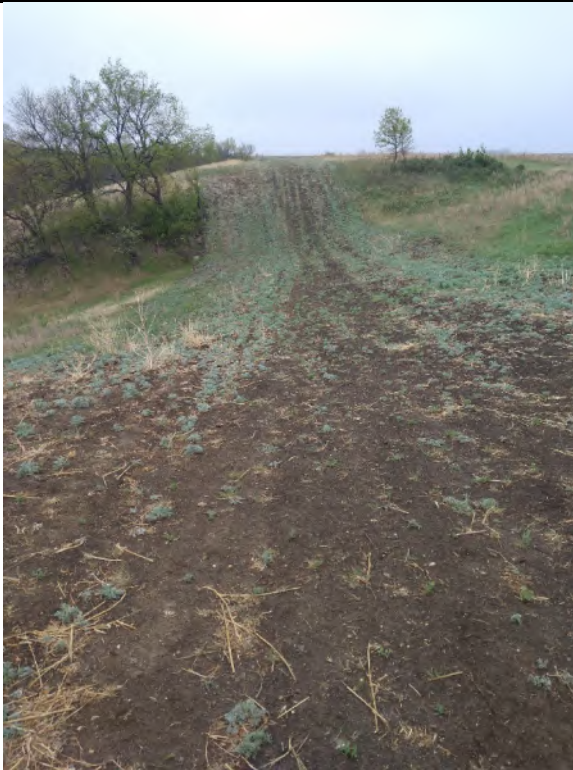
Photograph #41	CENEX Sidney to Minot Spread 2	Station 9335+00
Date Taken:	May 23, 2021

Direction:	Southwest	
Description:	Predominantly weedy vegetation, very sparse grasses.

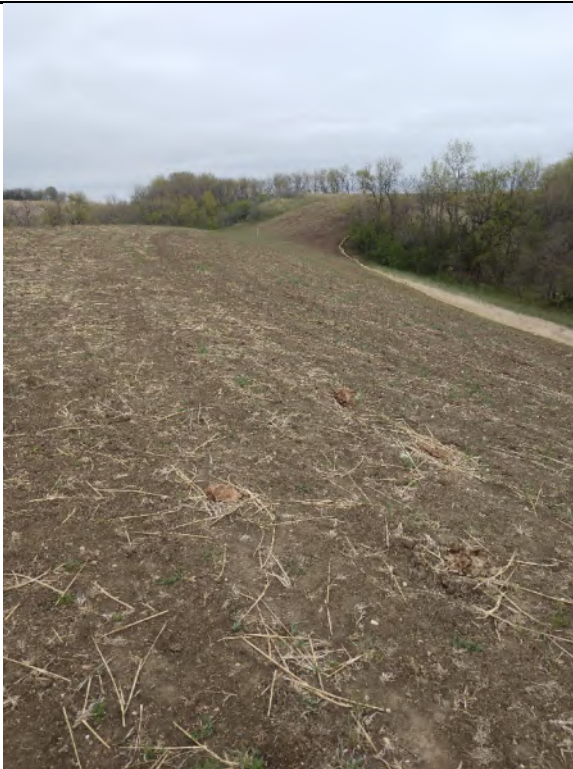
Photograph #42	CENEX Sidney to Minot Spread 2	Station 9354+00
Date Taken:	May 23, 2021

Direction:	Southeast	
Description:	Sparse vegetation, grasses establishing.

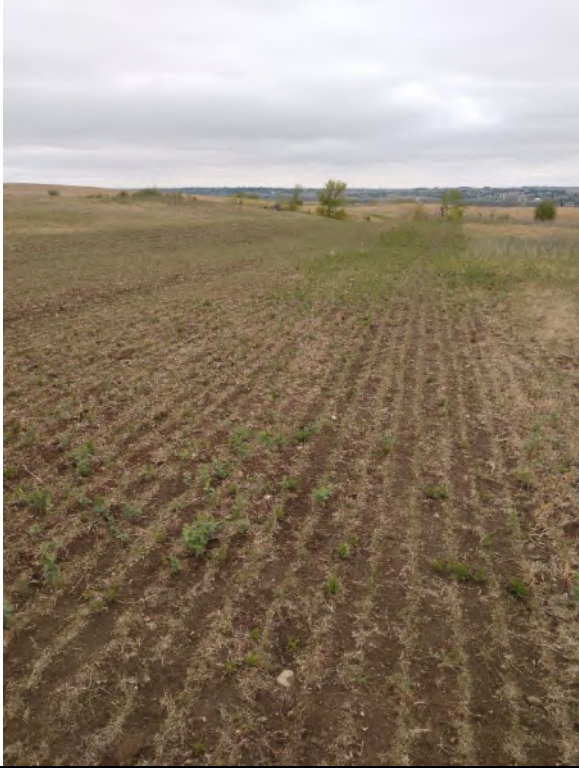
Photograph #43	CENEX Sidney to Minot Spread 2	Station 9528+00
Date Taken:	May 22, 2021

Direction:	North	
Description:	Grasses establishing.
