In re: Brady Wind, LLC  
150 MW Wind Energy Center  
PSC Case No. PU-15-690

**Brady Wind, LLC  
Brady Wind Energy Center – Stark County**

TO: Brady Wind, LLC  
FROM: Tetra Tech, Inc.  
DATE: August 9, 2017  
SUBJECT: Brady Wind Energy Center – Wetlands and Other Waters of the United States Survey Addendum No. 2

- Attachment 1 Figure 1-A: Wetland Survey Results (North Radar Tower)  
Figure 1-B: Wetland Survey Results (West Radar Tower)
- Attachment 2 Photo Log
- Attachment 3 Wetland Determination Form

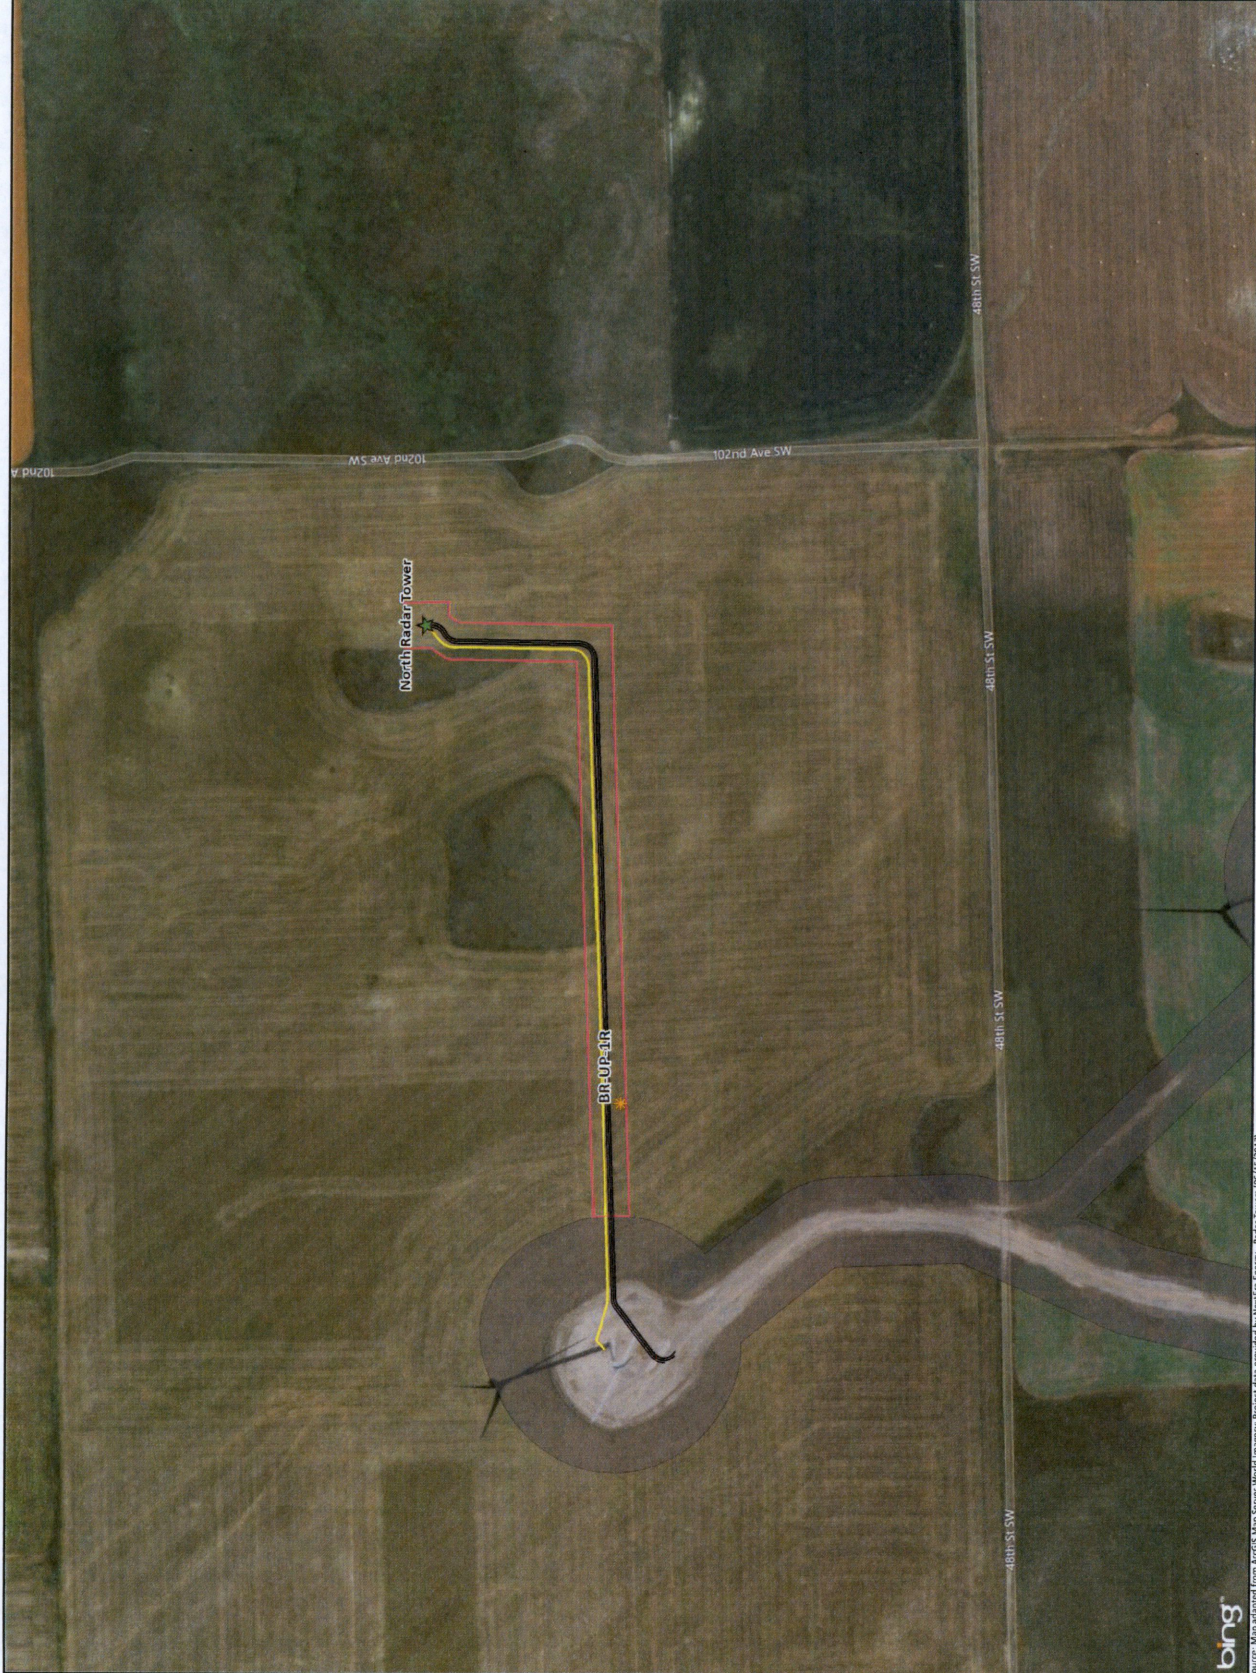
**Figure 1-A**  
**Brady**  
**Wind Energy Center**

**Addendum No. 2**  
**Wetland Survey Results**  
 STARK COUNTY, ND

- Proposed North Radar Tower
- Proposed Service Road
- Proposed Power Line
- Addendum No. 2 Survey Corridor
- Previously Surveyed for Wetlands
- Previously Inventoried Wetland\*
- Newly Identified Feature
- Upland/Swale

\*No previously inventoried wetlands are present within the previously surveyed areas shown on this map.

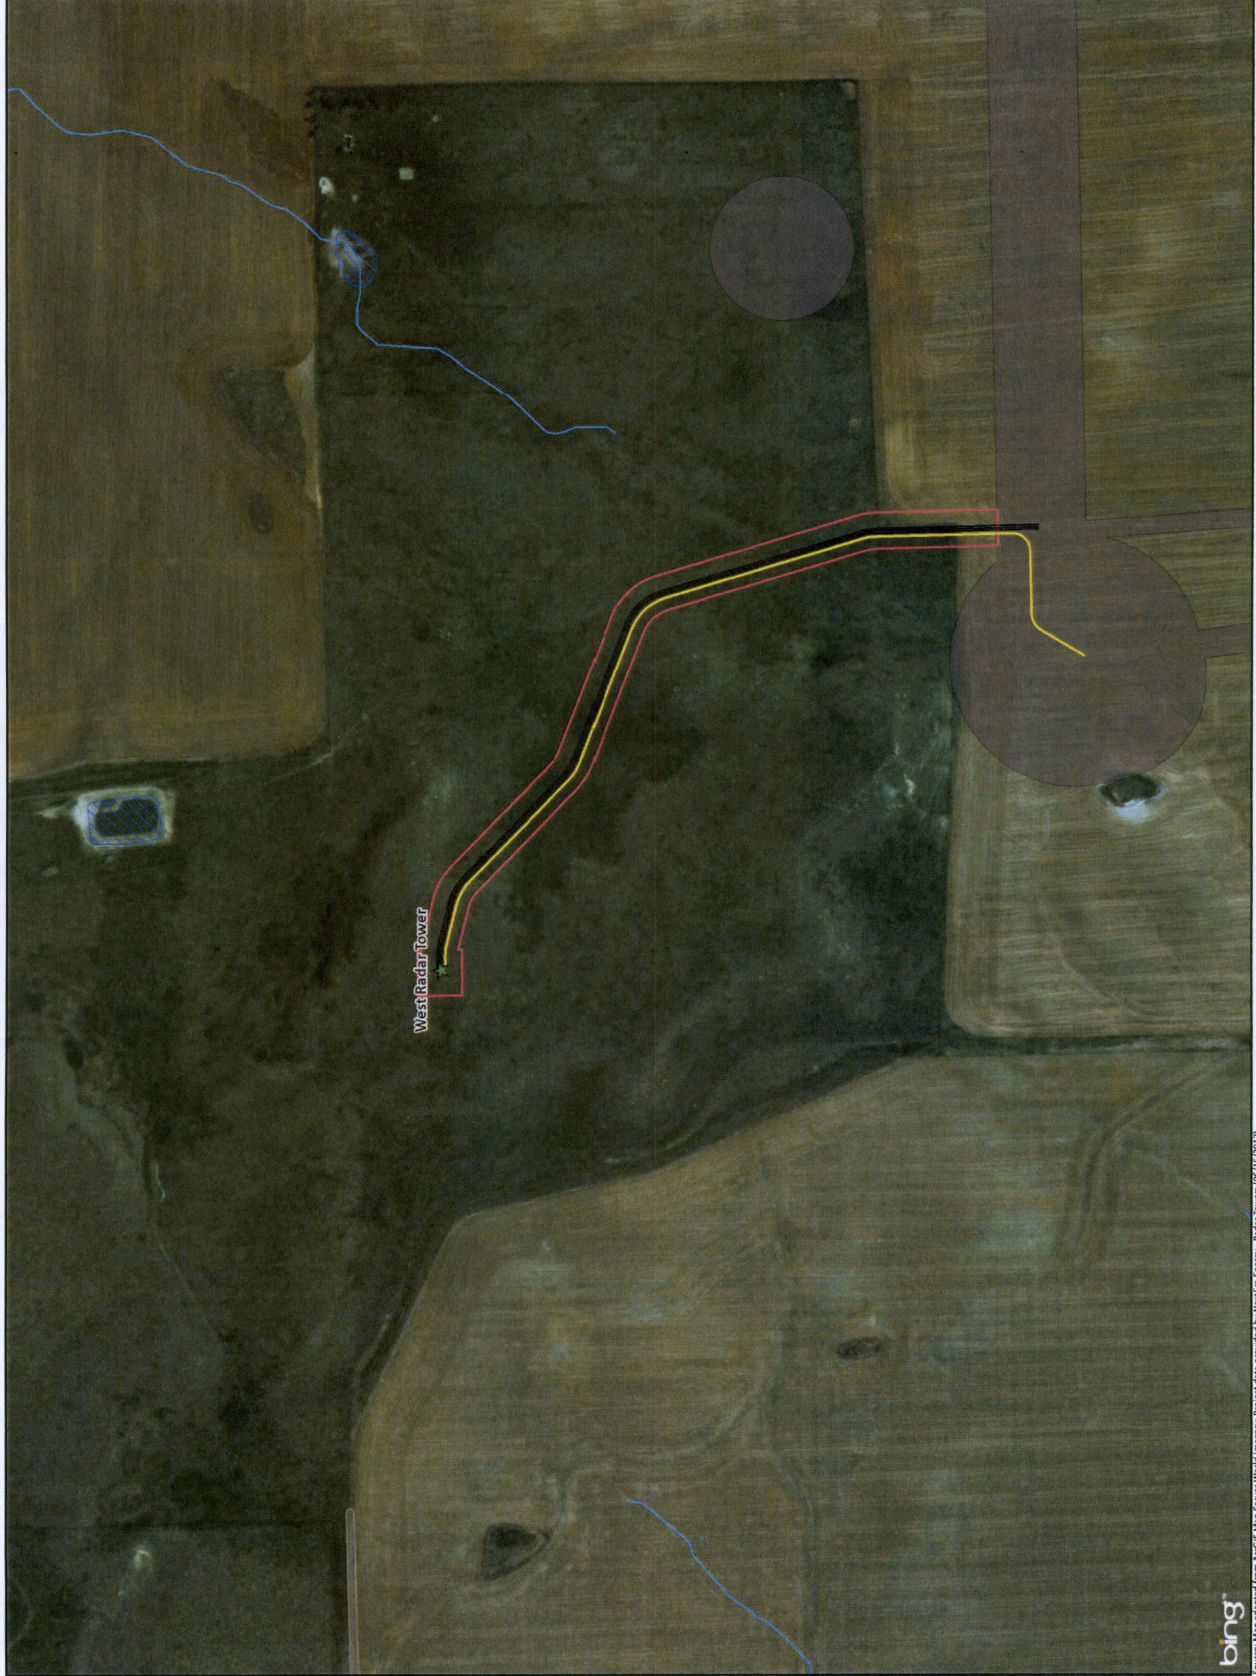
**Figure 1-B**  
**Brady I**  
**Wind Energy Center**

**Addendum No. 2**  
**Wetland Survey Results**  
 STARK COUNTY, ND

- ★ Proposed West Radar Tower
- Proposed Service Road
- Proposed Power Line
- Addendum No. 2 Survey Corridor
- Previously Surveyed for Wetlands
- Previously Inventoried Wetland\*
- NWI and NHD Data
- NWI Wetland
- NHD Stream or Waterbody

\*No previously inventoried wetlands are present within the previously surveyed areas shown on this map.

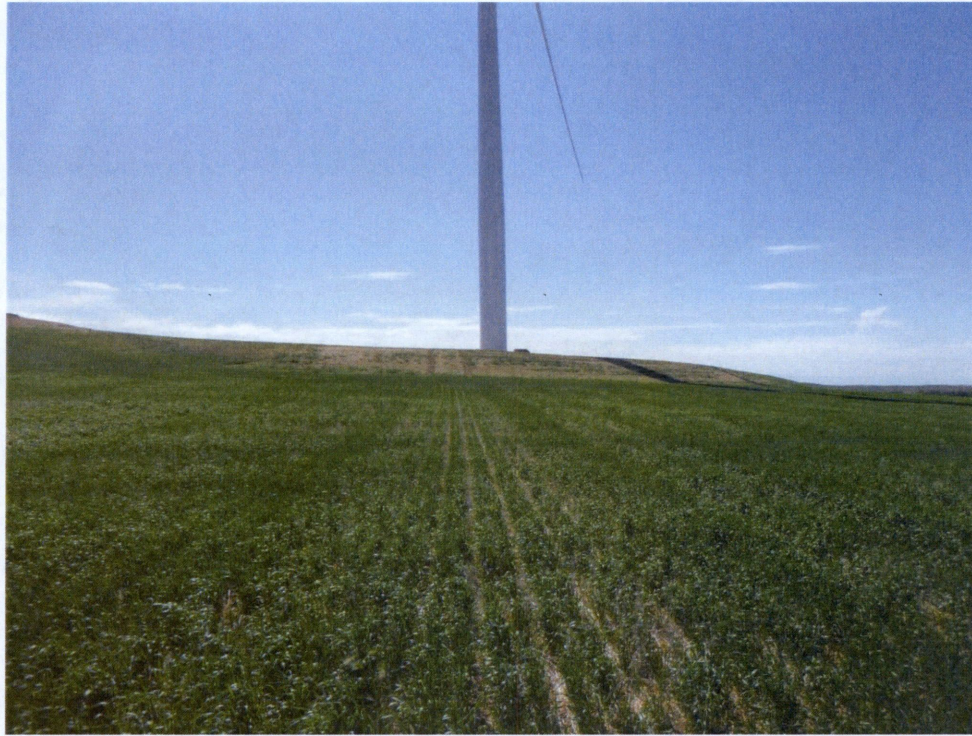
**Photograph 1 (West):** A view of the proposed service road to the North Radar Tower location from Turbine 80.

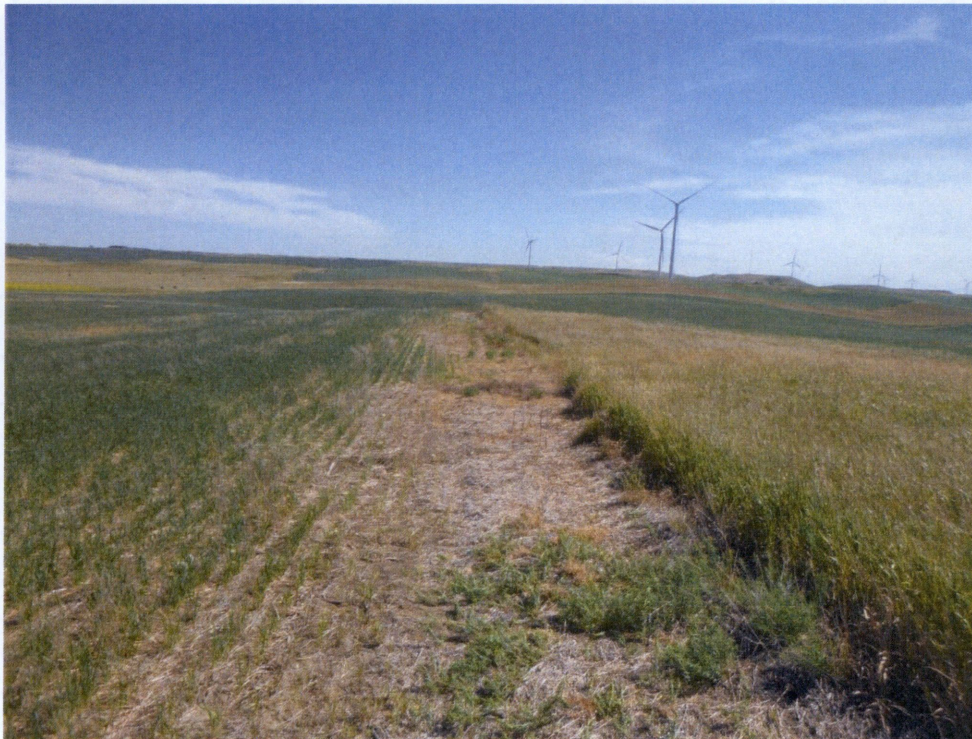
**Photograph 2 (South):** A view of proposed service road to the North Radar Tower location from the southwest corner of the proposed North Radar Tower staging area.

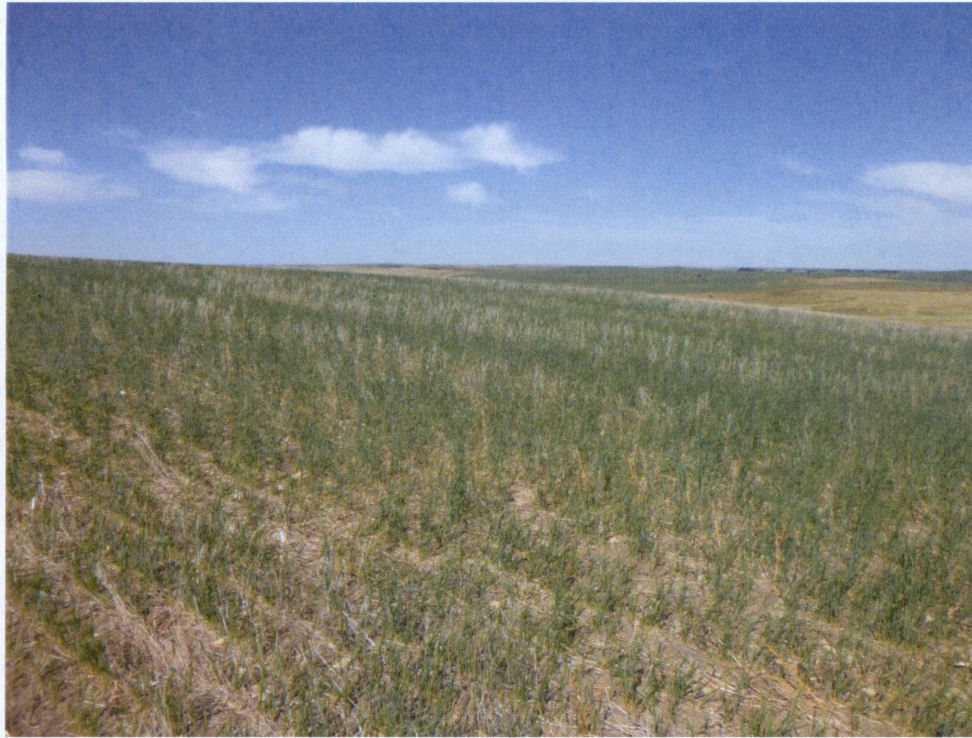
**Photograph 3 (Northeast):** A view of the proposed North Radar Tower staging area from the southwest corner of the proposed North Radar Tower staging area.

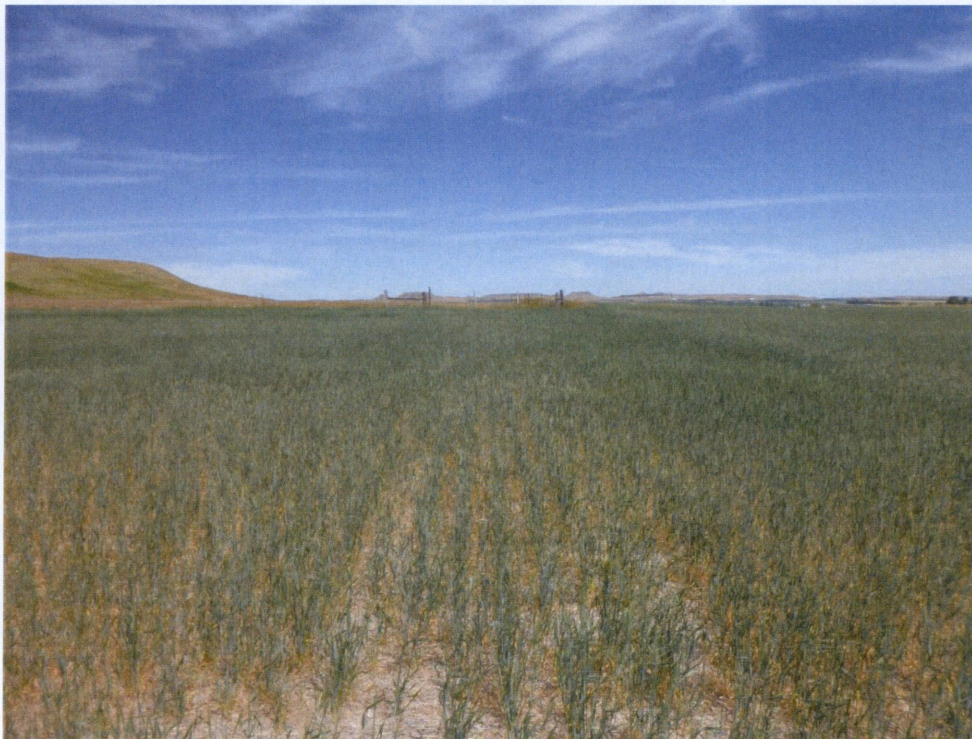
**Photograph 4 (North):** A view of the proposed service road to West Radar Tower from Turbine 1.

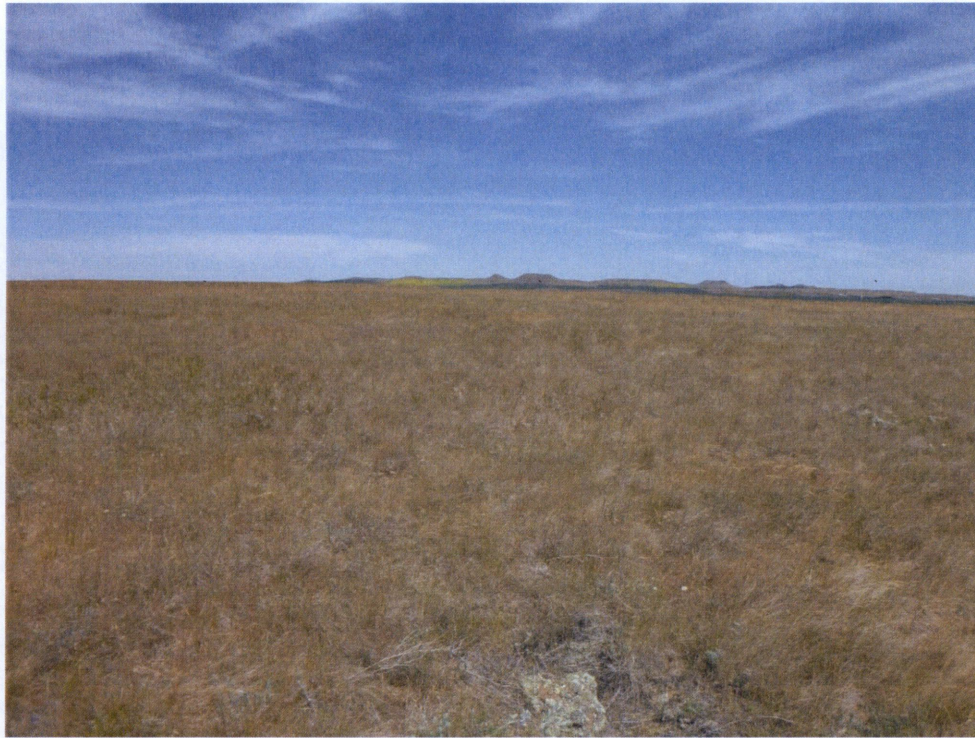
**Photograph 5 (Northwest): A view of the proposed West Radar Tower staging area from the southeast corner of the proposed West Radar Tower staging area.**

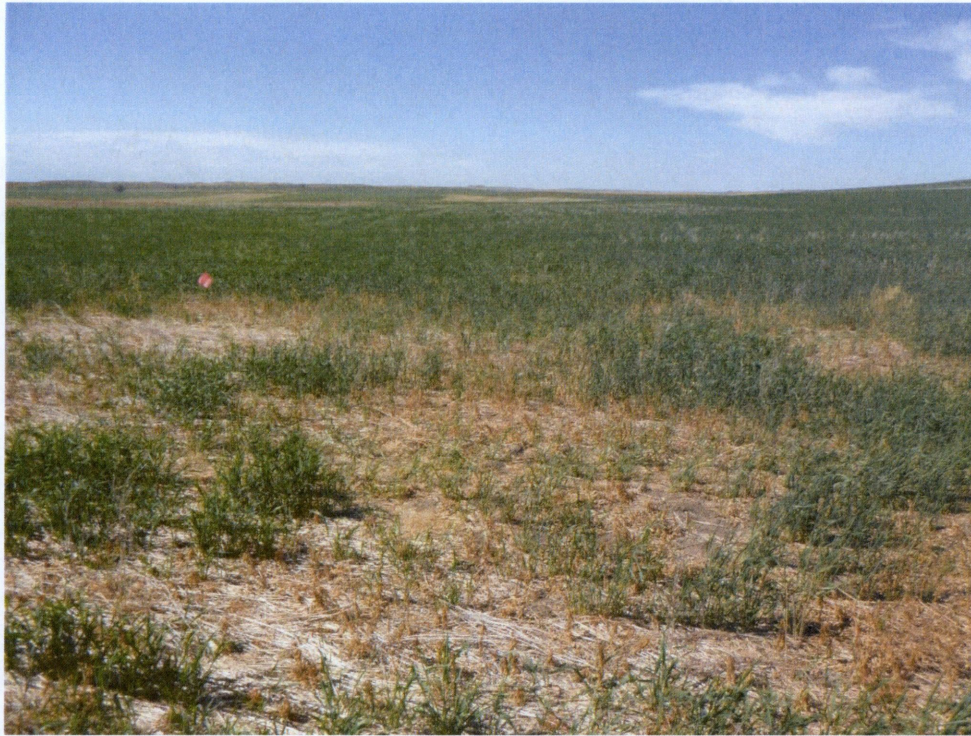
The wetlands and other WoUS survey for the Addendum No. 2 Survey Corridor was conducted in June 2017. During this survey, Tetra Tech identified a topographic low area with stressed vegetation potentially resulting from wetland hydrology within the access road to the north radar tower location. One sample point (BR-UP-1R) was taken in the area of lowest elevation where the likelihood of meeting wetland criteria was greatest. The sample location did not meet any of the wetland criteria. Based on these observations, it was determined that this area is not a wetland (Attachment 1: Figure 1, Attachment 2: Photo Log, Attachment 3: Wetland Determination Form). No other potential wetland or other WoUS features were observed within the Addendum No. 2 Survey Corridor.

**Photograph 1 (South):** A view of stressed vegetation observed within a topographic low area within the proposed service road.

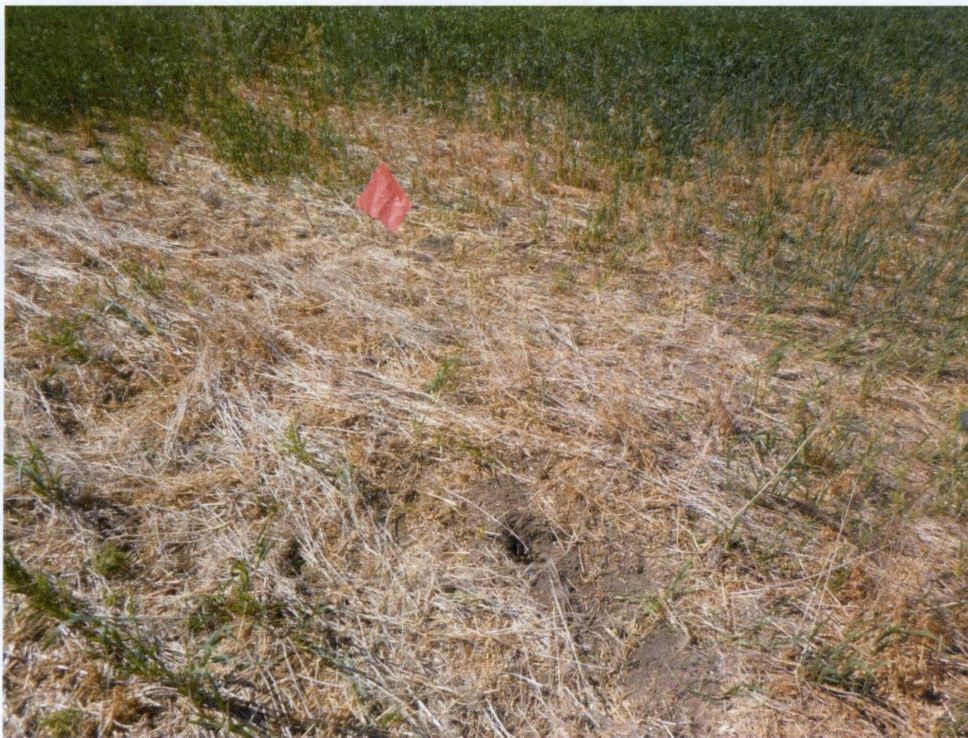
**Photograph 2 (NA):** A view of non-wetland sample point BR-UP-1R.
