**From:** [Troy Holzworth](#)  
**To:** [timrk@verendrye.com](mailto:timrk@verendrye.com)  
**Cc:** [steve.rotherham@summitutility.com](mailto:steve.rotherham@summitutility.com)  
**Subject:** PU-18-375  
**Date:** Wednesday, November 14, 2018 9:51:09 PM  
**Attachments:** [Summit damage sketch.pdf](#)

Ticket 18090429 was located the evening of 7-26-18 and all photos were uploaded to our system the morning of 7-27-18.

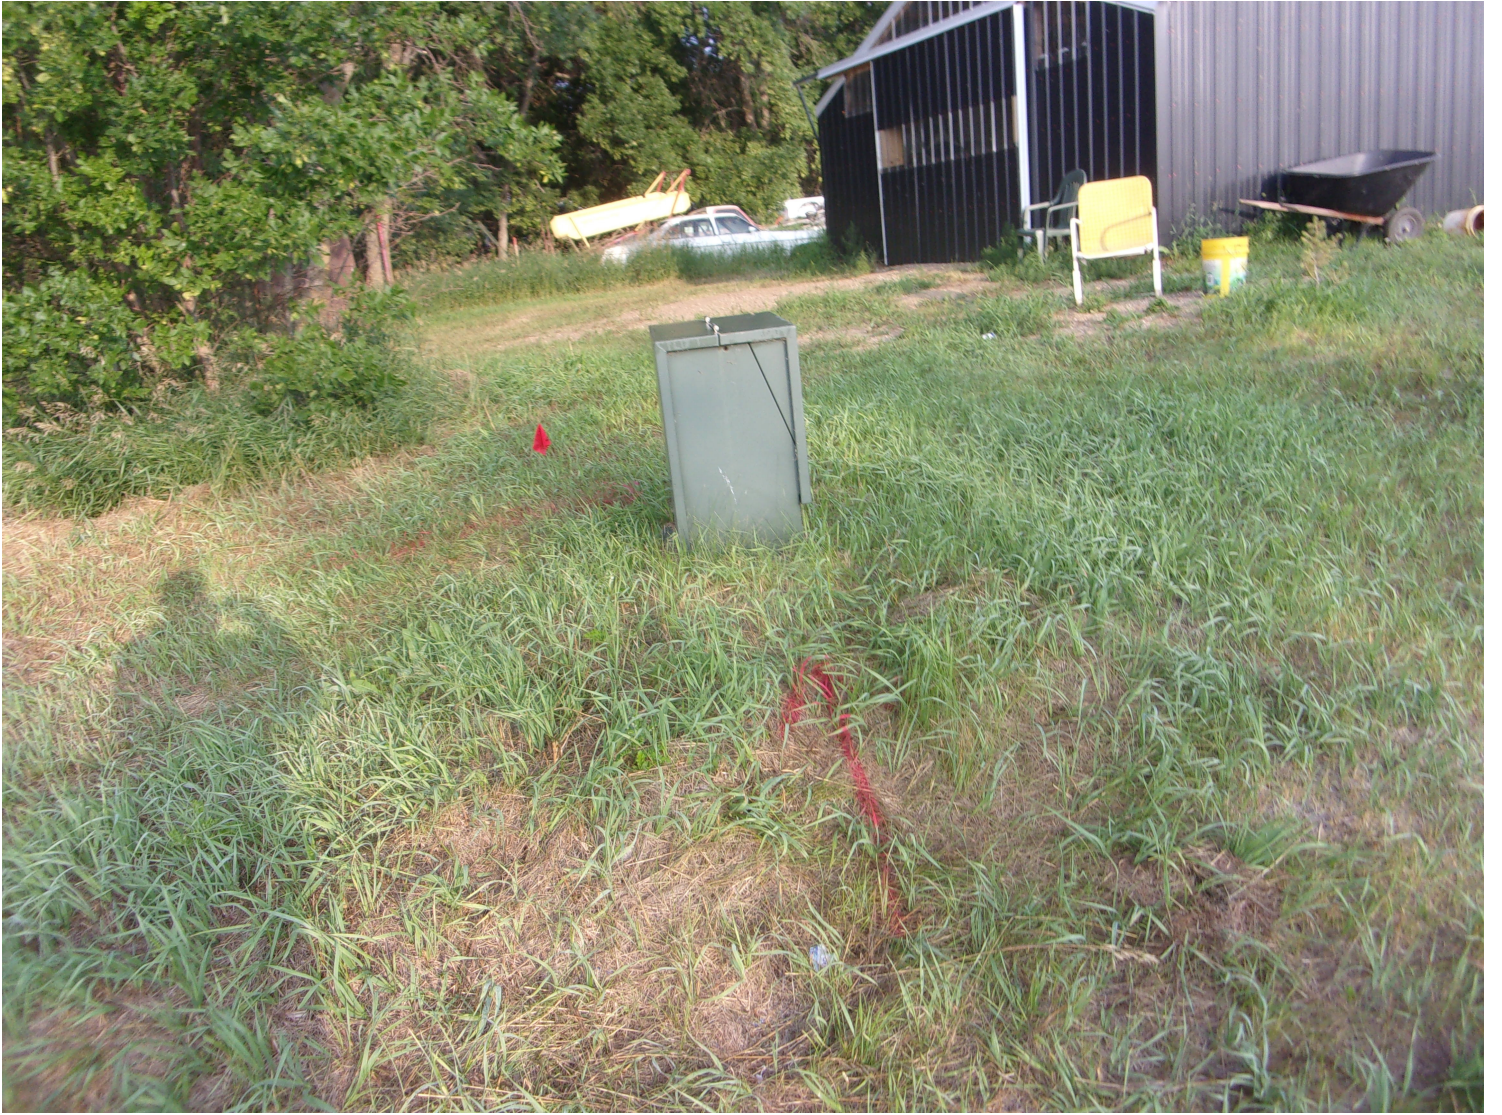
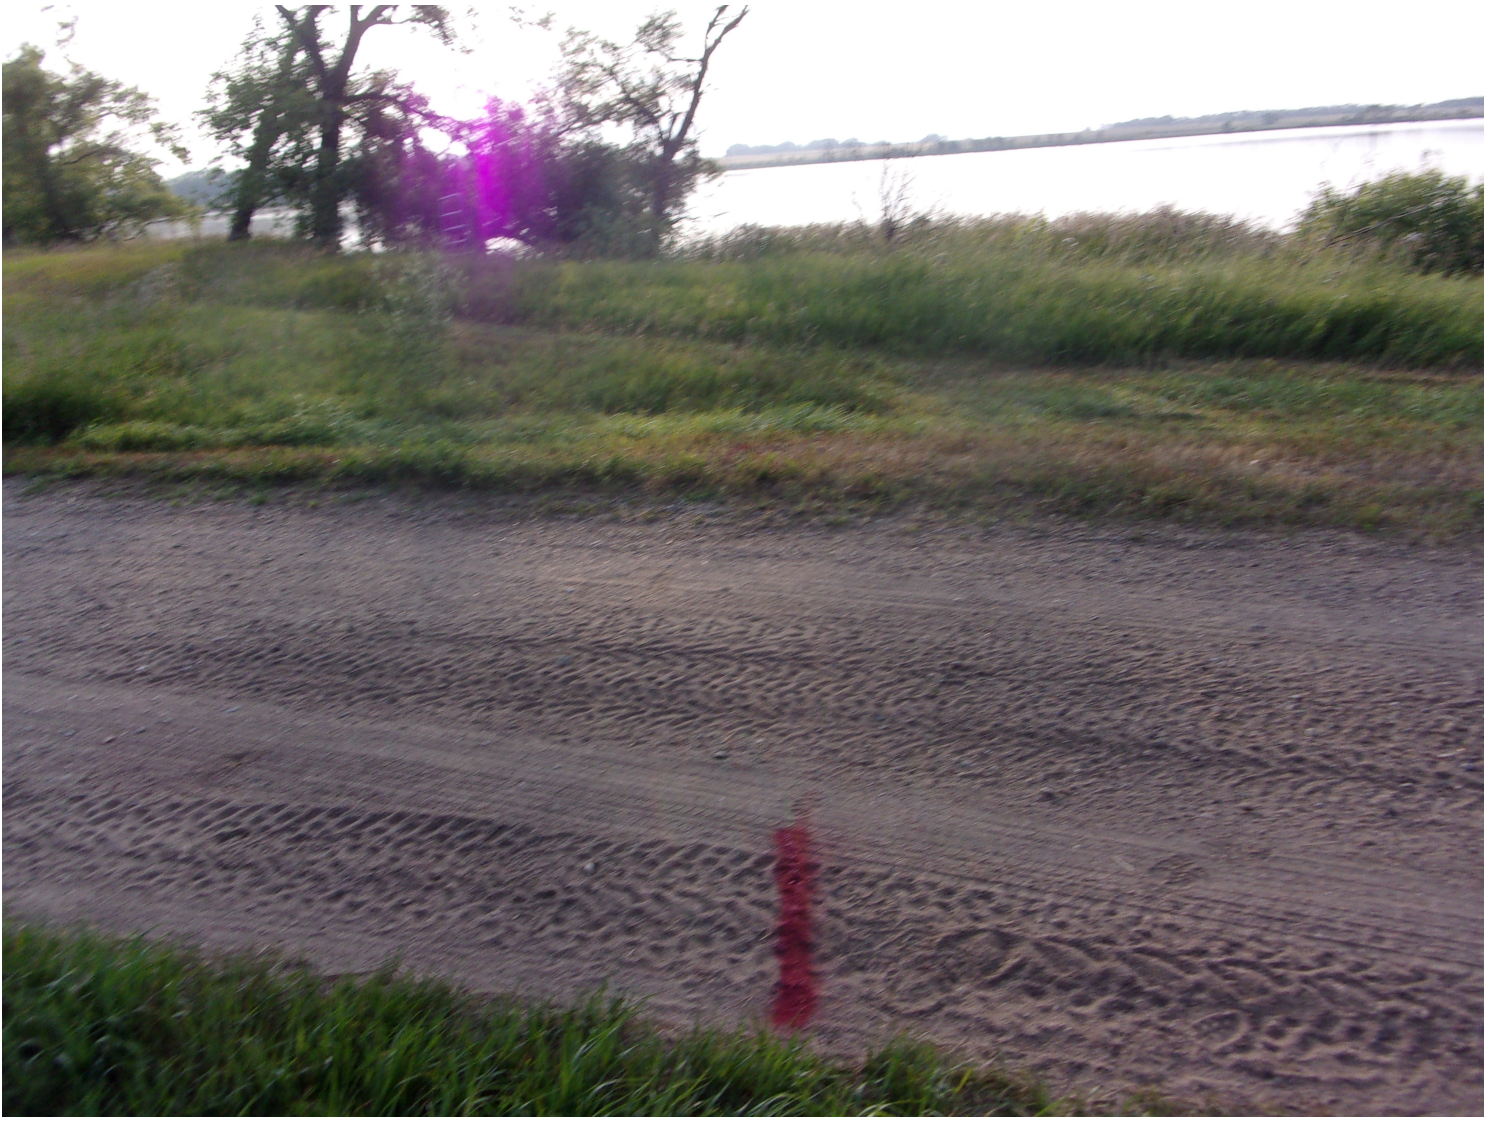
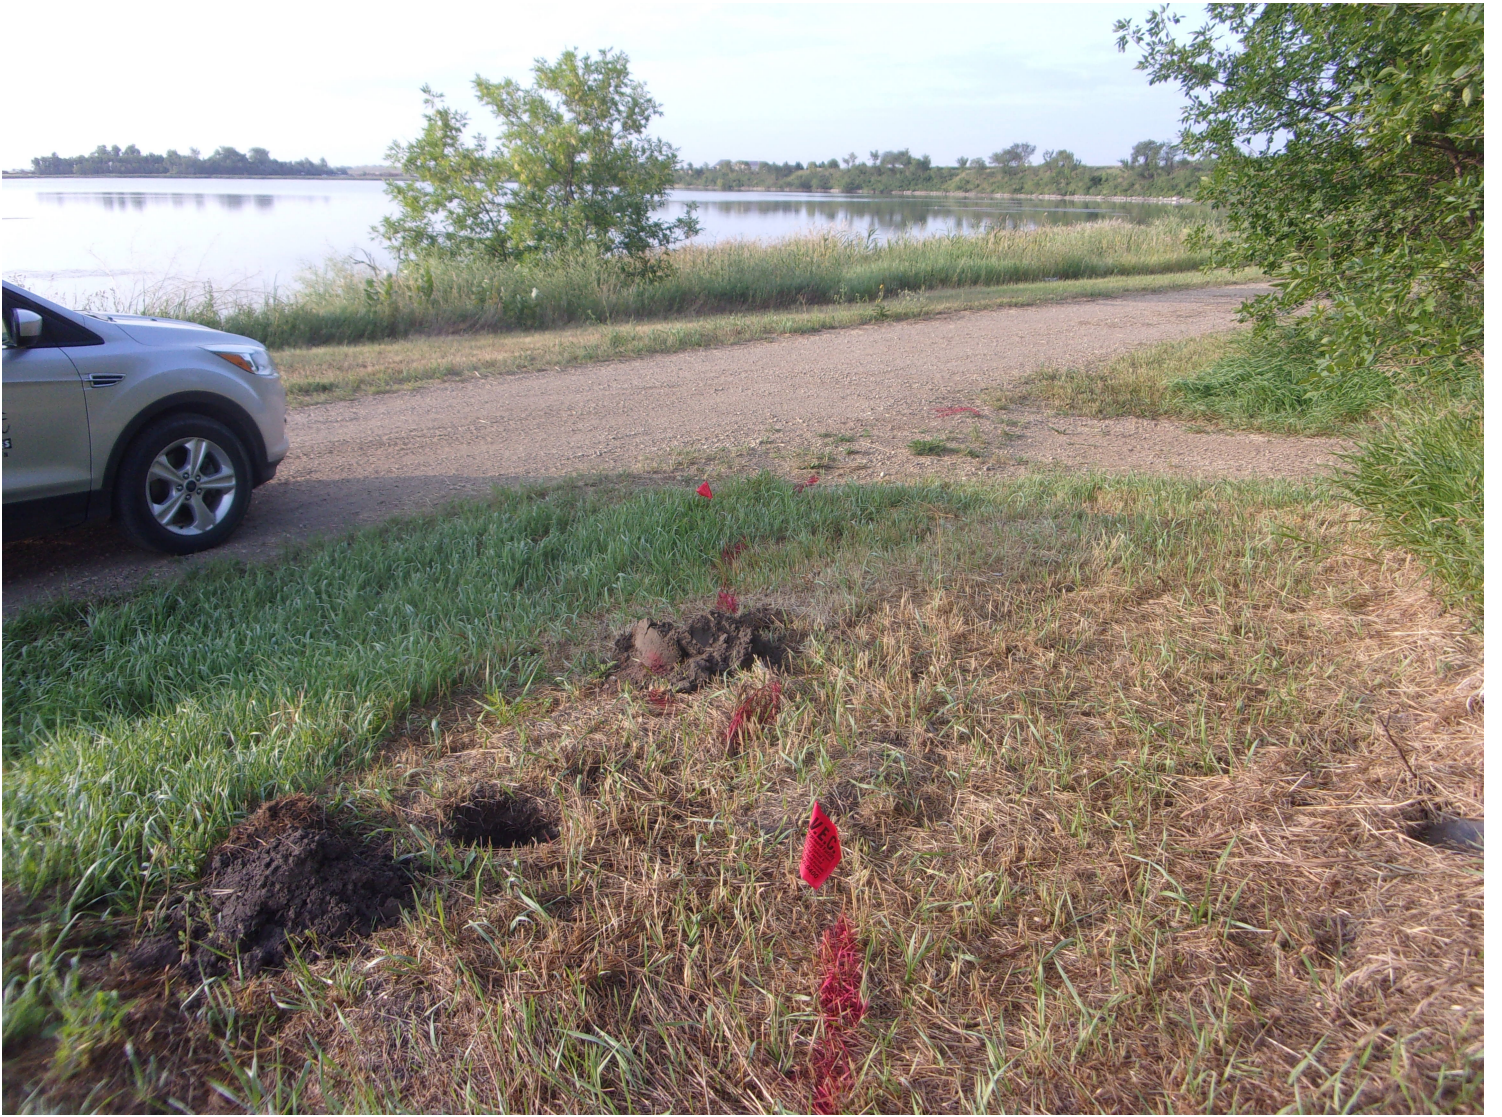
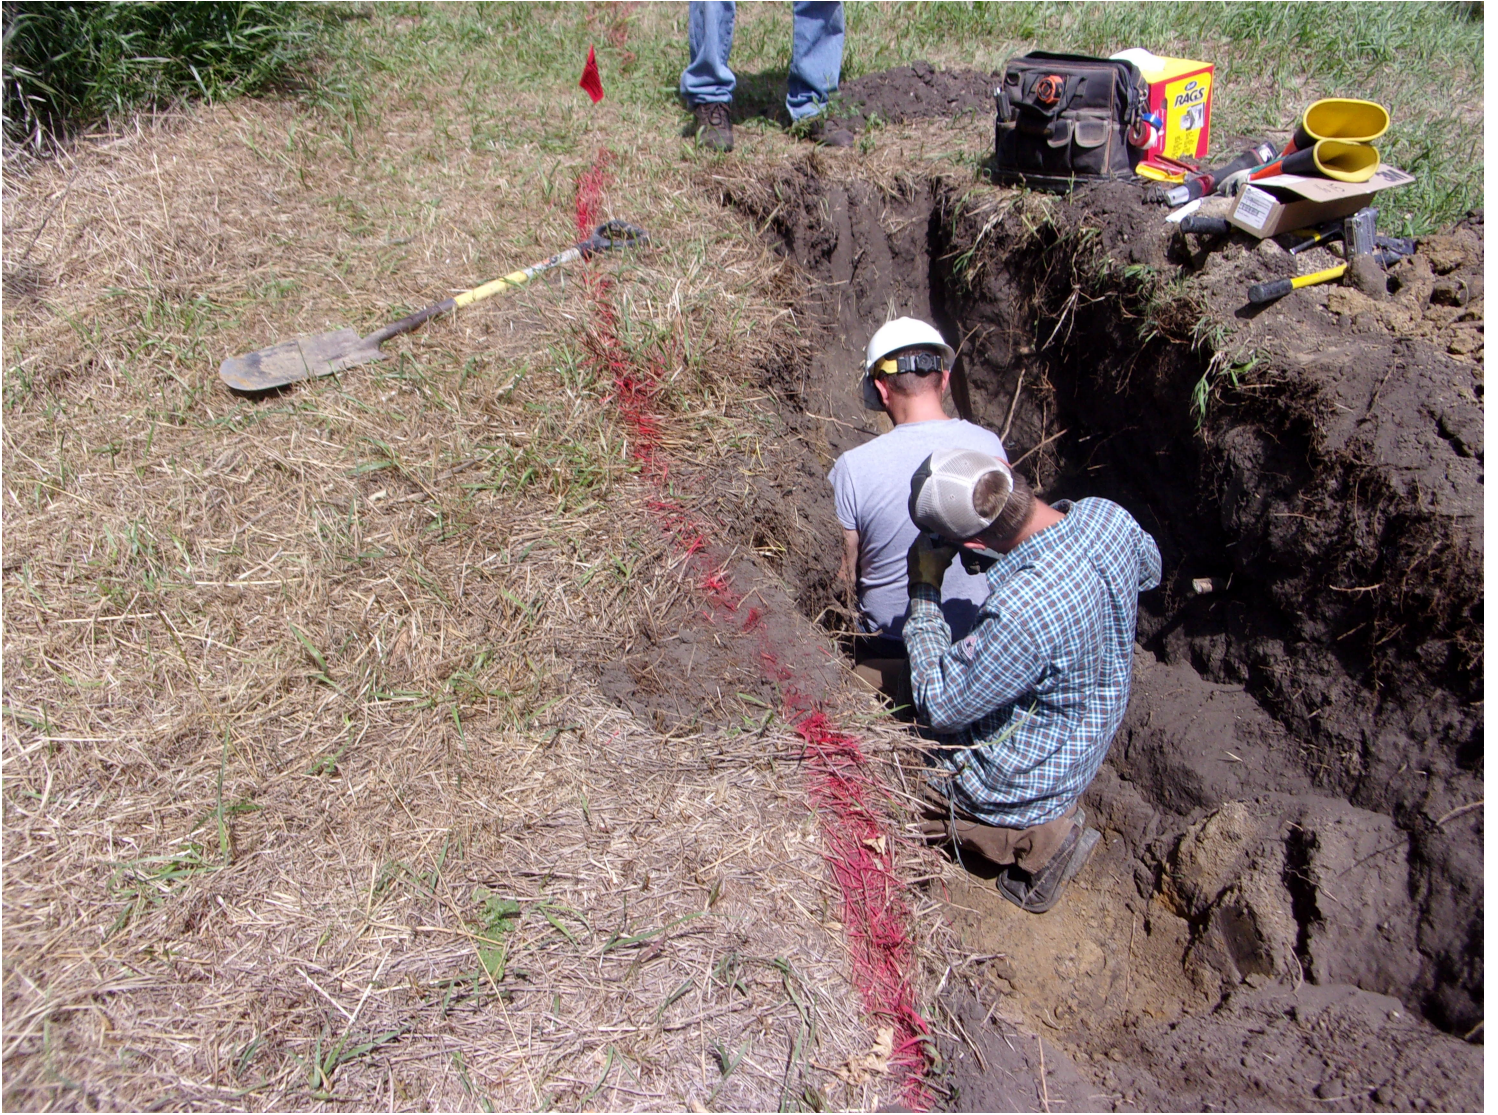
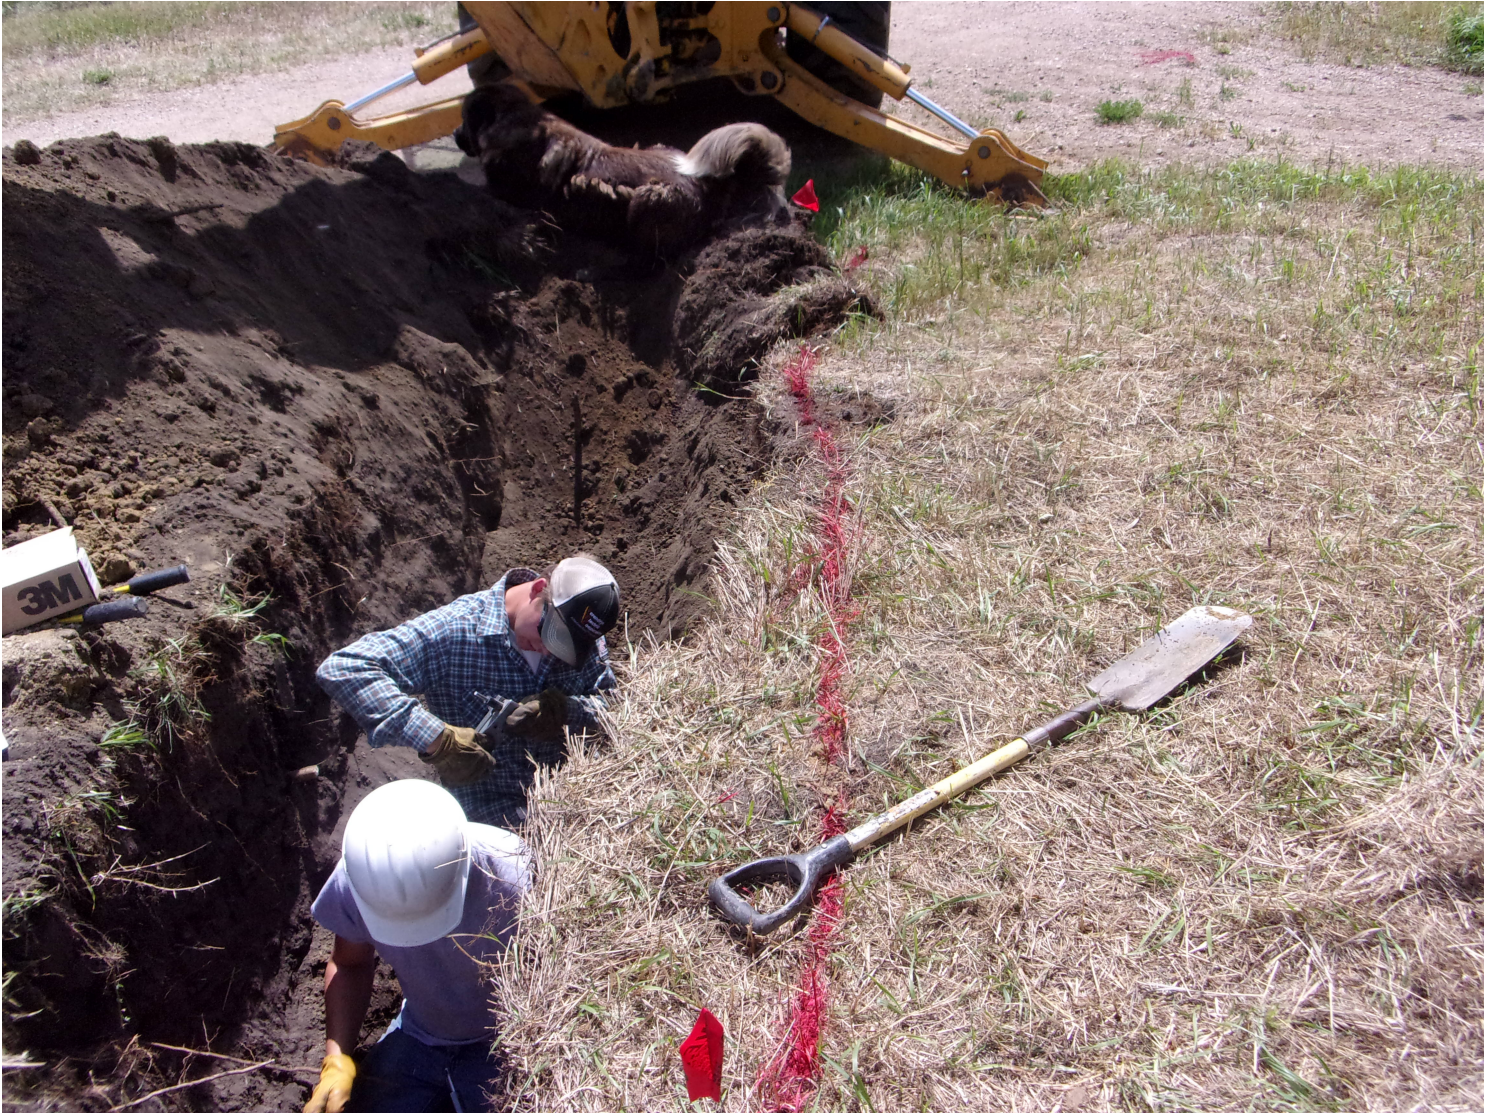
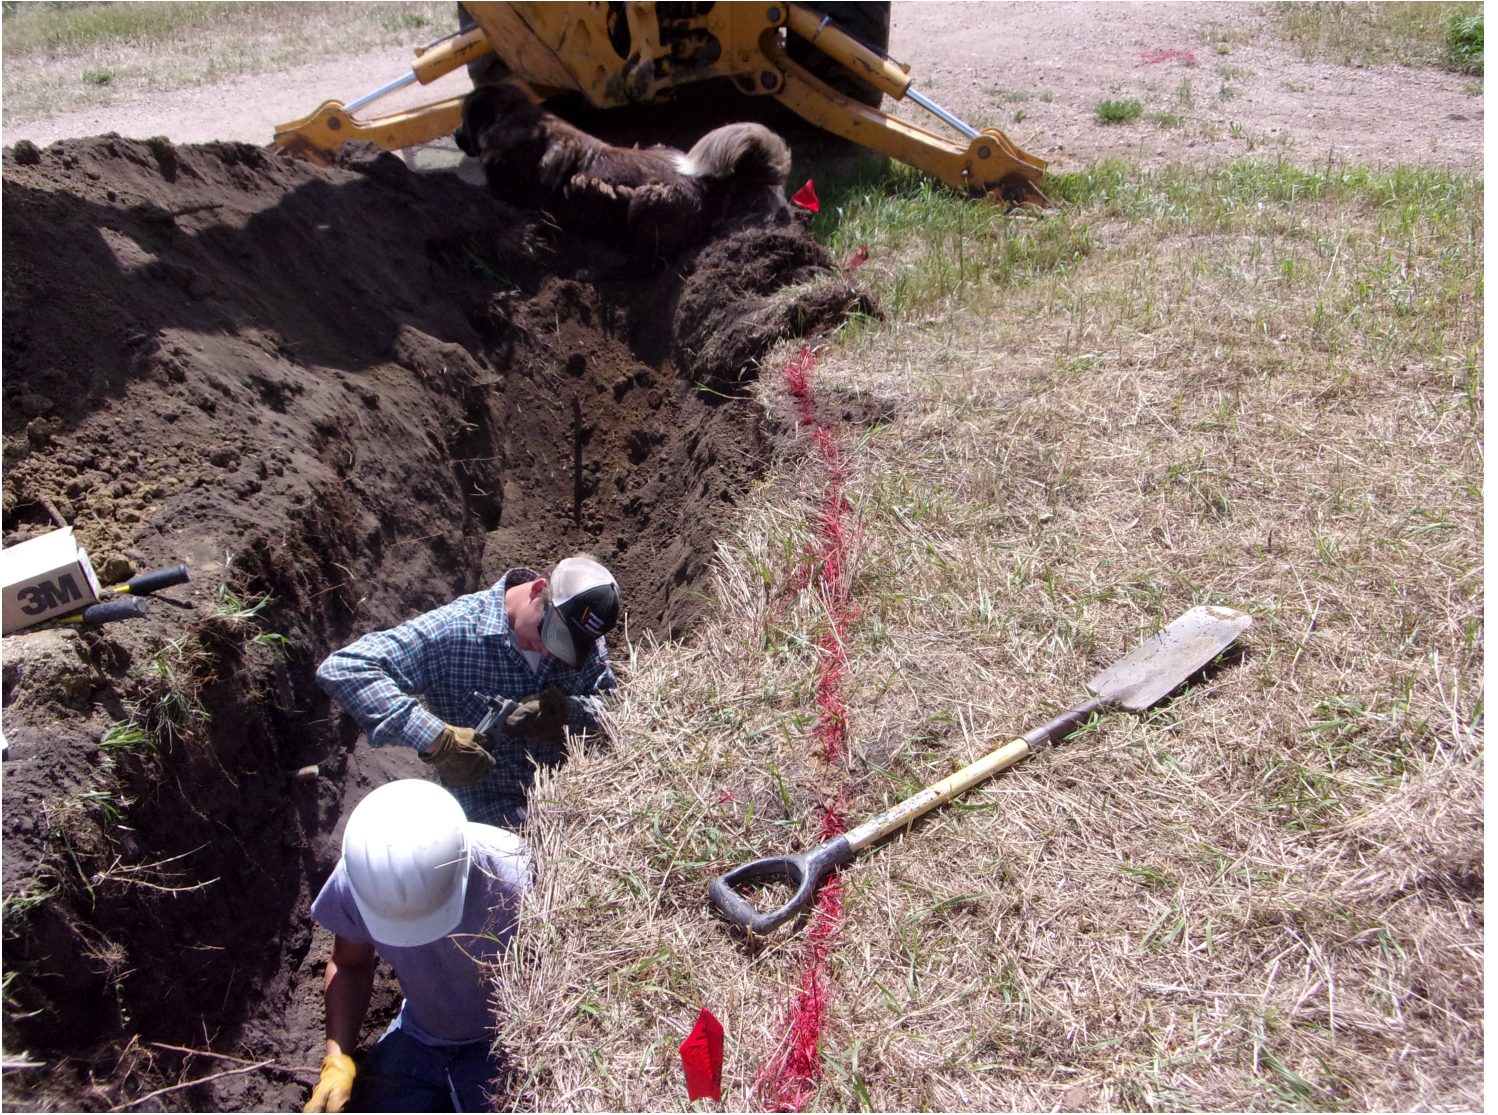
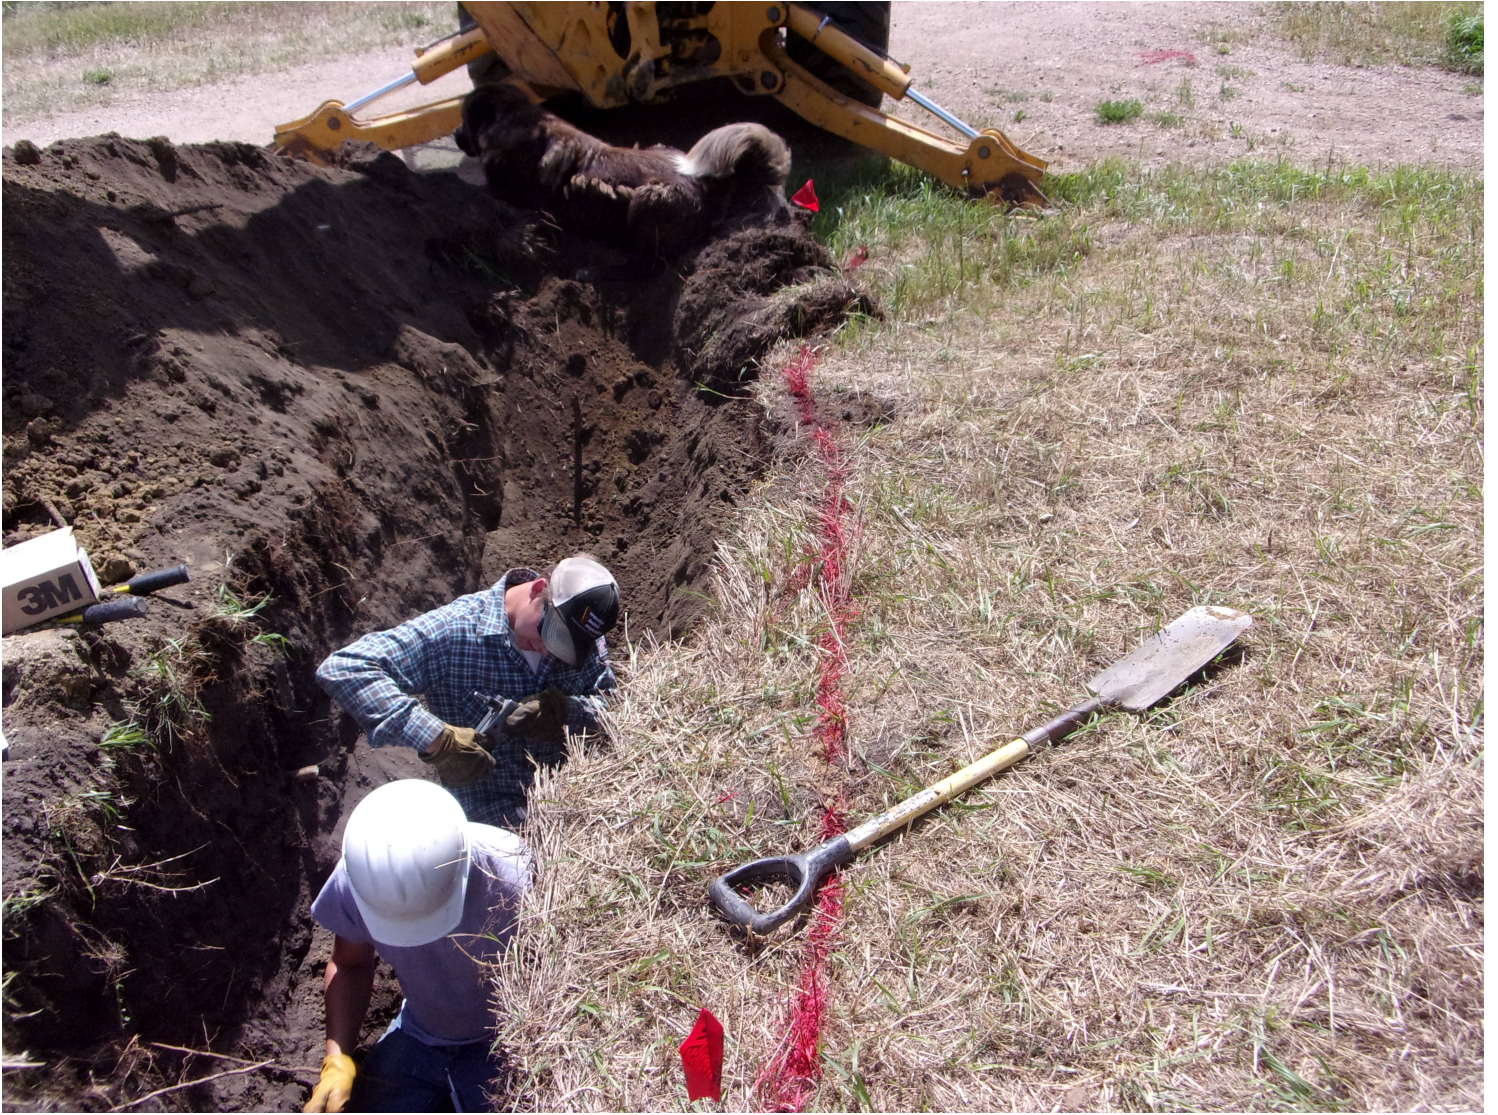
The line was damaged approximately 12 feet from a section can with two feeds coming out of it. The line was damaged close to a 90 degree turn in the route of the cable. The line damage was an old concentric neutral wrapped line and many of these lines are now being replaced because of the neutral being eroded over time, these lines are the most difficult lines to locate. The signal on the line going thru the corner was pushed to the inside curve of the actual location of the source cable thus making the accuracy outside the state tolerance of 24". The line was damaged at approximately 24.5 inches from the paint put on the ground.
