From: [Troy Holzworth](#)
To: timrk@verendrye.com
Cc: steve.rotherham@summitutility.com
Subject: PU-18-375
Date: Wednesday, November 14, 2018 9:51:09 PM
Attachments: [Summit damage sketch.pdf](#)

4 PU-18-374 Filed 11/14/2018 Pages: 9
Summit Utility Services response to One-Call complaint
Summit Utility Services, LLC
Troy Holzworth, President

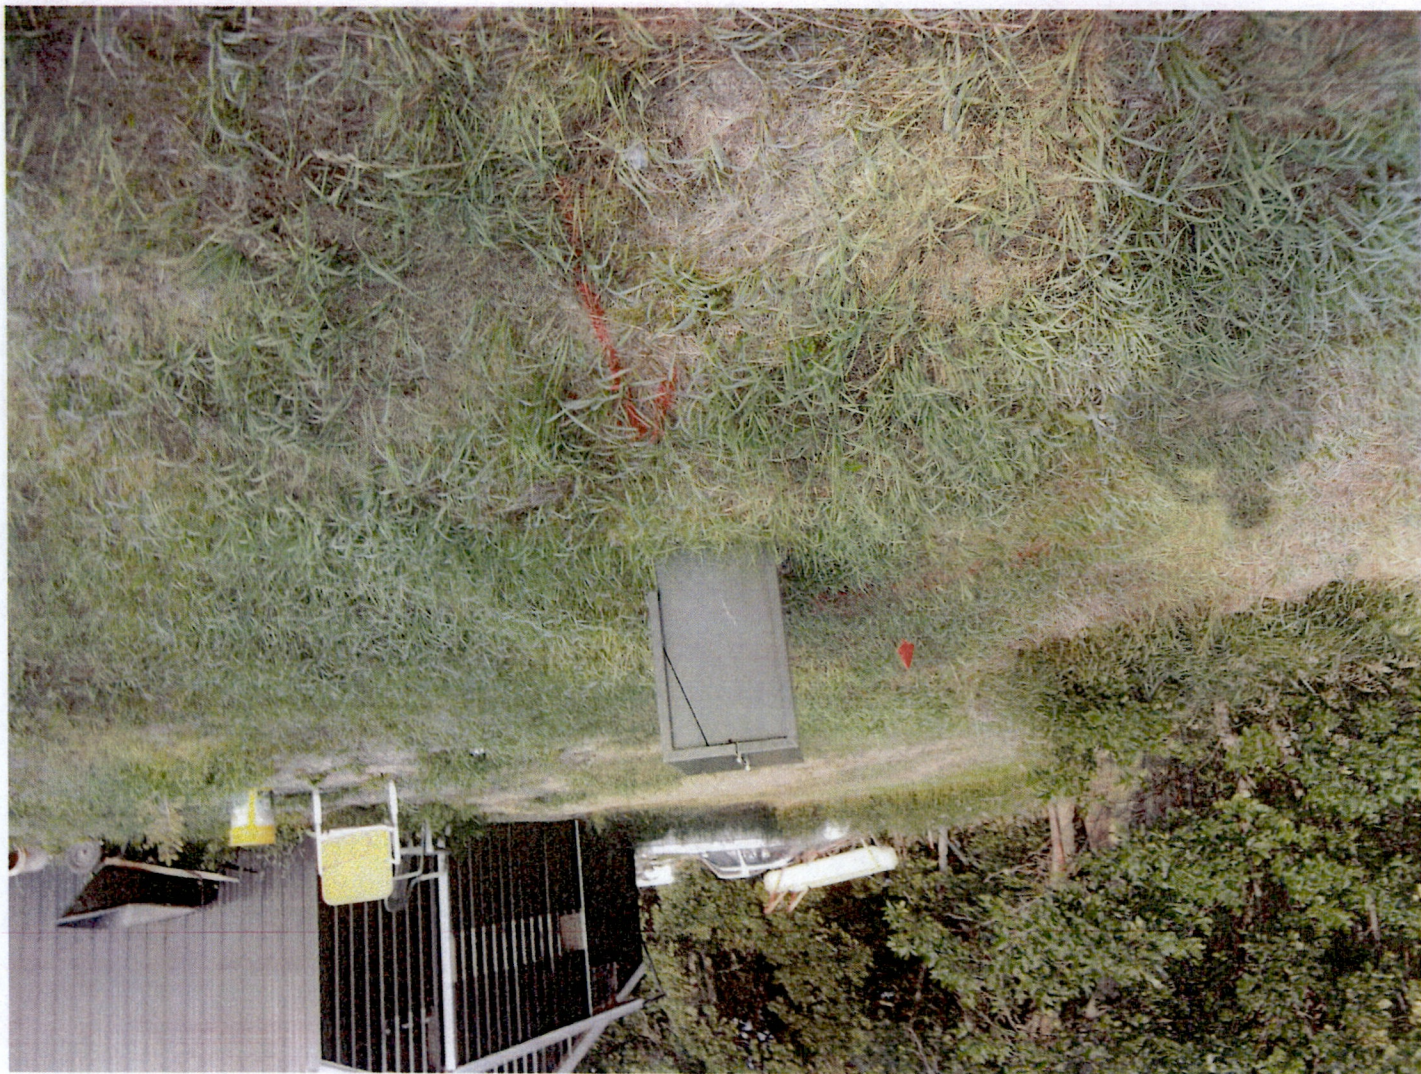
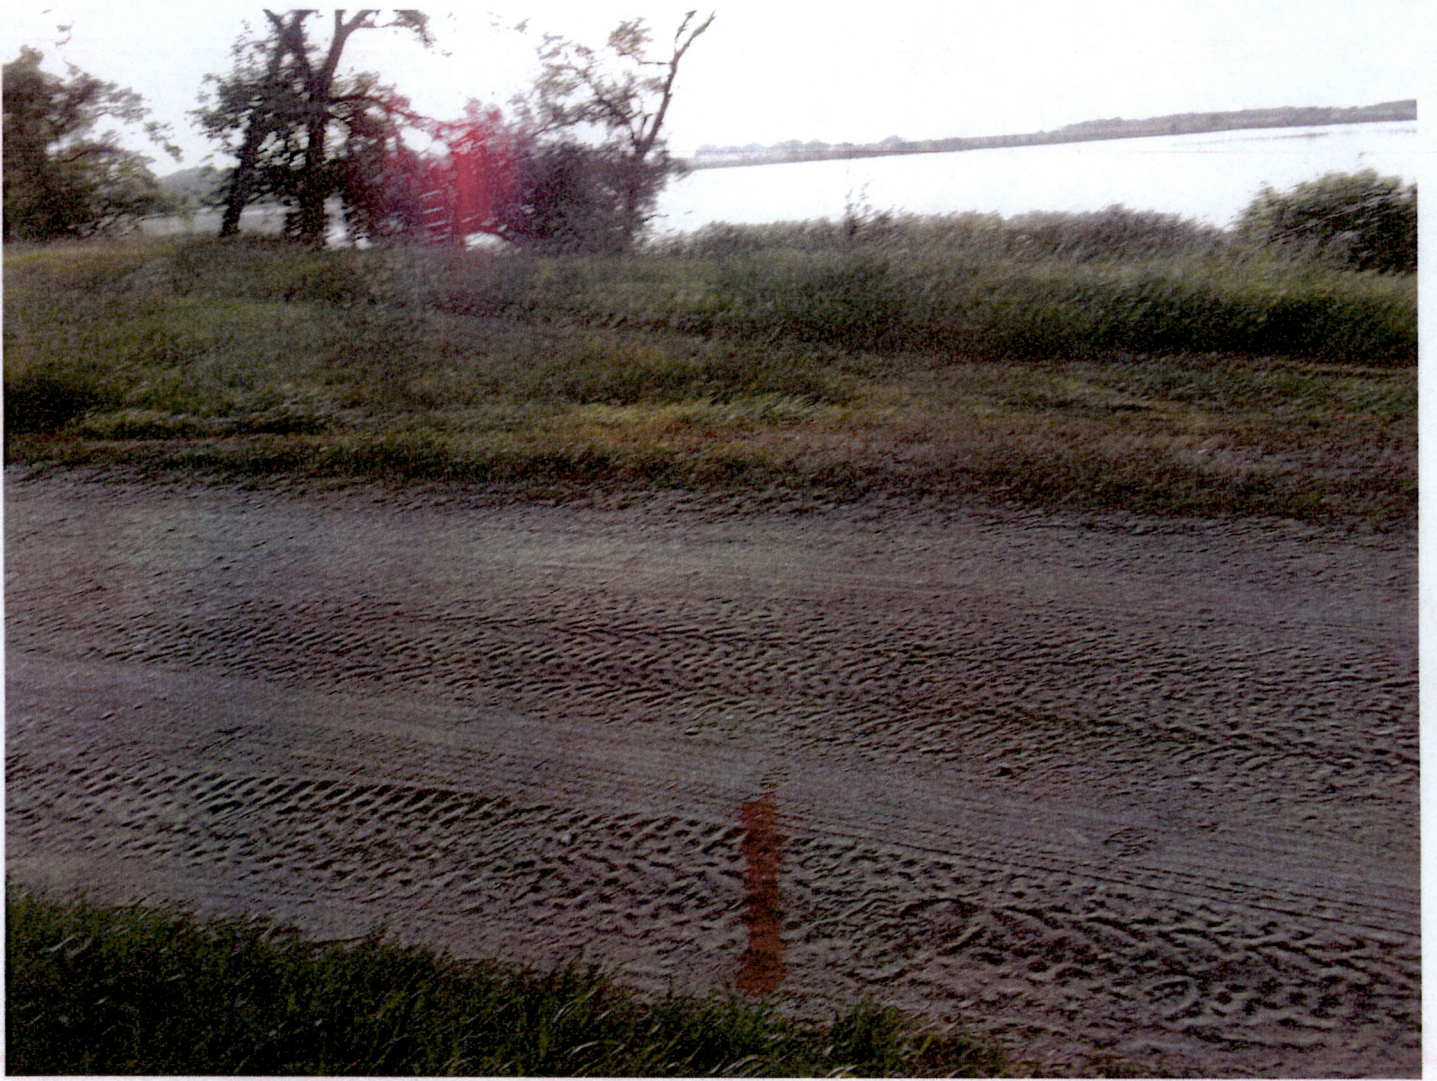
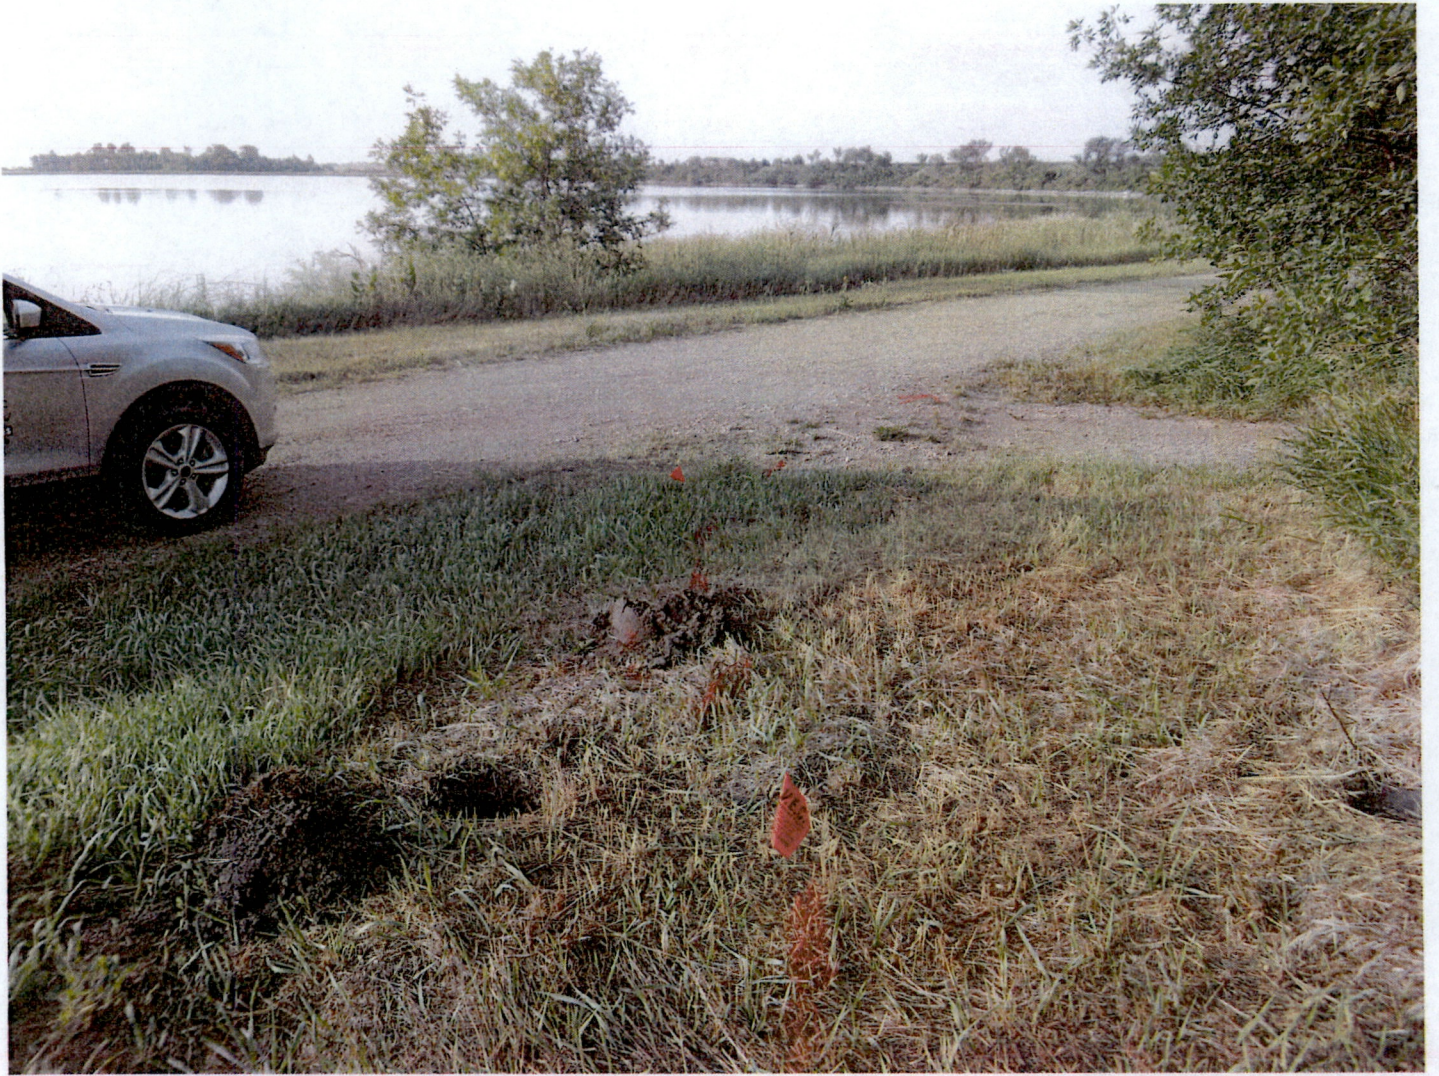
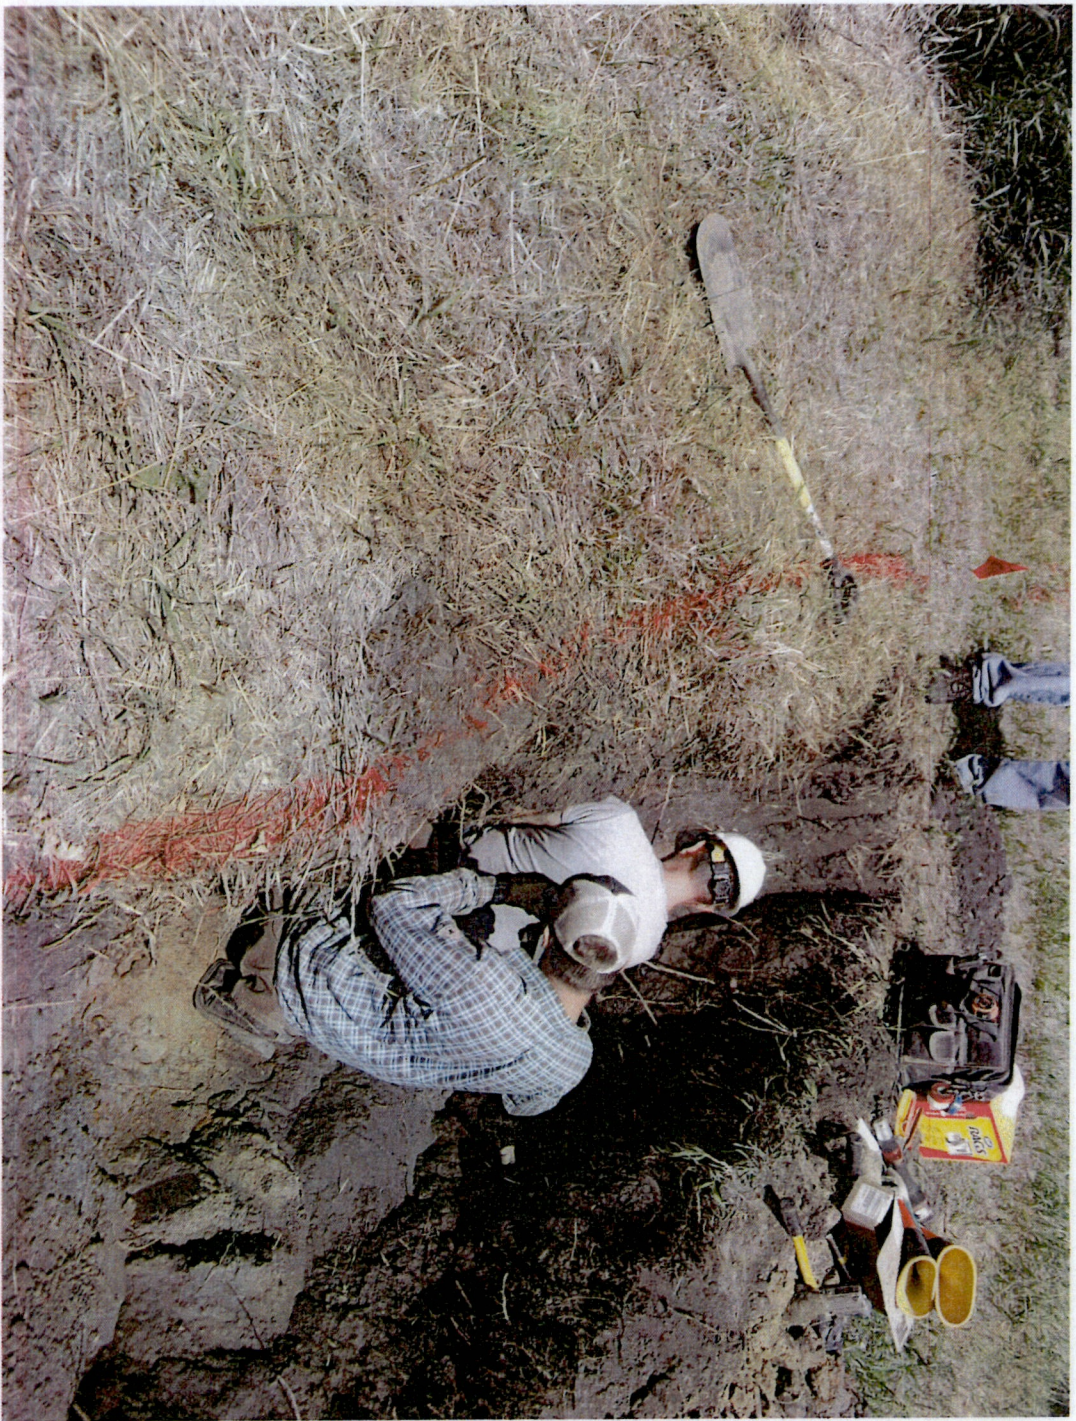
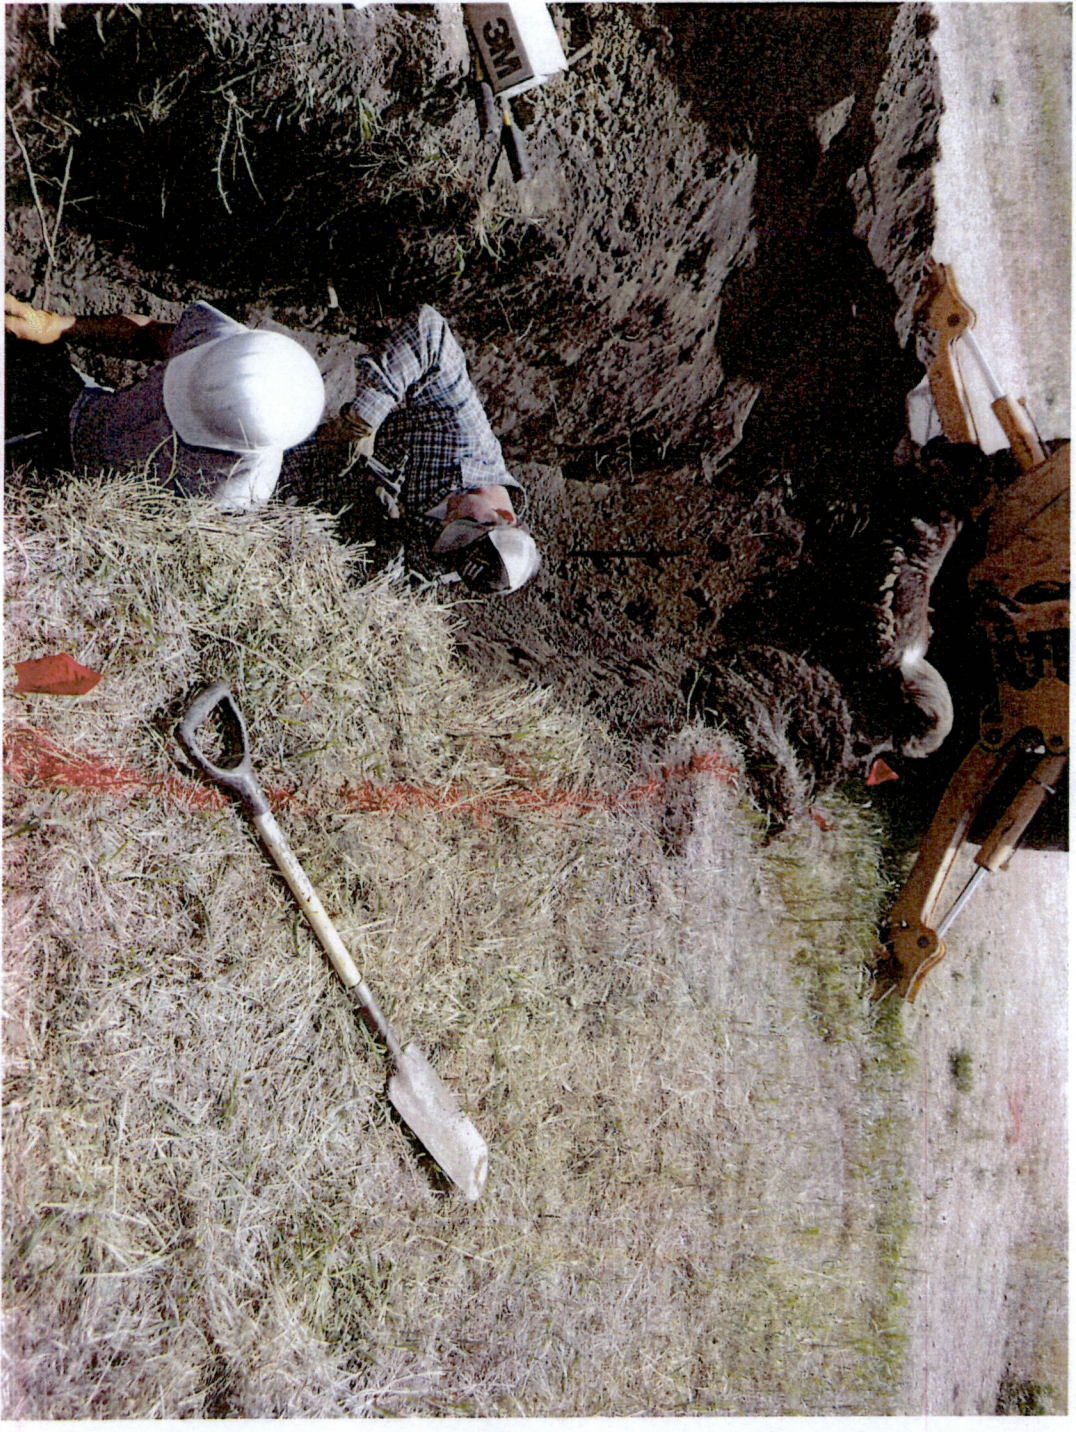
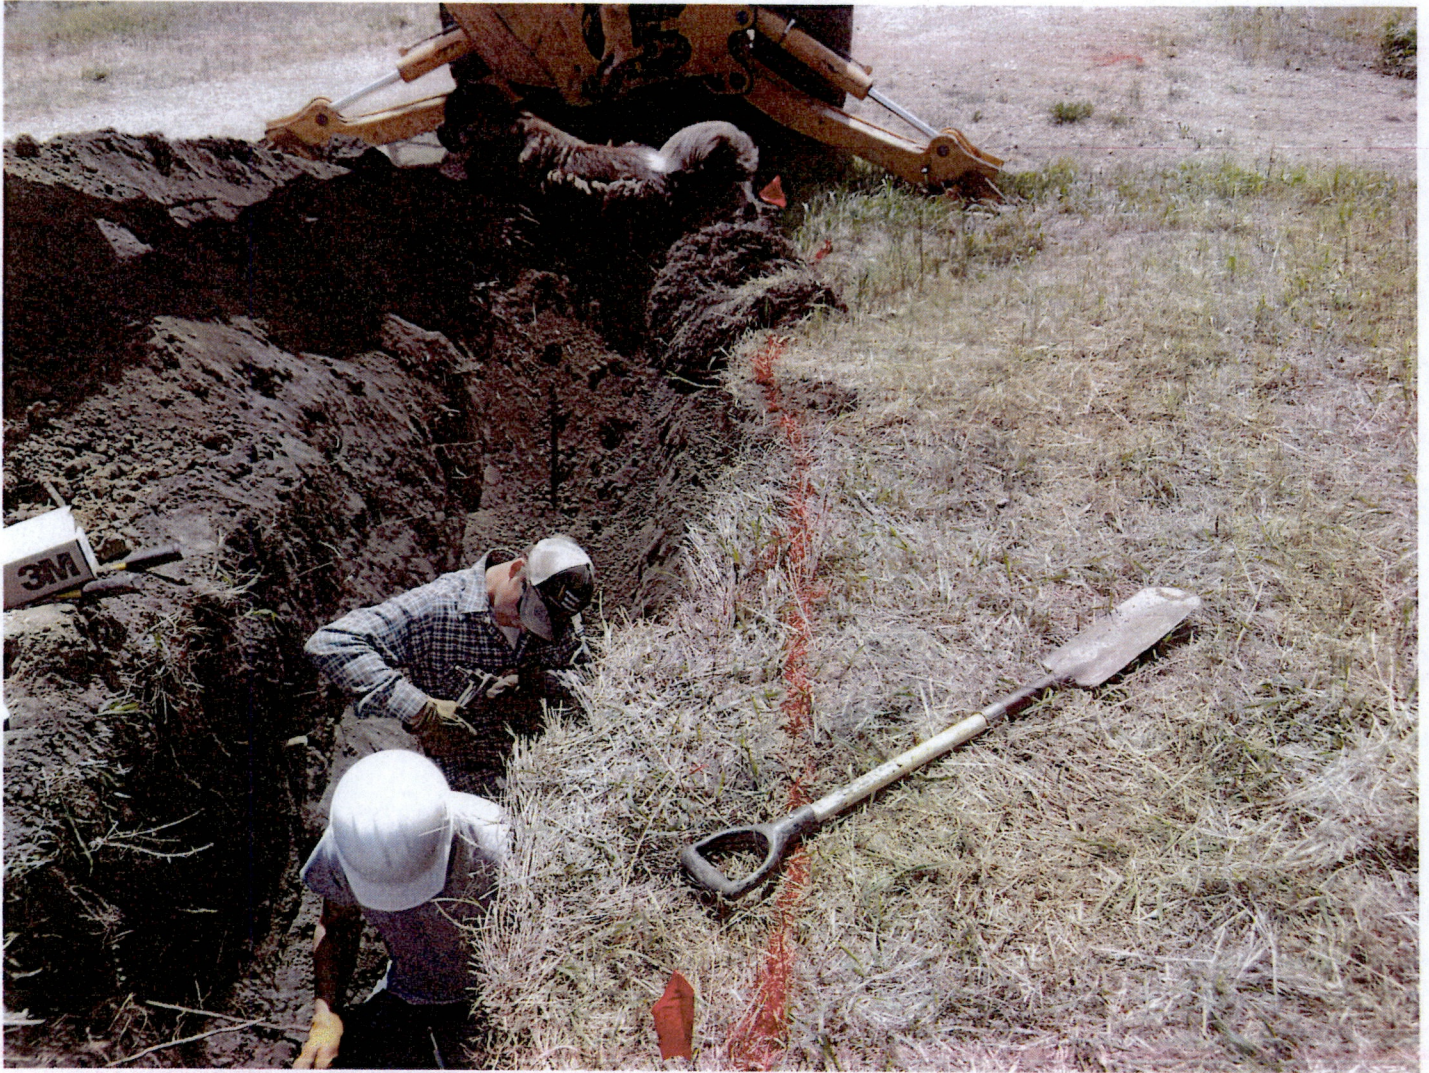
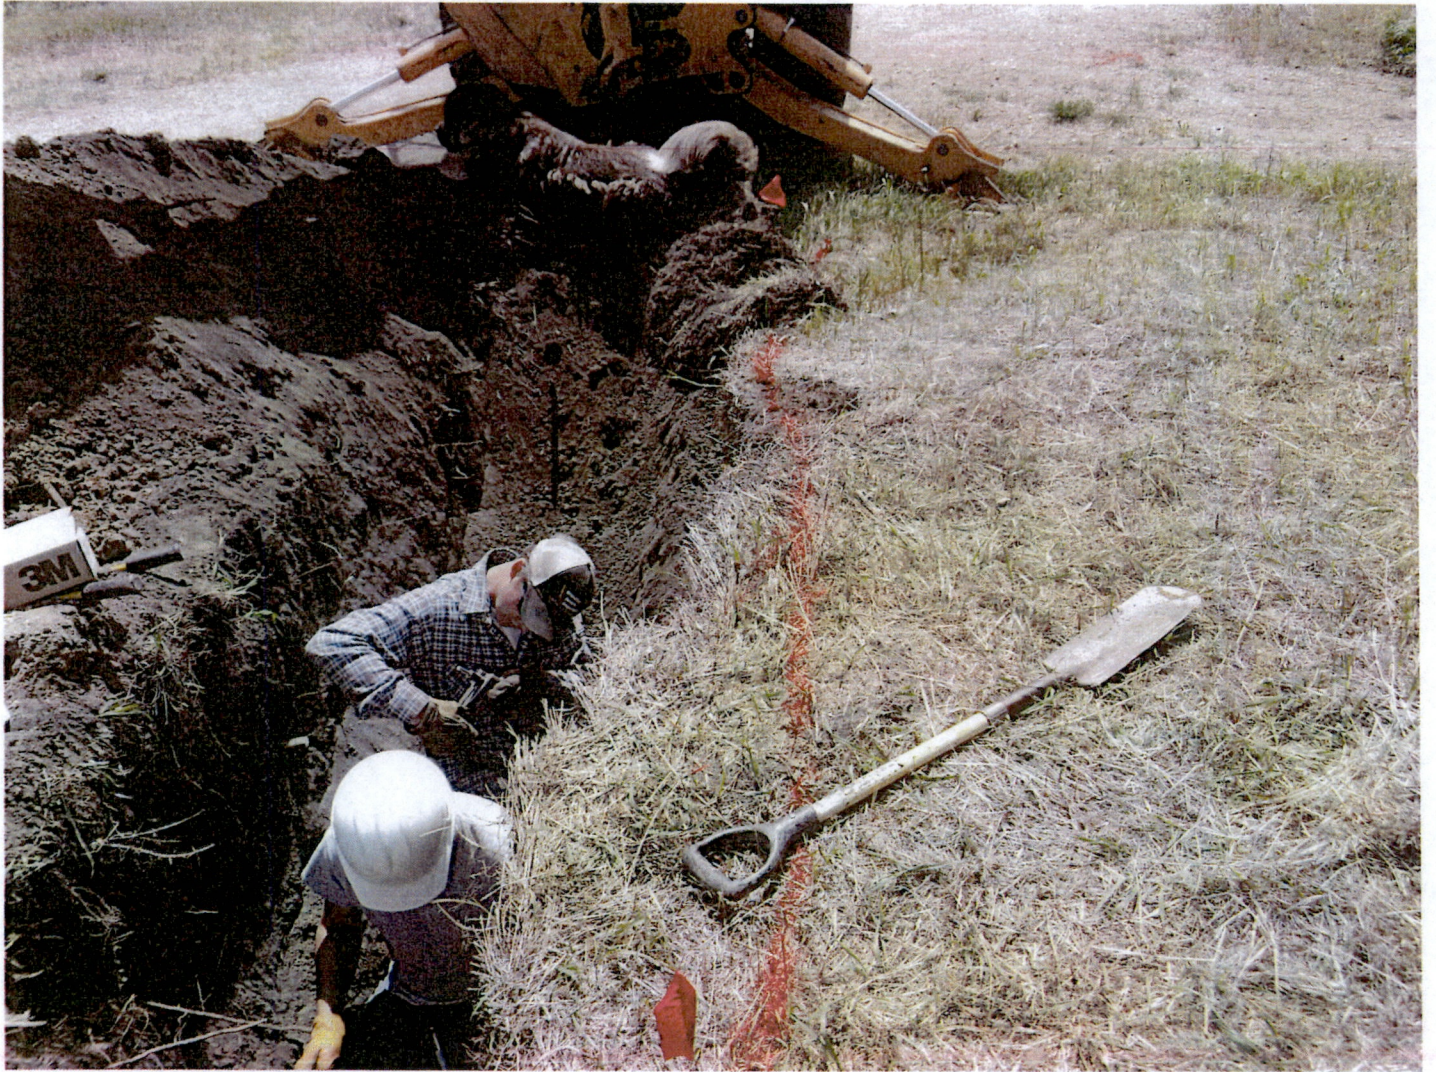
Ticket 18090429 was located the evening of 7-26-18 and all photos were uploaded to our system the morning of 7-27-18.

The line was damaged approximately 12 feet from a section can with two feeds coming out of it. The line was damaged close to a 90 degree turn in the route of the cable. The line damage was an old concentric neutral wrapped line and many of these lines are now being replaced because of the neutral being eroded over time, these lines are the most difficult lines to locate. The signal on the line going thru the corner was pushed to the inside curve of the actual location of the source cable thus making the accuracy outside the state tolerance of 24". The line was damaged at approximately 24.5 inches from the paint put on the ground.

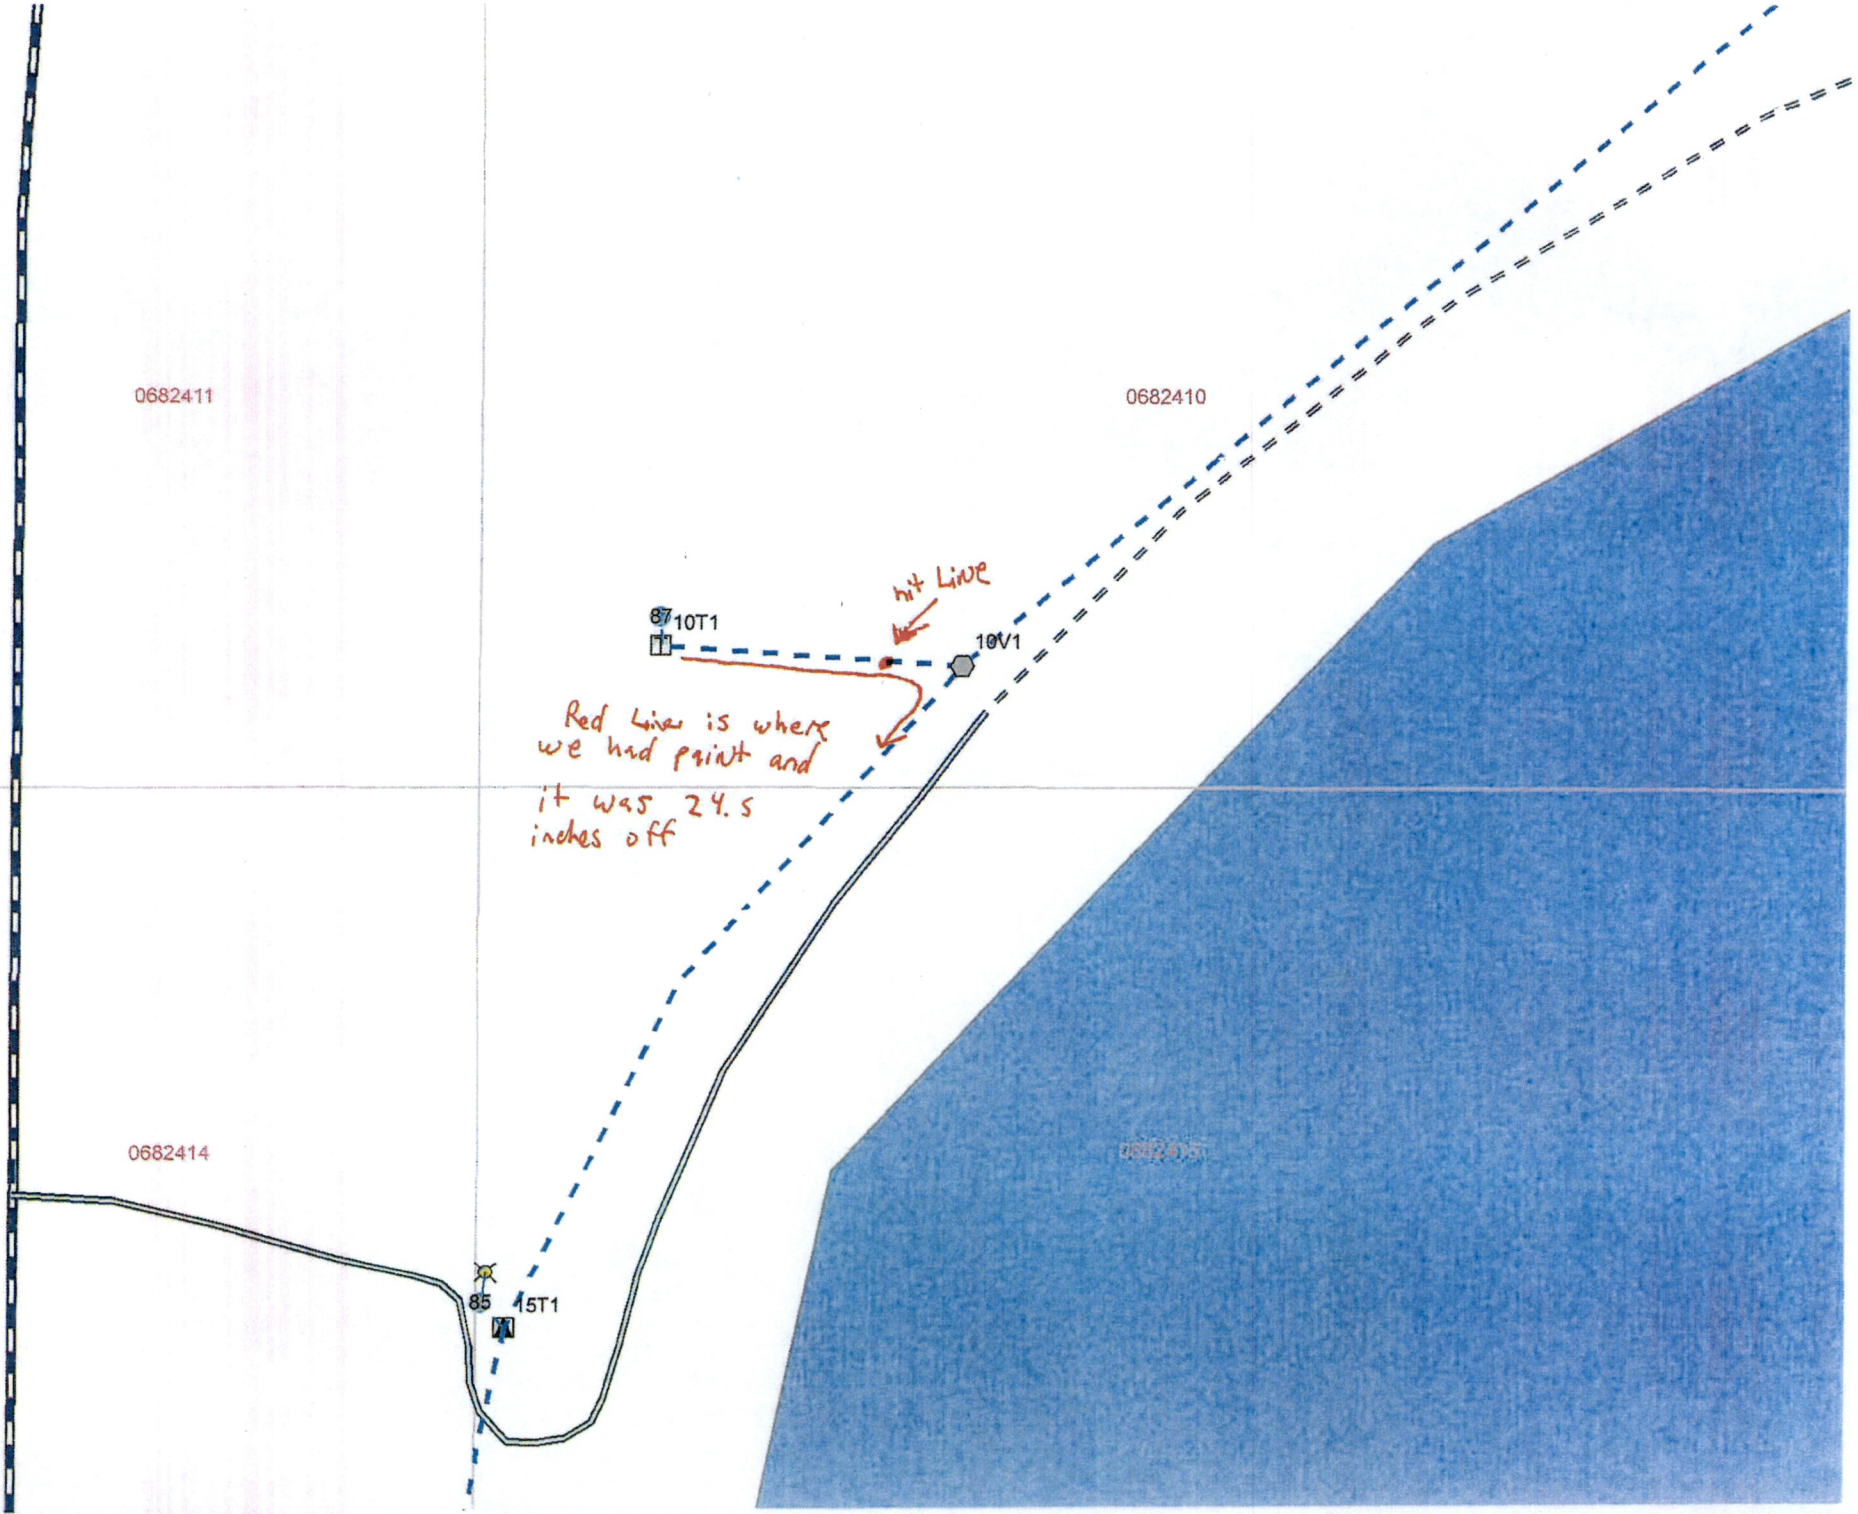
hit Line

Red Line is where
we had print and
it was 24.5
inches off

Our locator did the job correct, they read the maps, used direct connection, swept the area for any other non-target utilities in the area and then painted the target conductor in the spot that the locating equipment indicated. This ended up being just barley outside the 24 inch tolerance zone. Summit respects the homeowners concern and we understand the potential issue with a mis-locate. We are very happy that no one was injured and have taken full responsibility for the repair of this cable.
