From: [Troy Holzworth](#)
To: timrk@verendrye.com
Cc: steve.rotherham@summitutility.com
Subject: PU-18-375
Date: Wednesday, November 14, 2018 9:51:09 PM
Attachments: [Summit damage sketch.pdf](#)

Ticket 18090429 was located the evening of 7-26-18 and all photos were uploaded to our system the morning of 7-27-18.

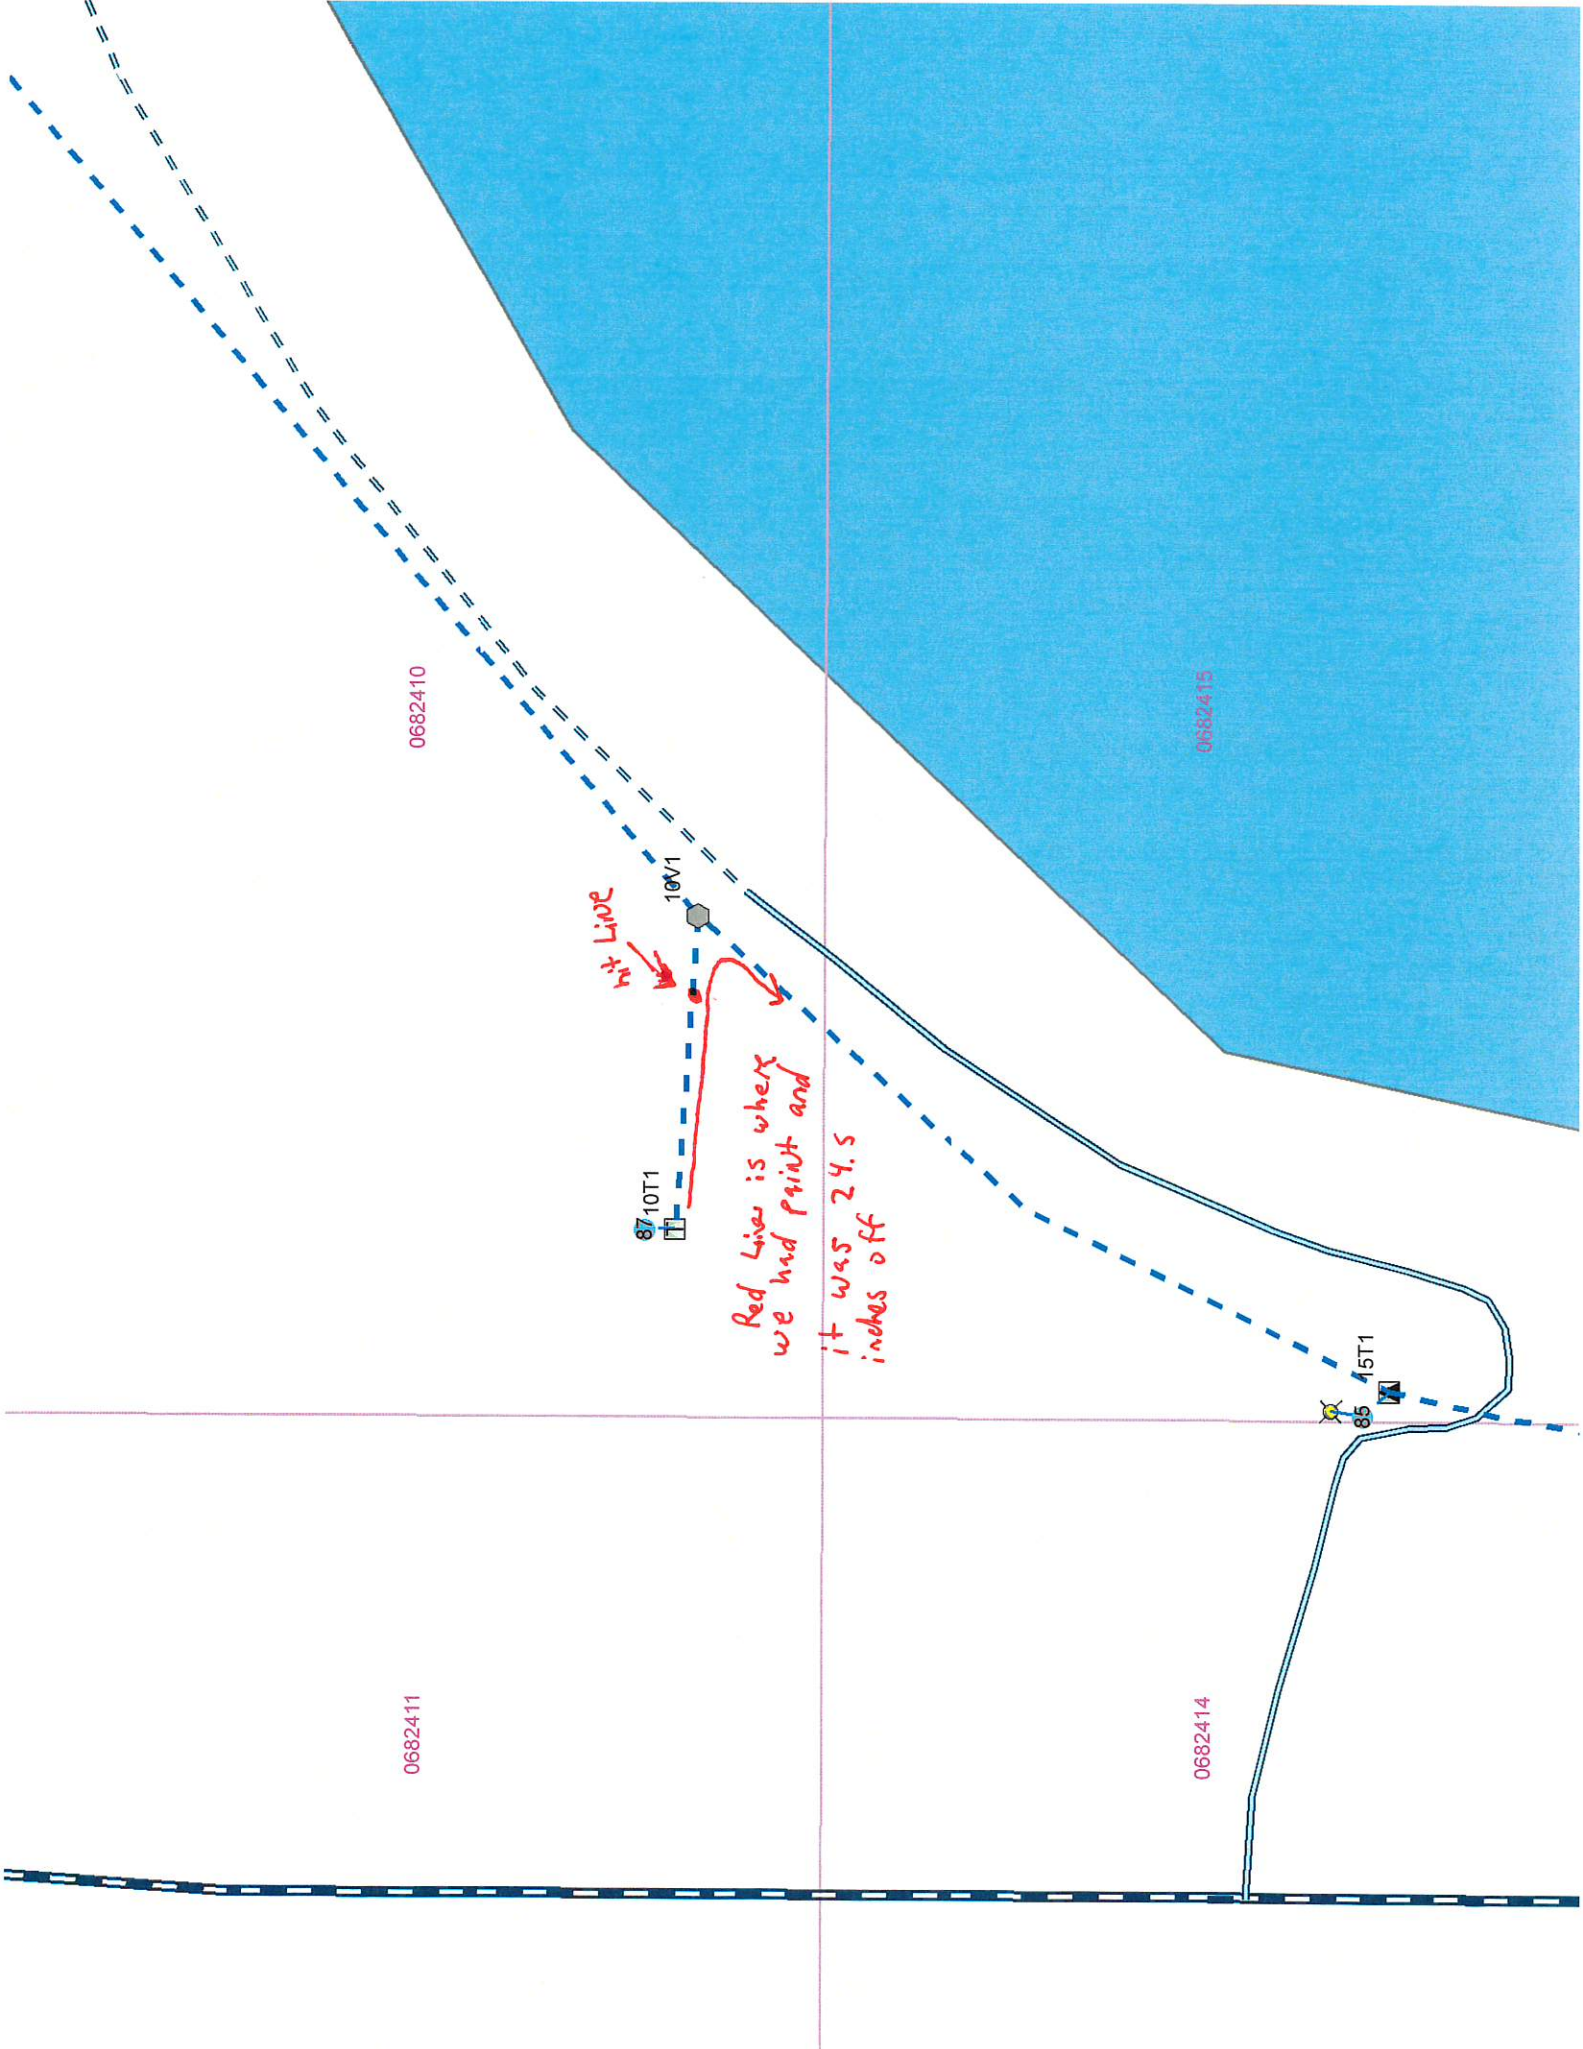
10x10
Red Line

The line was damaged approximately 12 feet from a section can with two feeds coming out of it. The line was damaged close to a 90 degree turn in the route of the cable. The line damage was an old concentric neutral wrapped line and many of these lines are now being replaced because of the neutral being eroded over time, these lines are the most difficult lines to locate. The signal on the line going thru the corner was pushed to the inside curve of the actual location of the source cable thus making the accuracy outside the state tolerance of 24". The line was damaged at approximately 24.5 inches from the paint put on the ground.

Red Line is where
we had print and
it was 24.5
inches off

Our locator did the job correct, they read the maps, used direct connection, swept the area for any other non-target utilities in the area and then painted the target conductor in the spot that the locating equipment indicated. This ended up being just barley outside the 24 inch tolerance zone. Summit respects the homeowners concern and we understand the potential issue with a mis-locate. We are very happy that no one was injured and have taken full responsibility for the repair of this cable.
