**A Class II Architectural Inventory and Viewshed  
Analysis of the Ruso Wind Project in Ward, McHenry,  
and McLean Counties, North Dakota**

BCA Project No.: 2019-1302  
August 2019

**MANUSCRIPT DATA RECORD FORM**

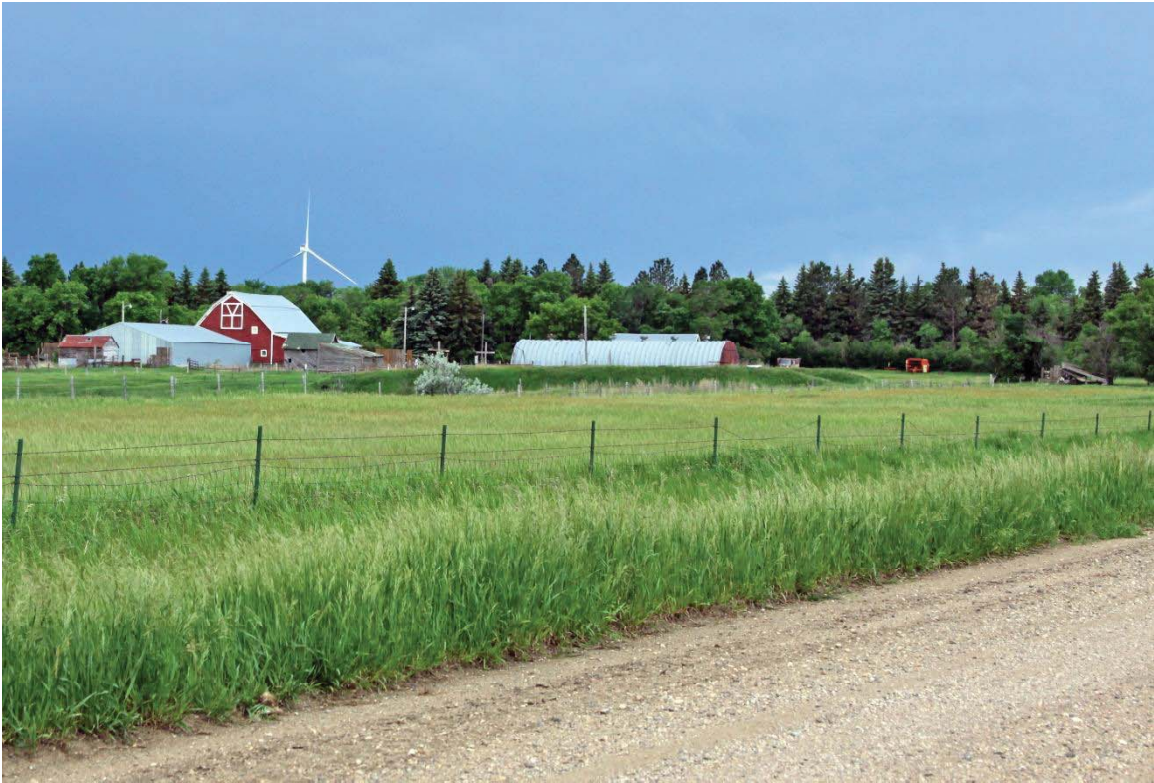
**Figure 2.** Site 32MH474, June 14, 2019, from 35th St N facing southwest (crop of IMG\_1829.jpg).

This property is thought to be potentially eligible for the NRHP, as the barn retains important architectural elements and presents a good example of a gambrel roof dairy barn, surrounded by less intact historic outbuildings that nevertheless support the integrity of the barn's historic setting, association, and feeling. Further research is needed to fully investigate this property and make a final determination of significance and eligibility to the NRHP under Criterion C.

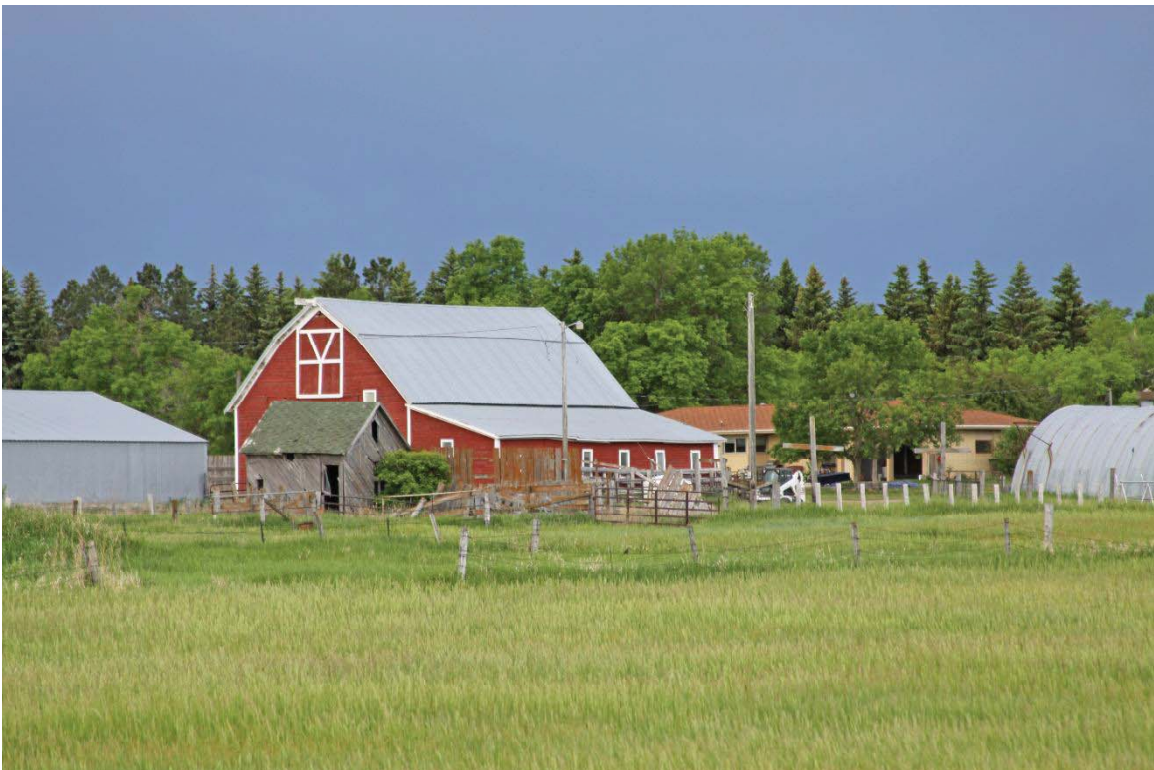
of alterations with non-historic materials, giving it the highest level of material integrity (Figure 3). The metal half-round Quonset, with a northern façade made of vertical wooden siding painted red, is more common in the North Dakota farming landscape, but it also has a high level of integrity. The three wooden storehouses/grain bins, two with gable roofs and one with a shed roof, are each in poor material condition, with damage to roofs and siding. All show evidence of adaptation with historically inappropriate roofing materials (asphalt shingles), and one (Feature 4) has been partially sided with sheet metal. Based on Farms Service Agency (FSA) aerial imagery (1957-1962), all of the historic buildings at site 32MH474 described above, with the exception of Feature 5 (the shed-roof grain bin), have been situated in their respective footprints continuously for at least 57 years.

**Figure 3.** Site 32MH474, June 14, 2019, from 35th St N facing southwest (IMG\_1832.jpg), with focus on the gambrel roof dairy barn. The storehouse is in the foreground.

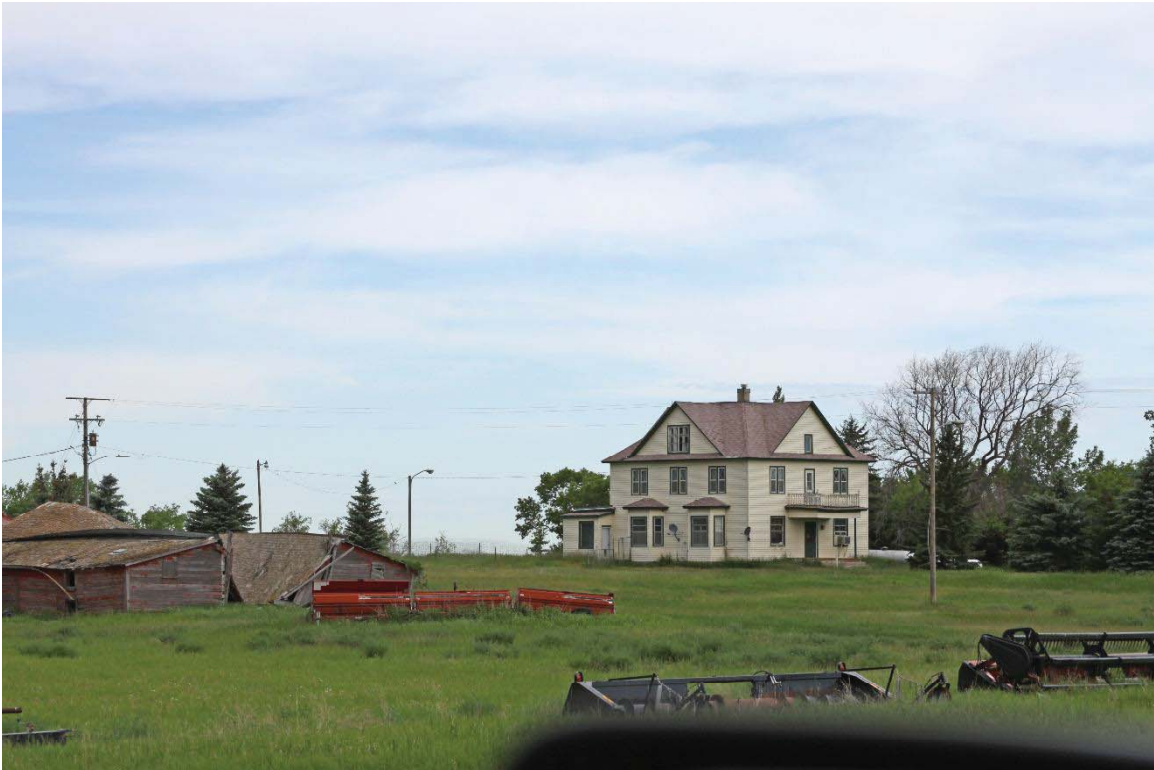
**Figure 4.** Site 32MH472 farmhouse, June 14, 2019, from 16th Ave N facing northwest (IMG\_1889.jpg).

Despite modern roofing and siding on the farmhouse and the state of the collapsed barns on the site, this property is thought to be potentially eligible for the NRHP, as it collectively presents the architectural evolution of an integral farm setting across a century of consistent farm use. Further research is needed to fully investigate this property and make a final determination of significance and eligibility to the NRHP under Criteria A and C. This research may also determine eligibility under Criterion B (association with the lives of significant persons in our past) at the regional or local level.

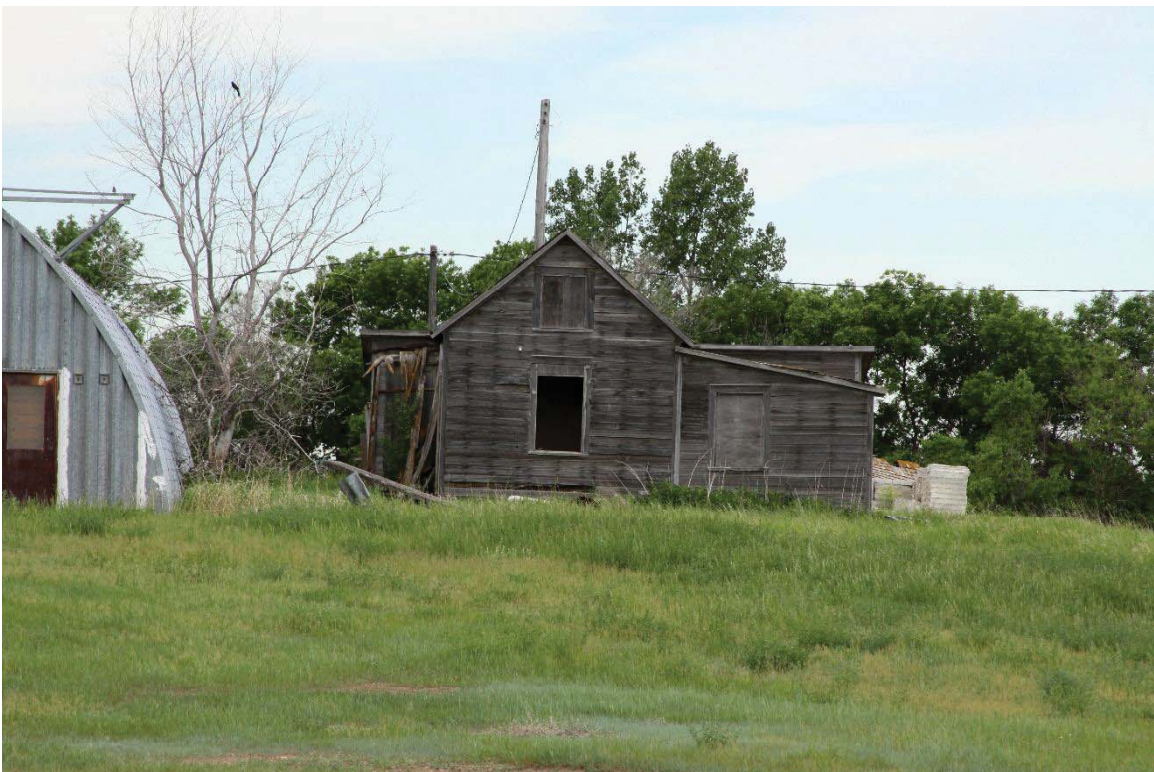
**Figure 5.** Site 32MH472, June 14, 2019, from 16th Ave N facing west with focus on the possible wooden claim shack (IMG\_1886.jpg).

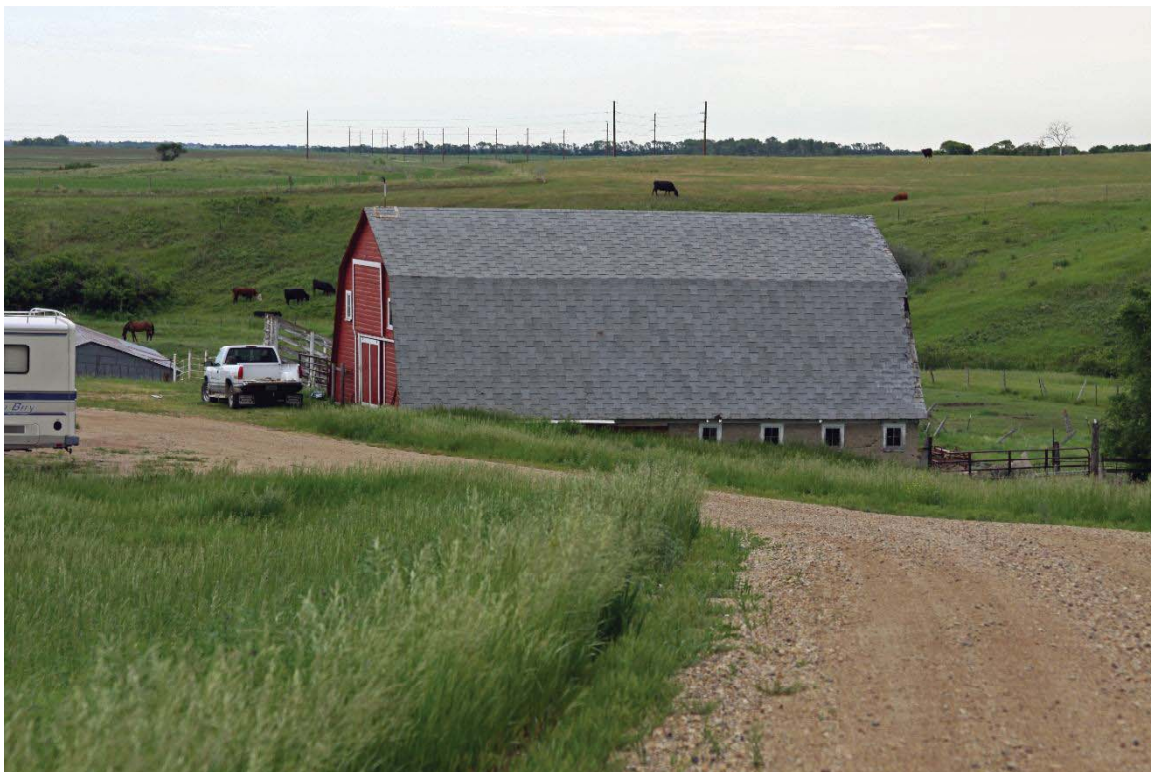
**Figure 6.** Site 32MH473 bank barn, June 14, 2019, facing east (IMG\_1901.jpg).

Despite alterations to the roof, this property is thought to be potentially eligible for the NRHP, as the barn retains important architectural elements and presents a good example of a historic bank barn. Further research is needed to fully investigate this property and make a final determination of significance and eligibility to the NRHP under Criterion C.

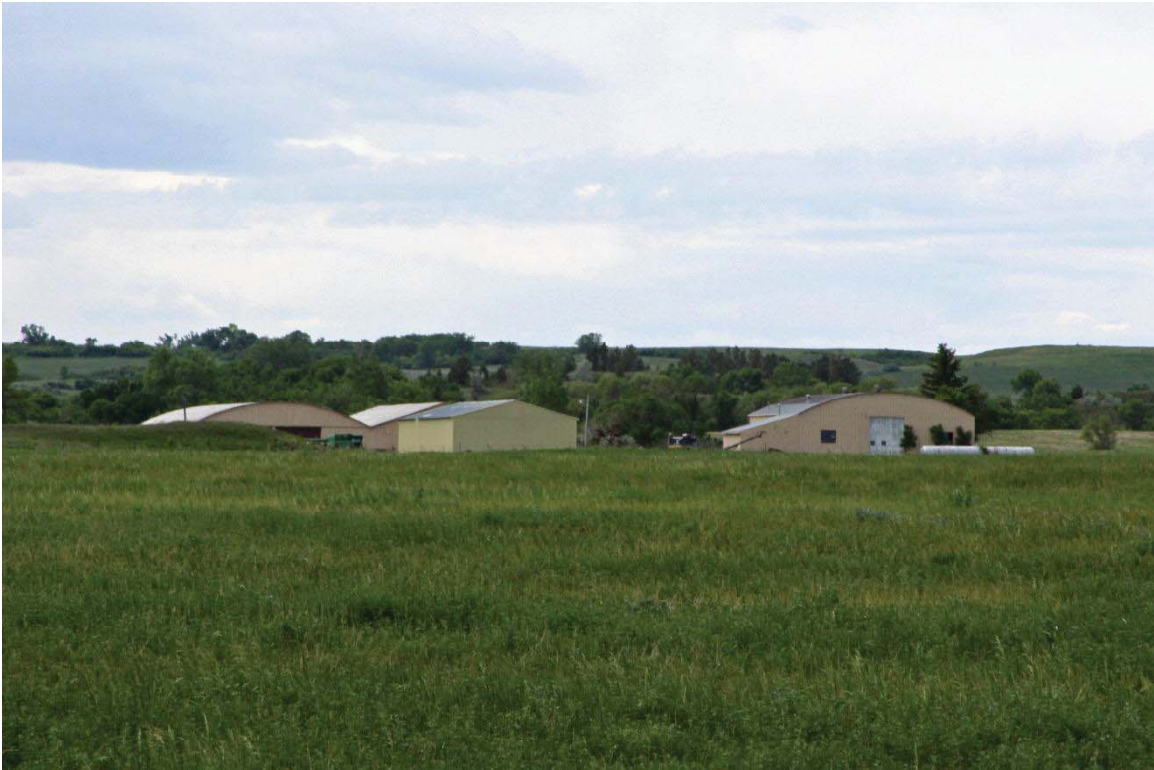
All historic buildings are metal framed with sheet metal sheathing and sheet metal roofs, and all retain original window openings, though many windows have been damaged or boarded. One vaulted-roof warehouse has a shed addition added after 1957-1962 (based on historic FSA aerial imagery) that is consistent in materials and design (Figure 8). The other is a twin vaulted-roof/gable-roof warehouse with halves that appear to have been constructed at roughly the same time; the gable-roof side presents evidence in its façade sheathing that its openings have been altered.

**Figure 7.** Site 32WD2462, June 14, 2019, looking south (crop of IMG\_1993.jpg).

Despite the shed addition to one warehouse, this site is thought to be potentially eligible for the NRHP, as the collective site presents a utilitarian landscape of supporting surface works to the historically significant Truax-Traer Company Velva Mine (1927-1962). Further research is needed to fully investigate this property and make a final determination of significance and eligibility to the NRHP under Criteria A and C.

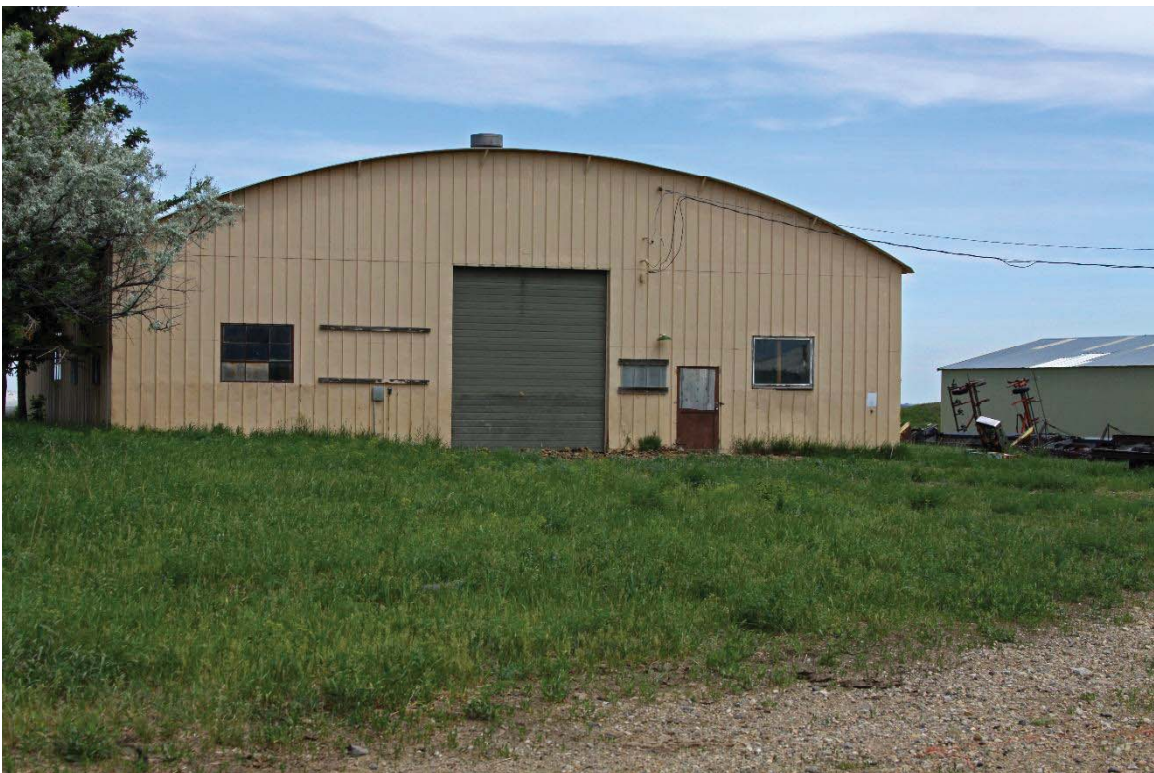
**Figure 8.** Site 32WD2462 warehouse, June 14, 2019, looking north (IMG\_1988.jpg).

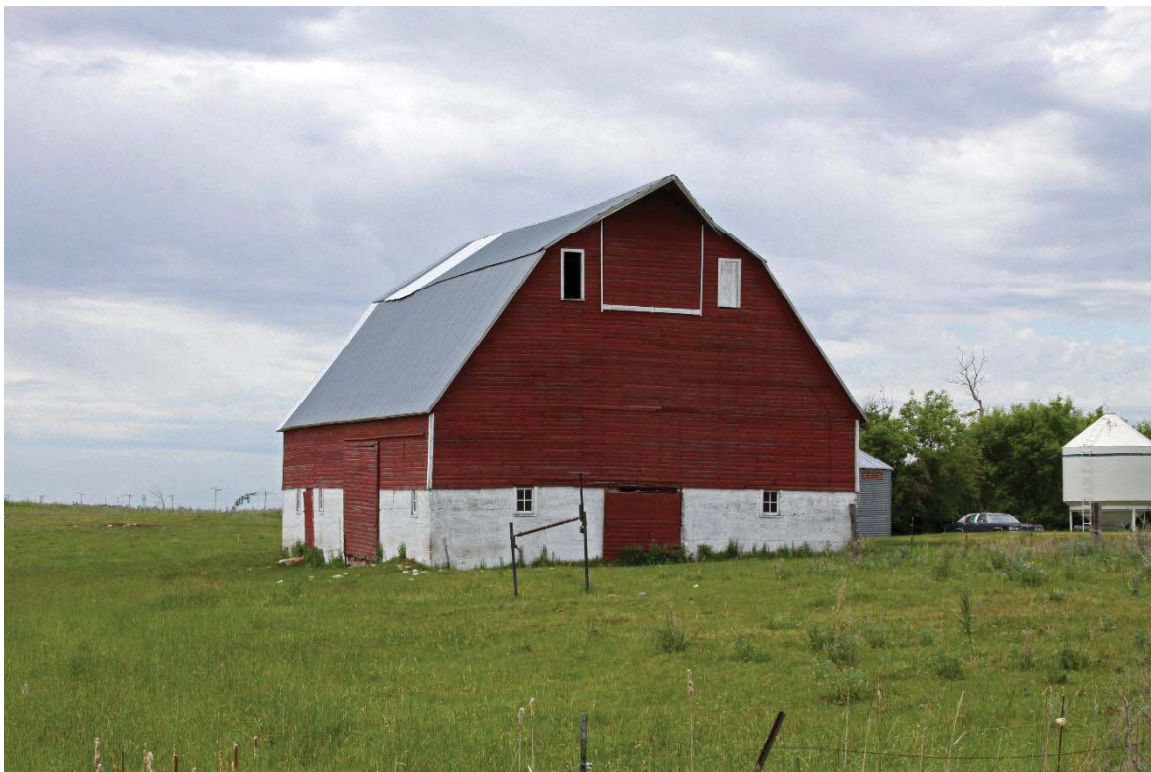
The site consists of one historic building, a raised-basement gambrel roof barn (ca. 1915-1930) with appropriate foundation, siding, and roof materials (whitewashed concrete, wood painted red, and metal). All visible windows appear to be original. It has exceptional integrity of materials, workmanship, and design (Figure 9). Modern outbuildings sit to the northeast of the barn, and a farmhouse of new construction is located north of those across the driveway. The yard also has modern grain bins.

Based on the pedestrian survey, 32WD2463 embodies the distinctive nature of a North Dakota raised-basement gambrel roof barn, presenting an excellent, unaltered example using period-appropriate materials. Therefore, due to its good integrity, 32WD2463 is recommended eligible under Criterion C.

**Figure 9.** Site 32WD2463 barn, June 14, 2019, looking west-northwest (IMG\_2045.jpg).

This property is thought to be potentially eligible for the NRHP, as it is an intact, unmodified example of a barn with important architectural elements (raised basement, gambrel roof). Further research is needed to fully investigate this property and make a final determination of significance and eligibility to the NRHP under Criterion C as a distinctive characteristic of a type, period, or method of construction.

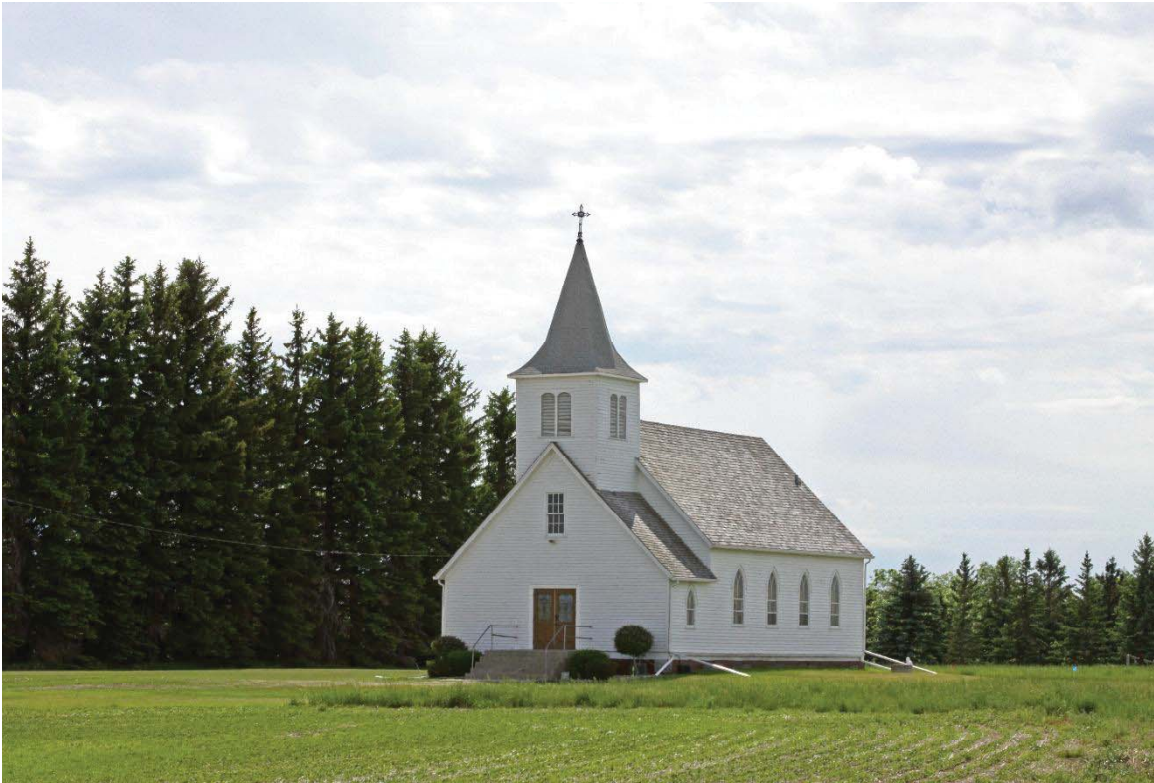
The site consists of one historic building: Hope Lutheran Church, a rural vernacular Gothic Revival church (ca. 1900-1915). It is associated with the Hope Lutheran Cemetery (32WDx770), which is located in the indirect APE, situated 0.8 miles to the southeast. The church has a gable roof, bell tower with a bellcast pyramid roof, stone or brick foundation, and wood siding painted white. Its strongest Gothic Revival inflection can be seen in the fenestration on its side (north and south) façades: a total of ten three-pointed arch windows with simple intersecting tracery, adapted with rectangular sashes for ventilation (Figures 10 & 11). Historically inappropriate alterations to the building include half-glass, two-panel entry doors, the addition of modern gutters, and asphalt shingles on the tower steeple. The church is situated in a grass field with an unpaved driveway and parking area, surrounded in all directions by farmland.

Based on the pedestrian survey, 32WD1590 embodies the distinctive nature of a rural vernacular Gothic Revival church with superficial alterations to its historic fabric. Therefore, due to its good integrity, 32WD1590 is recommended eligible under Criterion C. Research into the history of the church and its importance to the rural community of Sawyer may also reveal significance to local history that supports eligibility for Criterion A as well.

**Figure 10.** Site 32WD1590 church, June 14, 2019, looking southwest (IMG\_2169.jpg).

This property is thought to be potentially eligible for the NRHP, as it is a good example of a vernacular Gothic Revival church. Further research is needed to fully investigate this property and make a final determination of significance and eligibility to the NRHP under Criterion A for significance to historical events and Criterion C as a distinctive characteristic of a type, period, or method of construction.

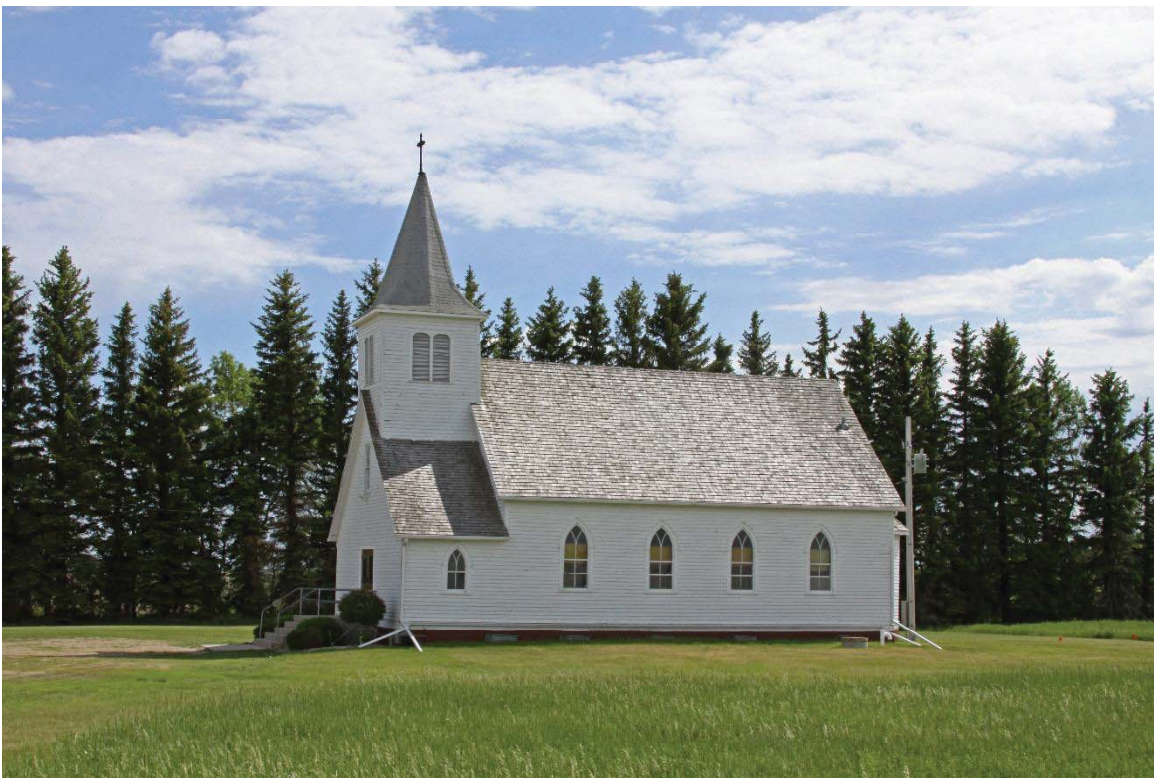
**Figure 11.** Site 32WD1590 church, June 14, 2019, looking south (IMG\_2171.jpg).

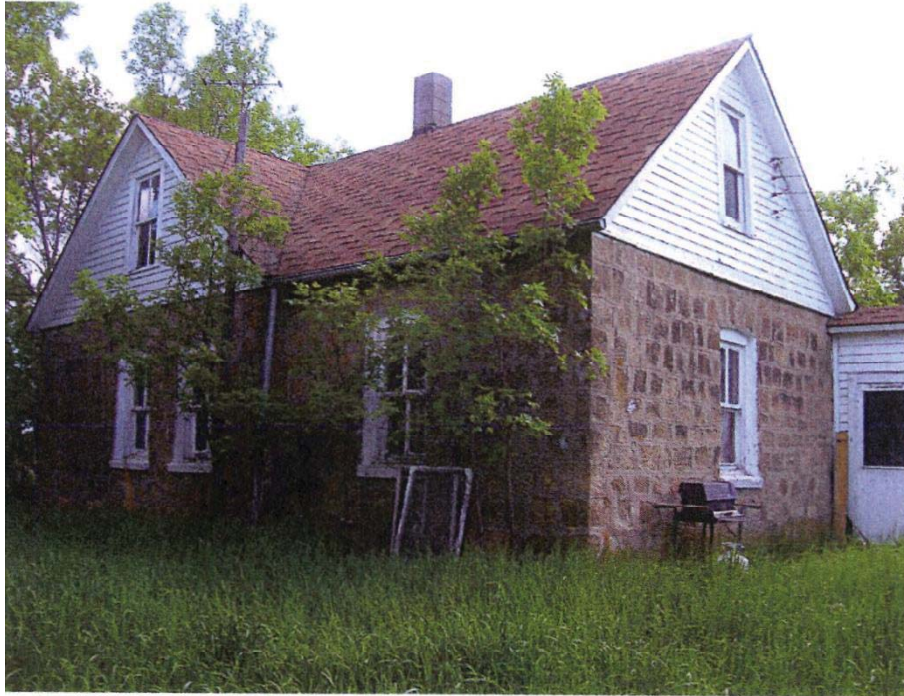
Based on the pedestrian survey, these three features represent the distinctive characteristics of early architecture on North Dakota farmyards at the turn of the 20th century. The barn and grain bin, while not eligible individually, support the significant and distinguishable feeling and association of a historic farmyard as a component part of the whole. For these reasons, 32WDx747 is recommended eligible for the NRHP under Criterion C.

**Figure 12.** Site lead 32WDx747 farmhouse, photographed in 2011, looking southwest (non-BCA image; Engel 2011).

This property is thought to be potentially eligible for the NRHP, as an excellent example of a historic farmyard with a farmhouse and outbuildings including a barn and wooden grain bin. Further research is needed to fully investigate this property and make a final determination of significance and eligibility to the NRHP under Criterion C as a distinctive characteristic of a type, period, or method of construction.

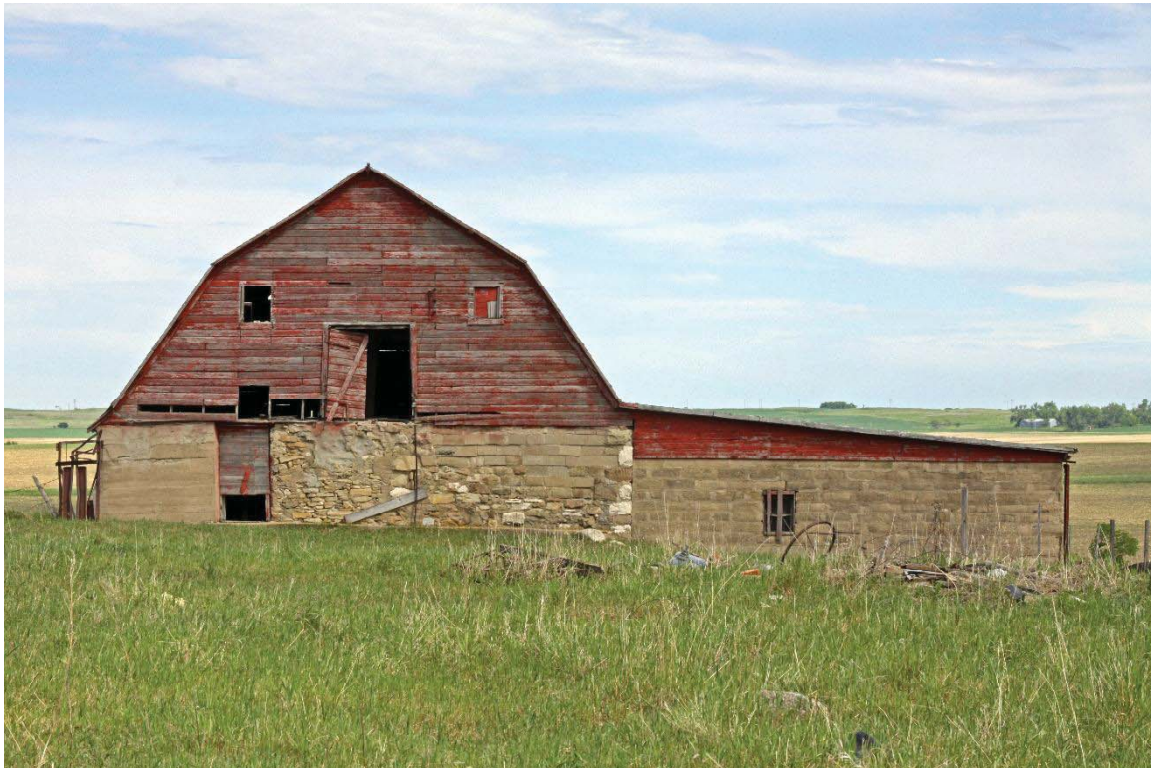
The barn is a raised basement gambrel roof barn with a large shed addition (Figure 13). Its raised basement is made of a mixture of stacked stone, mortared cut stone, concrete block, and poured concrete with evidence of significant in-fill and repair. The siding, made of wood and painted red, is in poor condition with several slats missing. During the pedestrian survey, roof material and condition were not visible. Access doors are missing and/or boarded, and the condition of the building makes at least one window opening indistinguishable from missing siding.

**Figure 13.** Site lead 32WDx747 gambrel barn, June 14, 2019, looking southeast (IMG\_2178.jpg).

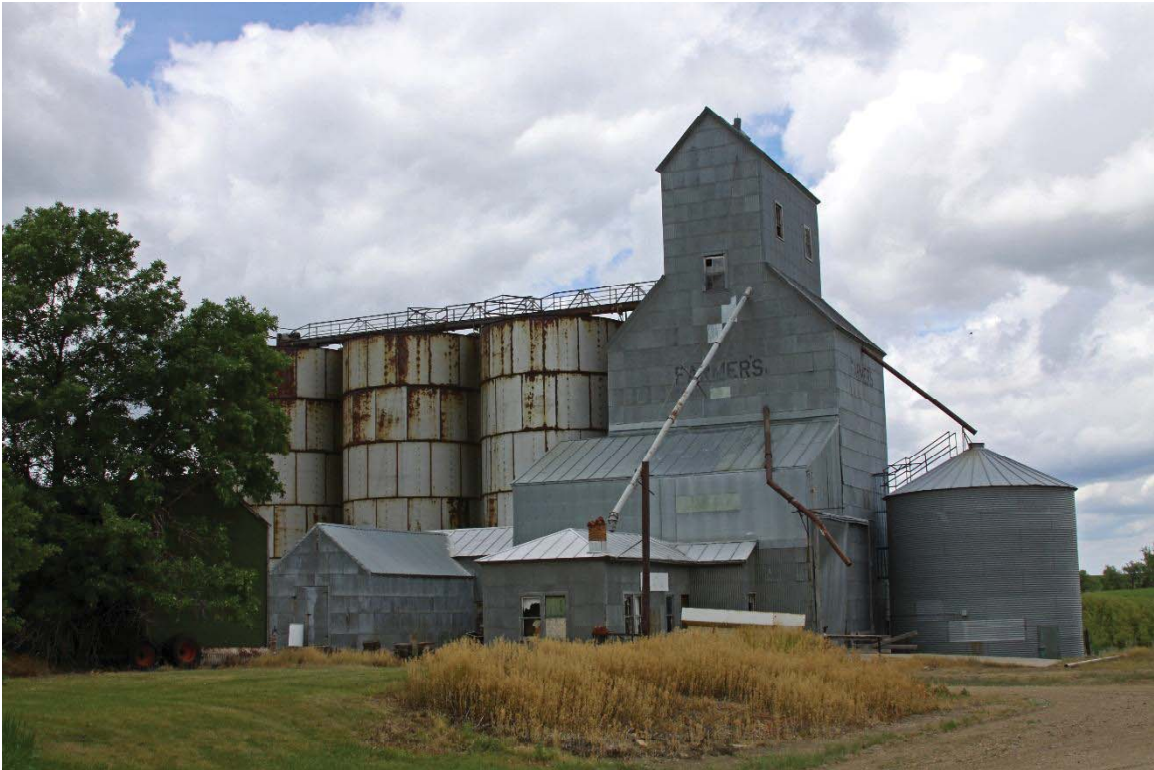
Figure 14. Site 32ML1362 grain elevator, June 18, 2019, looking north (IMG\_2416.jpg).

This property is thought to be potentially eligible for the NRHP, as it possesses research potential for connections to North Dakota farming and railroad history and also presents an intact example of a historic grain elevator complex. Further research is needed to fully investigate this property and make a final determination of significance and eligibility to the NRHP under Criteria A and C.

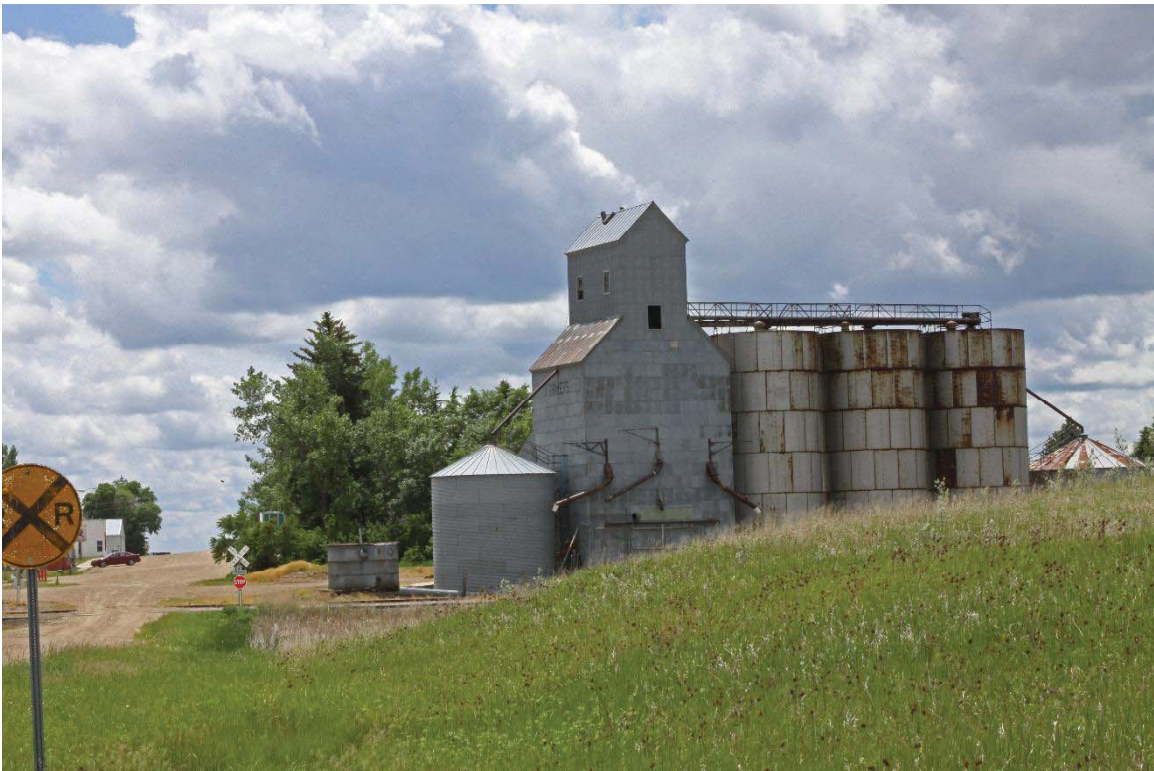
Figure 15. Site 32ML1362 grain elevator, June 18, 2019, looking south (IMG\_2390.jpg).

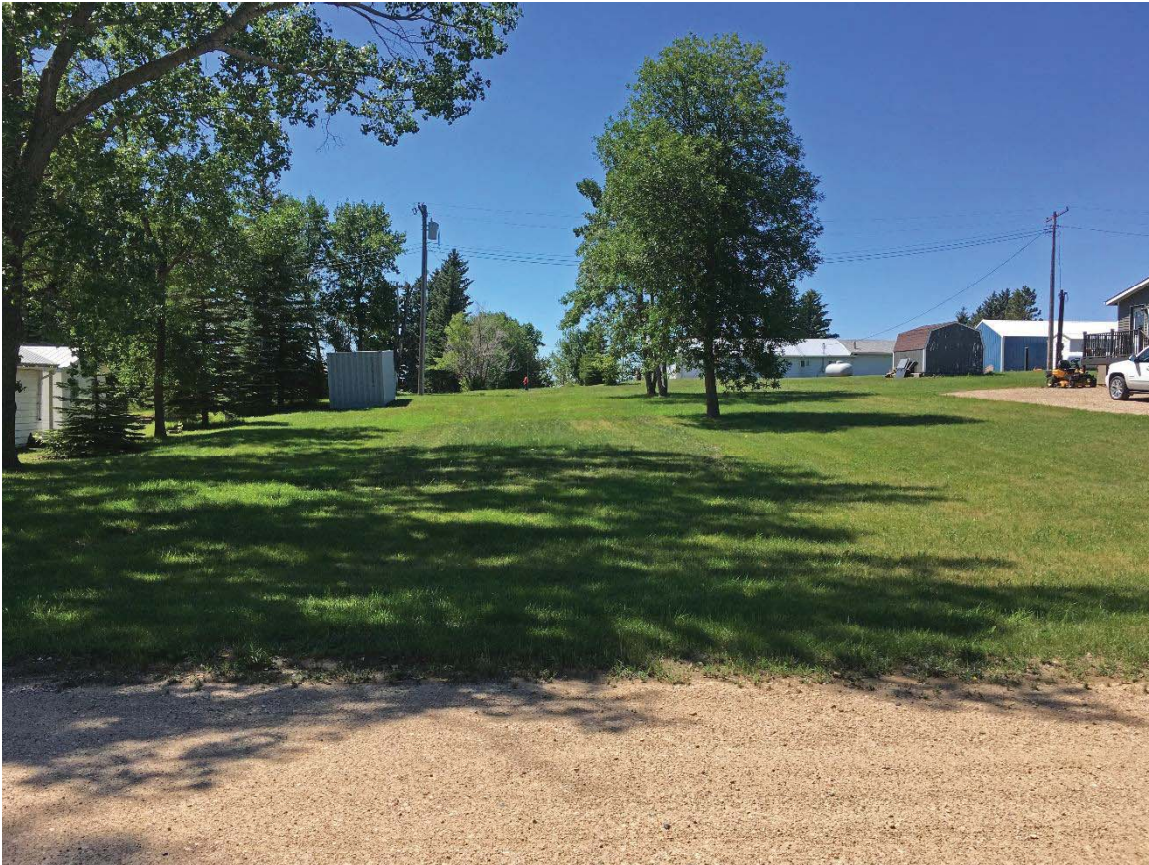
The site was surveyed due to existing 1998-9 records suggesting the presence of a historic building, the Church of the Nazarene, at 307 Main St in Benedict, ND. Records stated that the church had closed ca. 1970 and had been unused since then. Further research indicates that the building had a construction date of 1927 and that the congregation bought a new church in 1960, at which point the old one was abandoned (Sundbakken 1976). During the pedestrian survey, the lot was found to be empty, with the former footprint grown over with grass (Figure 16).

**Figure 16.** Empty site of 32ML949, June 18, 2019, looking west (IMG\_5002.jpg).

The information available at this time suggests that the property is ineligible for the NRHP.

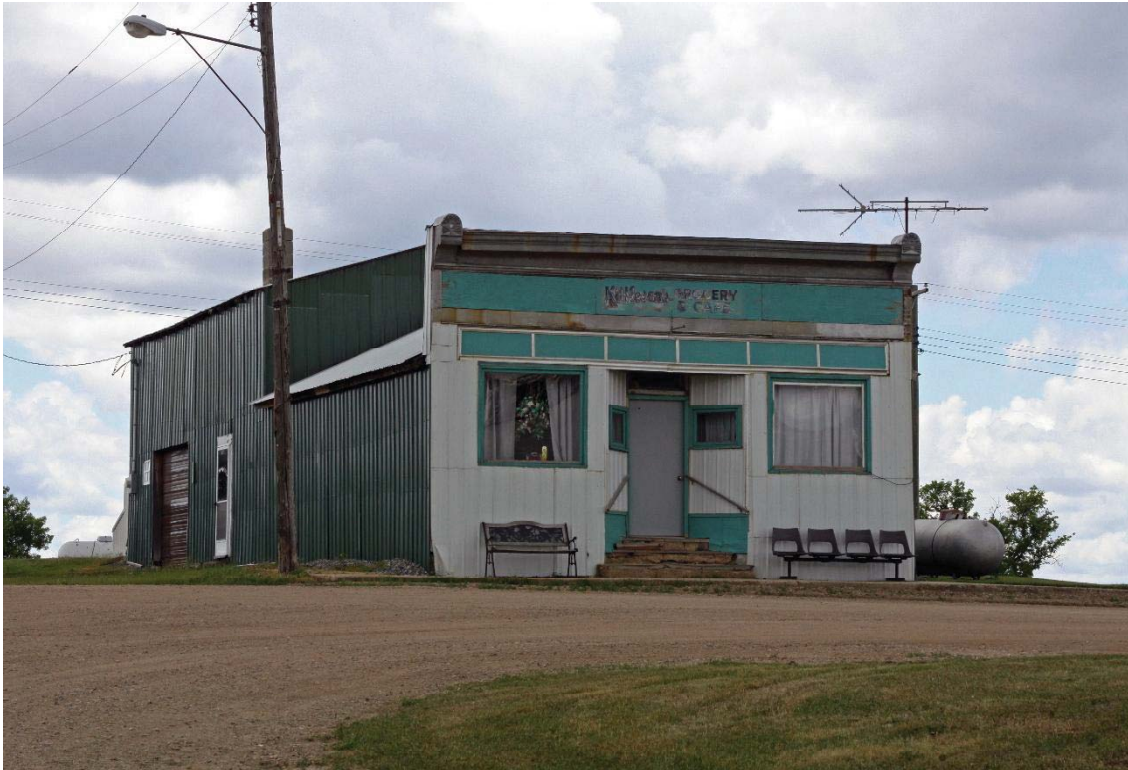
Based on the pedestrian survey, 32ML1363 embodies the distinctive nature of a Boomtown/False Front commercial building. Alterations to the windows have not significantly changed the look and feel of its character, and it presents an excellent example of its type using period-appropriate materials. Therefore, due to its good integrity, 32ML1363 is recommended eligible under Criterion C for its distinctive characteristic of a type, period, or method of construction.

**Figure 17.** Site 32ML1363 Boomtown/False Front commercial building, June 18, 2019, looking west-northwest (IMG\_2508.jpg).

Despite the replacement of original windows with new windows or plywood, this commercial building is thought to be potentially eligible for the NRHP, as it retains important architectural elements from its original style and period. Further research is needed to fully investigate this property and make a final determination of significance and eligibility to the NRHP under Criterion C.

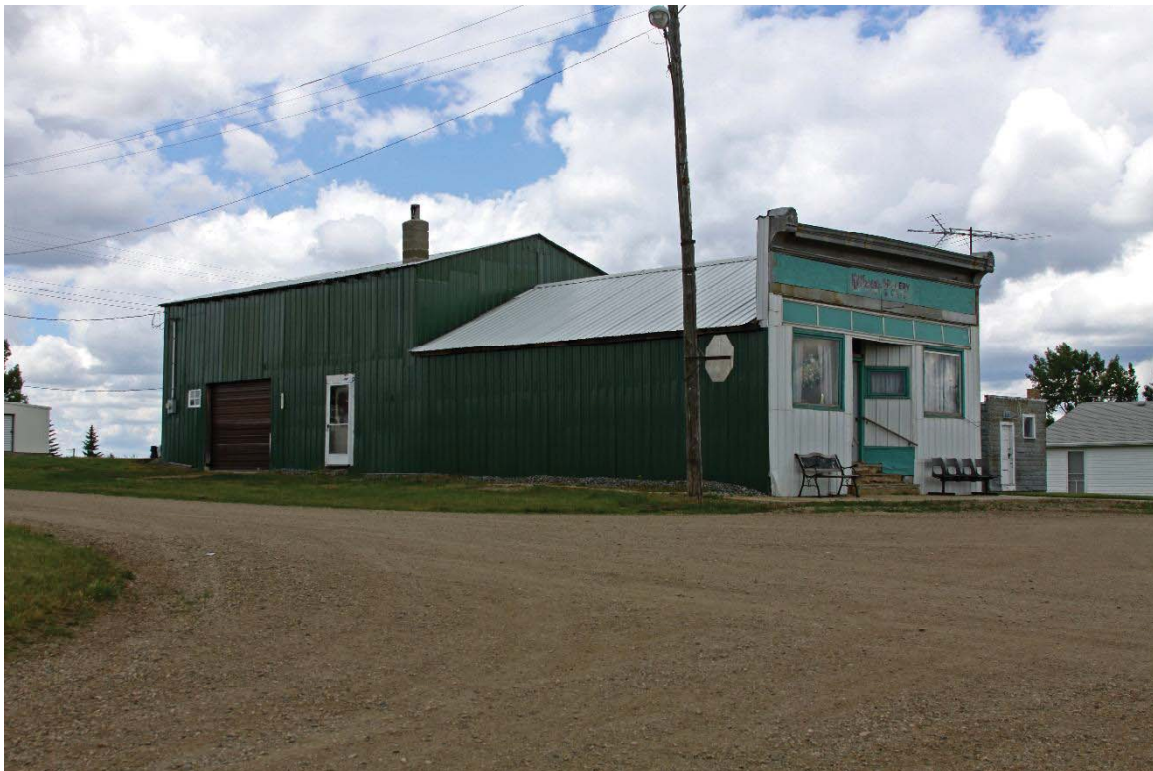
The building has a concrete foundation and is entirely clad in metal sheathing, with the false front painted white with turquoise details and the rest of the building painted forest green (Figure 18). The roof is made of standing seam metal. It consists of two main parts: a commercial front and a rear addition. The façade has a decorative cornice made of pressed metal, a recessed entry with door, and display windows (Figure 17). A historic transom has been boarded through with painted plywood, and windows in other intact historic window openings have also been replaced. There is a chimney made of stacked bricks mortared around a metal pipe on its southeastern corner. To the rear is an empty concrete foundation that currently serves as outdoor storage but may have been the site of another addition or separate building in the past. Other buildings on the block, and the buildings on the all surrounding blocks, are commercial in nature. It is the only commercial building with historic potential in this area. The terrain is open and flat.

**Figure 18.** Site 32ML1363 Boomtown/False Front commercial building, June 18, 2019, looking northwest (IMG\_2458.jpg).

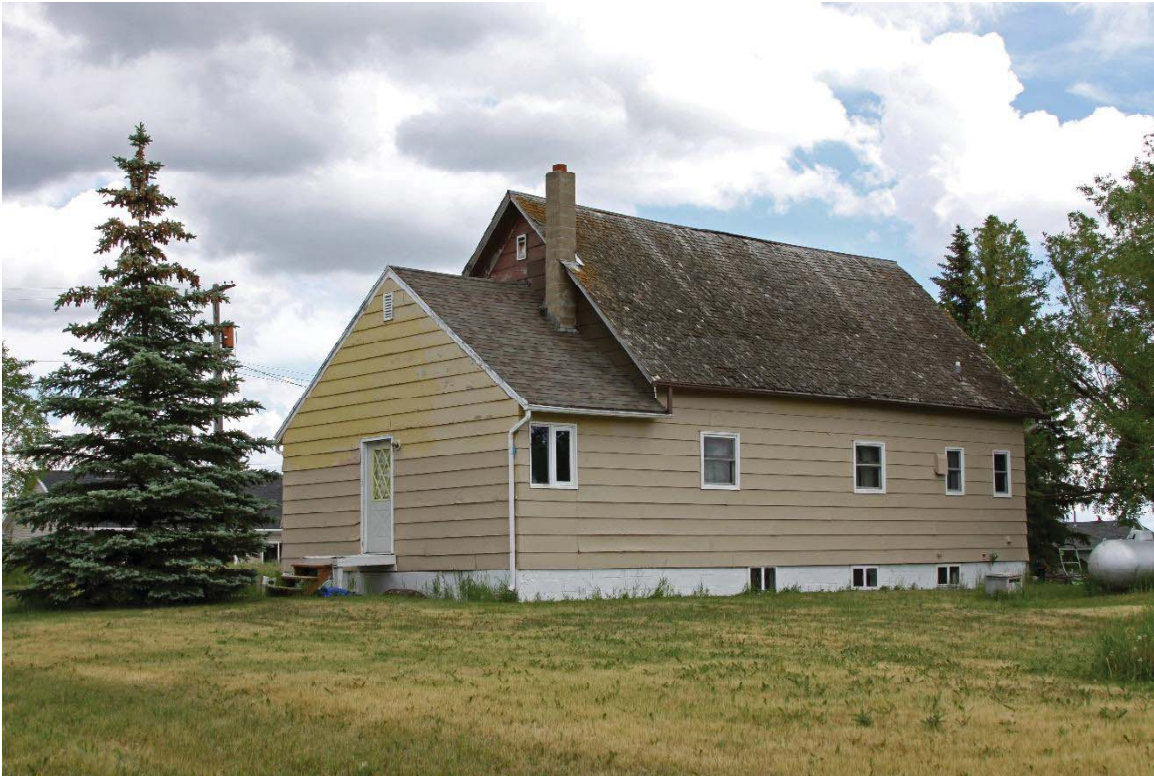
The property consists of a Gable Front, wood-frame residence, recorded in 1998-9 as Benedict's "Old Methodist Church," since converted into a single-family dwelling (Figures 19 & 20). FSA aerial imagery from 1957-1962 shows that the building has been at this site, unaltered in plan, for at least 57 years. Constructed with two rooflines, it has a 1-story gable at the north (front) of the house and a 1.5-story gable at the back (south). The north gable has asphalt shingles, while the south gable has wooden shingles. The building's foundation is concrete block or cut stone. Framed with wood, it is sided with heavily weathered composition board. A photograph from 1998-9 show that the fenestration has been altered in at least two places, changing the original entry door to a window and a window on the northern (front) façade into the new entry. Most, if not all, original windows appear to have been replaced.

Although this building remains in its original setting, its integrity is poor: window openings have changed, original windows have been replaced, a new entry has been established, and most importantly, it bears no architectural clues to suggest its original function as a Methodist church. The conversion to a private residence has fundamentally interfered with its integrity of design, feeling, and association, and as a residence, it shows no historic merit as an architectural representative of a particular type or style. For these reasons, at this time, 32ML947 is recommended ineligible for the NRHP under any criteria, and further research would be needed to establish future eligibility.

Figure 19. Site 32ML947 ineligible residence, June 18, 2019, looking southeast (IMG\_2533.jpg).

The information available at this time suggests that the property is ineligible for the NRHP.

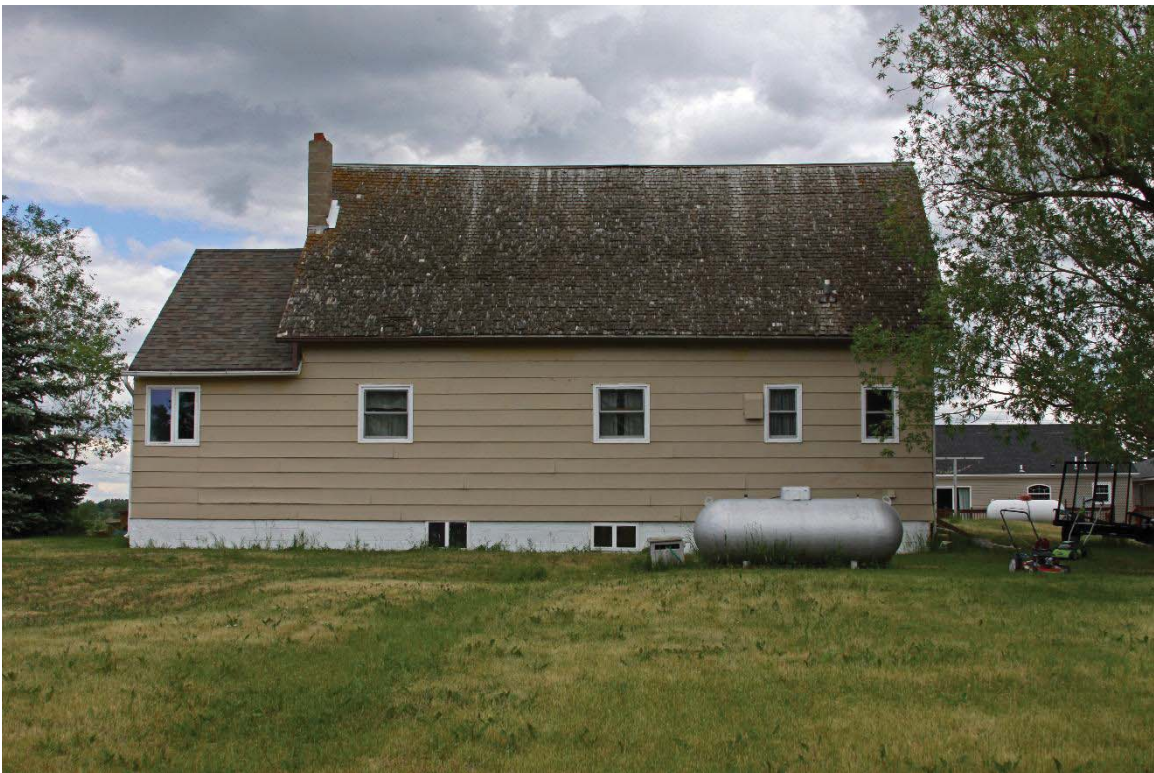
Figure 20. Site 32ML947 ineligible residence, June 18, 2019, looking east (IMG\_2525.jpg).

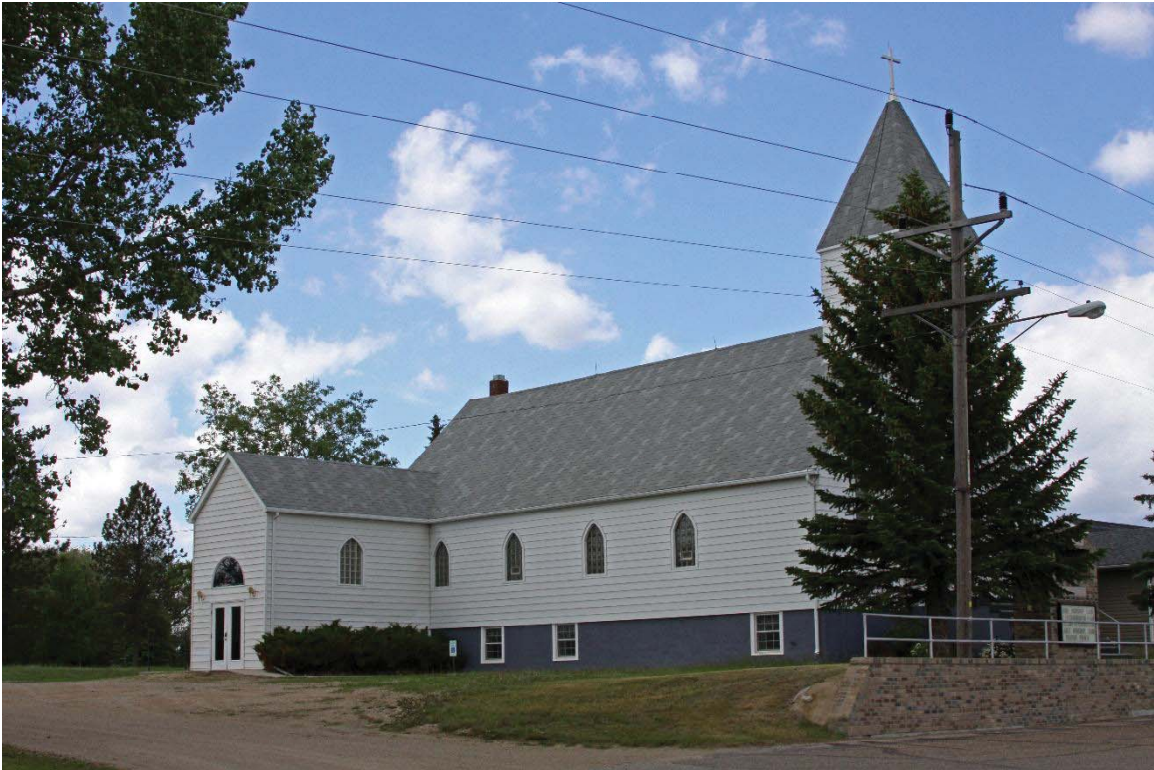
The site is a vernacular Gothic Revival church. Research suggests its construction dates to 1954 (Sundbakken 1976). It is located at the northwest corner of Highway St and 4th Ave in Benedict, ND (Figure 21). The gable roof church has a bell tower with a pyramidal roof and a non-historic gable roof addition on its southwest side. The church foundation is in excellent condition, appearing to be concrete or stone with plaster/stucco applied and painted slate blue. Siding is white vinyl, and the roof is asphalt shingle, neither of which are historically appropriate. Modern gutters have been attached to the building. Its fenestration mainly consists of Gothic Revival arched windows filled in with glass blocks and a semicircular transom light on the non-historic addition. Three basement-level windows are visible in the foundation on the south façade with a fourth on the west (rear) façade (Figure 22). All appear to be 6/6 single-hung windows appropriate in appearance and style.

Based on the pedestrian survey, in spite of its historic setting and location, the integrity of the church has been significantly impacted by the use of modern materials and design. The gable roof rear side addition is of incompatible design and likely dates to the 1970s or 1980s. The glass block windows noted throughout the church, used in the Gothic Revival pointed arch windows as a substitute for stained glass, may date to its construction in the 1950s, but the popularity of this material in the latter half of the 20th century suggests it could date to the same era of the church addition. Modern siding and roofing also impact the integrity of workmanship. While the church embodies the distinctive nature of a vernacular Gothic Revival church likely dating from Benedict's founding, its material integrity is poor, and further investigation is needed to determine the nature of its updates. Therefore, site 32ML946 is recommended ineligible under Criterion C.

**Figure 21.** Site 32ML946 ineligible church, June 18, 2019, looking northwest (IMG\_2584.jpg).

The information available at this time suggests that the property is ineligible for the NRHP.
