**A Class II Architectural Inventory and Viewshed  
Analysis of the Ruso Wind Project in Ward, McHenry,  
and McLean Counties, North Dakota**

BCA Project No.: 2019-1302  
August 2019

**MANUSCRIPT DATA RECORD FORM**

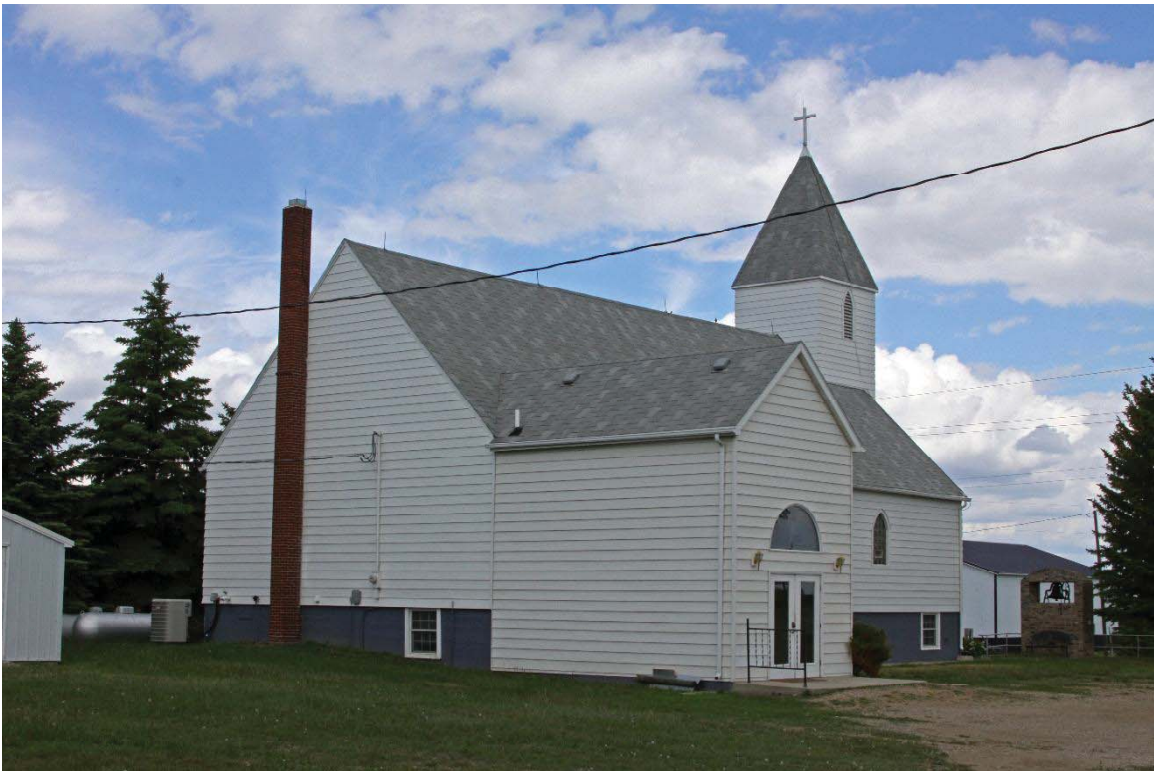
Based on the pedestrian survey, in spite of its historic setting and location, the integrity of the church has been significantly impacted by the use of modern materials and design. The gable roof rear side addition is of incompatible design and likely dates to the 1970s or 1980s. The glass block windows noted throughout the church, used in the Gothic Revival pointed arch windows as a substitute for stained glass, may date to its construction in the 1950s, but the popularity of this material in the latter half of the 20th century suggests it could date to the same era of the church addition. Modern siding and roofing also impact the integrity of workmanship. While the church embodies the distinctive nature of a vernacular Gothic Revival church likely dating from Benedict's founding, its material integrity is poor, and further investigation is needed to determine the nature of its updates. Therefore, site 32ML946 is recommended ineligible under Criterion C.

**Figure 22.** Site 32ML946 ineligible church, June 18, 2019, from rear, looking northeast (IMG\_2585.jpg).

The information available at this time suggests that the property is ineligible for the NRHP.

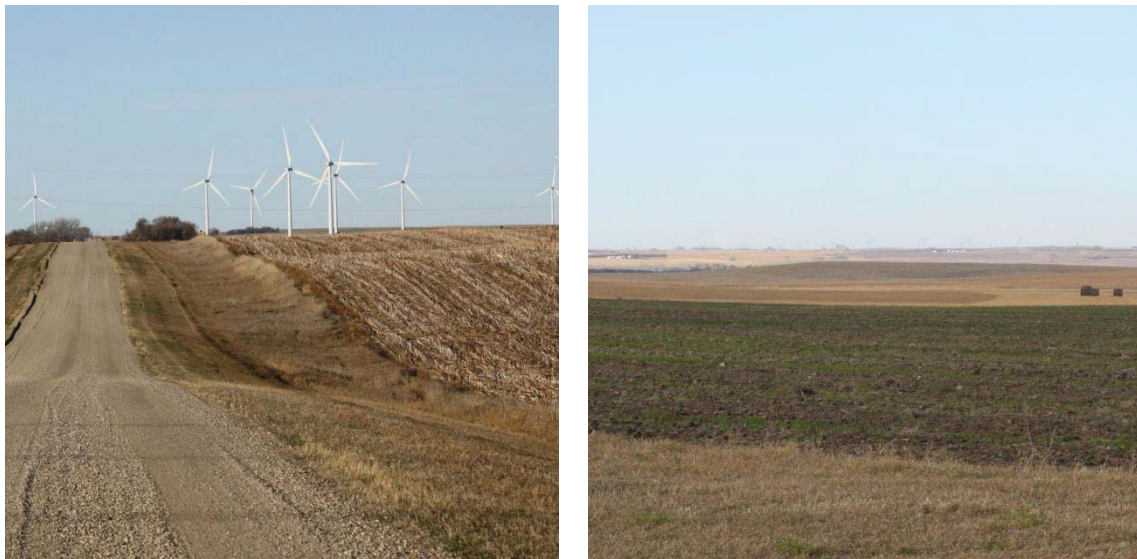
In fact, the farther an observer gets from an object, the smaller it appears, and the less an observer can see of the object. Utilizing photographs taken from an existing wind farm located in South Dakota at set distances, the figures below (Figure 23a & b) illustrate the impact distance has on the apparent size of a wind farm at a close distance (2.04 miles; Figure 23a) and at a distance farther away (16.35 miles; Figure 23b). Figure 28 indicates the results using this model for the visual impact of the Ruso Wind Project. Figure 29 illustrates the results of using this model for the visual impact of the existing wind farms.

**Figure 23a & b.** A wind farm silhouetted against the skyline at (a) a close distance at 2.04 miles and at (b) a distance farther away at 16.35 miles, which illustrates the effect distance has on the size of a wind facility. This is a wind farm located in South Dakota.
