PU-19-368
ONEOK Bakken Pipeline, L.L.C.
Tioga Lateral NGL Pipeline
As-Built Inspection Report

May 2021

Stantec Consulting Services Inc.
3303 Fiechtner Drive, Ste 100
Fargo, ND 58103

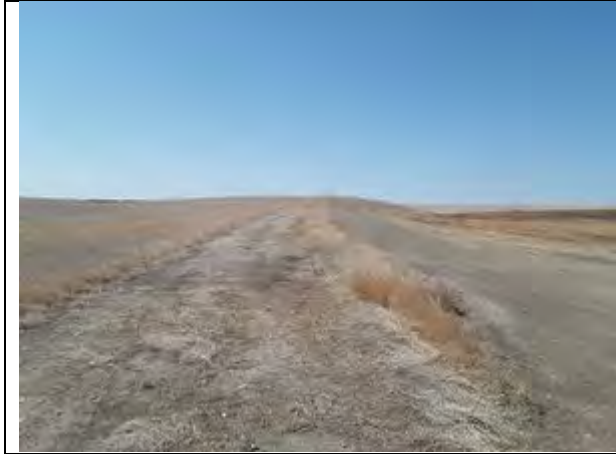
Observation Point: 7

Photo Description: Confirmation of landowner access route and appropriate reclamation to former conditions.

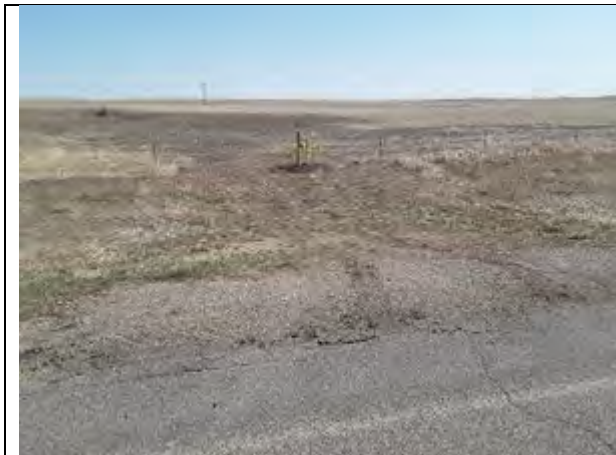
Observation Point: 8

Photo Description: Construction access located in road ROW appears to be not reclaimed to original conditions, as evident by gravel present along the road ditch.

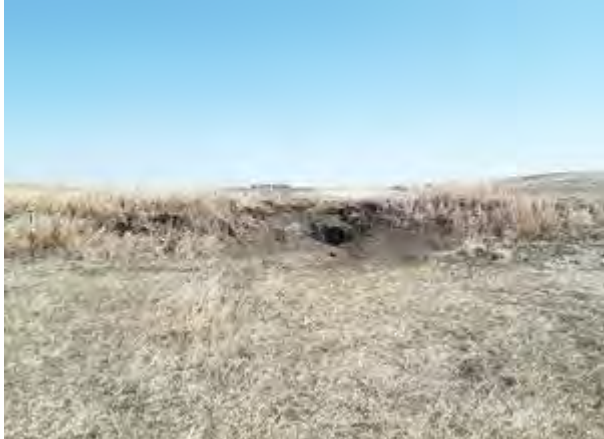
<p>Observation Point: 11 Date Taken: April 21, 2021 2:14 PM Direction Photo is Taken: East Spread: 2</p> <p>Photo Description: Apparent new culvert construction within road ROW improperly reclaimed and does not have BMPs. It is unclear if this was an action performed by Oneok contractors.</p> <p>Latitude: 48.298751667 Longitude: -103.777273334</p>
--	--

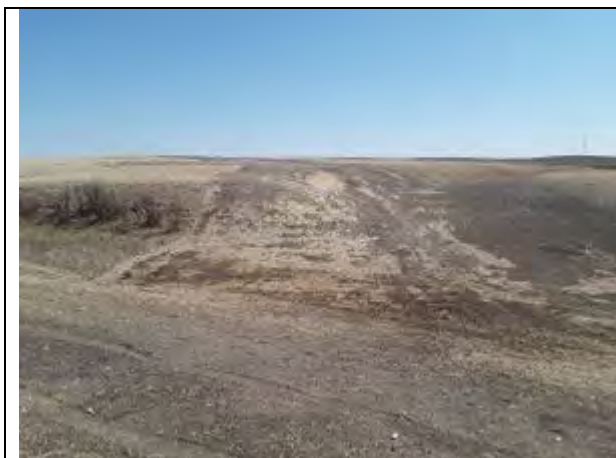
Observation Point: 15

Photo Description: Crimped straw in drainageway is inappropriate for erosion control. Fiber roll appears inappropriately sized and improperly installed (not trenched in). Overall lack of appropriate BMPs.

- Appropriate installation and selection of BMPs.
- Protection of drainageways from erosion and sedimentation.
- Erosion, sediment, energy dissipation controls near area of geologic instability.
- Conditions concerning reclamation at Observation Points 11-13.

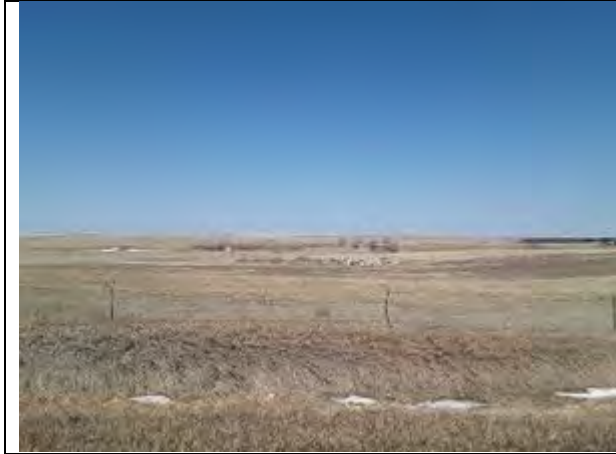
Observation Point: 16

Photo Description: Stockpile of rocks with significant portion of topsoil located in a minor drainageway within ROW.

- Refuse cast aside near potential Unanticipated Discovery violation.
- Rockpiles with significant soil fractions placed in drainageways.
- Potential compaction in staging areas or access points.
- Removed temporary approaches or access points within the roadway ROW where additional minor reclamation is required.
- Repair/Replacement of non-functioning BMPs.
- Placement of BMPs in areas prone to erosion as indicated in the SWPPP.

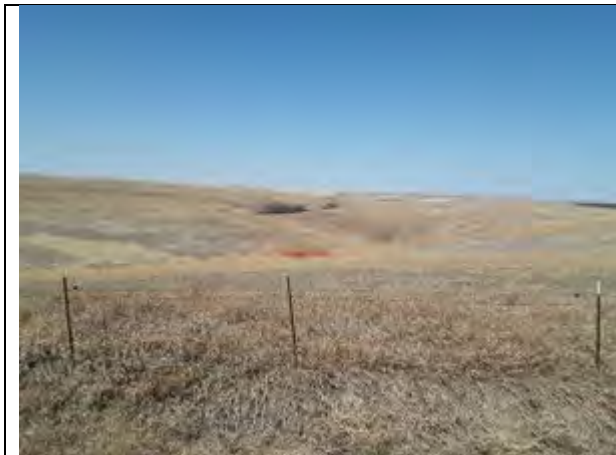
Observation Point: 17

Photo Description: Improper BMP choice. Silt fence placement perpendicular to flow within drainage is not considered to be construction industry standard practice.

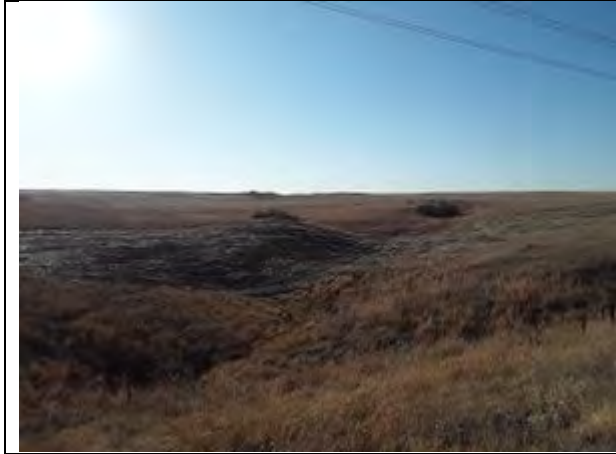
Observation Point: 19
Date Taken: April 22, 2021 8:47 AM
Direction Photo is Taken: West
Spread: 2

Photo Description: Lack of appropriate BMPs in drainageway. BMP maintenance required.

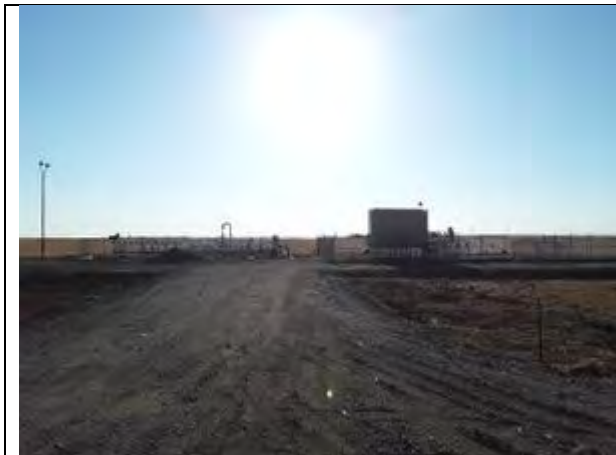
Observation Point: 20
Date Taken: April 22, 2021 8:52 AM
Direction Photo is Taken: East
Spread: 2

Photo Description: Aboveground infrastructure. Security fence, lighting, and well maintained.

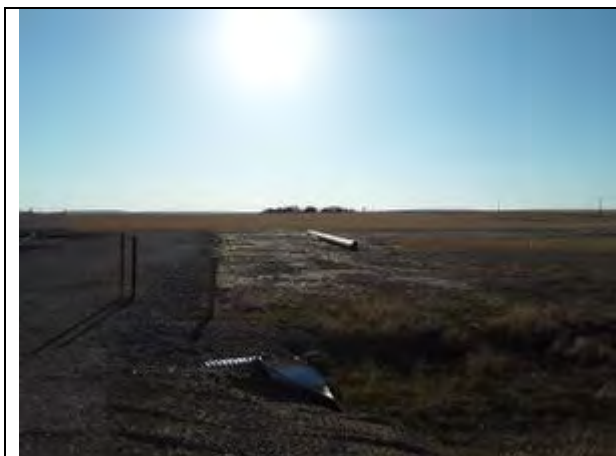
Observation Point: 21
Date Taken: April 22, 2021 8:55 AM
Direction Photo is Taken: East
Spread: 2

Photo Description: Left over pipe lengths from construction phase should be removed from the ROW.

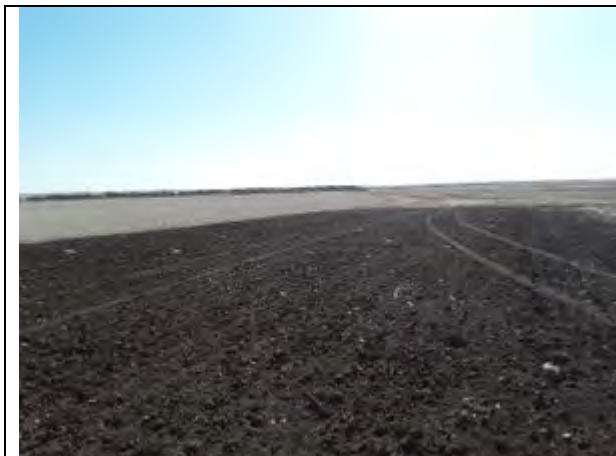
Observation Point: 24

Photo Description: Greater presence of rocks on ROW than off ROW. Topsoil replacement looks satisfactory.

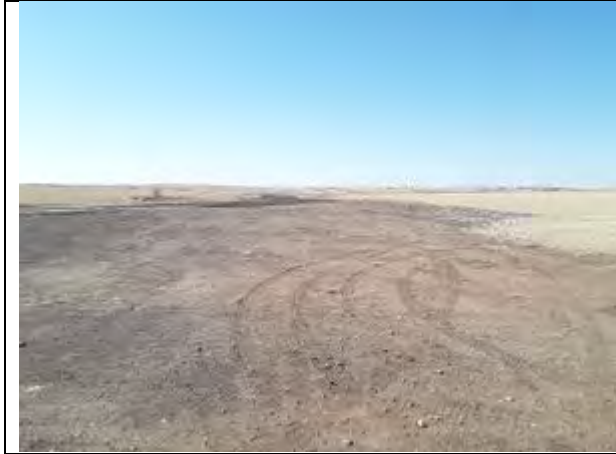
Observation Point: 28
Date Taken: April 22, 2021 10:34 AM
Direction Photo is Taken: South
Spread: 1

Photo Description: Evidence of minor topsoil mixing. Area does not appear plowed for decompaction like the rest of the ROW.

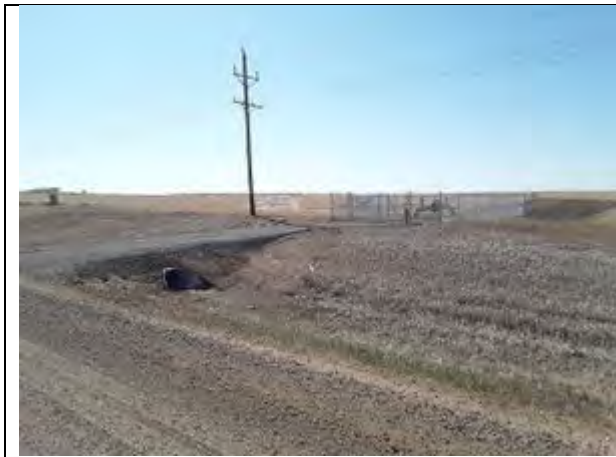
Observation Point: 29
Date Taken: April 22, 2021 10:51 AM
Direction Photo is Taken: Southeast
Spread: 1

Photo Description: Lack of inlet and outlet BMPs on newly installed access within ROW of road.

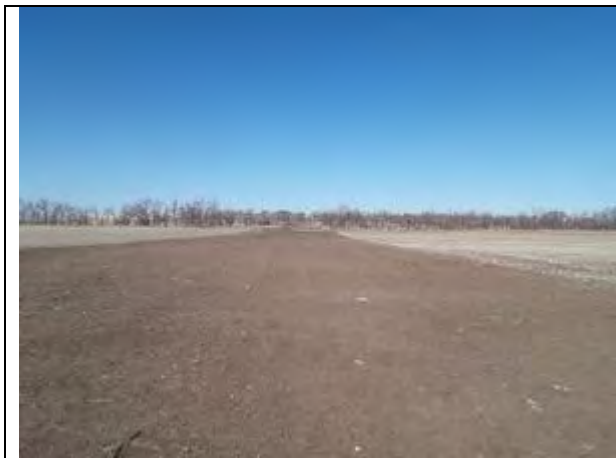
Observation Point: 30
Date Taken: April 22, 2021 11:01 AM
Direction Photo is Taken: West
Spread: 1

Photo Description: Evidence of proper tree width clearing.

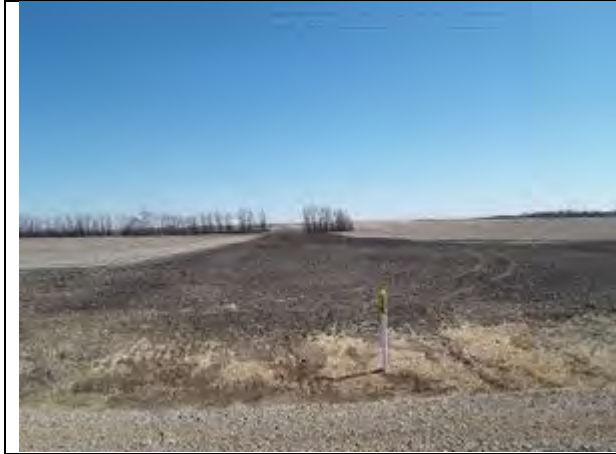
Observation Point: 32
Date Taken: April 22, 2021 1:13 PM
Direction Photo is Taken: East
Spread: 1

Photo Description: Overview of well graded, plowed, and proper tree clearing.

ONEOK submitted Docket 86: Tree and Shrub Clearing Expansion Request; requesting a 75 foot clearing for 2 locations. PSC submitted Docket 89: Commission Motion to approve tree and shrub clearing expansion request; in response to Docket 86. ONEOK refined or necked down the construction ROW through woody areas so that tree and shrub loss was mitigated during construction. During inspections, Stantec observed this to be accurate in multiple areas. In general, major woody areas or planted shelterbelts were cleared in 50-foot construction ROWs (**Photo Observation Points 30, 32**).

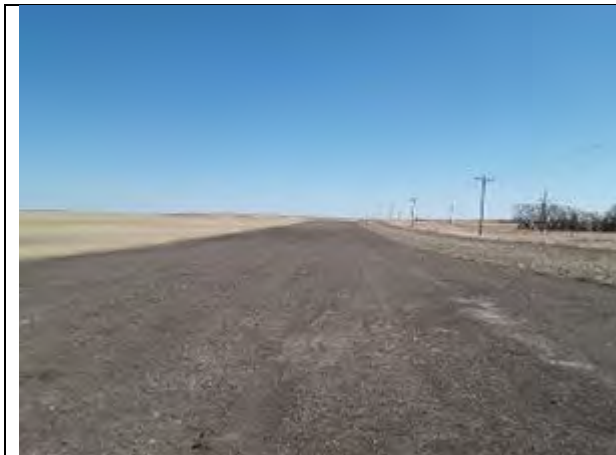
Observation Point: 33
Date Taken: April 22, 2021 1:31 PM
Direction Photo is Taken: East
Spread: 1

Photo Description: Evidence of minor topsoil mixing.

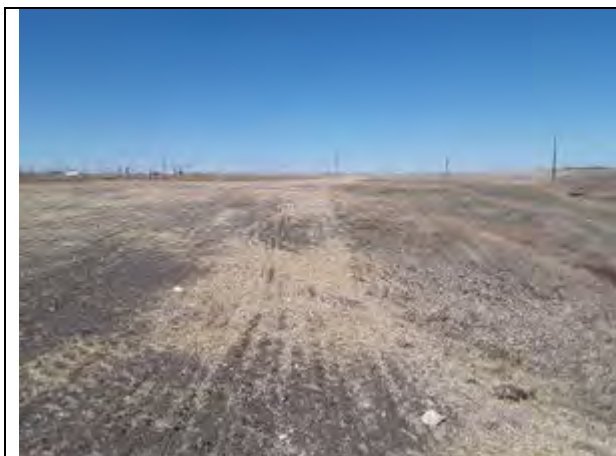
Observation Point: 34
Date Taken: April 22, 2021 1:45 PM
Direction Photo is Taken: North
Spread: 1

Photo Description: Near areas of geologic instability. Greater abundance of BMPs required to ensure runoff does not destabilize slopes.

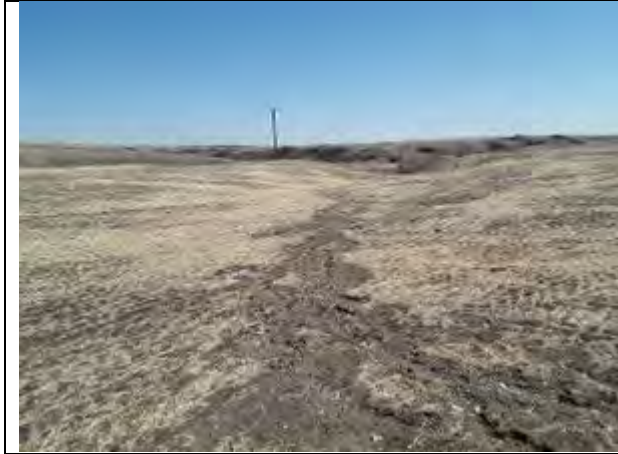
Observation Point: 35
Date Taken: April 22, 2021 1:47 PM
Direction Photo is Taken: Southeast
Spread: 1

Photo Description: Near areas of geologic instability. Evidence of rill erosion and sedimentation. Inappropriate BMP choice. Stabilize with proper BMPs.

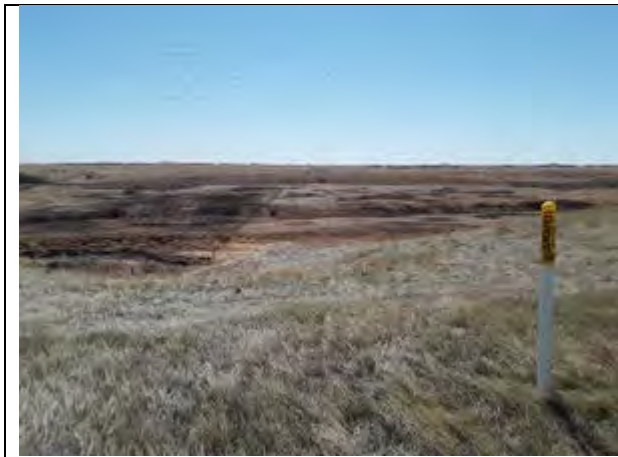
Observation Point: 36
Date Taken: April 22, 2021 1:54 PM
Direction Photo is Taken: South
Spread: 1

Photo Description: Evidence of HDD avoidance of geologic instability areas.

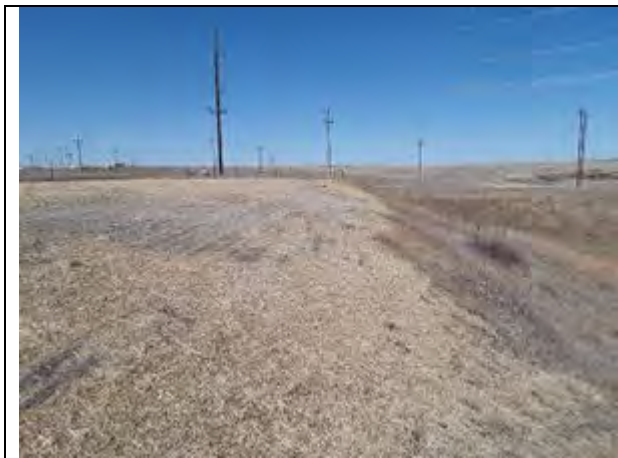
Observation Point: 37
Date Taken: April 22, 2021 1:59 PM
Direction Photo is Taken: North
Spread: 1

Photo Description: Crimped straw BMP may not hold up. Consider other BMPs to ensure geologic stability.
