BOND RELEASE INSPECTION REPORT

DATE OF INSPECTION: May 12, 2020

PERMITTEE - MINE: BNI Coal Ltd. - Center Mine

PERMITS INSPECTED: BNCR-9401

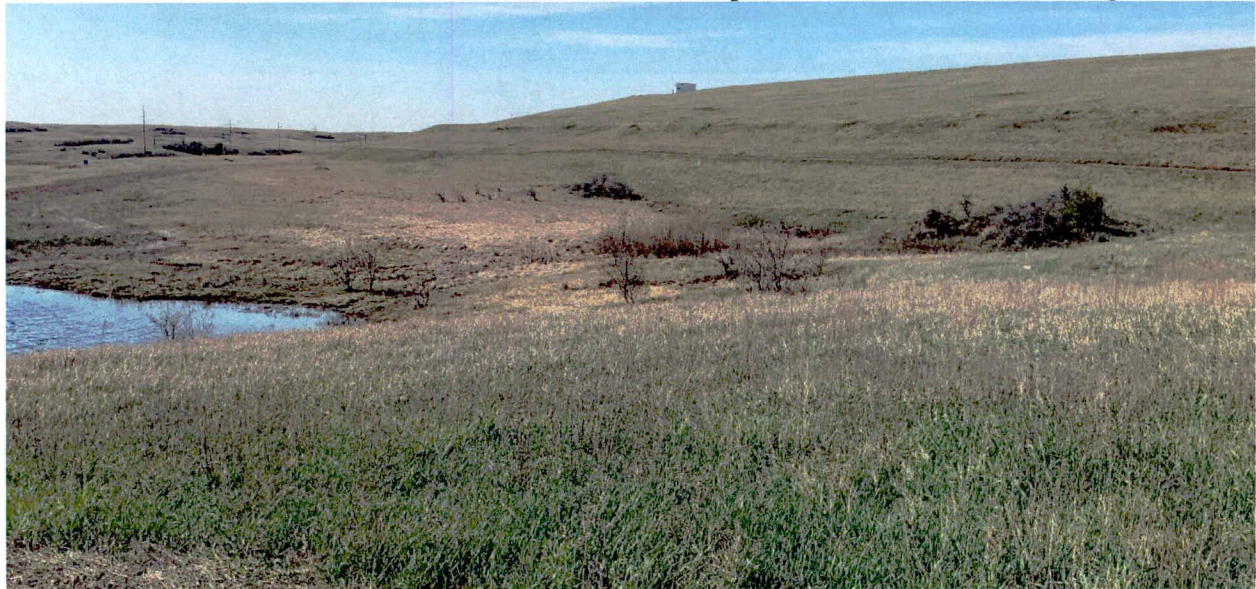
Figure 1. The north end of the west portion of the bond release tract facing south. Pond 5-1 is visible on the left and the embankments of ash disposal cells are visible on the right.

Vegetation on the west portion of the bond release tract is adequate to control erosion and minimize any contributions of suspended solids outside the bond release tract as required by NDAC 69-05.2-22-07(4)(j) and NDAC 69-05.2-12-12(7). BNI provided vegetation survey data with the bond release application that indicated the west portion of the bond release tract had 95.3% total cover. The visual assessment of vegetative cover during the field inspection was consistent with the data included in the bond release application. See **Figures 1 and 2**.

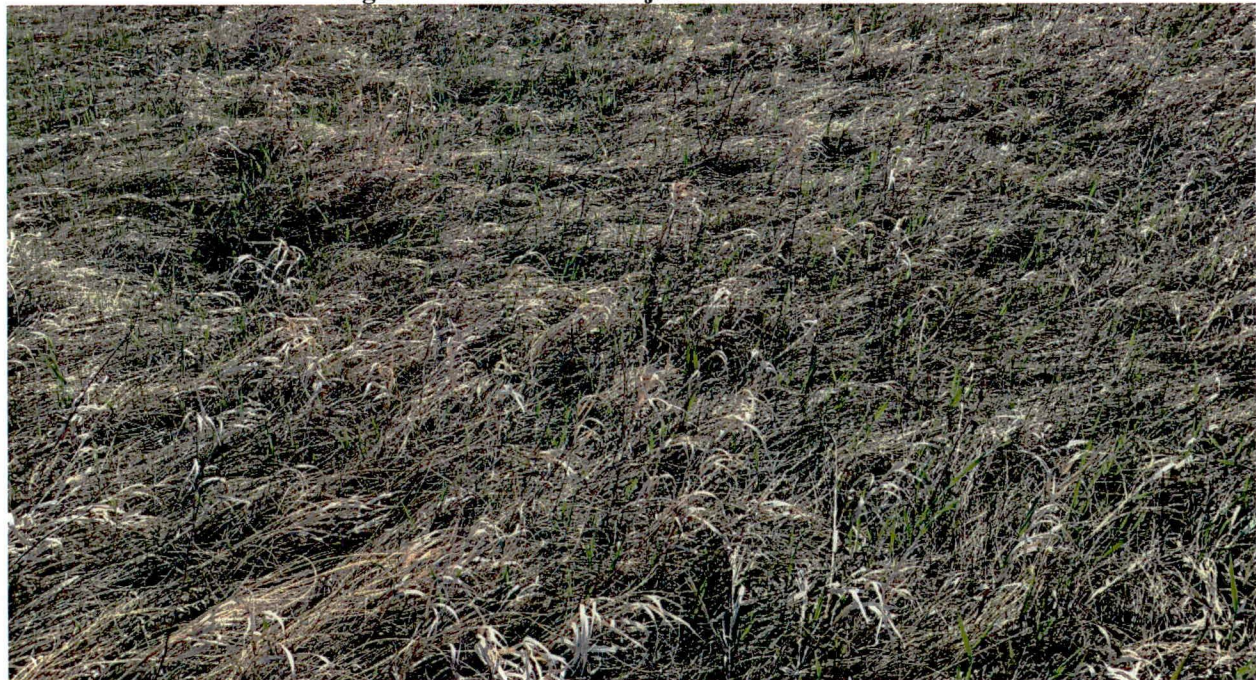
Figure 2. Ground cover just south of Pond 5-1.

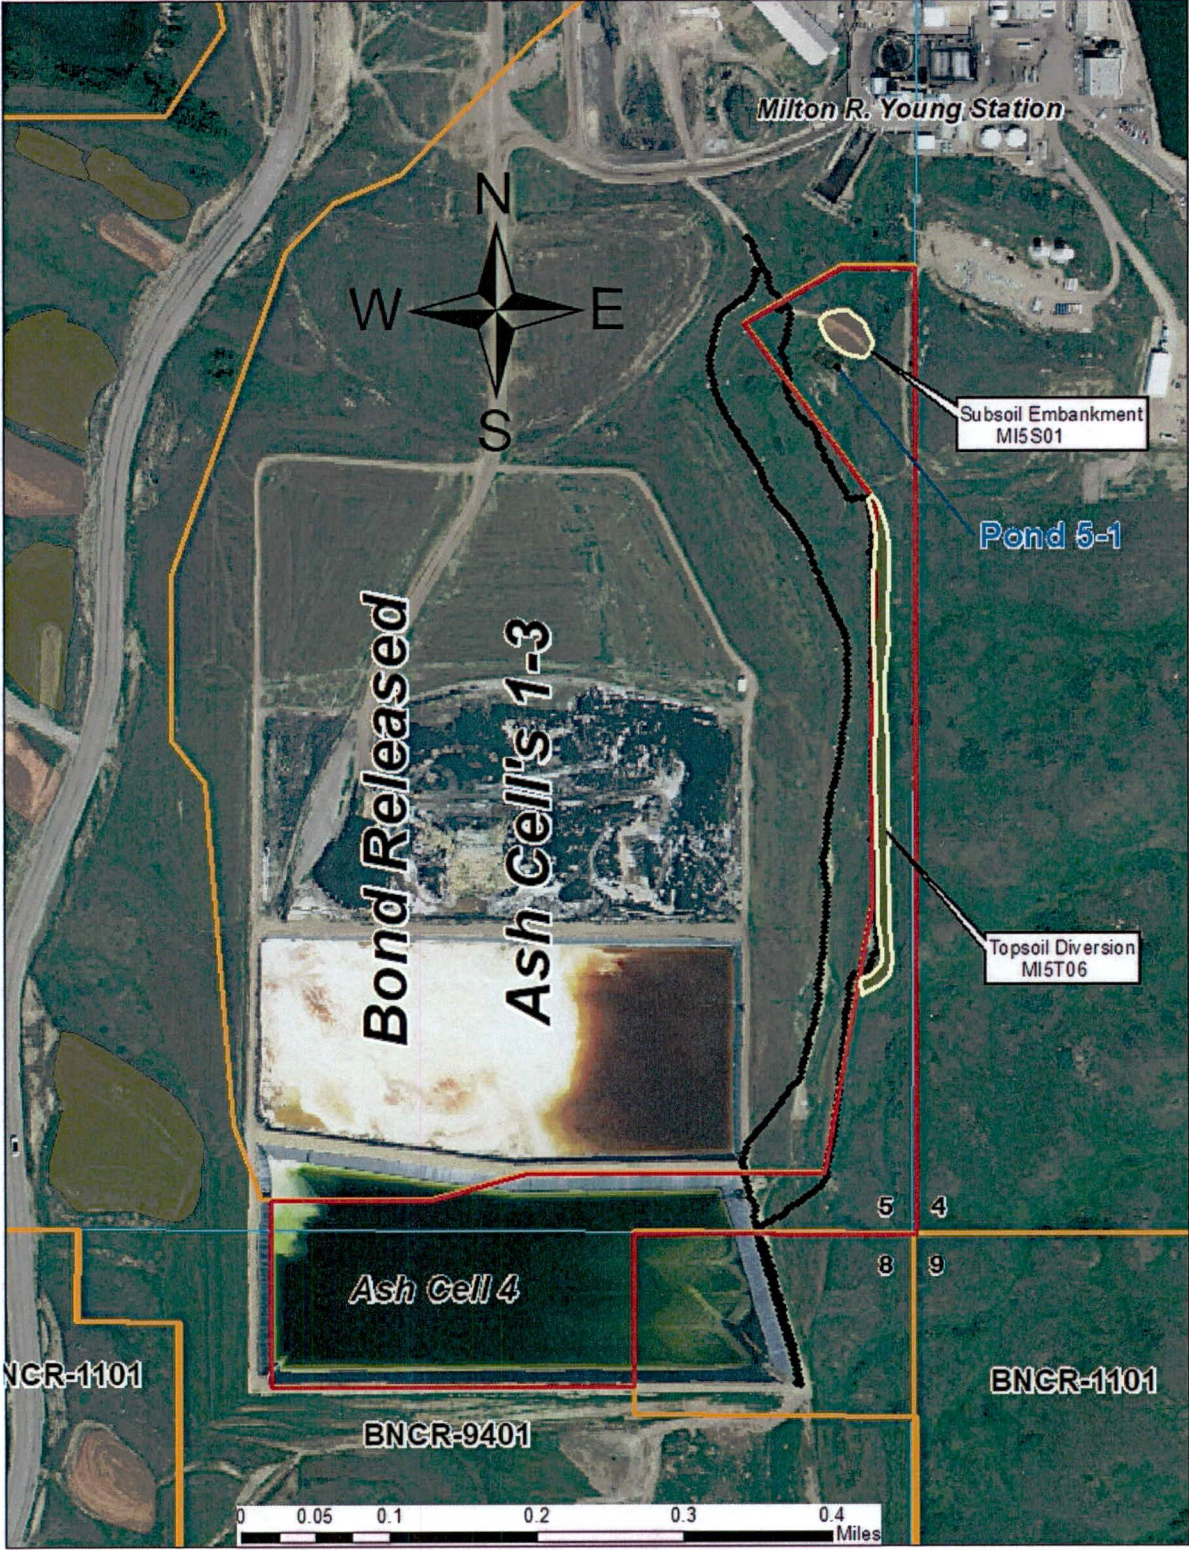
Figure 3: Final Bond Release 5 (outlined in red), Center Mine permit areas (orange) and the May 12, 2020 tracklog of the bond release inspection (black)

The application for Bond Release No. 5 to Permit BNCR-9401 consists of 43.6 acres located in Sections 5 and 8, T141N, R83W, in Oliver County. The bond release tract includes two distinct areas, the south portion and the west portion. The south portion of the bond release tract contains approximately two-thirds of ash disposal cell number 4 of Minnkota's disposal facility for Flue Gas Desulfurization (FGD) sludge and other power plant wastes. The southeast corner of ash disposal cell number 4 is located outside the permit boundary. The facility is subject to Solid Waste Permit SP-159 issued by the North Dakota Department of Environmental Quality. **See Figure 3.** The designated post mine land use for the entire tract is industrial/commercial.

A GPS point tracklog of the inspection route is depicted on **Figure 3**. The tracklog and additional photographs taken during the inspection are on file with the Reclamation Division.
