AMENDED- BOND RELEASE INSPECTION REPORT

DATE OF INSPECTION: May 12, 2020

PERMITTEE - MINE: BNI Coal Ltd. - Center Mine

PERMITS INSPECTED: BNCR-9401

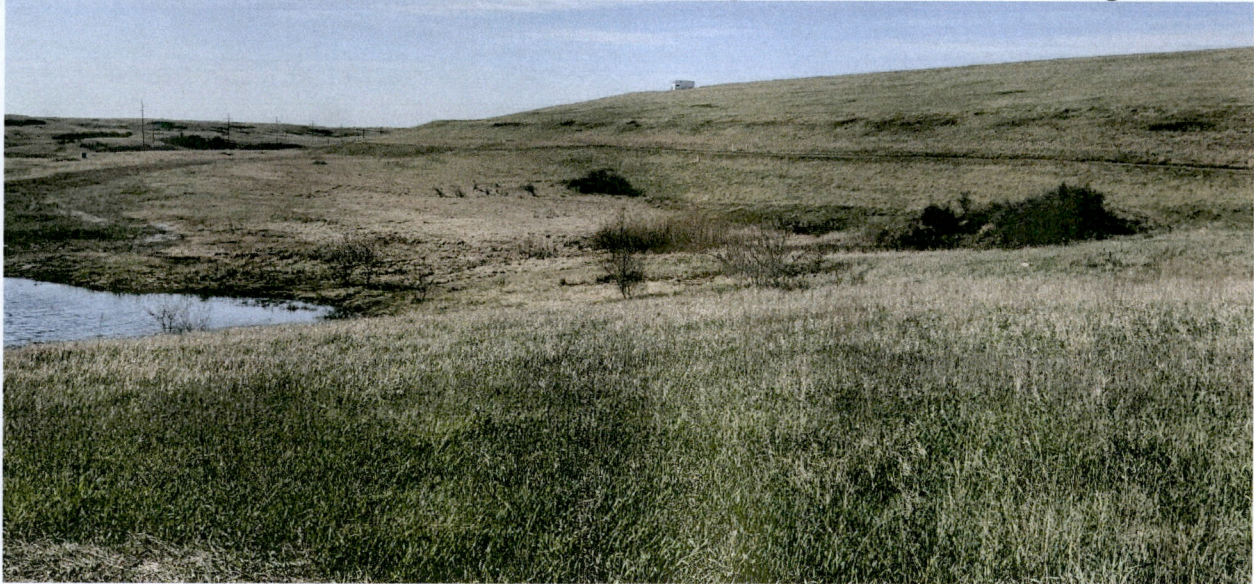
Figure 1. The north end of the east portion of the bond release tract facing south. Pond 5-1 is visible on the left and the embankments of ash disposal cells are visible on the right.

Vegetation on the east portion of the bond release tract is adequate to control erosion and minimize any contributions of suspended solids outside the bond release tract as required by NDAC 69-05.2-22-07(4)(j) and NDAC 69-05.2-12-12(7). BNI provided vegetation survey data with the bond release application that indicated the west portion of the bond release tract had 95.3% total cover. The visual assessment of vegetative cover during the field inspection was consistent with the data included in the bond release application. **See Figures 1 and 2.**

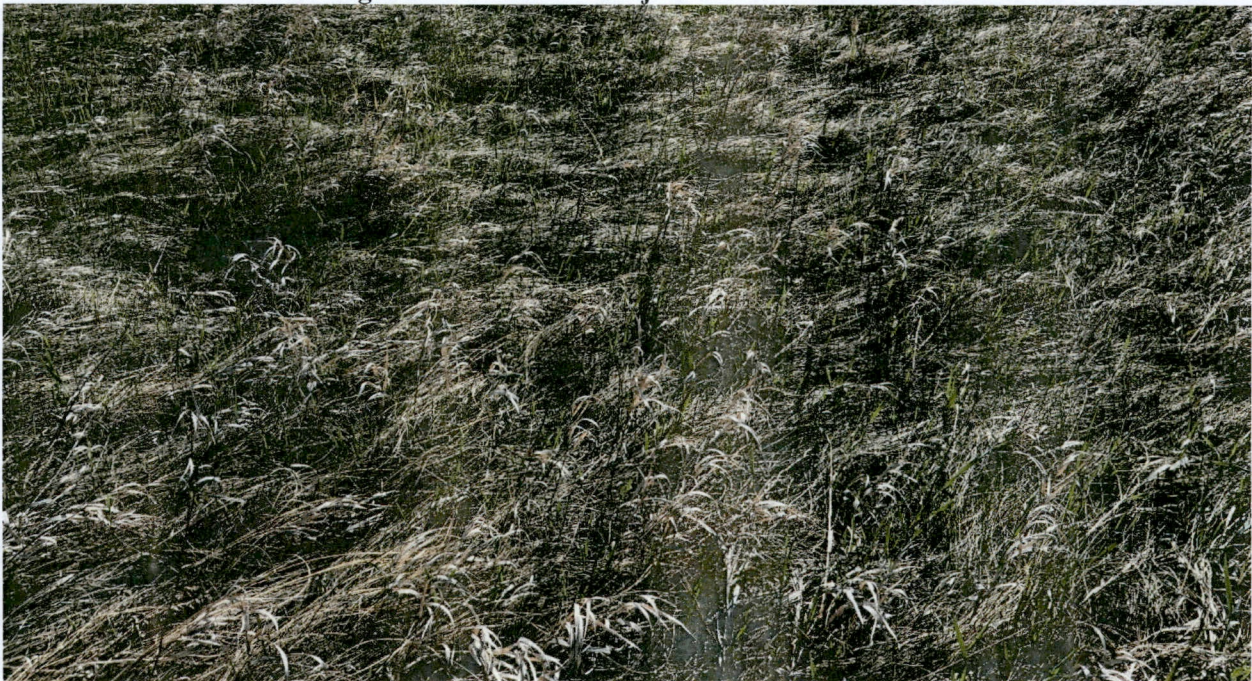
Figure 2. Ground cover just south of Pond 5-1.

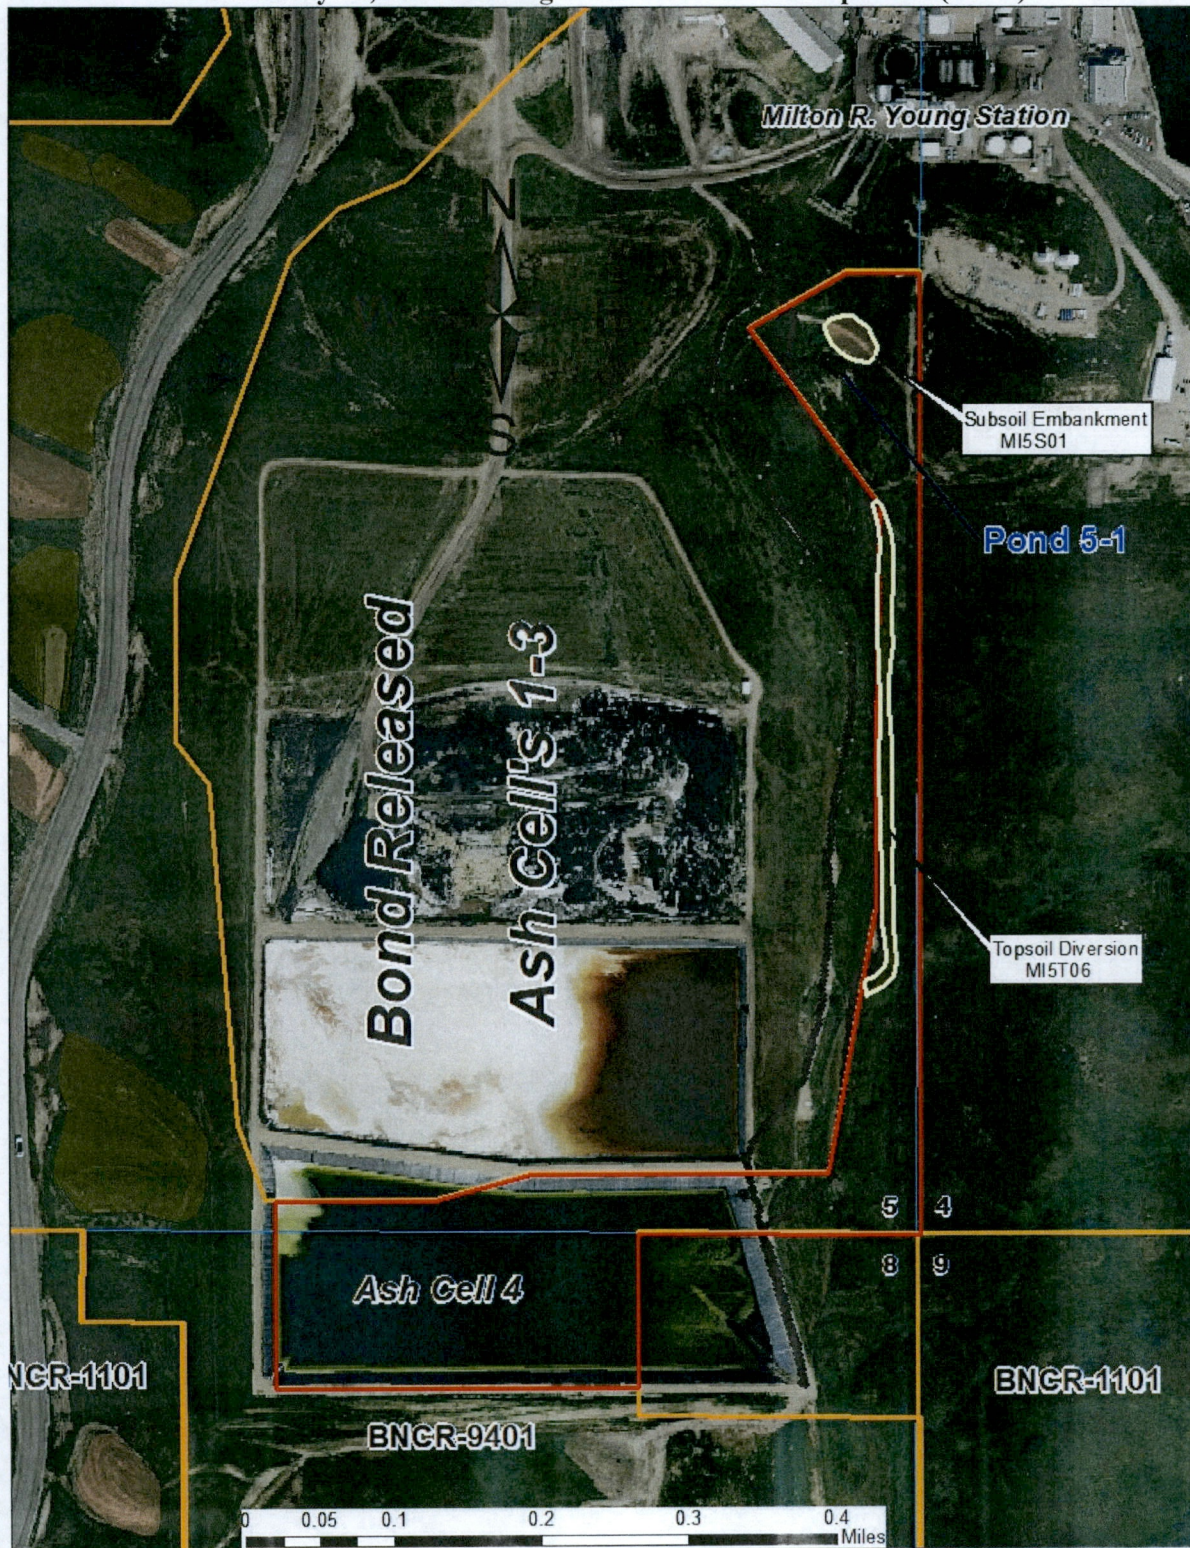
Figure 3: Final Bond Release 5 (outlined in red), Center Mine permit areas (orange) and the May 12, 2020 tracklog of the bond release inspection (black)

The application for Bond Release No. 5 to Permit BNCR-9401 consists of 43.6 acres located in Sections 5 and 8, T141N, R83W, in Oliver County. The bond release tract includes two distinct areas, the south portion and the east portion. The south portion of the bond release tract contains approximately two-thirds of ash disposal cell number 4 of Minnkota's disposal facility for Flue Gas Desulfurization (FGD) sludge and other power plant wastes. The southeast corner of ash disposal cell number 4 is located outside the permit boundary. The facility is subject to Solid Waste Permit SP-159 issued by the North Dakota Department of Environmental Quality. **See Figure 3.** The designated post mine land use for the entire tract is industrial/commercial.

A GPS point tracklog of the inspection route is depicted on **Figure 3**. The tracklog and additional photographs taken during the inspection are on file with the Reclamation Division.
