**RE: Bill Sanderson Gas Processing Plant Field Summary – May 1, 2020**

Grouse Mountain Environmental Consultants (Grouse Mountain) would like to report on results from a field visit conducted for OE2 North LLC's (OE2) Bill Sanderson Gas Processing Plant (Plant) project located within section 27 T154N-R104W in Williams County, North Dakota. OE2 requested that Grouse Mountain assess wetland indicators of the Unit 9 "unknown wetland" as well as conduct a passerine and raptor nest survey within the Plant footprint on April 28<sup>th</sup> and 29<sup>th</sup>, 2020. Please see summary findings for the proposed Bill Sanderson Gas Processing Plant below.

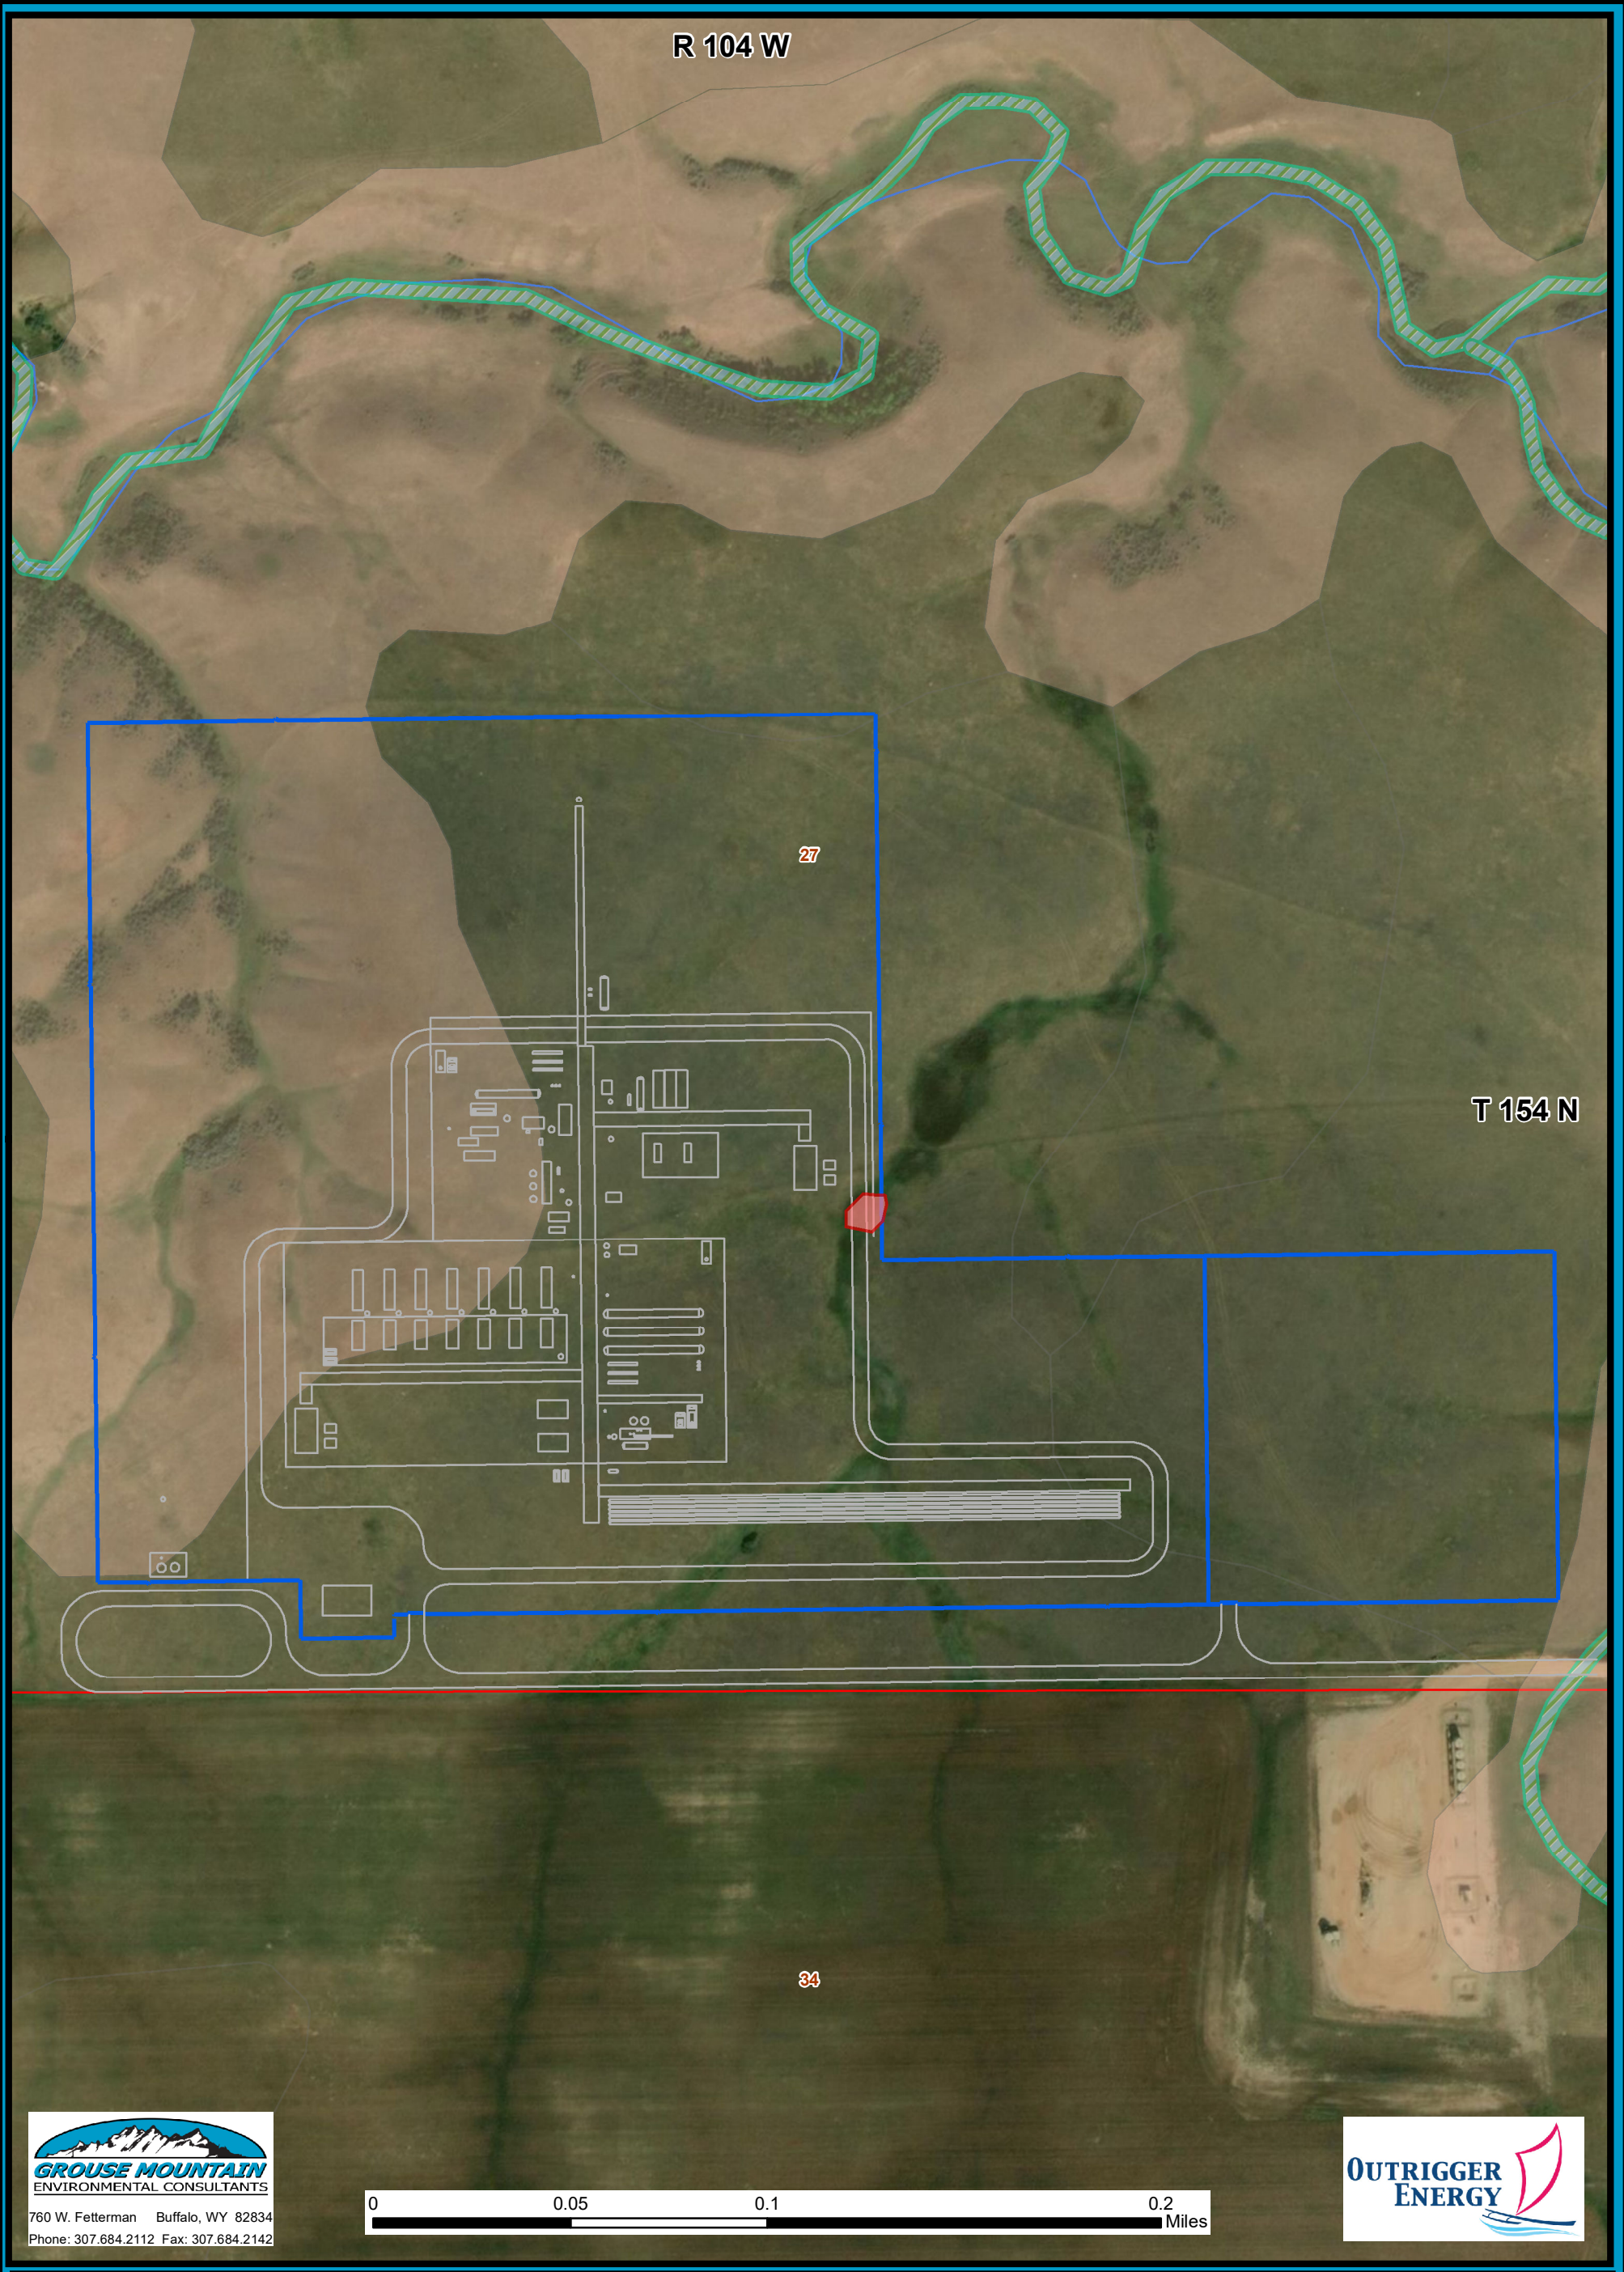
**Figure 1. OE2 North LLC: Bill Sanderson Gas Processing Plant Summary Report Map**

- Plant Boundary (fence line)
- Plant Site Features
- Offsite Assessment**
- Unit 9 Potential Wetland
- ▨ National Wetlands Inventory Wetland
- Intermittent Stream
- Soils (per Web Soils Survey)**
- Not Hydric
- 0-5% Hydric

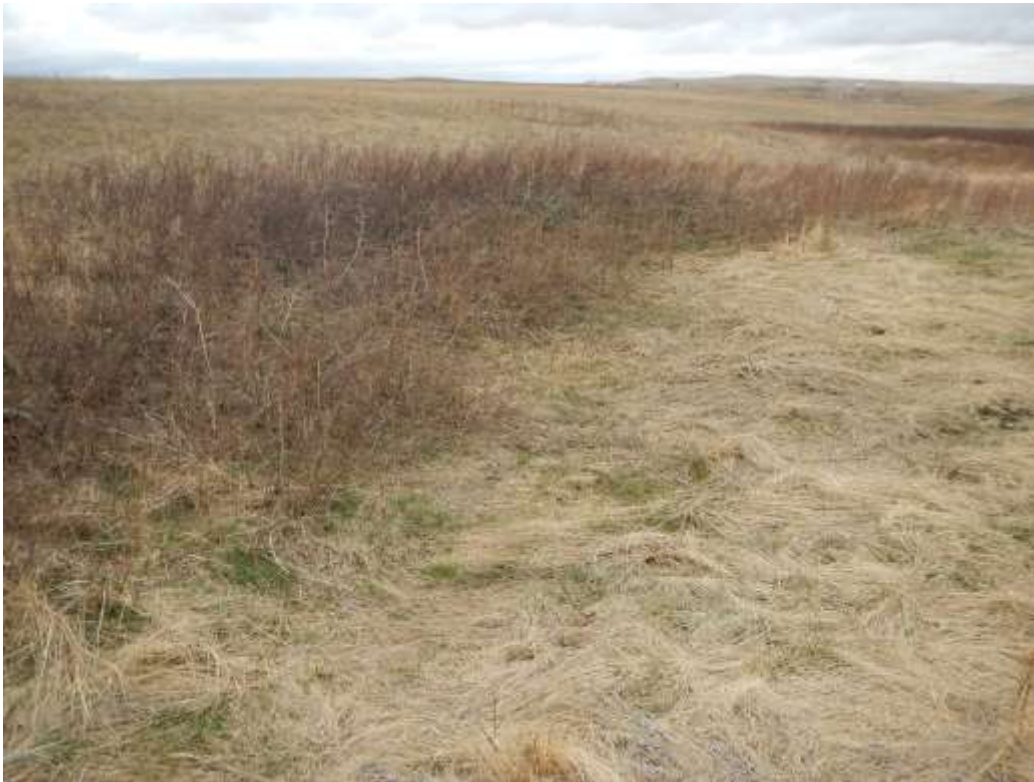
*Photo 1. Overview of Unit 9 potential wetland site. Photo taken on April 28<sup>th</sup>, 2020.*

On April 28<sup>th</sup> and 29<sup>th</sup>, 2020, the depression associated with Unit 9 no longer held standing water and Grouse Mountain was able to complete a wetland assessment for the site (Photo 1). The assessment of the Unit 9 site occurred at the very beginning of the potential growing season for this region, based on 28°F (-2.2°C) air temperature thresholds (USACE Growing Season Definition and Use in Wetland Delineation 2010) where there is a 70% chance the growing season occurs between April 27 and October 9. Some vegetation, including sedges within Unit 9, was beginning to grow. Two (2) dominant species of vegetation were identified within the potential wetland by assessing residual vegetative cover from the 2019 growing season. Both species are considered hydrophytic (Facultative Wetland status), indicating that the primary vegetative cover within Unit 9 meets the vegetation requirements of a wetland. Additional plant species

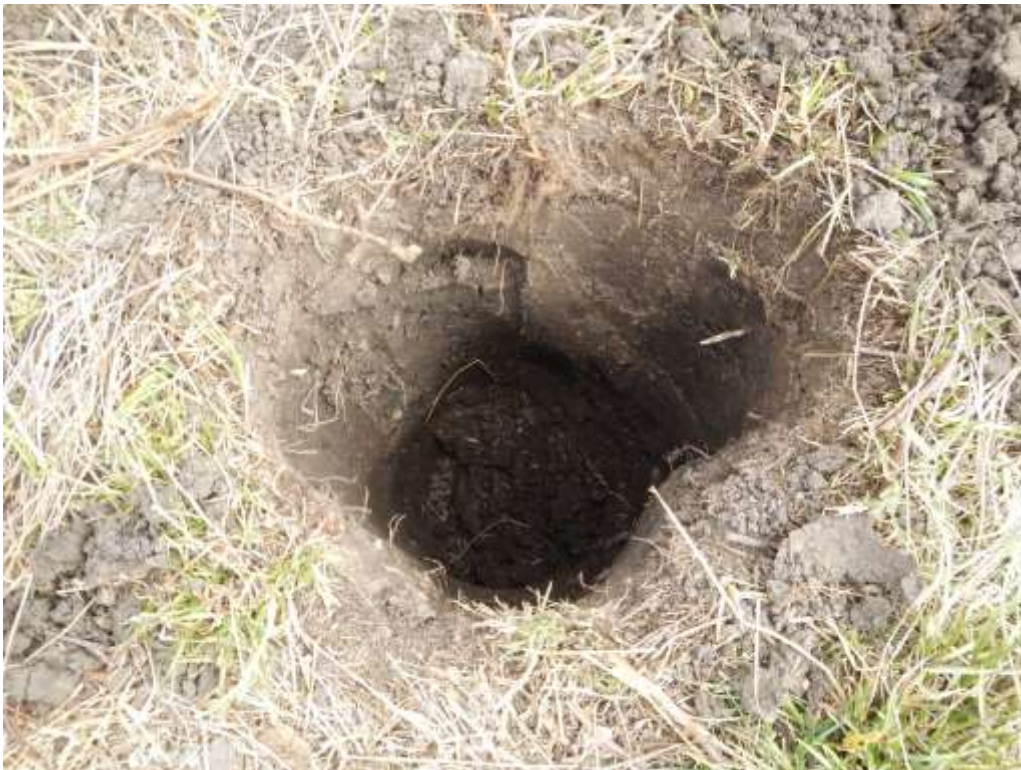
*Photo 2. Soils Pit A taken within potential wetland boundary. Photo taken on April 29<sup>th</sup>, 2020.*

may be observed later in the season. Grouse Mountain also assessed soil indicators for one (1) soils pit dug within the middle of the potential wetland boundary (Soils Pit A, Photos 2-5). Redox concentrations were observed only below 19 inches after long exposure to air. However, soil saturation was not present, iron-oxide was not observed along living roots, soil values and chromas were not indicative of depleted matrices, nor were any other hydric soils indicators present. Thus, these soils did not meet the indicator criteria for hydric soils as provided in the U.S. Army Corp of Engineers (USACE) Wetland Delineation Manual and USACE Great Plains Regional Supplement nor did they meet the definition of hydric soils set by the National Technical Committee for Hydric Soils definition “a soil that formed under conditions of saturation, flooding, or ponding long enough during the growing season to develop anaerobic conditions in the upper part” (USDA Soil Conservation Service 1994). Additionally, the site did not meet the wetland hydrology indicator criteria as provided in the USACE Wetland Delineation Manual and Great Plains Regional Supplement. Although hydrophytic vegetation is present, a wetland assessment must take into account all of the criteria of a wetland. As the soils and hydrology of the site do not show the indicators required, Unit 9 does not meet the criteria of a wetland.

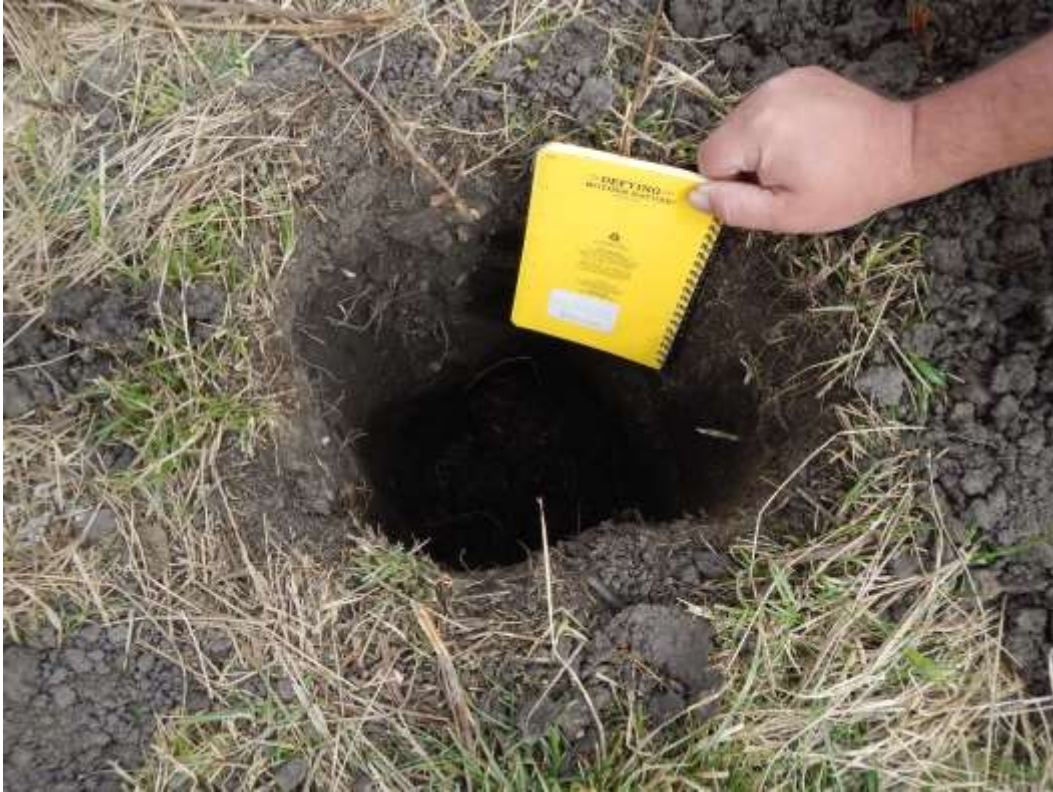
*Photo 3. Soils Pit A taken within potential wetland boundary. Photo taken on April 29<sup>th</sup>, 2020.*

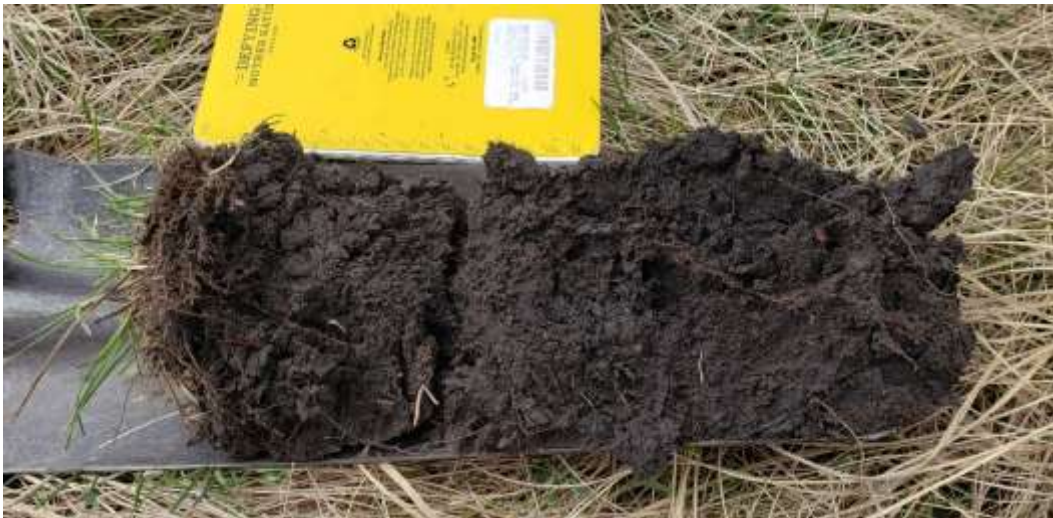
*Photo 4. Top section of soil removed from Soil Pit A. Photo taken on April 29<sup>th</sup>, 2020.*

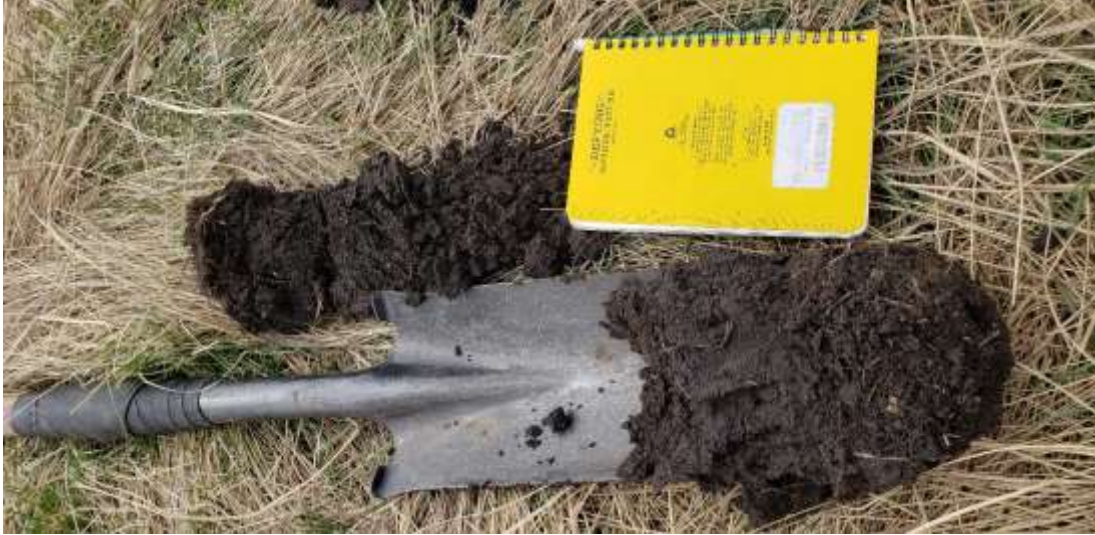
*Photo 5. Soils removed from Soil Pit A, with soils from the lower section of the pit on the shovel. Photo taken on April 29<sup>th</sup>, 2020.*
