INSPECTION REPORT

DATE OF INSPECTION: September 9, 2020
TYPE OF INSPECTION: Partial
PERMITEE - MINE: Coteau Properties Company - Freedom Mine
PERMITS INSPECTED: NACT-0201, NACT-9001

This inspection was scheduled for the purpose of evaluating reclaimed lands associated with Final Bond Release Application No. 1 to Permit NACT-9001. The bond release application consists of 811.8 acres of land in Sections 1 and 2, T145N, R88W, in Mercer County. The property contains 683 acres of reclaimed native grassland, 4 reclaimed stock ponds, a reclaimed seasonal wetland, a portion of relocated County Road No. 15 and approximately 112.7 acres of undisturbed land. The property is owned by the Coteau Properties Company.

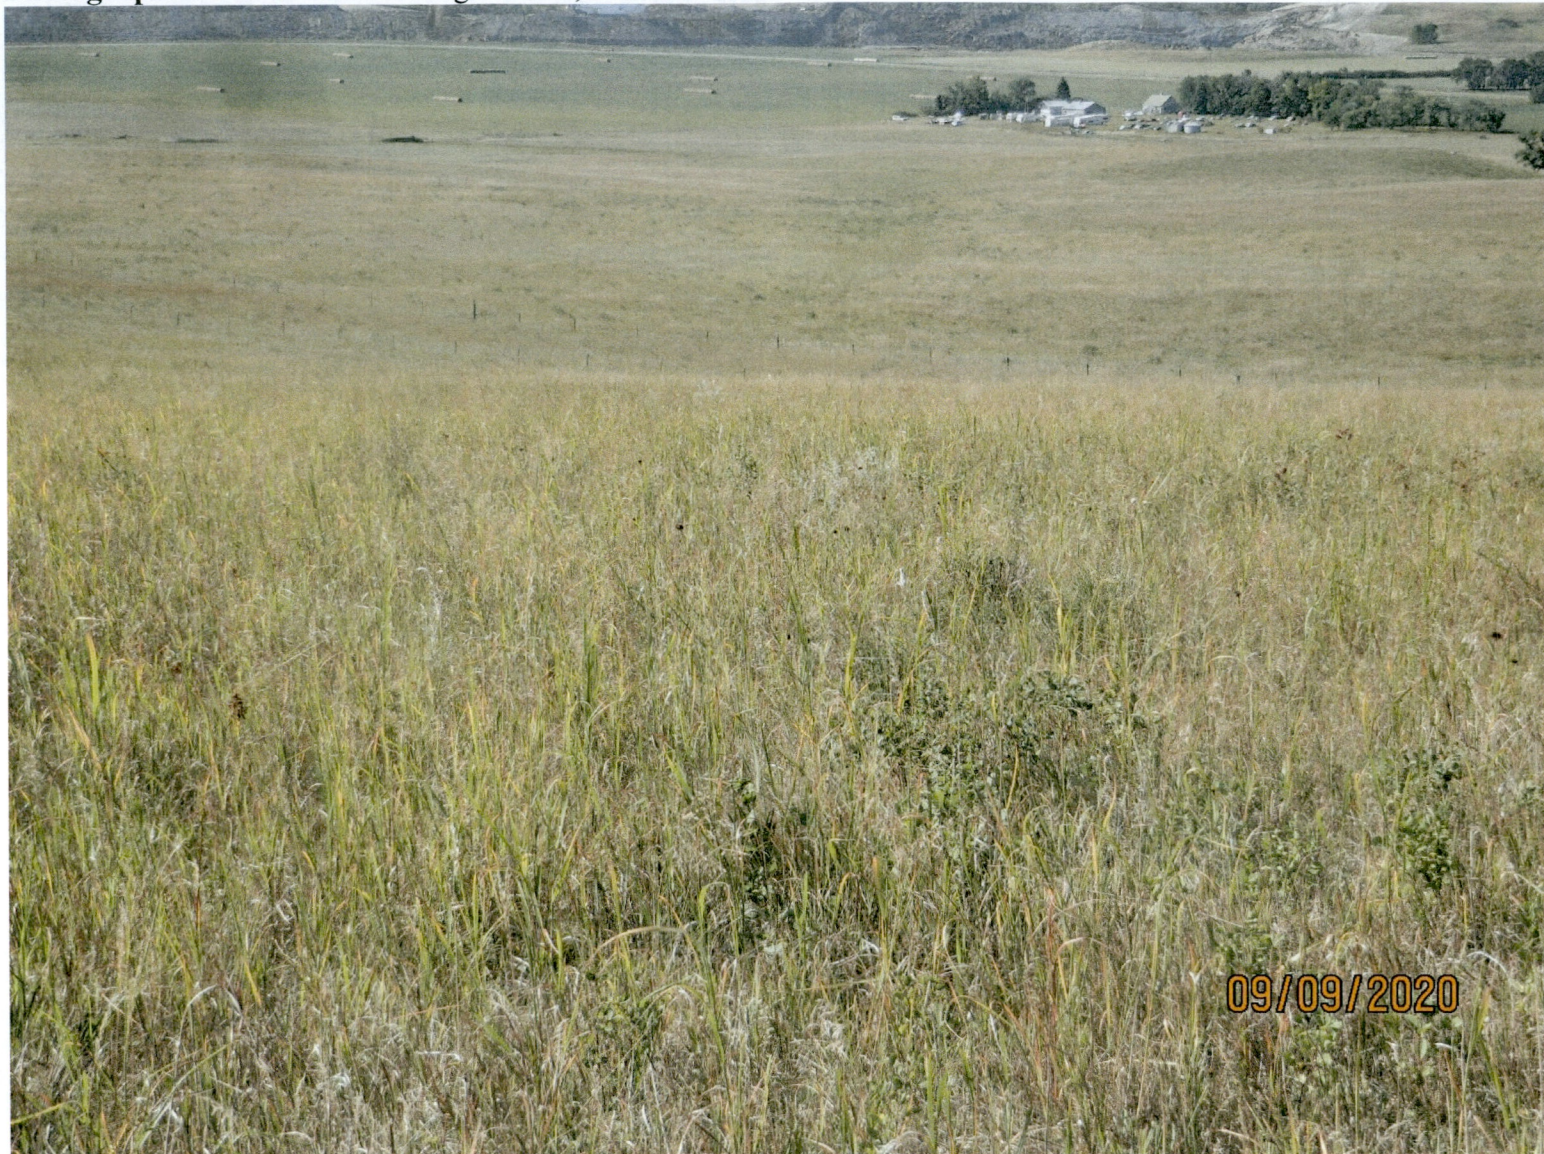
The reclaimed native grassland was seeded to western wheatgrass, slender wheatgrass, green needlegrass, blue grama, sideoats grama, switchgrass and little bluestem. Western wheatgrass, green needlegrass, sideoats grama, switchgrass and little bluestem are the principle seeded native species currently established. Vegetation composition differences are apparent between some of the numerous seedings on these tracts of land. Smooth brome grass and Kentucky bluegrass are quite abundant on some of the older seedings and alfalfa is prominent in places. Other native grasses, forbs and shrubs have established on portions of this reclaimed land, presumably through direct respread of native grassland topsoil. Native grass species present that were not seeded includes big bluestem, porcupine grass, prairie Junegrass and prairie sandreed. Numerous species of native forbs that have established on some areas include silverleaf scurfpea, cudweed sagewort, Heath aster, purple coneflower, American licorice, curlycup gumweed, American vetch, prairie rose, wavyleaf thistle, yellow coneflower and Missouri goldenrod. Non-native forbs identified growing on this reclaimed grassland include alfalfa, yellow sweetclover, cicer milkvetch, black medic, Canada thistle and absinth wormwood.

Photograph 1: Reclaimed native grassland, NW1/4 of Section 2

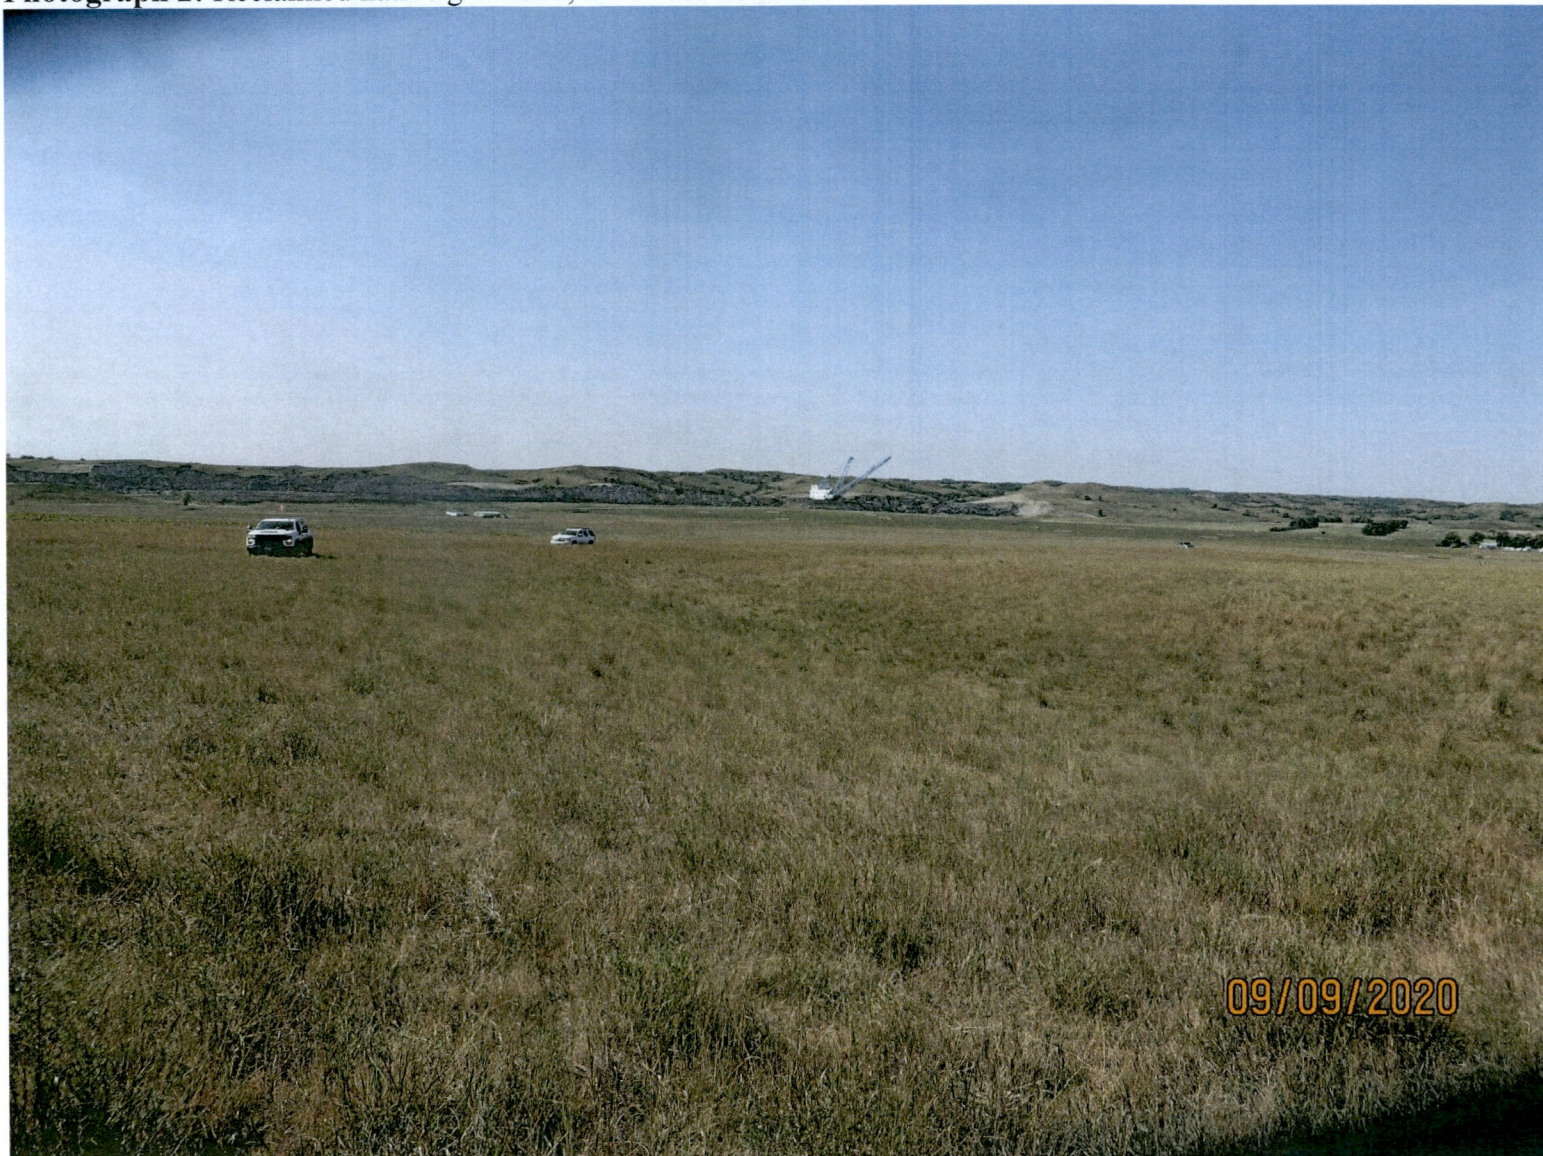
Photograph 2: Reclaimed native grassland, SW1/4 of Section 2

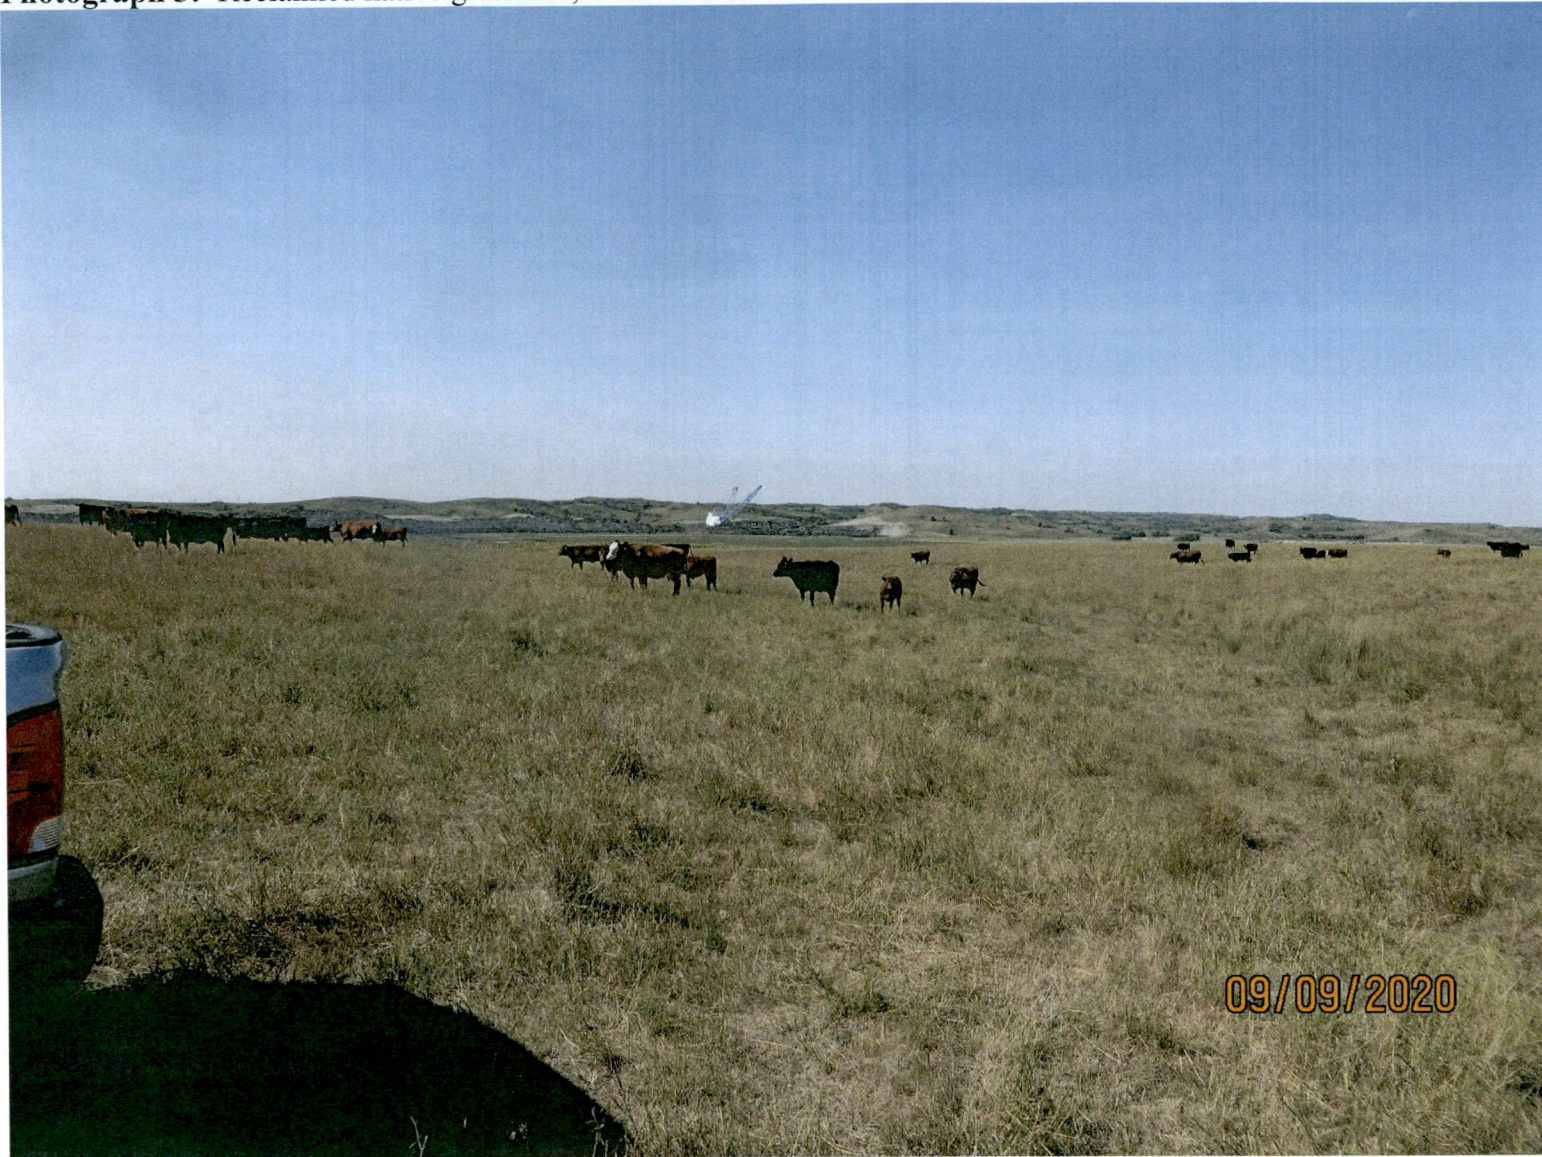
Photograph 3: Reclaimed native grassland, SW1/4 of Section 2

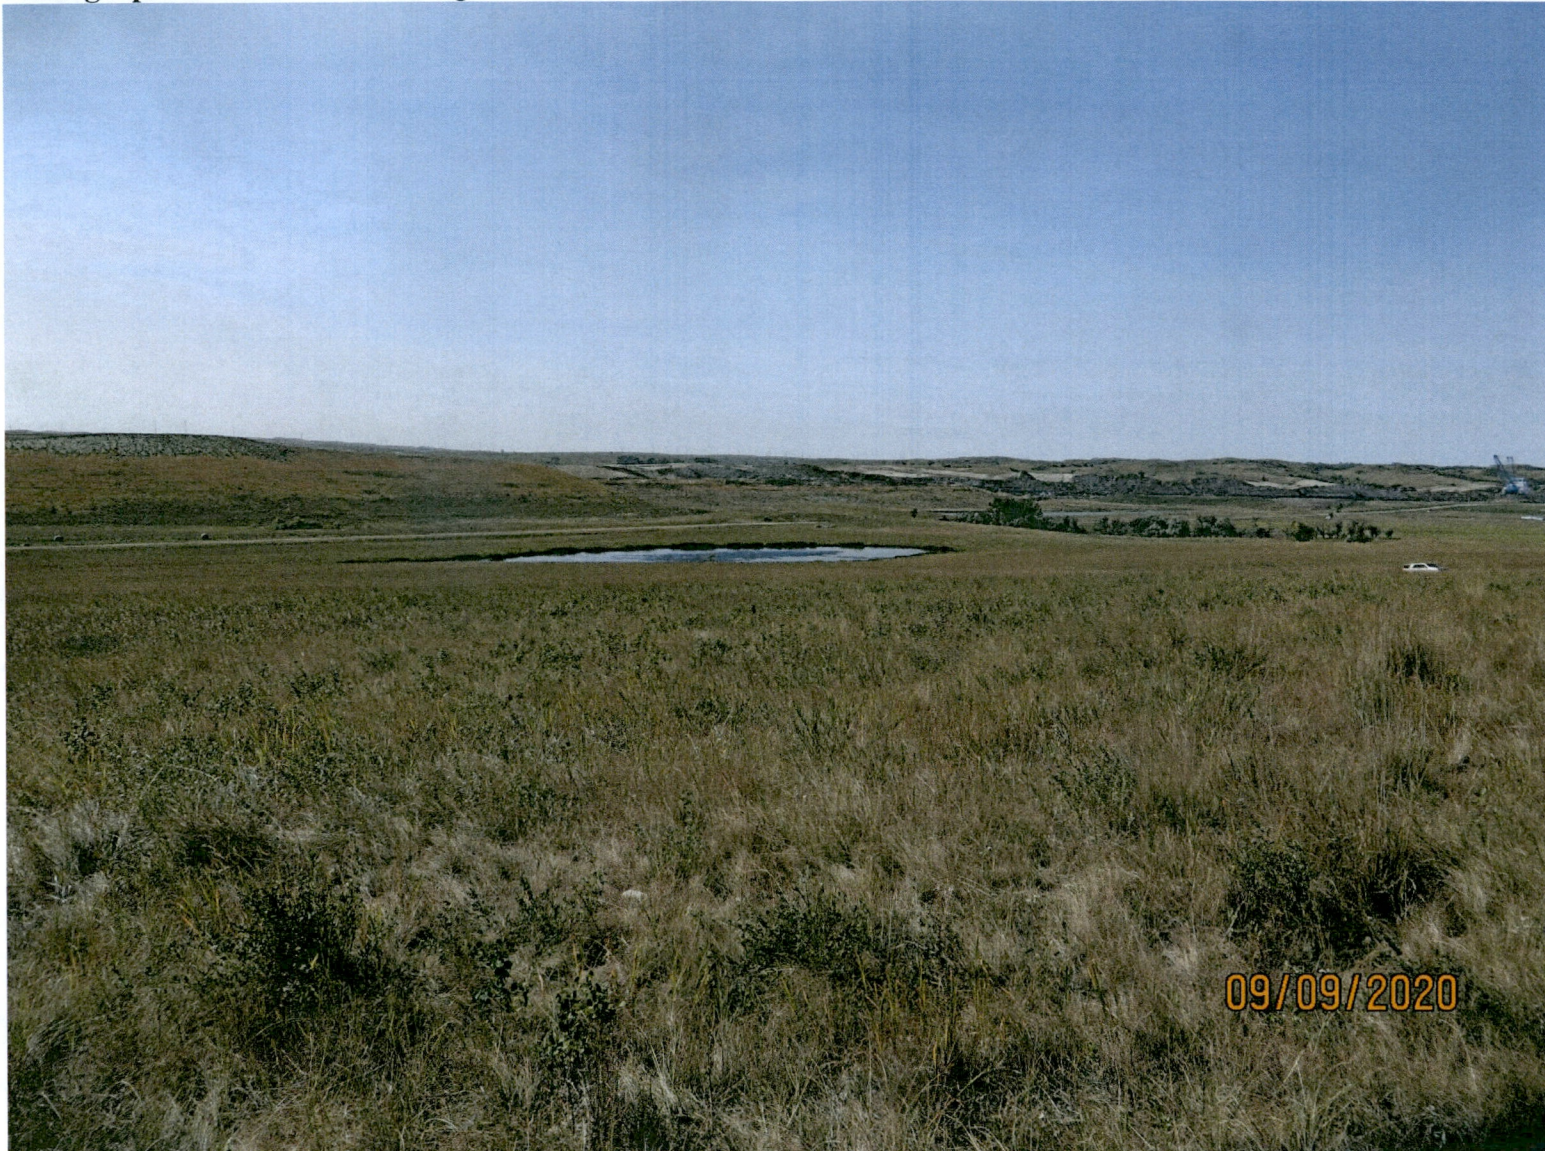
The reclaimed seasonal wetland, CWI02-01, is approximately 2.5 acres in size. This wetland is not fenced to exclude cattle and thus it also functions as a stock pond. The low prairie and wet meadow zones around the wetland are quite heavily impacted by livestock. The low prairie zone is dominated with native and introduced grasses while reed canarygrass, common spikerush, needle spikerush, hardstem bulrush, water plantain, carex spp. and cattail occupy portions of the wet meadow and shallow marsh zones not heavily impacted by cattle. Steeper sideslopes around the perimeter of the pool area of the wetland limits the size of the low prairie and wet meadow zones and most of the shallow marsh zone is open water that may be supporting species such as American milfoil, sago pondweed and star duckweed. Two gadwall ducks were observed utilizing this wetland.

Photograph 4: Reclaimed native grassland and reclaimed wetland in SE1/4 of Section 2

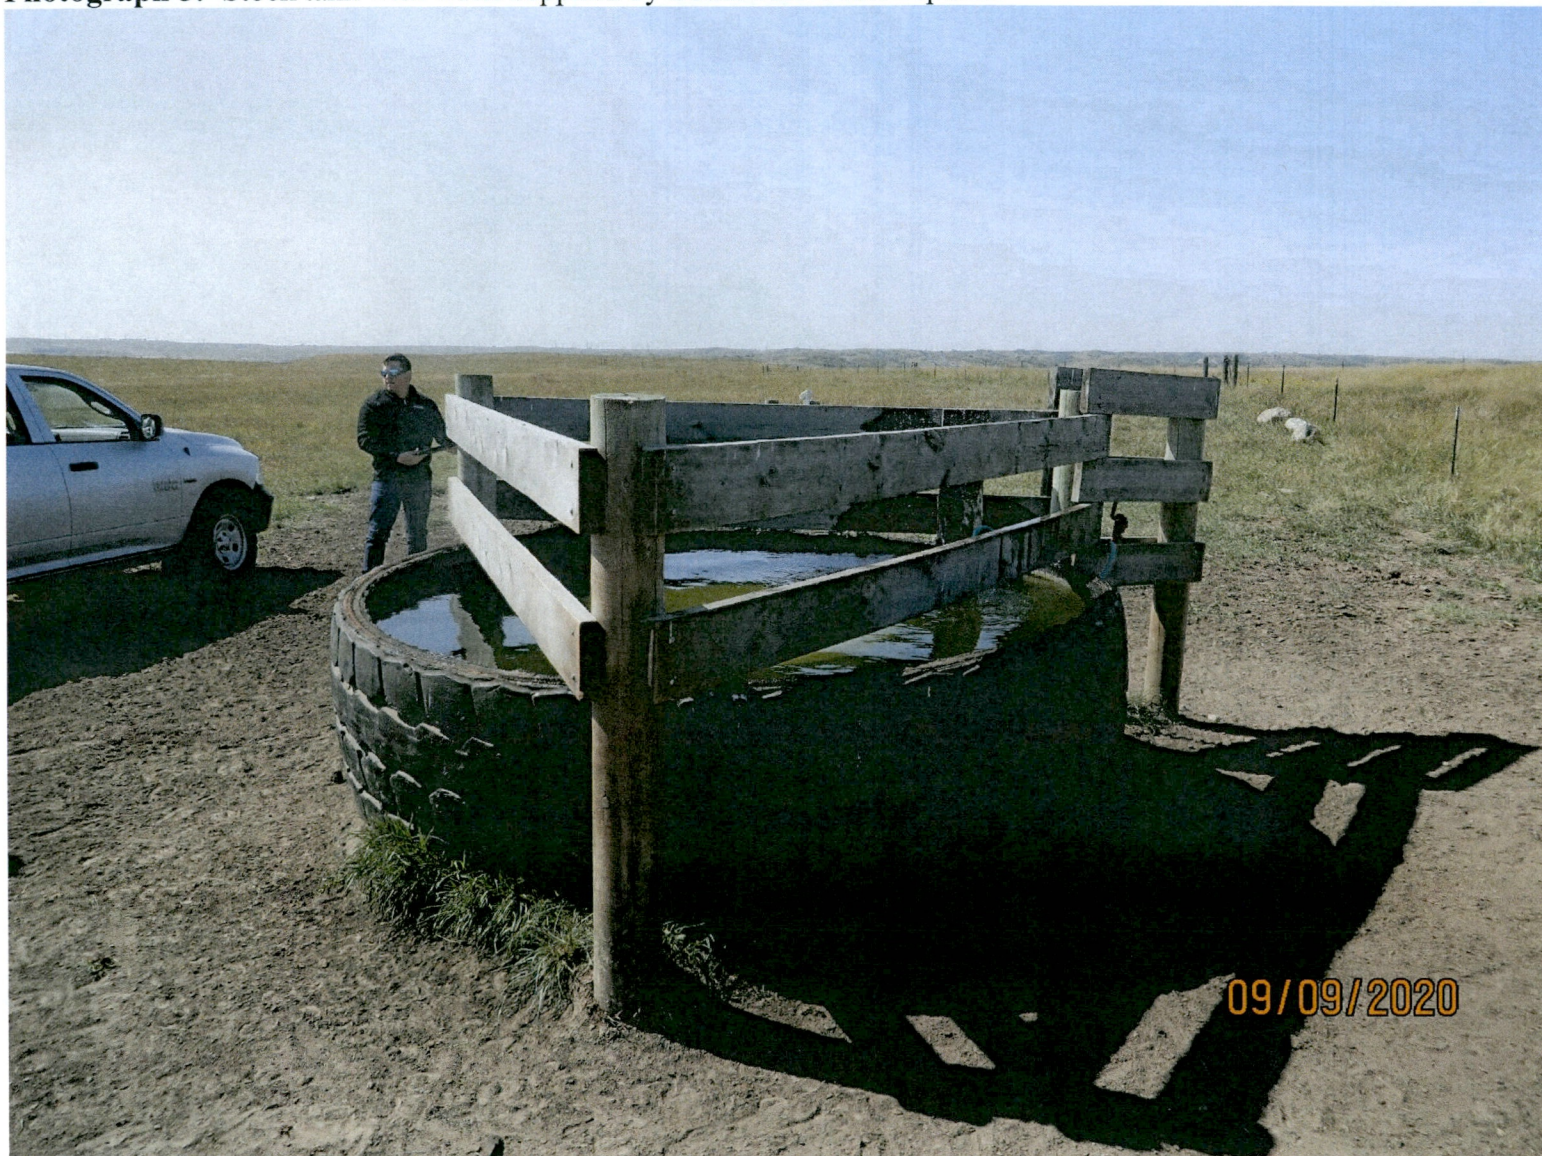
described as the NE1/4, SE1/4 and W1/2 of Section 2. Stock ponds and a seasonal wetland were constructed and Southwest Water pipeline pasture taps supply water to four stock tanks in the W1/2 of Section 1 and E1/2 of Section 2.

Photograph 5: Stock tank with water supplied by Southwest Water Pipeline

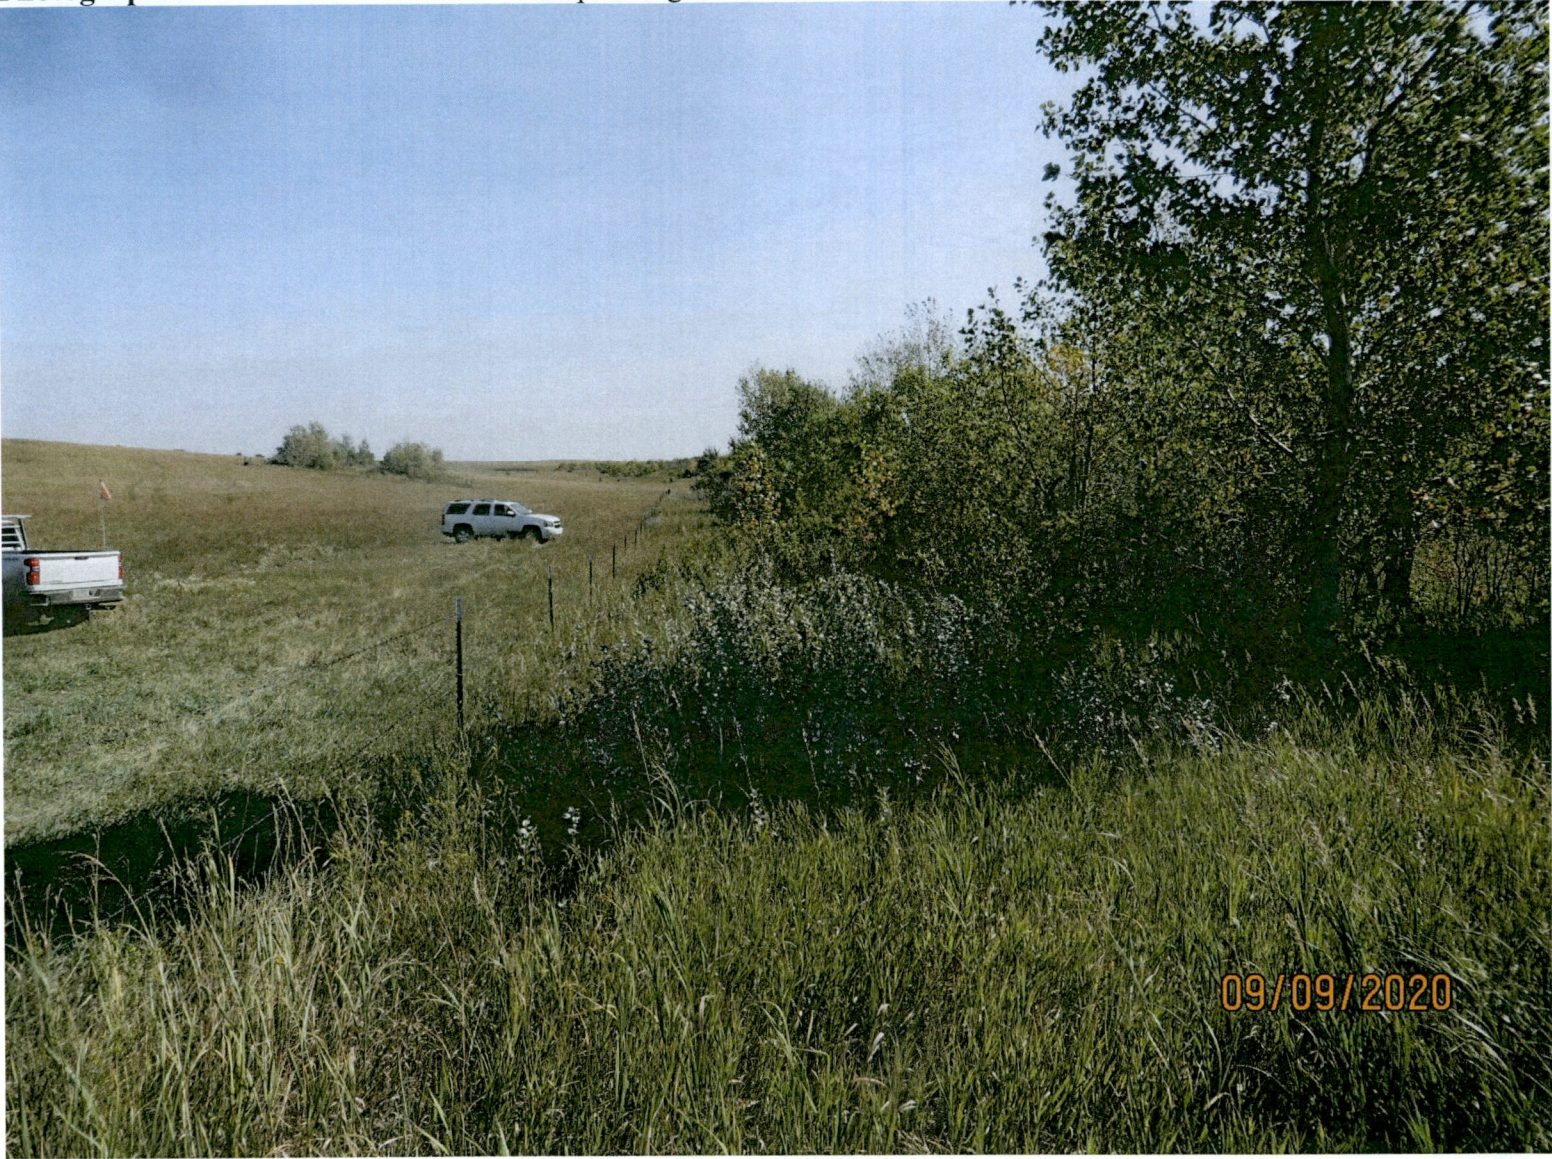
Three wildlife habitat enhancement tree plantings comprising 5 acres were planted on reclaimed native grassland in Section 1. These trees were planted in the early 2000's and fenced to exclude livestock. Cottonwood, green ash, common chokecherry, American plum, silver buffaloberry, and silverberry have established in these plantings and the low and tall shrub species have expanded through suckering. Tree and shrub density is variable within and between these three plantings and herbaceous vegetation, primarily smooth brome grass, and the tree and shrub canopy are providing excellent aerial ground cover. Silver buffaloberry, American Plum and chokecherry produced fruit this year. Tree species appear more prominent in the western planting, SB-01-02, compared to the other plantings, SB-01-01 and SB-01-03, and tree height and tree and shrub vigor appeared better in planting SB-01-02. These tree and shrub plantings are providing landscape diversity and an area not intensively used for agricultural purposes.

Photographs 6: Wildlife enhancement tree planting in the SW1/4 of Section 1

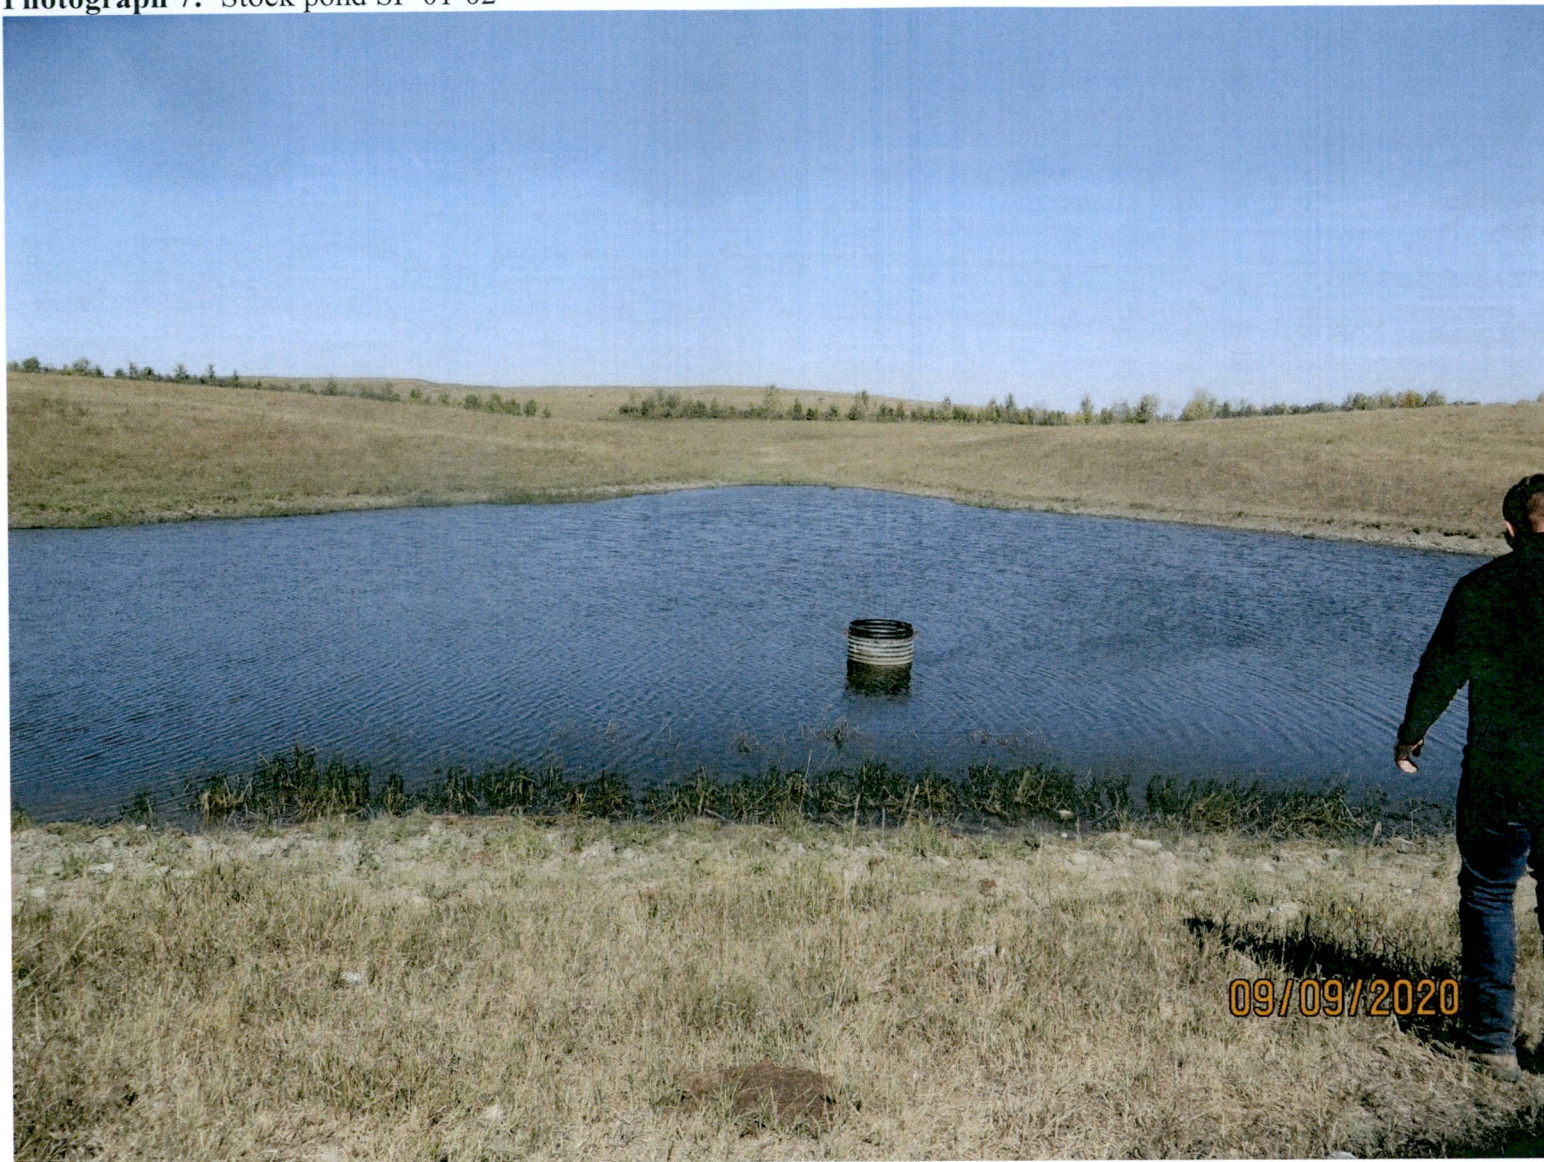
Reclaimed stock ponds SP-01-01, SP-01-02, SP-02-01 and SP-02-02 are functioning as intended. Cattle utilize these stock ponds and areas around the the ponds are barren of vegetation from cattle

Photograph 7: Stock pond SP-01-02

concentration. Surface water runoff passes through stock ponds SP-01-01, SP-02-01 and SP-02-02 to reclaimed drainageways and there is no embankment or risers to maintain on these stock ponds. Stockpond SP-01-02 has a riser that functions as the principle spillway. A trash rack should be installed on top of this riser as recommended by NRCS Agriculture Handbook No. 590. A diversion has been constructed west of stock pond SP-02-01 to increase the watershed size of this pond. A circuitous waterway has been constructed on a fairly long and steep slope in the S1/2 of the SE1/4 of Section 2 to direct surface water runoff over this slope to created wetland CW-102-01. The diversion above stockpond SP-02-01 and this drainageway in the SE1/4 of Section 2 are stable and no erosion was observed in these drainage ways.
