BEFORE THE PUBLIC SERVICE COMMISSION OF NORTH DAKOTA

Public Service Commission
Wagner Construction, Inc.
Damage Prevention Enforcement

Case No. PU-20-423

Complaint

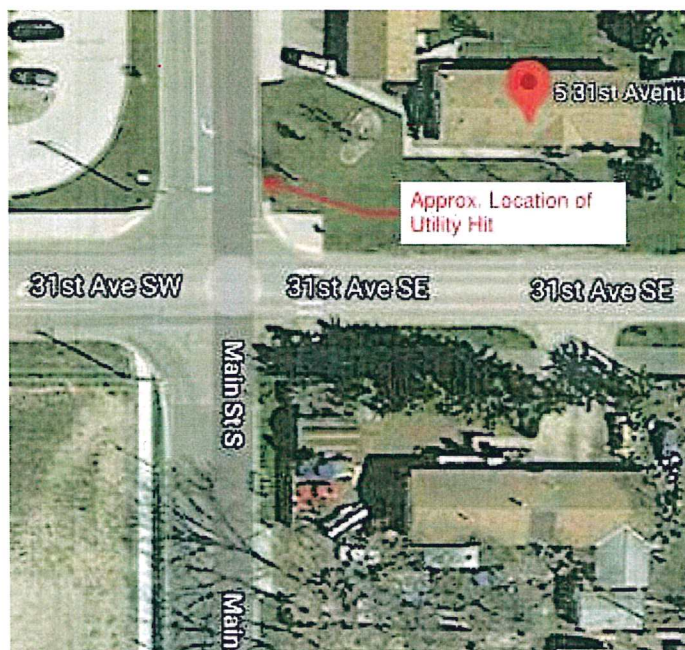
After an internal investigation and conversations with the onsite personnel. Wagner Construction was prepping subgrade for placement of Class 5 prior to concrete pavement. The operator Jess Kindred was using a dozer to prep the area in front of the house at 31st and Main St. S when he caught the gas service line for the house with the corner of the dozer blade. Exhibit A shows the approximate location of the gas line hit. Prior to starting work at this location the operator had a laborer dug down and located the

service in the road at the main. They found the service at a depth of approx. 5-6" below the needed level for subgrade prep. However while prepping subgrade they caught the service line at the approximate centerline of where the new concrete curb was to be placed. The service line went from being flat to almost a 90° out of the road into the bank. See photos Exhibit B and Exhibit C. These show that the service line was well above the depth that was needed for the project.

Upon further conversations with the operator and other crew members, it appears that previous discussions were had with MDU explaining that any utilities in this area of the project that were not at the specified grade would need to be lowered due to the contours and elevations of the new road. Jesse McIntosh had asked the MDU worker on site repairing the gas line why the service had not been lowered as previously discussed, to which he was told all utilities in this area had been lowered. This would have been improbable considering that Wagner had just removed the asphalt a few days prior to our work starting.

Wagner Construction took all necessary precautions to locate the gas service line prior to starting their grading work. It was assumed that the service line would have followed the same grade that it was found at when they crew members dug down and located it at the main. There was no way for Wagner to know that the service was going to jump up from the location it was found at below grade. Had this line been relocated to a proper depth prior to our work or had the service line been buried at the same depth across from where it was located at the main, no utility would have been hit.

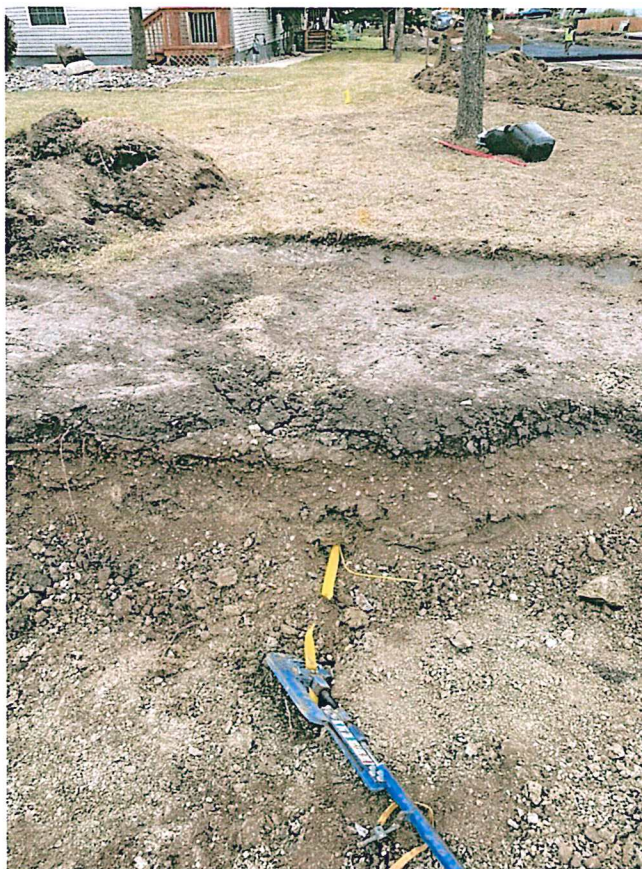
Exhibit C

For the two remaining utility strikes at houses 2 & 5 31st Ave SE, Minot, ND these had been refreshed on 9/23/2020 for work to start on 9/26/2020. No work was completed at this area until 9/26/2020 where the grading crew was prepping the subgrade for placement of Class 5. For the gas hit on 9/26, there was only one mark approximately 5-6' from back of curb with no other marks being present in the road way or on the bank showing where the gas line was prior to work starting. In the picture Exhibit C, below there is only one paint line that denotes where the gas line is located.

These pictures show that the marks that had been provided in the refresh on 9/23/2020 were still present when we started construction meaning that Wagner had continued to maintain the marks that were provided to us prior to any gas hits. While these gas hits are unfortunate, we feel we have complied with the One-Call Notice System Law as it pertains to acting as a responsible contractor and maintaining the marks that were provided to us.

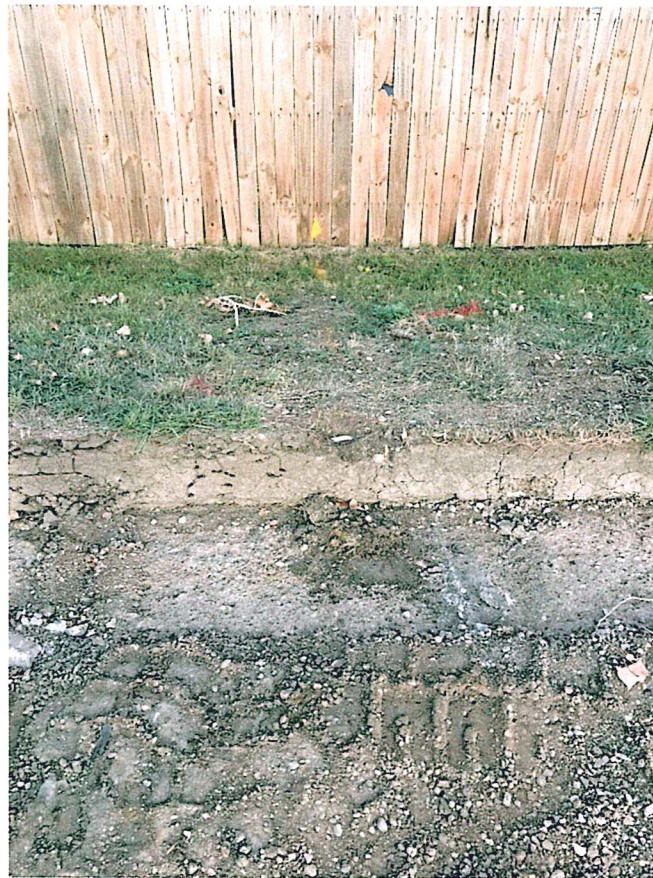
For the gas line hit on 9/29/2020 again there was only one paint mark and flag on the back side of the curb. The marks were still present as no work had been completed in this area until 9/29 and there were no additional paint marks on the roadway or bank marking where the gas line came up at. See Exhibit H below. This was the only mark for MDU in this area. The gas main running in the roadway was never actually marked in the refresh as it ran north back to the intersection of 31st and Main. This photo was taken on 9/28, the day prior to any work commencing in this area of the project.

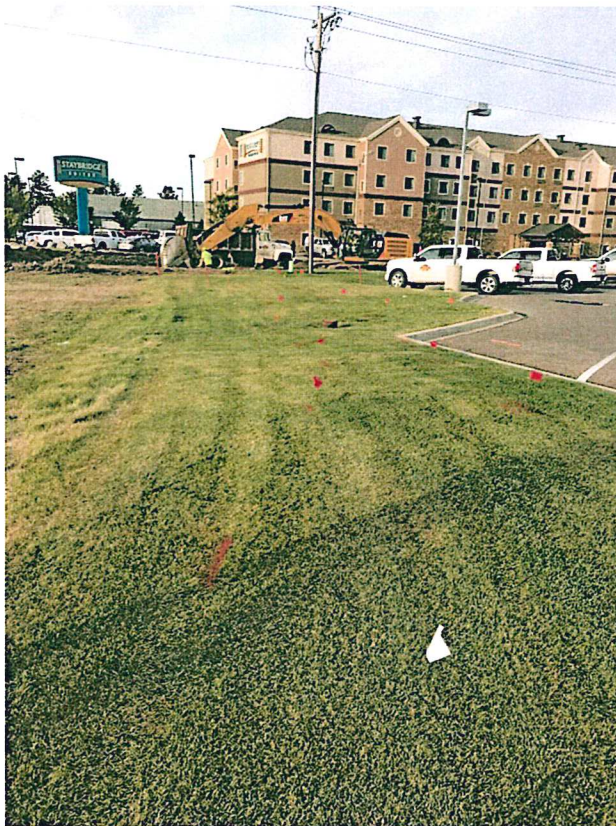
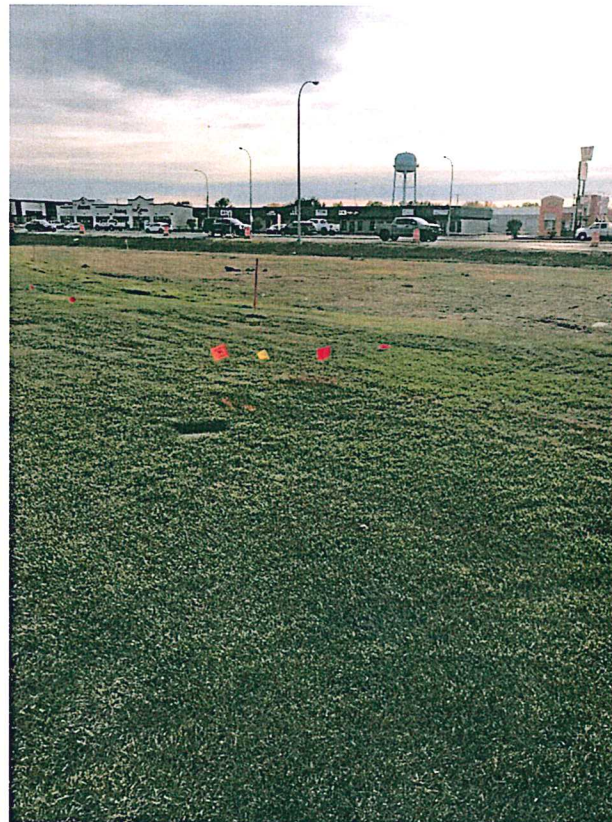
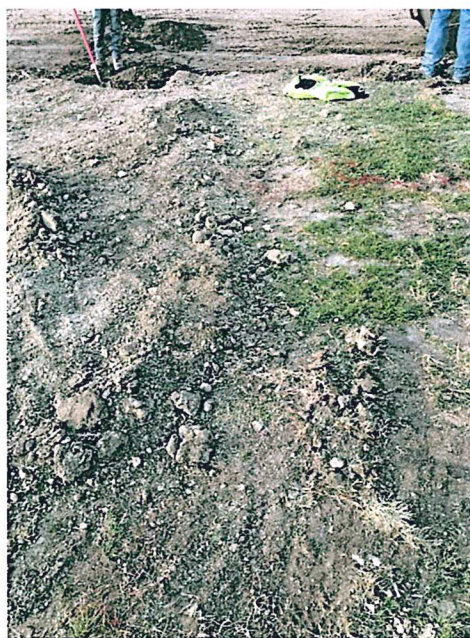
Below are several pictures that I personally took on the afternoon of September 28, 2020, prior to the final gas line being struck by our dozer. In these pictures it show the marks that were provided by ELM, often times there only being one single mark within a 50 to 60 foot area. In pictures Exhibit I and J there is merely 2 flags and 2 paint marks for approximately 100-150 ft. While we were not working in this area these were the only marks that had been refreshed for the 9/23/2020 locates that had been called in. No marks were present in the road way or near the edge of roads we were working in.

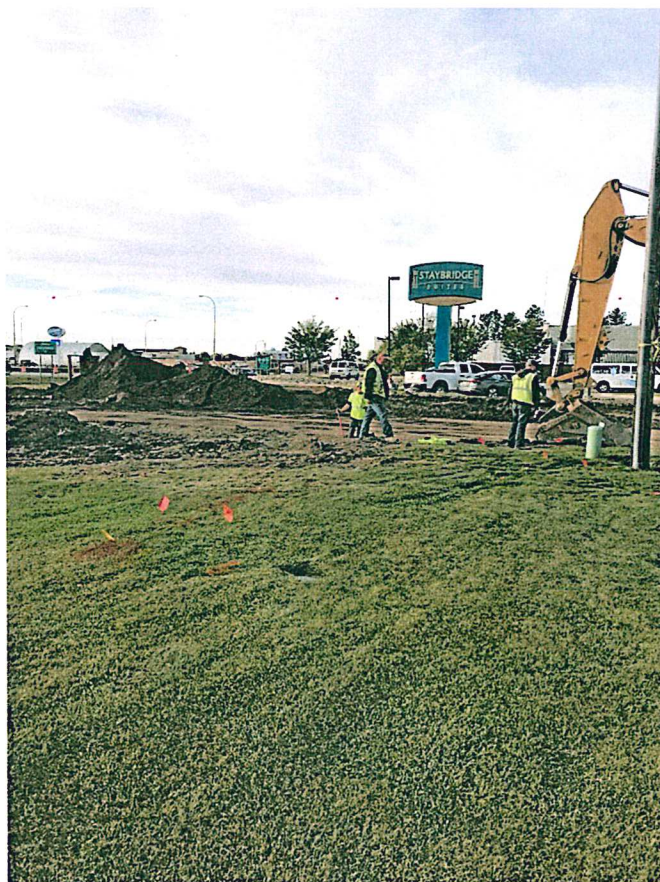
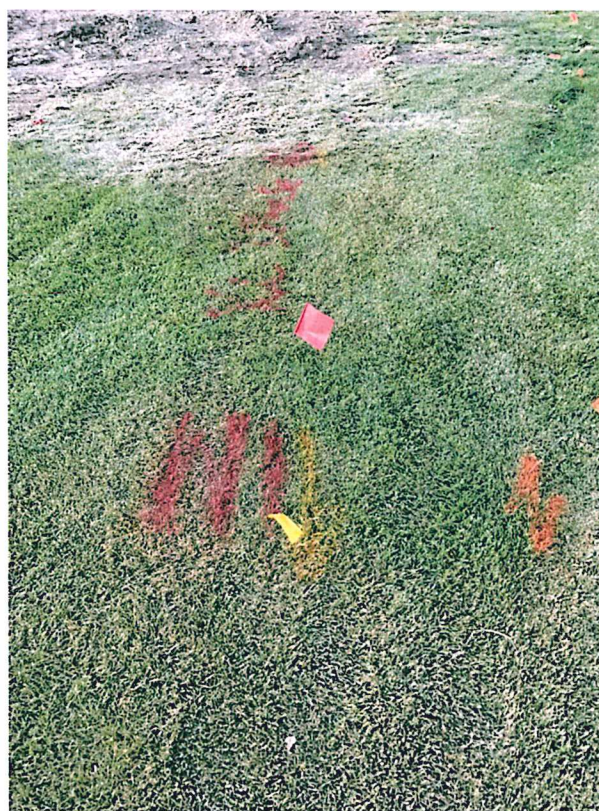
In pictures Exhibit K and L in the page above, the paint mark and flag shown was approximately 30' feet from our work area and no additional marks were present even though we were digging and preparing subgrade in the roadway. This area was supposedly refreshed with the locate #**20140113**, but this was the only mark provided in this refresh. In Exhibit M Wagner can be seen digging down to locate a gas service that crossed the road, but its actual location was only known because we had worked around it weeks earlier. Although we knew of the gas service location, it does not change the fact that no new marks were present across the road prior to the start of our work in this area.

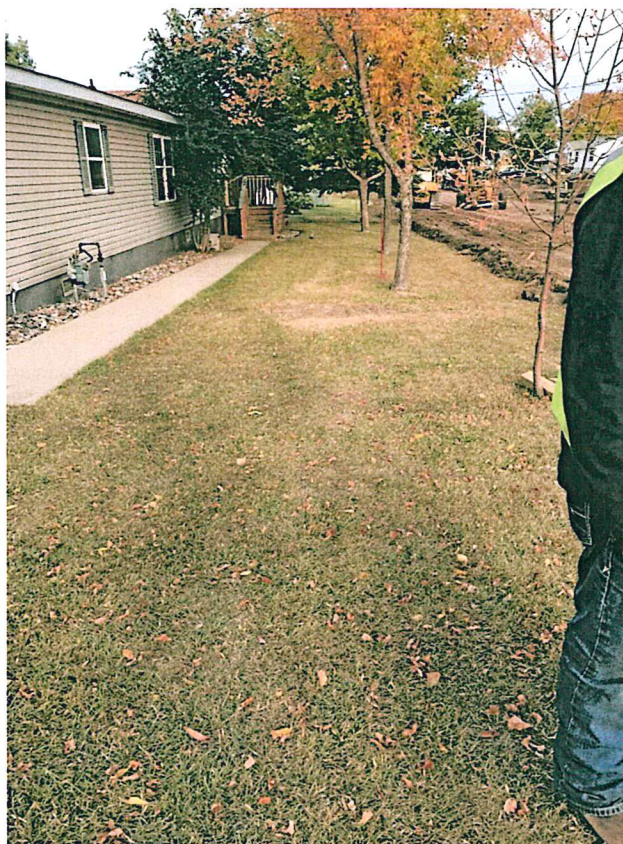
In Exhibit N this shows an area just east of the paint mark and flag as seen in Exhibit C, earlier in this report. This shows that there are no additional markings or flags after what was is seen in Exhibit C. This area was supposed to have been remarked prior to our start date of 9/26/2020 according to locate #**20140114** and #**20140113**, but not new marks had been placed.
