# **Dakota Carbon Pipeline Project**

## ***Topsoil Removal Inspection Report***

***Docket Number: PU-21-150***

Prepared for North Dakota Public Service Commission

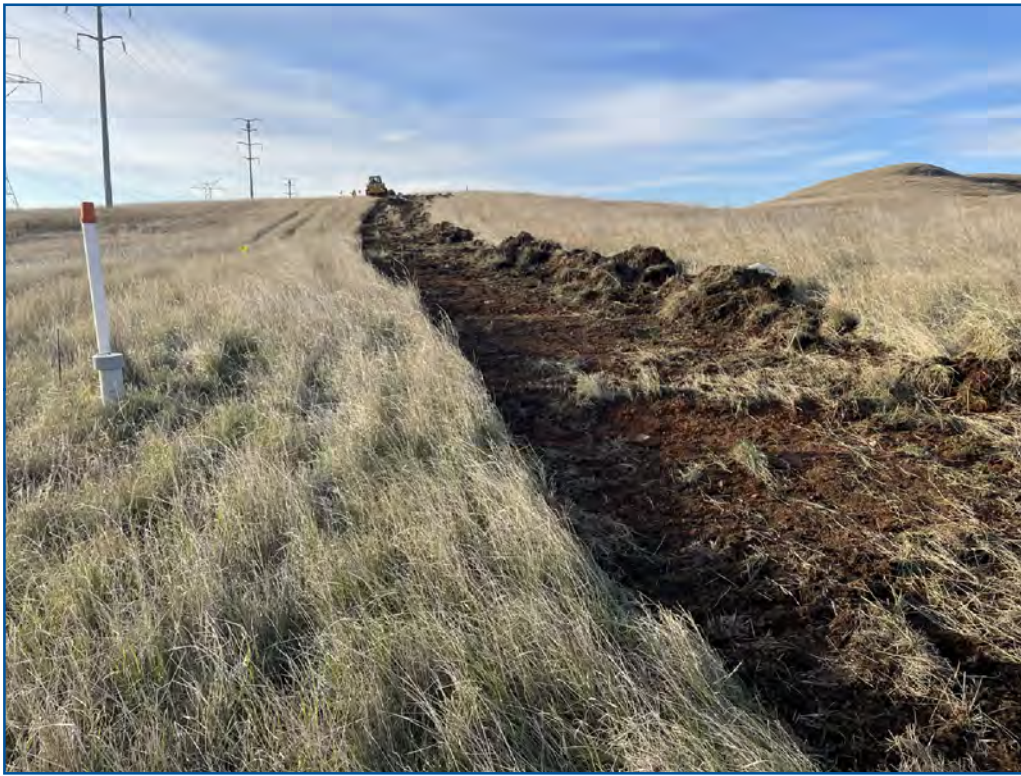
Map 1 of 8  
**DAKOTA CARBON PIPELINE  
 TOPSOIL REMOVAL INSPECTION**  
**PU-21-150**

Date: 10/15/2021  
 Photo Direction: South  
 Comment: Initial top soil scrape.

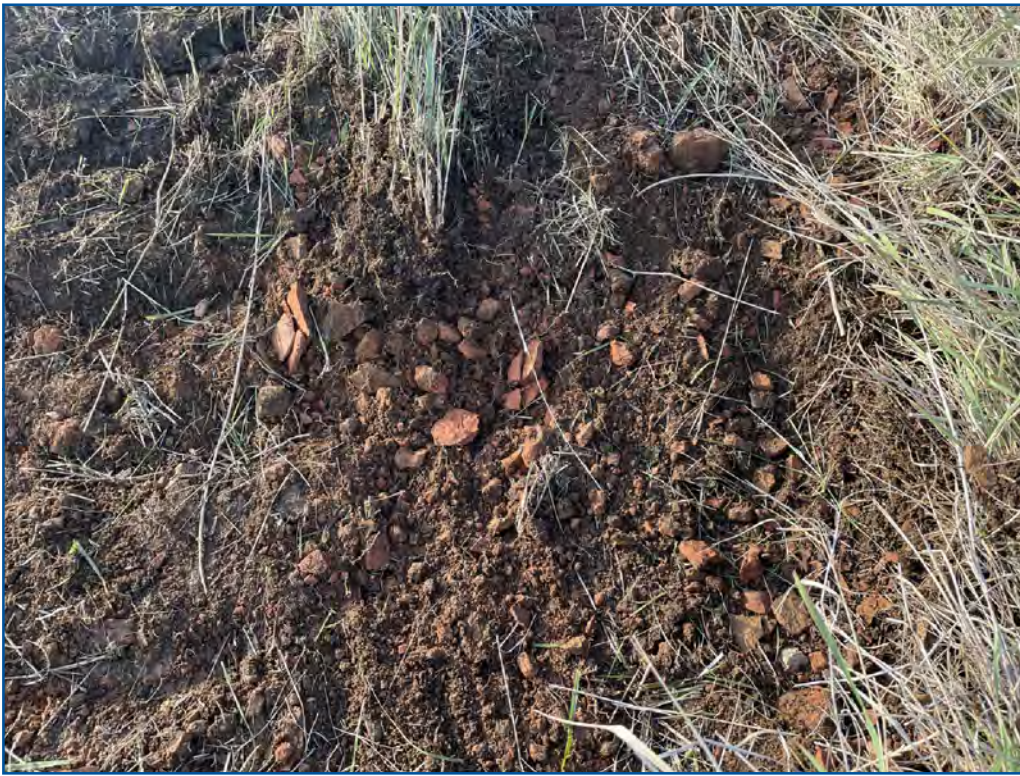
Map 2 of 8

Date: 10/15/2021  
 Photo Direction:  
 Comment: Scoria present in top soil, likely from previous mine reclamation.

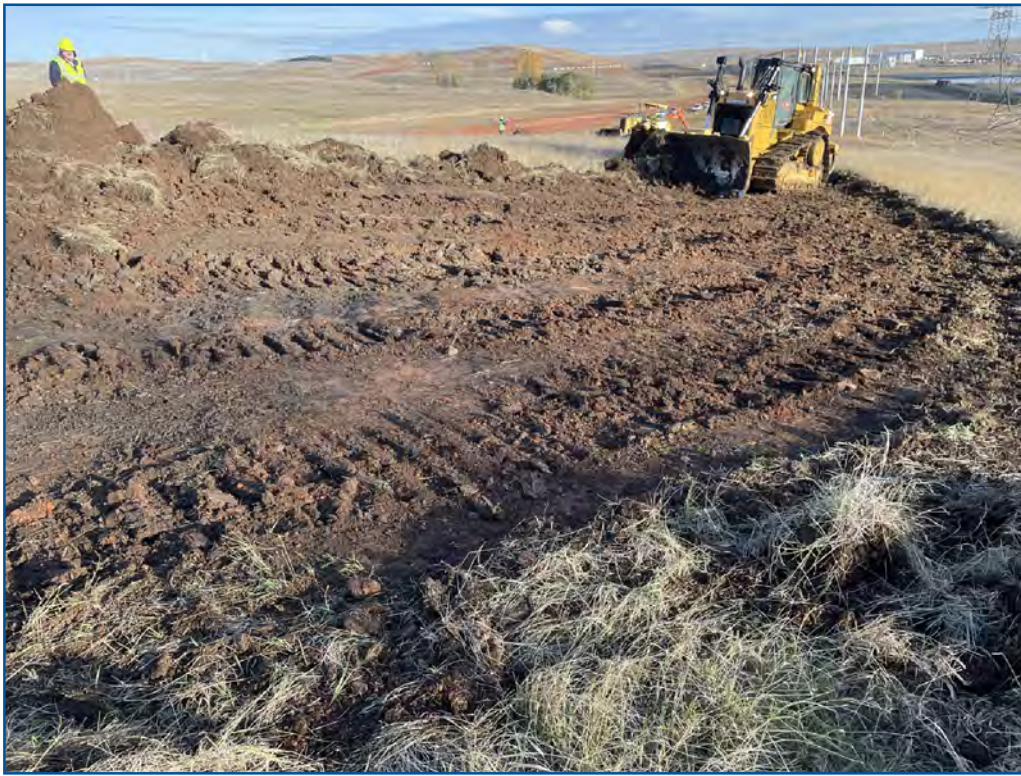
Map 3 of 8

Date: 10/15/2021  
 Photo Direction: North  
 Comment: Stripping occurring in layers.

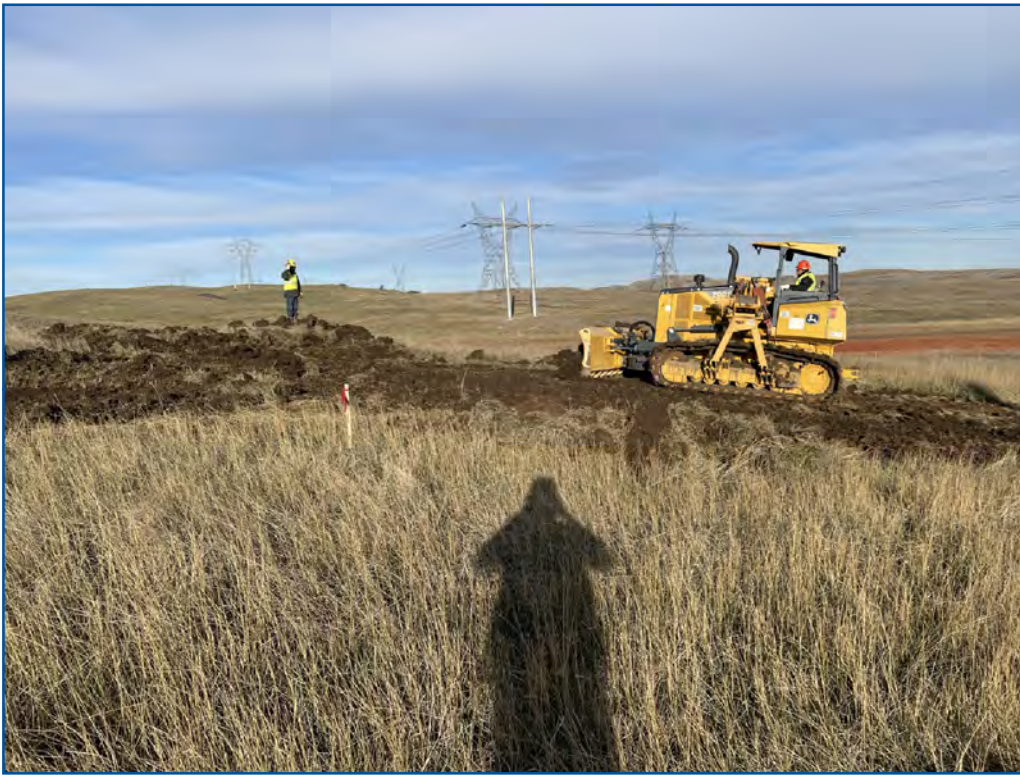
Map 4 of 8  
**DAKOTA CARBON PIPELINE  
 TOPSOIL REMOVAL INSPECTION**  
**PU-21-150**  
 North Dakota Public Service Commission  
 Mercer County, North Dakota

Date: 10/15/2021  
 Photo Direction: West  
 Comment: Spotters in use during stripping.

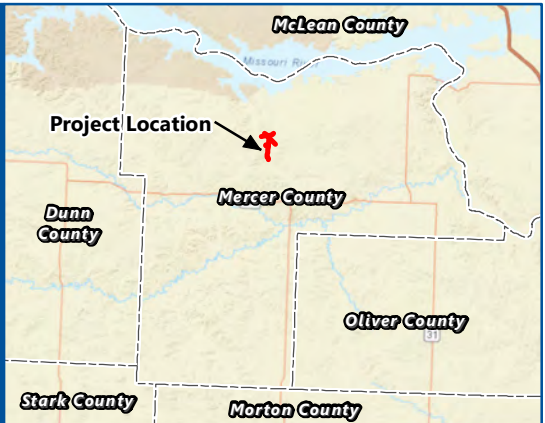
Map 5 of 8  
**DAKOTA CARBON PIPELINE  
 TOPSOIL REMOVAL INSPECTION**  
**PU-21-150**  
 North Dakota Public Service Commission  
 Mercer County, North Dakota

Date: 10/15/2021  
 Photo Direction: Northwest  
 Comment: Track hoe used to strip sensitive areas.

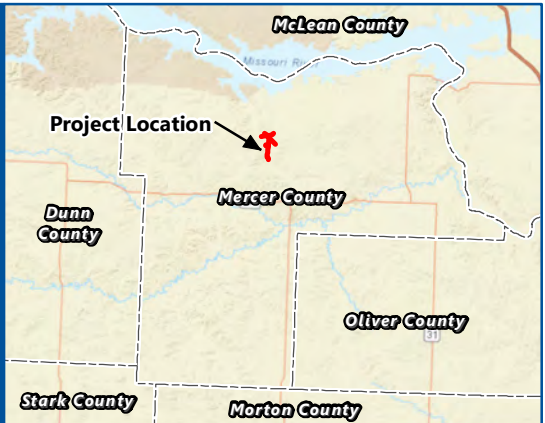
Map 6 of 8  
**DAKOTA CARBON PIPELINE  
 TOPSOIL REMOVAL INSPECTION**  
**PU-21-150**  
 North Dakota Public Service Commission  
 Mercer County, North Dakota

Date: 10/15/2021  
 Photo Direction: South  
 Comment: Topsoil segregation during removal.

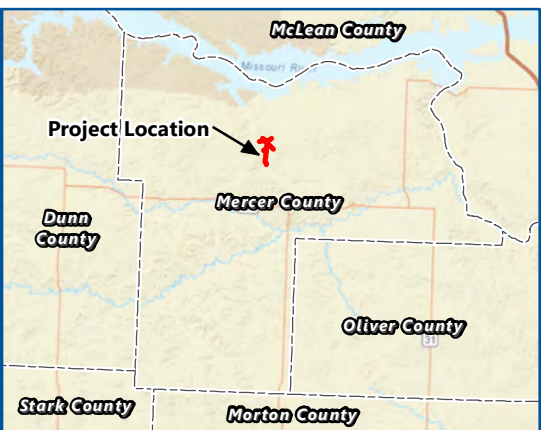
Map 8 of 8  
**DAKOTA CARBON PIPELINE  
 TOPSOIL REMOVAL INSPECTION**  
**PU-21-150**  
 North Dakota Public Service Commission  
 Mercer County, North Dakota

During the site inspection, topsoil segregation was observed by multiple operators as work started on one spread near west of Antelope Valley Station near Beulah, ND. Minor subsoil disturbance was noted during topsoil removal but was immediately corrected by spotters and equipment operators. Barr observed that topsoil depth varied in places on the ROW and spoke with project managers and operators to ensure that spotters and equipment operators use care during continuing topsoil removal.

Date: 10/15/2021  
 Photo Direction: West  
 Comment: Subsoil just visible in areas of topsoil removal.

Issues	Recommendations
<b>Minor disturbance of subsoil during topsoil removal</b>	Continue to utilize spotters and ensure operators are focusing on maintaining equipment blades at topsoil depth as removal continues.
