Dakota Carbon Pipeline Project- Mercer County

Reclamation Inspection Report

Docket Number: PU-21-150

Prepared for North Dakota Public Service Commission

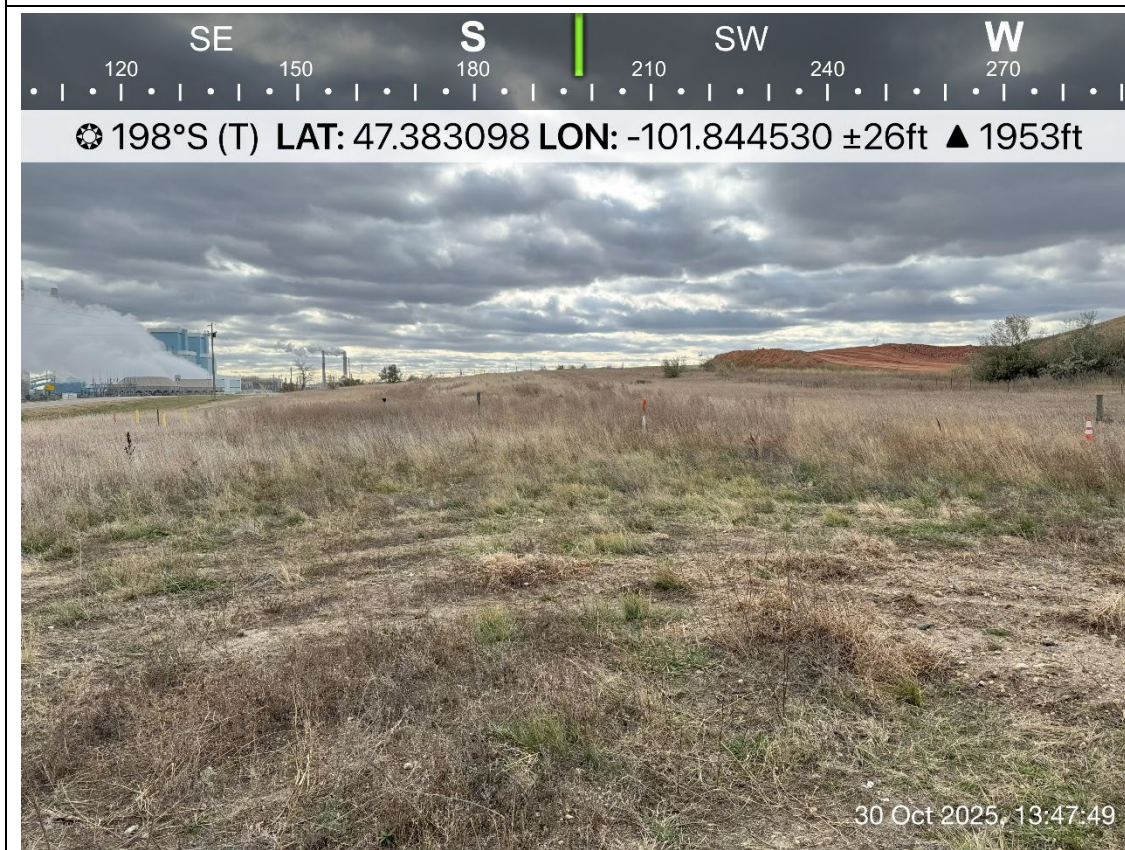
Mr. Peterson met Mr. Eslinger at the Dakota Gasification Antelope Valley Station to begin the inspection. The main 12-inch line was inspected first. The majority of the main line is located along the County Road 26 roadway. The pipeline ROW where the main line was located along the west and east sides of County Road 26 was completely vegetated with a mix of native grasses and encroaching nonnative species that make up the majority of the surrounding landscape. No issues were observed with the main line reclamation, and the ROW appeared to be reclaimed properly, and vegetation was similar to the adjacent areas.

Photo #: 2
Direction: South
Description: 12-inch main line ROW along west side of County Road 26.
Observer: Zach Peterson
Date: 10/30/2025
Latitude: 47.383098
Longitude: -101.844530

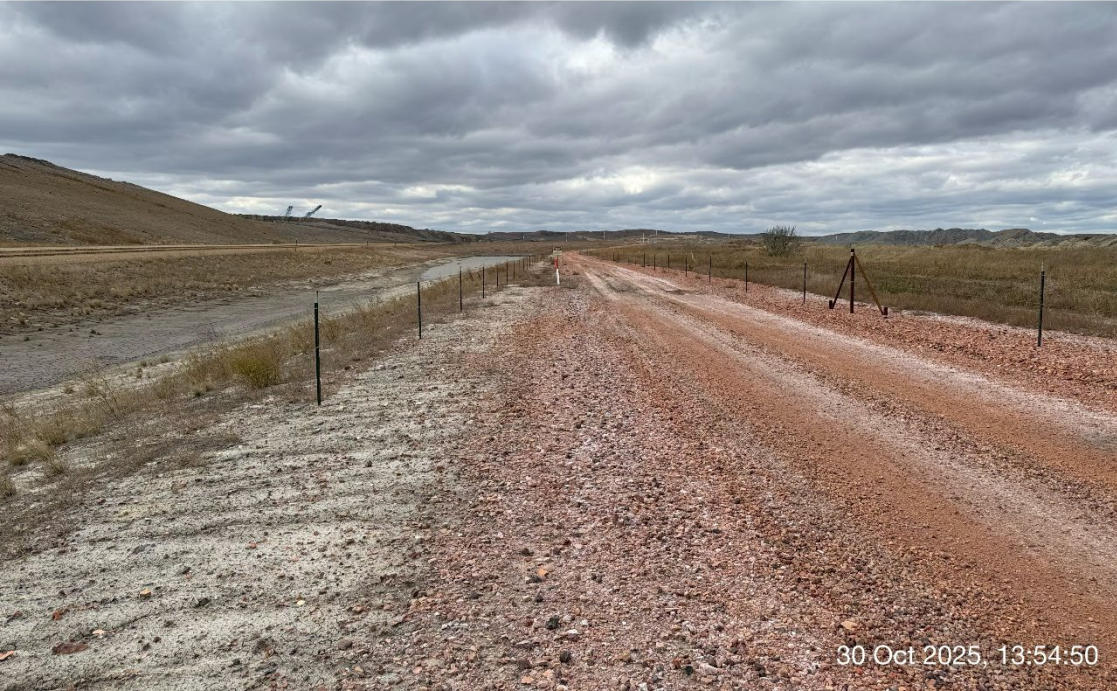
Branch 1 of the 6-inch pipeline was bored underneath an access road to the Coteau Mine and did not appear to have any reclamation related issues. Branch 2 of the 6-inch pipeline runs through pasture and hayland. The Branch 2 ROW appeared to be composed of vegetation similar to the adjacent areas on both sides and did not appear to have any reclamation issues. Branches 3 and 4 of the 6-inch pipeline were located in CRP and cropland with vegetation similar to the adjacent areas with no reclamation issues noted. Branch 5 of the 6-inch pipeline crossed through CRP and had vegetative composition similar to the adjacent areas with no reclamation issues noted. Branch 6 of the 6-inch pipeline also ran through mostly CRP with similar plant composition to the areas adjacent to the ROW. Plant composition of the branch lines were composed of a mix of seeded native grasses and invasive non-native plants that made up the majority of the vegetation on the areas directly adjacent to the ROW.

<p>30 Oct 2025, 13:54:50</p>	<p>Photo #: 3</p> <p>Direction: West</p> <p>Description: Branch 1 of 6-inch line running underneath access road to Coteau Mine.</p> <p>Observer: Zach Peterson</p> <p>Date: 10/30/2025</p> <p>Latitude: 47.386395</p> <p>Longitude: -101.847464</p>
<p>NW 300 N 330 0 NE 30 E 60 90</p> <p>☉ 22°NE (T) LAT: 47.392459 LON: -101.843953 ±2788ft ▲ 1952ft</p>

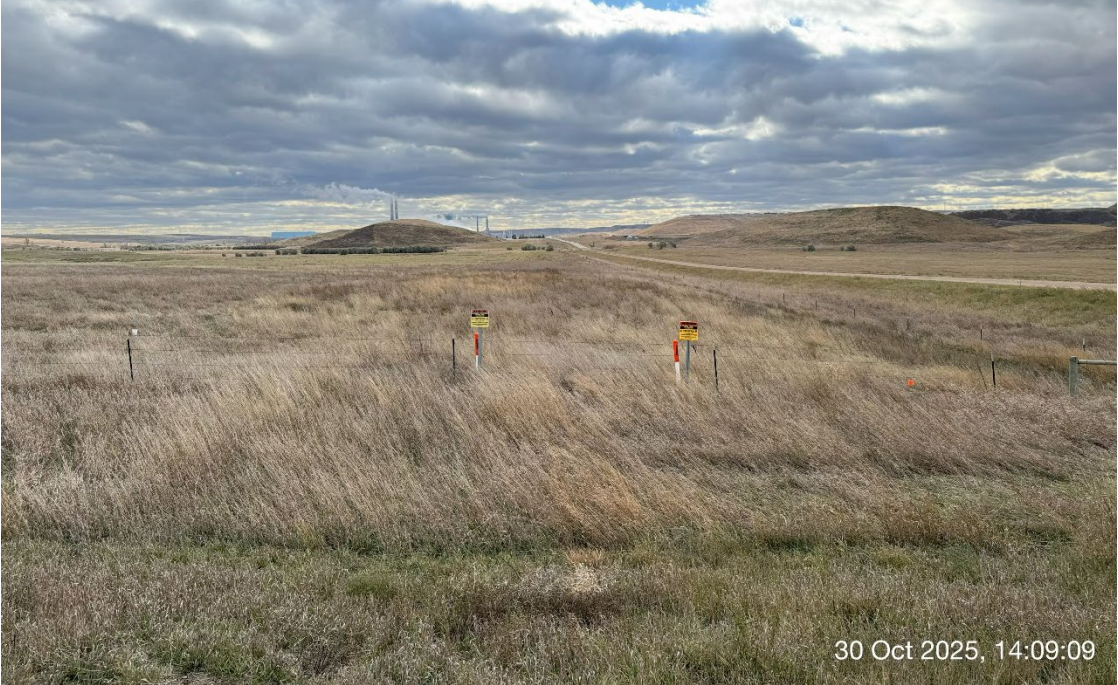
<p>E 90 SE 120 150 S 180 SW 210 240 W 270</p>	<p>Photo #: 5</p> <p>Direction: South</p>
<p>🌐 182°S (T) LAT: 47.400433 LON: -101.843456 ±16ft ▲ 1976ft</p>	<p>Description: Branch 2 of 6-inch line running southeast through pasture and hayland.</p>

Potential Issues	Recommendations
Noxious Weeds	Monitor the Project ROW for noxious weeds and manage weeds as necessary.

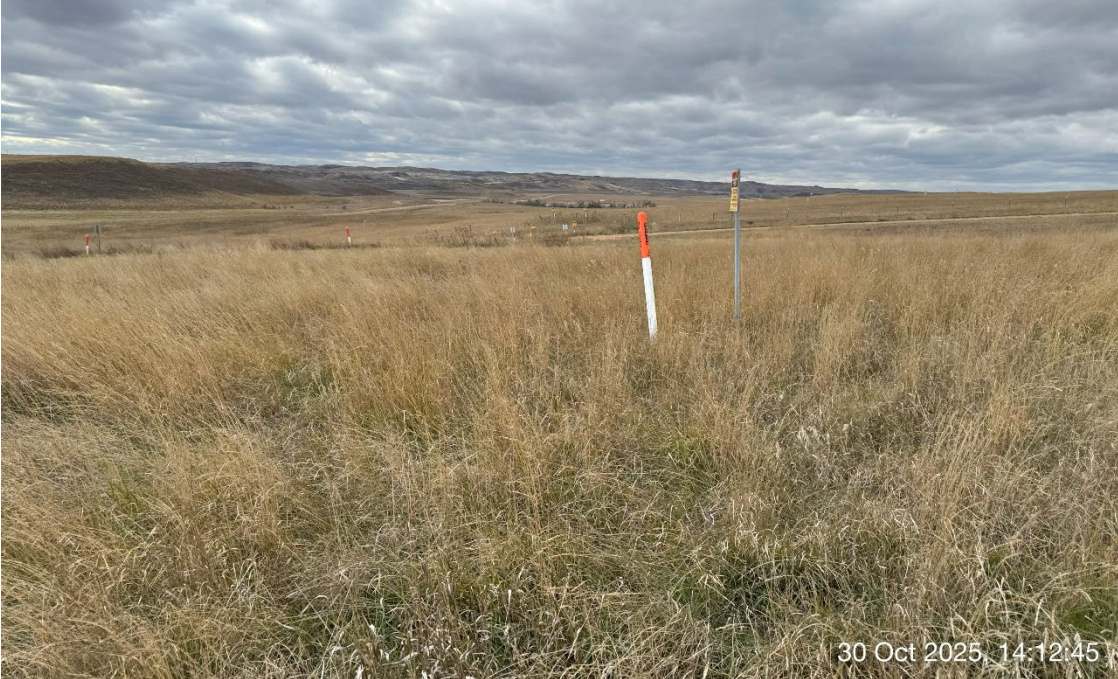
<p>S 180 SW 210 240 W 270 NW 300 330</p>	<p>Photo #: 6</p> <p>Direction: West</p>
<p>🌐 263°W (T) LAT: 47.402070 LON: -101.842977 ±16ft ▲ 2013ft</p>	<p>Description: Branch 4 of 6-inch line running along north side of County Road 15.</p>
