INSPECTION REPORT

DATE OF INSPECTION: September 8, 2021

PERMITTEE - MINE: Falkirk Mining Company - Falkirk Mine

PERMITS INSPECTED: NAFK-8405

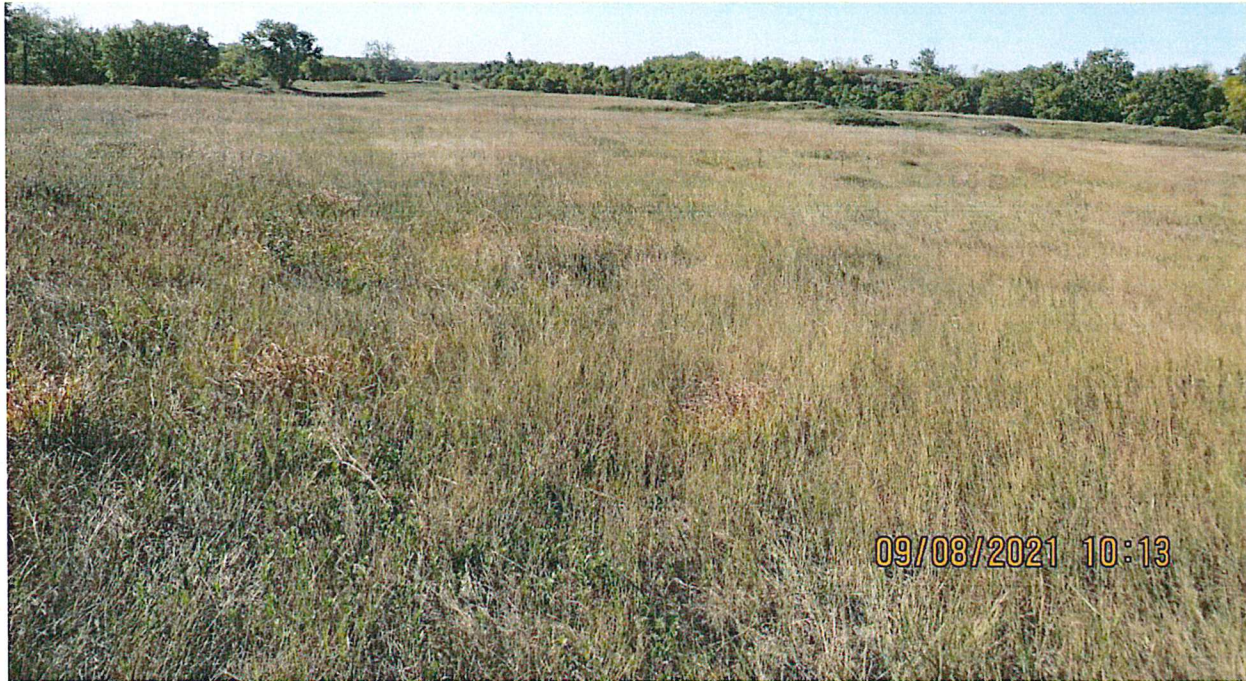
The reclaimed native grassland and re-disturbed orphan spoil are supporting a dense stand of native and introduced species and there was no evidence of any erosion. The principal species established on the reclaimed grassland and orphan spoil were western wheatgrass, sideoats grama, Kentucky bluegrass, smooth brome grass, big bluestem and switchgrass (**Figure 3**). Native and introduced forbs, such as Missouri goldenrod, cicer milkvetch, and buckbrush were also observed. The reclaimed pond site and diversion that was seeded in 2015 in Section 23 is dominated with pubescent wheatgrass, western wheatgrasses, and quackgrass while the 2015 and 2018 seedings in Section 24 are dominated with native grasses, primarily western wheatgrass, sideoats grama, green needlegrass, big bluestem, and smooth brome grass. The reclaimed cropland in Section 24 that was seeded in 2018 (**Figure 4**) is becoming established with perennial grasses but annual weeds continue to persist in places. It appears this reclaimed cropland was seeded to the native grassland seed mixture rather than the temporary seed mixture since sideoats grama, green needlegrass, blue grama and switchgrass were observed along with smooth brome grass. This 2018 seeding was recently hayed (**Figure 5**) and is sufficiently established with perennial species to protect the soil from erosion.

Figure 3. 1995 native grassland seeding in the SE $\frac{1}{4}$ SE $\frac{1}{4}$ of Section 23. Area is well established with native and introduced perennial vegetation.

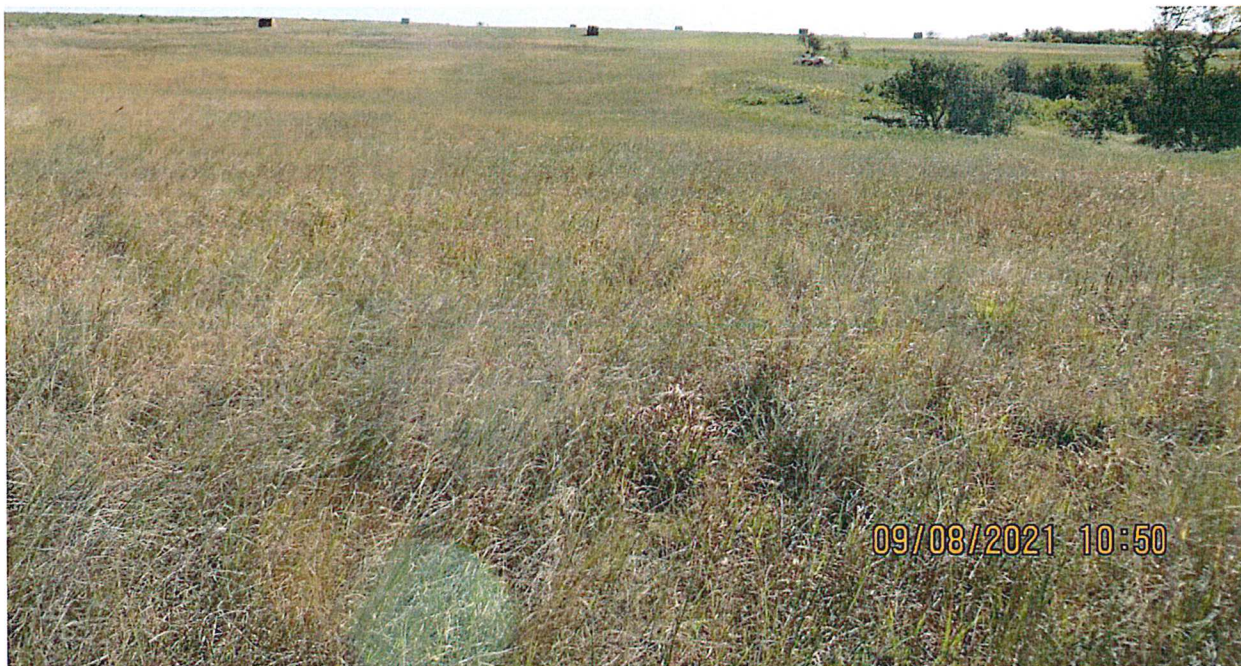
Figure 4. 2015 seeding in the NW $\frac{1}{4}$ SW $\frac{1}{4}$ of Section 24 is well established with native and introduced perennial vegetation.

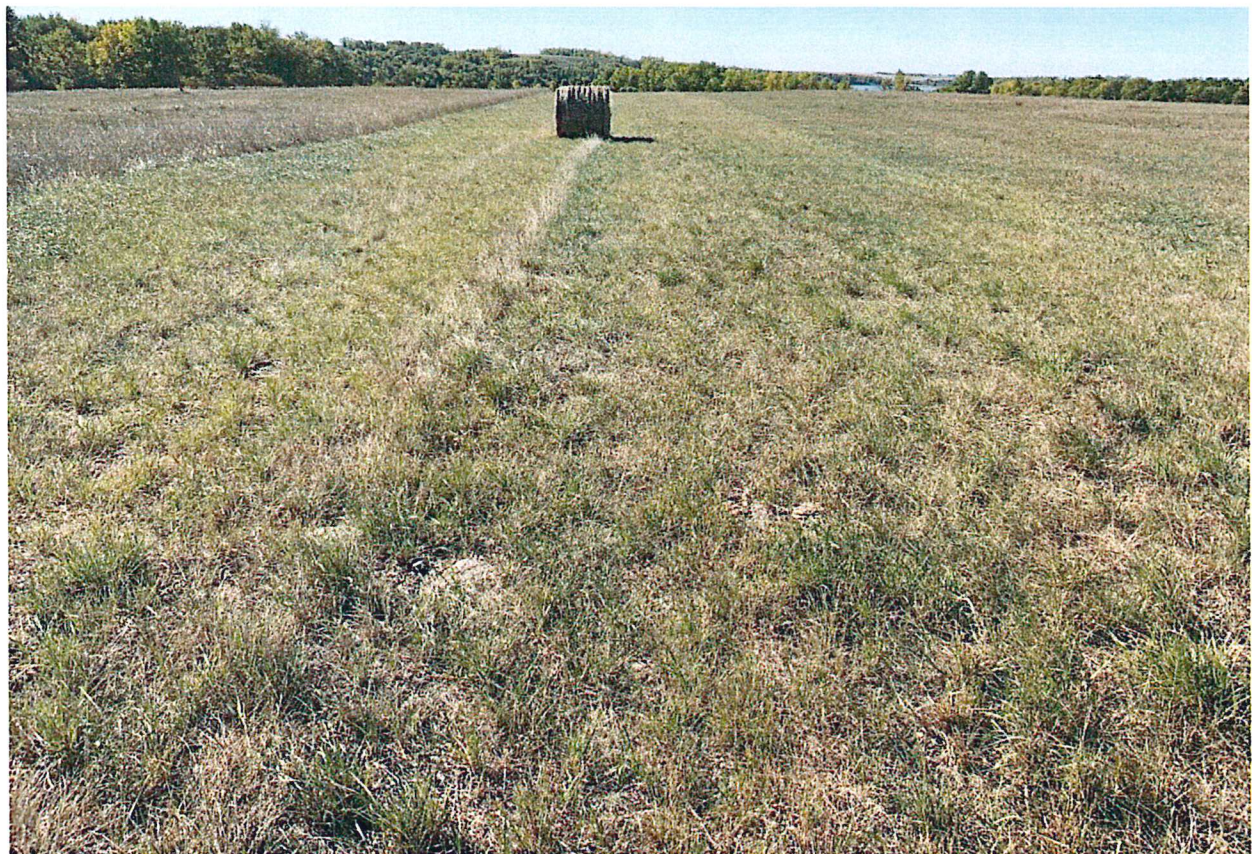
Figure 5. Recently hayed portion of the 2018 seeding area in the NW¼SW¼ of Section 24.

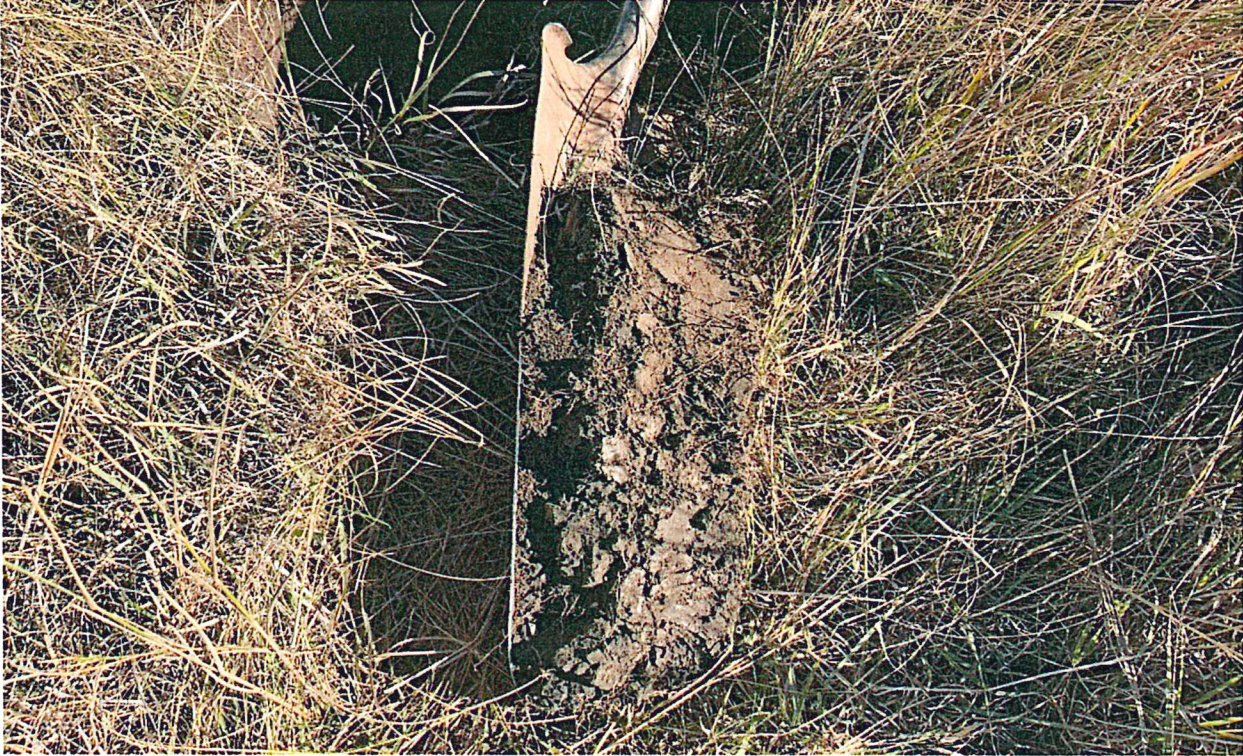
was 24 inches (10 inches of topsoil and 14 inches of subsoil). The topsoil respread depth was verified on each grade approved area with a 15-inch tile spade and/or a 10-inch soil-sampling probe. Topsoil respread depths observed in the field averaged over 10 inches. **Table 1** identifies the topsoil respread depths and the locations where depths were verified. Two locations of topsoil respread depth are shown in **Figures 6 and 7**. Topsoil depth-check locations and the GPS point track log of the inspection route are depicted in **Figure 8**.

Figure 6. Topsoil respread depth checked with a 15-inch tile spade at location No. 1 in the SE¹/₄SE¹/₄ of Section 23.

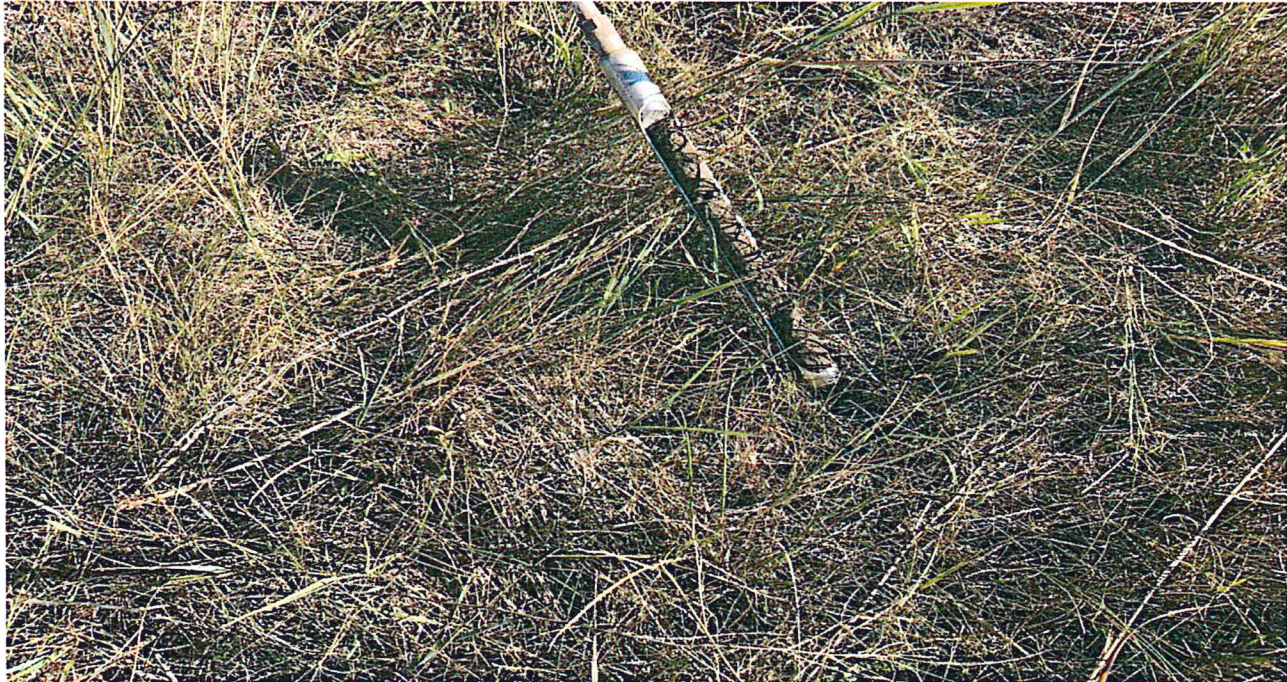
Figure 7. Topsoil respread depth checked with a 10-inch soil probe at location No. 1 in the SE¹/₄SE¹/₄ of Section 23.
