Site/Project Location: MDU 12" Water Pipeline

Date of Inspection: 22 June 2022

Keitu staff visited the MDU 12" Water Pipeline project for a construction inspection. Inspection of construction site focused on (1) confirming surface disturbance/work occurring within ND PSC-approved work corridor and/or route; (2) topsoil segregation occurring; (3) vegetation removal consistent with tree & scrub mitigation plan; and (4) storm water runoff and sediment control.

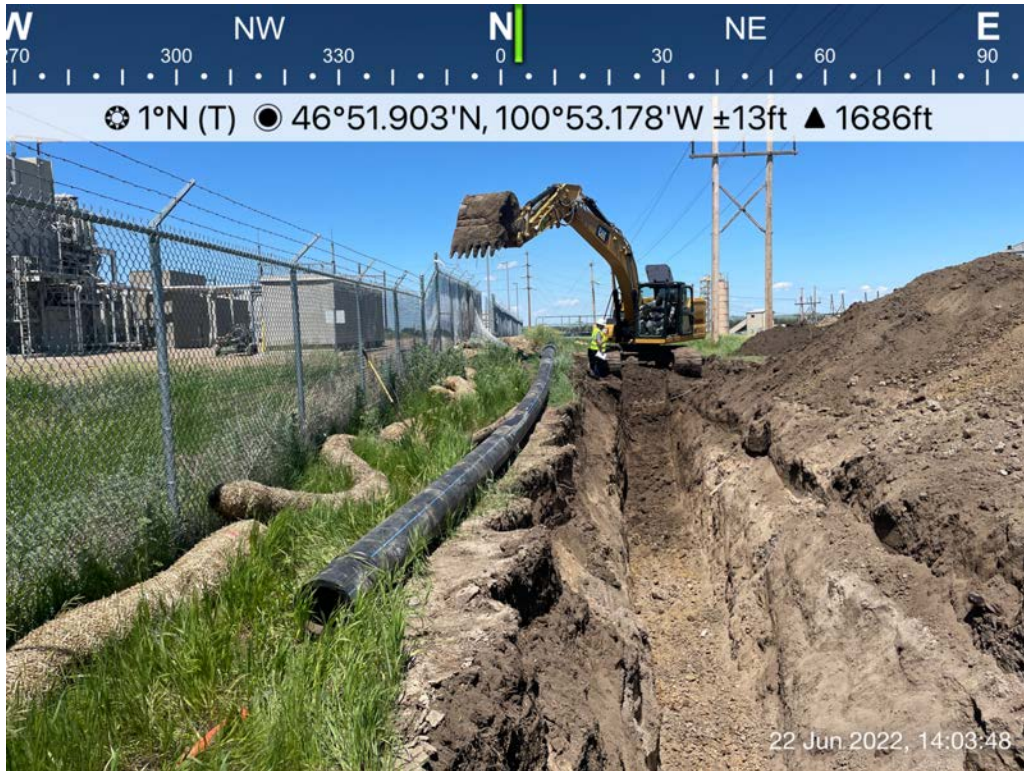
Trenching activities observed during the inspection consisted of an excavator removing subsoil to a depth of 12-13 feet and backfilling with the removed subsoil once the pipe was in the ground. Trenching activities were nearly complete for the Project at the time of the inspection. The ROW was walked and found to be in good condition and silt fences on both sides of the ROW were working properly.

Report Photo #1 "Trenching Activities Near Heskett Tie-In"

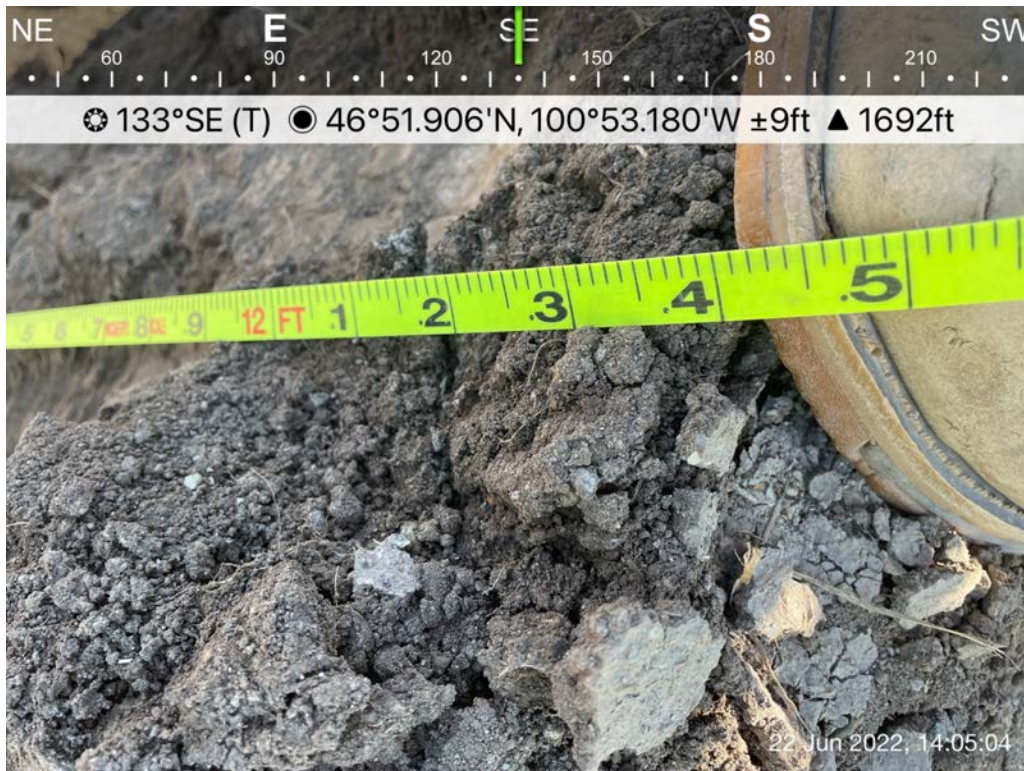
Report Photo #2 "Trench Depth"

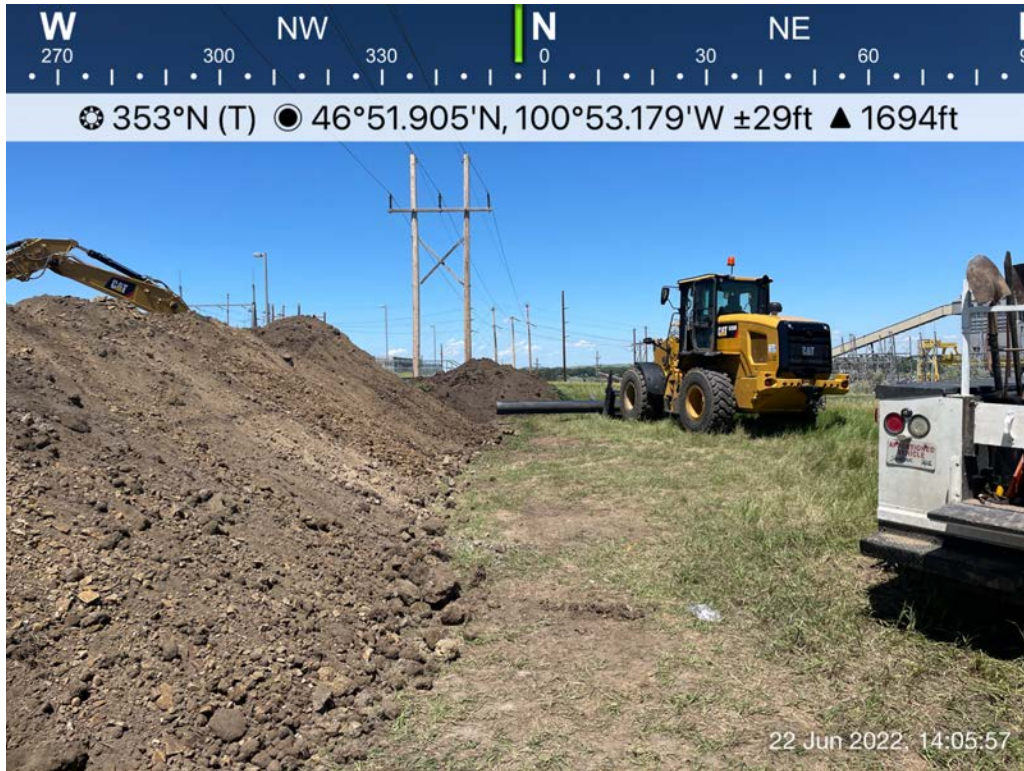
During the inspection, stripped topsoil was segregated in berms on one side of the ROW. There were no subsoil piles on the ROW as all excavated subsoil was replaced as backfill during trenching activities. The outside of the areas cleared for boring activities. The topsoil piles were properly segregated from any removed subsoil. Erosion control and stormwater management BMPs were in good condition and working effectively.

Report Photo #3 "Subsoil Piles During Trenching Activities"

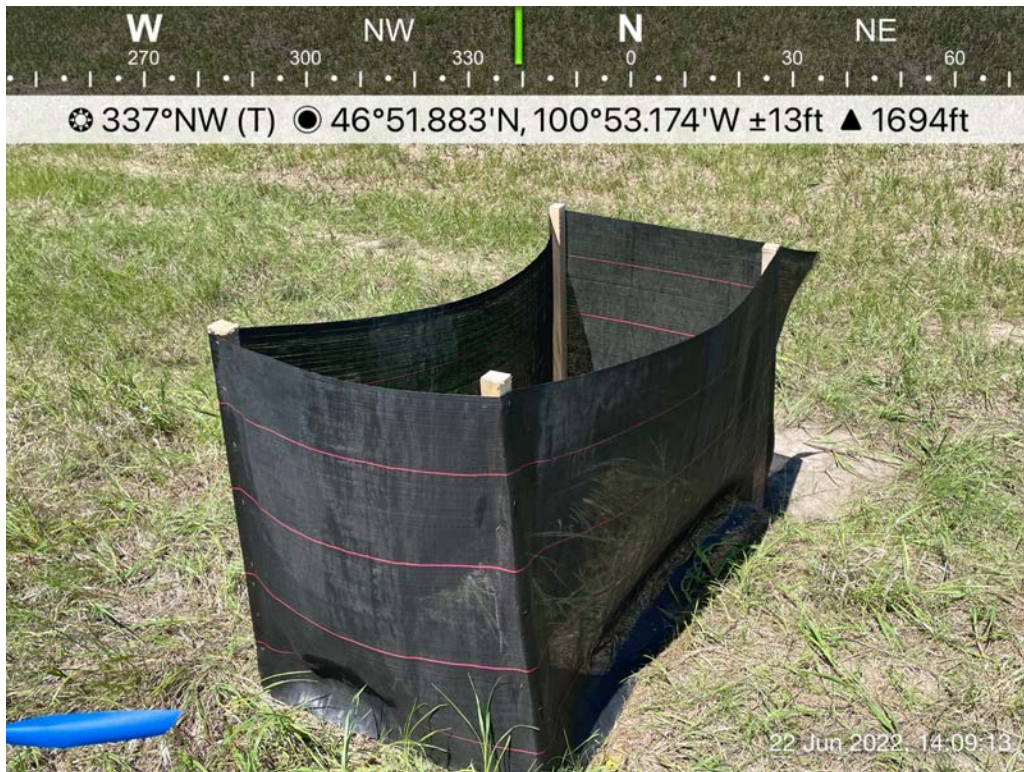
The 12" pipeline project has been underway since May of 2022. At the time of the inspection, construction activities consisted of completing the HDD bore under 38th Street. Topsoil was cleared along the ROW and the pipe was in the ground and backfilled with subsoil. A second HDD bore underneath a wetland area was completed prior to the inspection.

Report Photo #4 "Bore Location Under 38th Street"

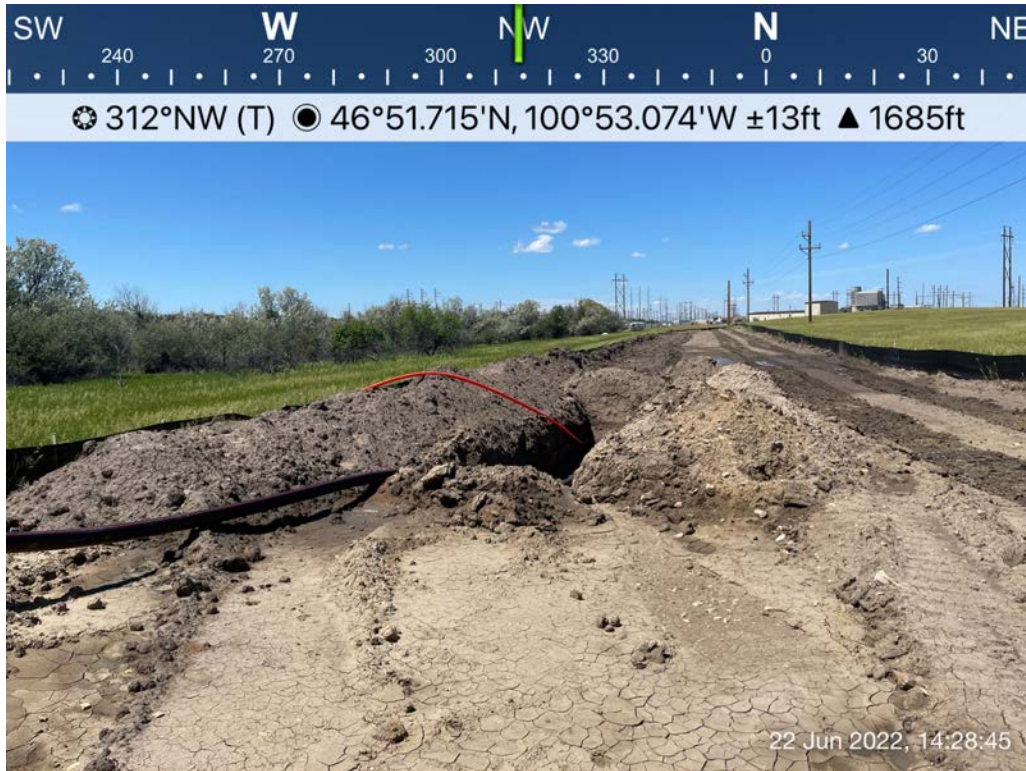
Report Photo #5 "Bore Location on North Side of Wetland"

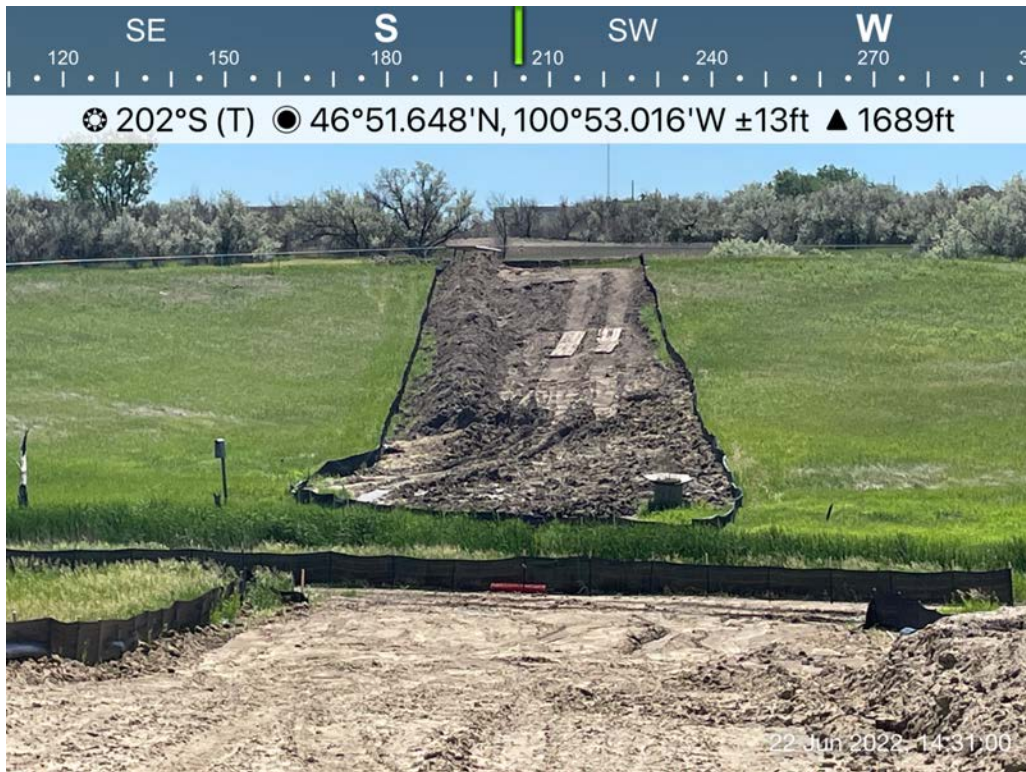
Report Photo #4 "Bore Location on South Side of Wetland"
