Permit ID: KRSB-8603
Subject: NOV 2201-Investigation of Embankment Failures

The following is in response to Notice of Violation #2201, dated May 25, 2022, regarding completion of the *Investigation of the Embankment Failures* within 20 days of the receipt of the NOV.

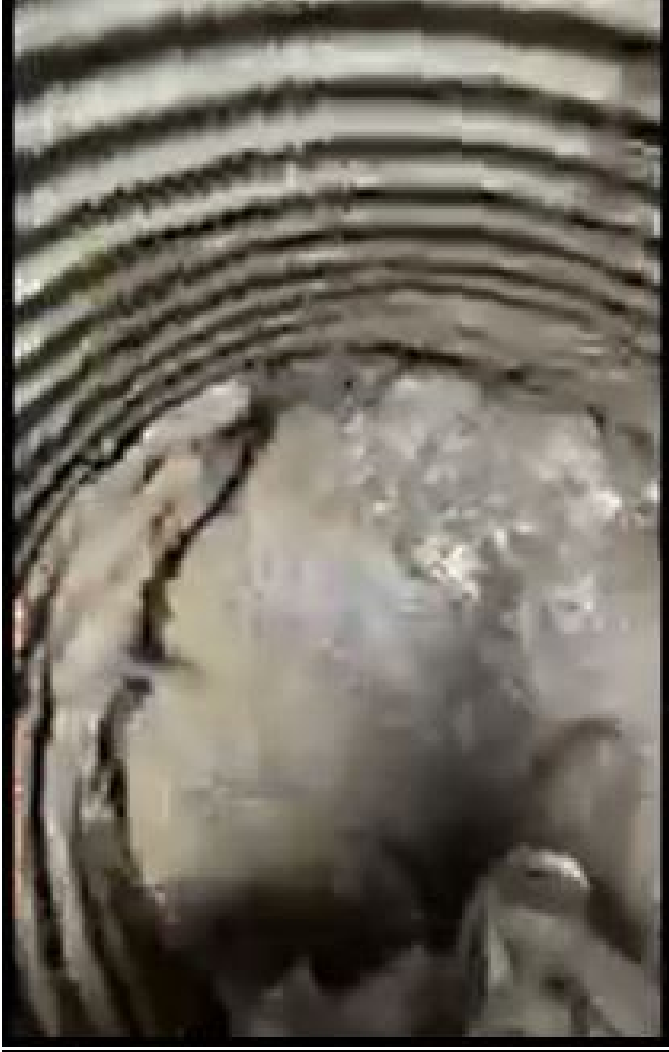
Erosion around the 36-inch vertical standpipe was caused by rusting that occurred at the connection of the standpipe to the bottom faceplate. The rusting allowed water to erode around the base of the vertical standpipe, prior to the water entering the downslope culvert. Westmoreland Beulah Mining (WBM) had a culvert contractor evaluate the rusting to determine the best corrective action to fix the issue. One alternative was to sleeve the entire pipe and grout between the sleeve and the original pipe. Because of the near 90-degree turn in the pipe, sleeving could not be done. The next alternative was to cement, in-place, the base of the standpipe to fully seal the rusted area. The rusted area extends approximately 6 to 8 inches above the base plate about a foot in circumference in the standpipe. The concrete in-place alternative appears to be the best solution to the piping. Once concreted, the piping area around the standpipe will be packed in place with suitable, dry material. Either after or prior to construction, the downslope culvert will be cleaned of any extraneous sediment.

Pond 081 Vertical Standpipe Base, June 1, 2022

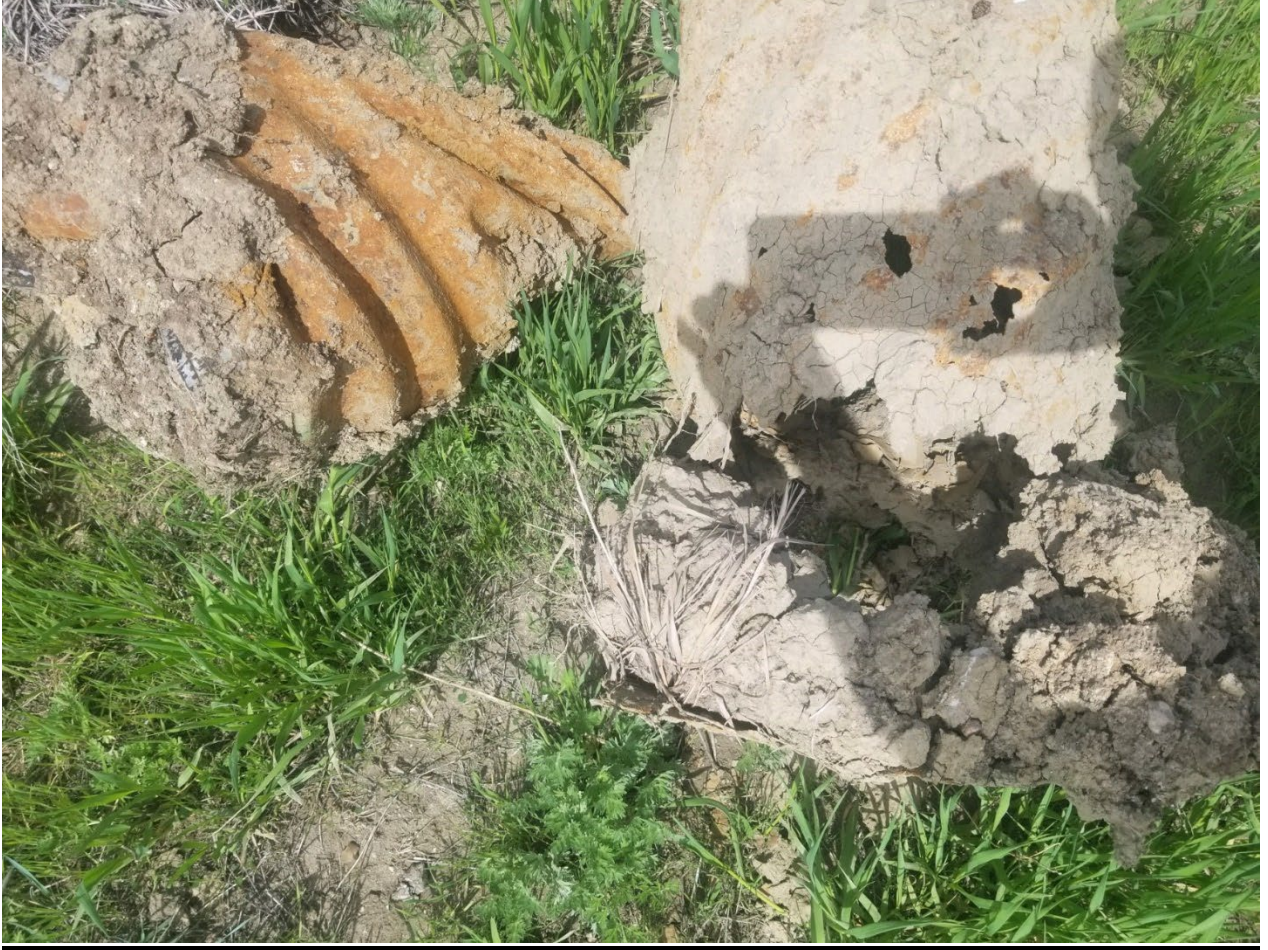
As with Pond 081, erosion around the standpipe was caused by rusting that occurred at the connection of the vertical standpipe to a 90-degree elbow. The rusting cannot be concreted in place because of the size of the standpipe and elbow. A new High-Density Polyethylene (Poly) elbow and standpipe will be connected to the existing downslope culvert. The new poly structure will be 10-inch in circumference, and will slip inside the existing 12-inch downstream culvert. A foam grout will be used to seal the Poly elbow to the downstream culvert, and the new Poly elbow will be concreted to the faceplate to hold it in place. Once completed, the piping area around the standpipe will be packed in place with suitable, dry material. Either after or prior to construction, the downslope culvert will be cleaned of any extraneous sediment.

Pond 082 Vertical Standpipe Base, June 1, 2022
