Petition for Reconsideration, Notice of Route Adjustment and Request for Limited Rehearing

SCS Carbon Transport LLC Midwest Carbon Express CO2 Project **Sitting Application**

CASE NO. PU-22-391

This report summarizes the results of a Phase II Landslide Assessment (Phase II Assessment) completed by Geosyntec Consultants, Inc. (Geosyntec) for 16 possible landslide locations that were identified by others along Summit Carbon Solutions' (SCS') proposed carbon capture pipeline system in North Dakota, USA. A Phase II Assessment consists of visual assessment by conducting a non-invasive (i.e., no ground disturbance) ground reconnaissance at possible landslide sites that are typically identified during a desktop assessment (e.g., Phase I Geologic Hazards Assessment) and have not previously been field assessed with respect to the project objectives.

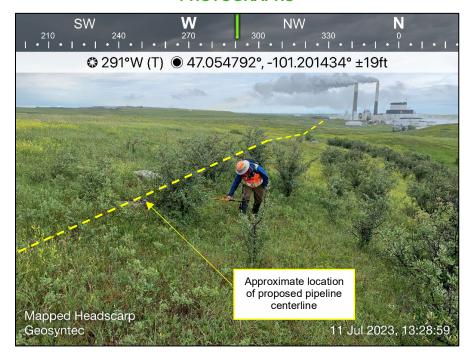
The morphology observed at Site #2 appears consistent with a dormant landslide on a northeast facing slope. The landslide boundary mapped by the NDGS was approximately 250 feet long and 450 feet wide. The direction of landslide movement was northeast and perpendicular relative to the proposed pipeline centerline. The mapped and observed landslide headscarp intersected the proposed pipeline centerline over an approximate length of 130 feet and was less than 1 foot high while appearing to be highly weathered, rounded, and subdued. Downslope of the proposed pipeline centerline, the landslide body exhibited rounded and subdued hummocks less than 1 foot high while lateral flanks were indistinct. The rounded and subdued landslide toe was 2 to 3 feet high and located greater than 100 feet from the proposed pipeline centerline. No sharp or fresh landslide features were identified. The inferred landslide depth was estimated to be less than 4 feet based on the size and condition of the landslide features observed. At the time of the visit the feature was uniformly vegetated with mixed grasses and wooded shrubs less than 4 ft high. Another, smaller landslide boundary mapped by the NDGS that is located adjacent to, and southwest of, Site #2 was similarly evaluated due to its proximity to the proposed pipeline centerline. The landslide boundary mapped by the NDGS was approximately 135 ft long and 250 ft wide. The direction of landslide movement was northeast and perpendicular relative to the proposed pipeline centerline. The mapped and observed landslide headscarp was located approximately 15 feet downslope of the proposed pipeline centerline and was less than 1 foot high while appearing to be highly weathered, rounded, and subdued. Approximately 50 feet downslope of the proposed pipeline centerline, a series of distinct internal scarps approximately 2 to 3 feet high were observed within the mapped landslide boundary. The condition of the observed internal scarps suggests this area of the slope may have experienced localized ground movement in the past 10 years. The mapped landslide toe was 2 to 3 feet high and appeared rounded and subdued. The inferred landslide depth was similarly estimated to be less than 4 feet based on the size and condition of the landslide features observed. This evaluation was conducted by Geosyntec on 7/11/2023.

Looking northwest along the mapped headscarp of Site #2 where it intersects the proposed pipeline centerline. Geosyntec field personnel is pointing at the mapped headscarp that appeared as a <1 ft subdued slope break. The approximate location of the proposed pipeline centerline is represented by the dashed yellow line.

Five landslide sites are categorized as Class B landslides: Sites #2, #12, #14, #15, and #17. The landslides observed at Site #2 occur on a gentle side slope that is partially crossed by the proposed pipeline centerline. However, the area immediately upslope of the observed landslides is a broad and flat hilltop that contains sufficient workspace area. Geosyntec understands that SCS will propose a micro-reroute of the pipeline alignment approximately 75 to 100 feet to the west-southwest of the landslide. A small reroute would avoid intersecting the landslide and therefore the site is categorized as a Class B. Without a micro-reroute around the landslide, Site #2 would be considered a Class C site.

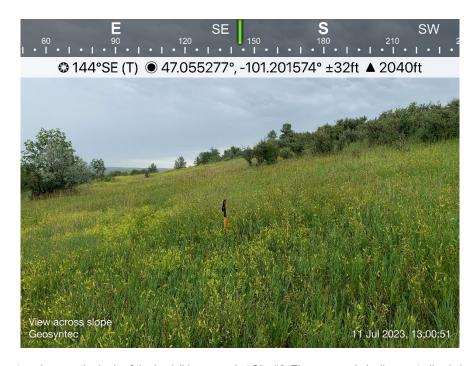
Looking southeastward across the body of the landslide mapped at Site #2. The proposed pipeline centerline is located out of view at the top of the slope to the right of the photo.

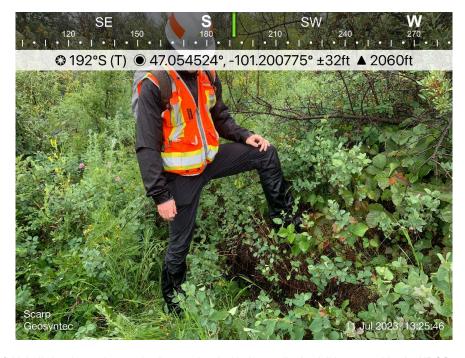
Example of a 2 ft high distinct internal scarp that is associated with the smaller landslide mapped by the NDGS to the southeast of Site #2. The feature is ~50 ft downslope of the proposed pipeline centerline.

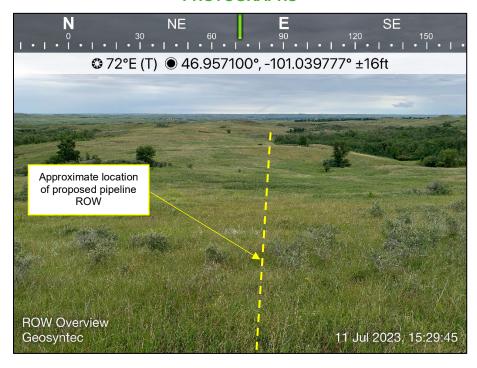
View to the east downslope along the proposed pipeline ROW. No apparent landslide morphology is visible in the photo. The proposed pipeline centerline is approximated by the yellow dashed line.

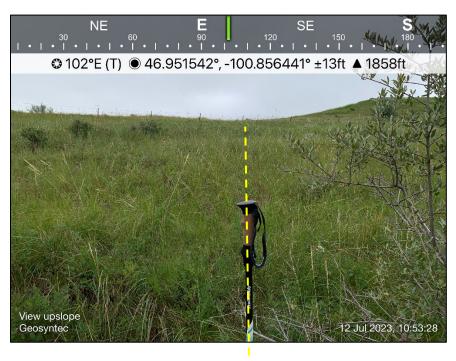
View of the overall slope looking southeast from the opposite slope. The terrain crossed by the proposed pipeline centerline appeared as a generally smooth and gradual slope with no evidence of landslide morphology exhibited. Multiple cattle trails traversed the slope and there was a distinct berm constructed to the south of the ROW. The proposed pipeline centerline is approximated by the dashed yellow line.

View facing east and upslope along the proposed pipeline centerline from within the mapped boundary. The slope was generally smooth and uniform with no observed geomorphic indicators of a landslide headscarp. The proposed pipeline centerline is approximated by the dashed yellow line.

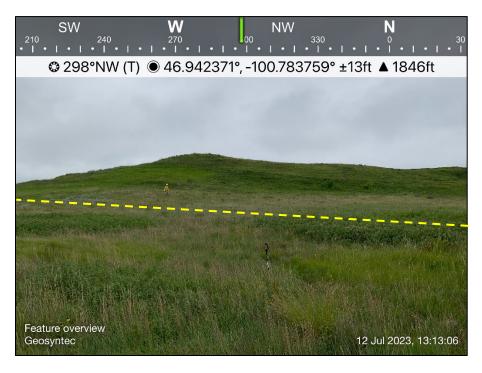
View facing east along the proposed pipeline centerline. The area is a generally smooth and gradual side slope with no discernible landslide morphology. The proposed pipeline centerline is approximated by the dashed yellow line.

View facing northwest and upslope across the proposed pipeline centerline. No discernible landslide morphology was observed as the slope increases in steepness towards the ridgetop. The proposed pipeline centerline is approximated by the dashed yellow line.

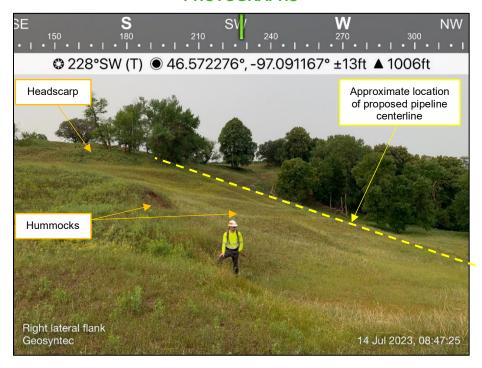
The morphology observed at Site # 12 appears consistent with a dormant landslide on a northwest-facing slope. The landslide boundary mapped by the NDGS was approximately 460 feet long and 1100 feet wide. The direction of landslide movement was northwest and axial relative to the proposed pipeline centerline. The proposed pipeline centerline crosses the center of the mapped landslide boundary. The observed landslide features were generally distinct but rounded with no discernible evidence of recent movement. The slope corresponding with the mapped headscarp was 10 to 12 feet high in the vicinity of the proposed pipeline centerline. Observed hummocks downslope of the mapped headscarp were rounded and approximately 4 feet high. The mapped landslide toe was up to 6 feet high and appeared to be modified or truncated by fluvial processes related to the Sheyenne River. West of the proposed pipeline centerline, a rounded headscarp up to 15 feet high and a rounded internal toe up to 10 feet high were observed with backward leaning trees up to 24 inches in diameter situated on the internal landslide body. The vegetation along the proposed pipeline centerline mostly consisted of grass up to 2 feet high with occasional deciduous trees. The inferred landslide depth was estimated to be 20 to 30 feet deep in the vicinity of the proposed pipeline centerline based on the size and condition of observed landslide features. A proposed HDD crossing for the Sheyenne River is planned for this location. Based on Geosyntec's review of the proposed HDD site plan and profile, including the proposed entry and exit points, the landslide morphology observed at this location would be avoided by the proposed pipeline as a result of HDD construction beneath the landslide. The evaluation was conducted by Geosyntec on 7/14/2023.

View facing southwest overlooking the landslide with the 4- to 10-foot-high headscarp slope and 4-foot-high hummocks visible in the background. The proposed pipeline centerline is approximated by the dashed yellow line.

Proposed HDD crossings are planned for the Sheyenne River coinciding with Site #12 and the Maple River coinciding with Site #14. Based on our review of the proposed HDD site plans and profiles, including the proposed entry and exit points for these river crossings, the landslides at Site #12 and Site #14 would be avoided through HDD construction beneath the landslides. The landslide observed at Site #15 is located about 98 feet away from the proposed pipeline centerline and there appears to be sufficient workspace area on both sides of the proposed pipeline centerline to avoid intercepting this landslide. Similarly, the landslide at Site #17 is located about 70 feet west of the proposed pipeline centerline, and there appears to be sufficient workspace on the east side of the proposed centerline such that avoidance of this landslide appears feasible. Therefore, we recommend that temporary workspace delineations do not intercept the landslides at Sites #15 and #17.

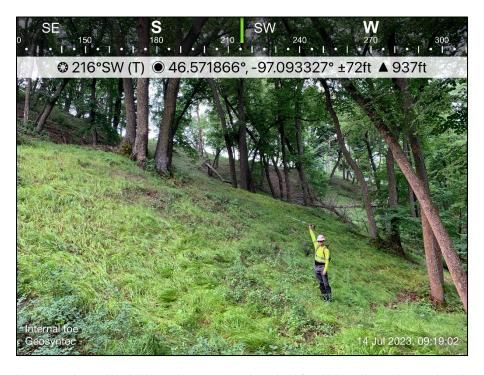
View facing southwest at an internal landslide toe that was approximately 10 feet high and located approximately 150 feet west of the proposed pipeline centerline.

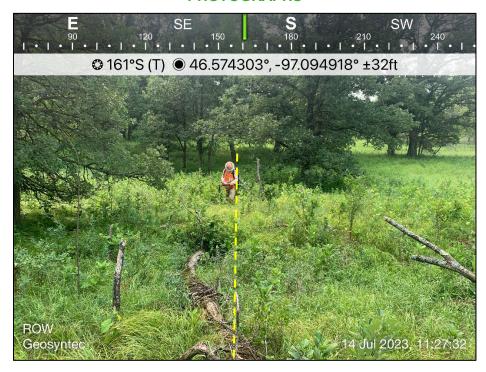
View facing south along the proposed pipeline centerline. The site consisted of a gradual and smooth slope with no evidence of landslide disturbance. The proposed pipeline centerline is approximated by the dashed yellow line.

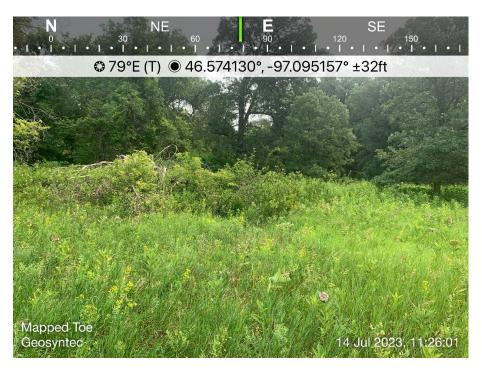
View facing east at the mapped toe which corresponded with a mound of material that did not appear consistent with a landslide toe and may be related to differential weathering of the underlying geologic material.

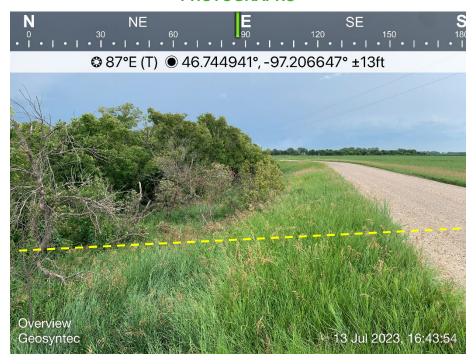
Looking east along the slope in the vicinity Site #14. The approximate proposed pipeline centerline is located near the center of the image (dashed yellow line). The proposed pipeline centerline crosses a possible recently active bank slump in the left portion of the image. Note the road was undisturbed.

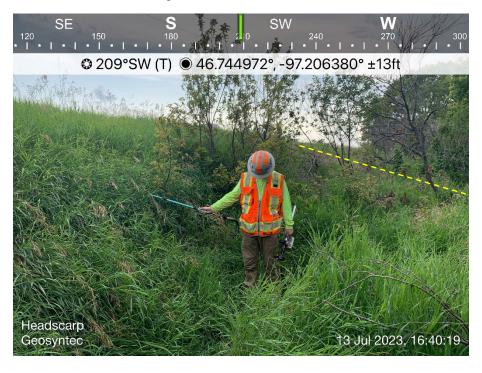
Looking southwest at a possible 3-foot high headscarp crossed by the proposed pipeline centerline. The approximate location of the proposed pipeline centerline is represented by the dashed yellow line.

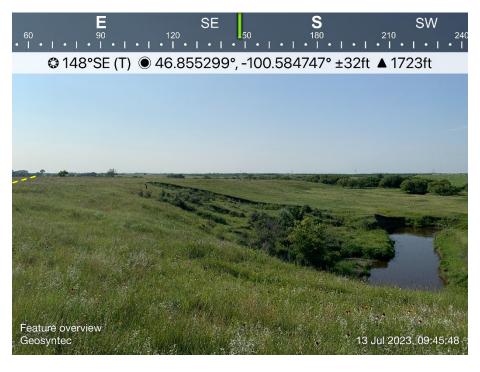
Looking southeast towards Site #15 mapped by the NDGS where recently active landslide morphology was observed approximately 98 ft from the proposed pipeline centerline. The approximate proposed pipeline is located at the far left of the image (dashed yellow line).

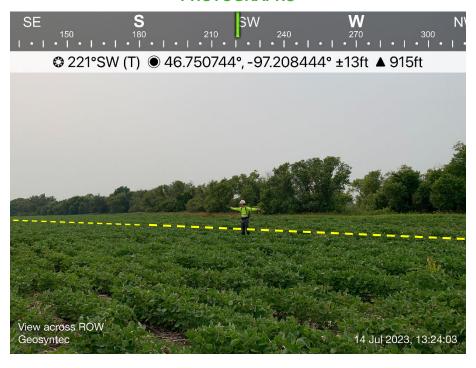
Looking southwest across the slope. The approximate proposed pipeline is located in the center of the image (dashed yellow line). Site #17 was located beyond the tree line in background of photo.

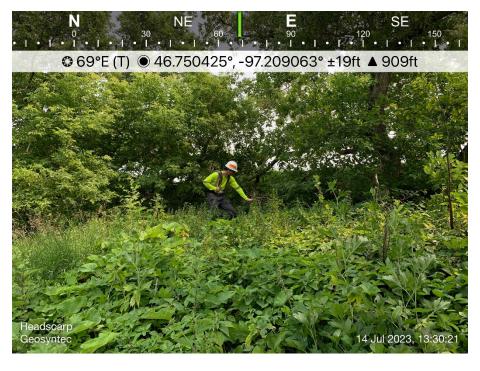
Looking northeast at the possible 3-foot high headscarp of the inactive bank slump at Site #17. The approximate proposed pipeline is located beyond the crest of the slope in a cultivated farm field.

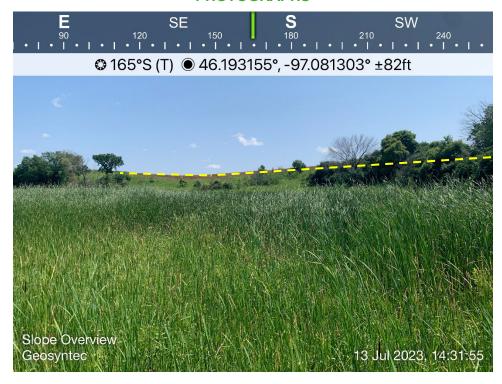
Looking south across the slope in the vicinity NDT-211 (MP 3.5-3.7). The approximate proposed pipeline is located in the center of the image (dashed yellow line). No landslide morphology was observed in the vicinity of the proposed pipeline.

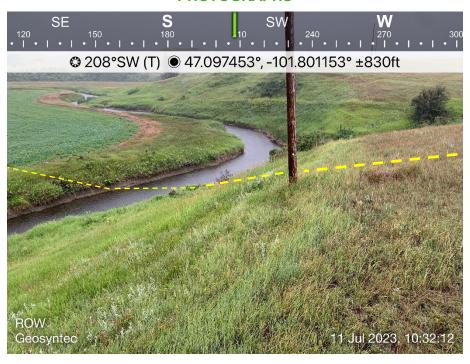
Based on the Phase II evaluation, no landslide morphology was identified along the proposed NDL-325B pipeline centerline between MP 4.6 and 4.7. The features observed between MP 4.6 and 4.7 included a steep slope adjacent to a small stream, an area of exposed soil likely related to minor erosion that was located to the west of the proposed pipeline alignment, and a drainage gully located to the west of the proposed pipeline. At the time of the site visit, the area crossed by the proposed pipeline centerline was uniformly vegetated with mixed grasses up to 2 ft high. The slope gradient along the proposed pipeline centerline was generally moderate to the north and low to the south. It is possible that the observed erosion features may have been misidentified as possible indicators of landslide activity as they resemble scarps or tension cracks when viewed in aerial imagery. The evaluation was conducted by Geosyntec on 7/11/2023.

Looking southwest across the slope in the vicinity NDL-325B (MP 4.6-4.7). The approximate proposed pipeline is located in the center of the image (dashed yellow line). No landslide morphology was observed in the vicinity of the proposed pipeline.

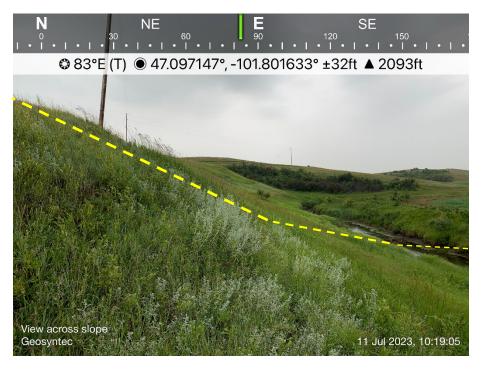
Looking east across the slope in the vicinity NDL-325B (MP 4.6-4.7). The approximate proposed pipeline is located in the center of the image (dashed yellow line). No landslide morphology was observed in the vicinity of the proposed pipeline.

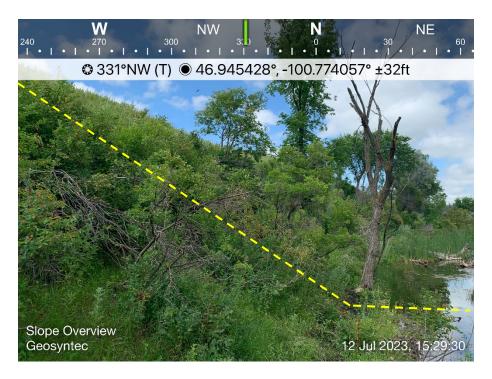
View across slope looking towards the north. The approximate proposed pipeline crosses the center of the image (dashed yellow line). A cattle trail is shown in the center of the photo.

View across slope looking towards the north-northwest. The approximate proposed pipeline crosses the center of the image (dashed yellow line). The observed oxbow lake is located along the right side of the image.

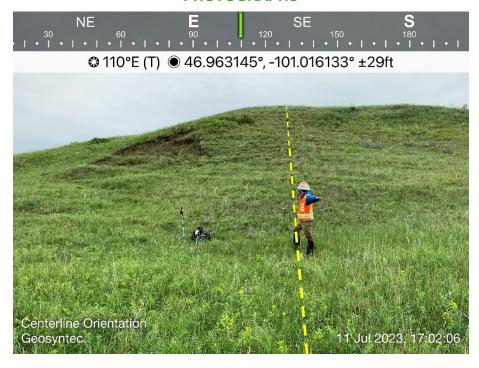
Based on the Phase II evaluation along the proposed NDM-106 pipeline between MP 145.3 and 145.4, a shallow landslide was observed on a west facing slope approximately 20 feet north of the proposed pipeline centerline. The landslide was relatively small and measured approximately 70 feet long by 25 feet wide. The direction of ground movement was west and axial relative to the orientation of the proposed pipeline centerline. The headscarp measured approximately 2 feet high, the left and right lateral flanks measured approximately 2 ft high, and the toe measured approximately 1-foot high. The landslide appeared to be inactive (>10 years old) based on the condition of the morphology observed. The landslide was estimated to be 1-2 feet deep based on the observed size of the landslide features and topography. At the time of the site visit, the landslide was uniformly vegetated with mixed grass up to 2 feet tall except where recent cattle activity had exposed bare soil within and around the landslide. The slope gradient along the proposed pipeline centerline was generally moderate and increased from west to east. The evaluation was conducted by Geosyntec on 7/11/2023.

Looking east-southeast along the slope in the vicinity NDM-106 (MP 145.3-145.4). The approximate proposed pipeline is located along center right of the image (dashed yellow line). Recently active shallow landslide morphology was observed approximately 20 ft from the proposed pipeline centerline.

Two landslide sites are categorized as Class A landslides: Site #7 and NDM-106 (MP 145.3-145.4). Site #7 exhibited questionable dormant landslide morphology while the adjacent mapped landslide to the south exhibited more definitive, but inactive landslide features. The landslide observed near the proposed NDM-106 pipeline between MP 145.3 and 145.4 appeared to be a relatively small and inactive surficial failure about 20 feet north of the proposed pipeline. Based on the inferred estimated depths of less than 4 feet for the landslides observed at Site #7, and less than 2 feet for the landslide observed at NDM-106 (MP 145.3-145.4), it is likely that any landslide morphology intercepted within the construction limits of disturbance would be removed by standard construction practices and no additional mitigative action is recommended beyond implementation of BMPs for pipeline construction along steep slopes, as warranted.

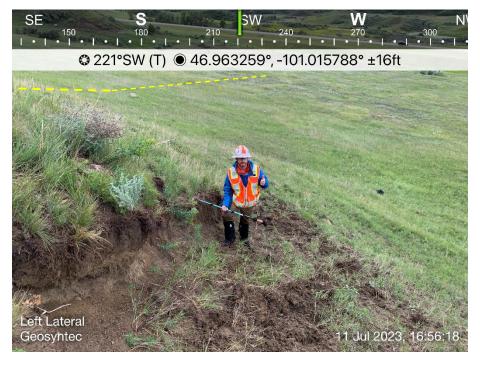
Looking southwest at the left lateral flank of the recently active shallow landslide. The approximate proposed pipeline is located along top left of the image (dashed yellow line). Recent cattle activity had exposed bare soil within the landslide.

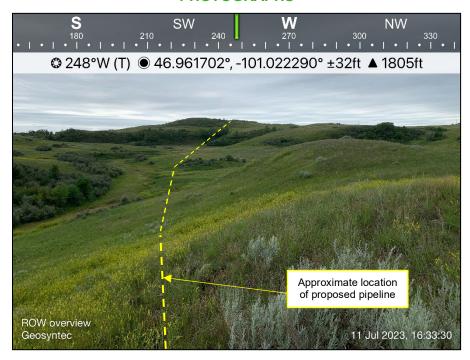
Looking southwest along the slope in the vicinity NDM-106 (MP 145.7-145.8). The approximate proposed pipeline is located along center left of the image (dashed yellow line). No landslide morphology was observed in the vicinity of the proposed pipeline.

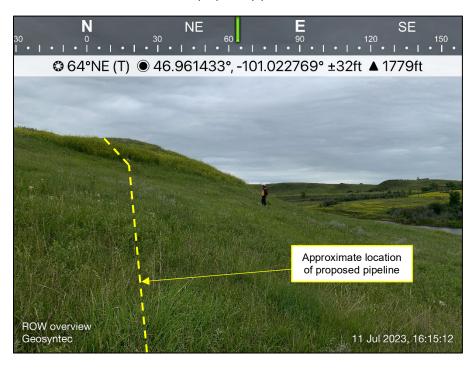
Looking northeast in the vicinity NDM-106 (MP 145.7-145.8) and along the proposed pipeline alignment, which climbs the ridgeline and appeared to be in good condition at the time of visit. The approximate proposed pipeline is located along center left of the image (dashed yellow line). No landslide morphology was observed in the vicinity of the proposed pipeline.
