In re: ONEOK Rockies Midstream, L.L.C.
Cherry Creek Extension Pipeline Project
McKenzie County
Case No. PU-23-015
Our File No. 072530-000018

ONEOK Rockies Midstream, L.L.C.
Cherry Creek Extension Pipeline Project

Tree and Shrub Mitigation Plan
for the North Dakota Public Service Commission
Case No. PU-23-015

February 2024

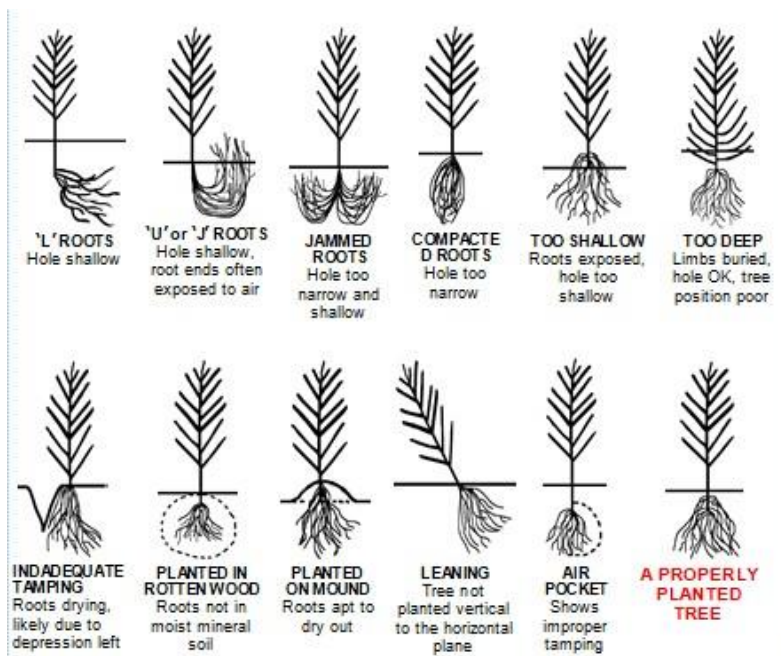
The planting trench or hole must be deep and wide enough to allow the roots to properly spread out and down. Trim roots of bare-root stock as need to prevent J-roots, L-roots, broken roots, or compacted roots. Do not trim roots more than needed, see Part 4.1. See Figure 2 for common planting issues and proper planting.

Rooted stock will be planted in a vertical position with root collars approximately ½ inch below the soil surface.

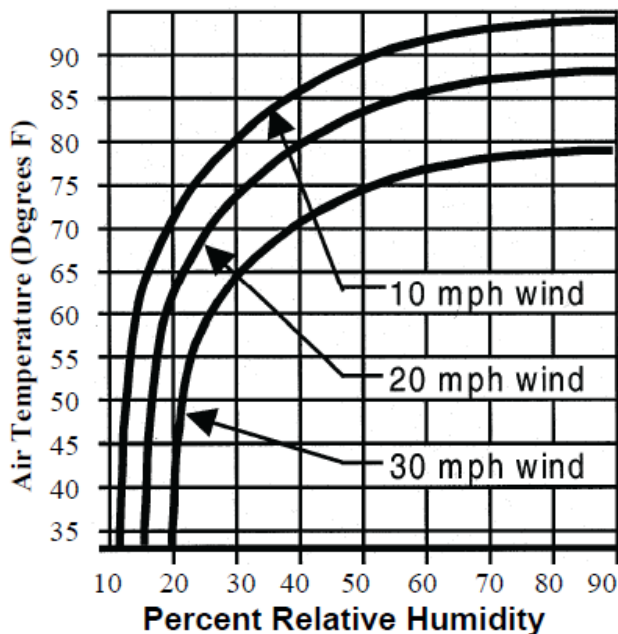
Figure 9. Climate Stress Chart – do not plant if conditions are above this line.
