Class I and Class III Cultural Inventory Report

**CERILON GTL ND SITE:
A CLASS III CULTURAL RESOURCE INVENTORY IN
WILLIAMS COUNTY, NORTH DAKOTA**

December 2022

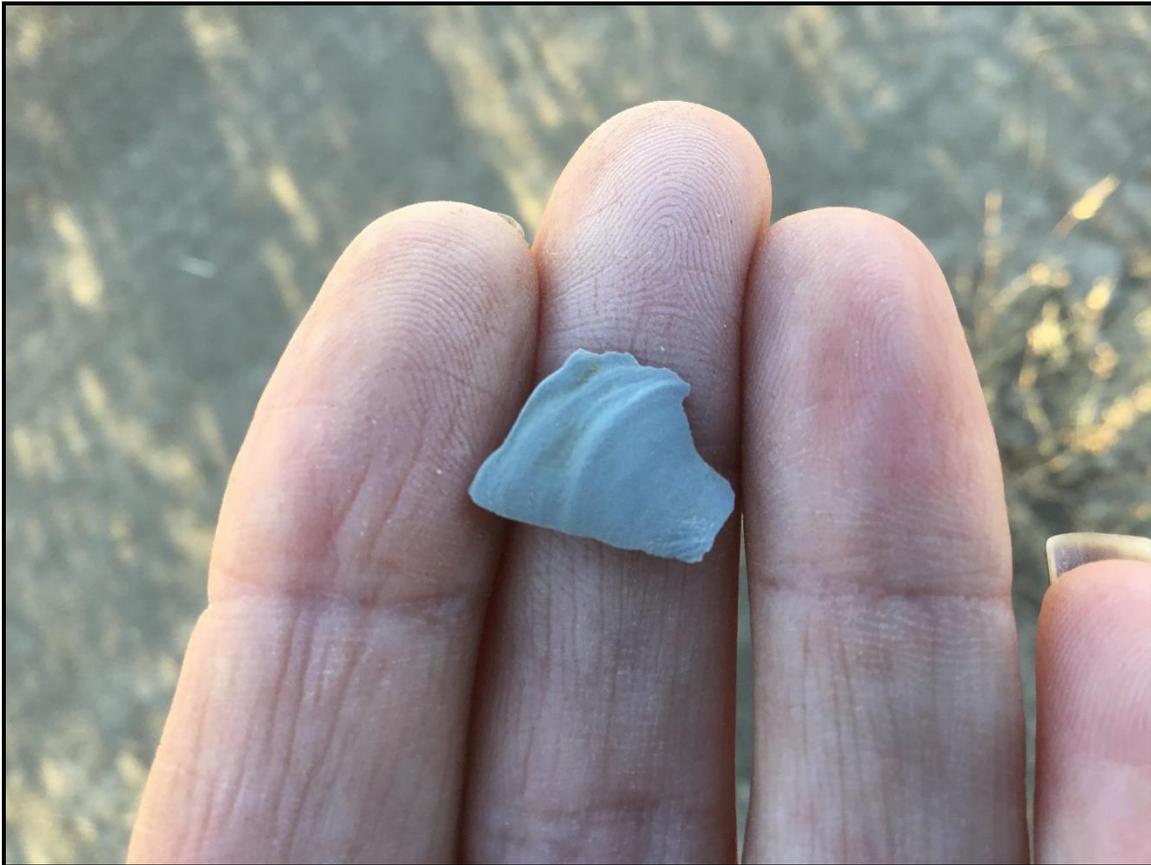
Isolated Find 32Wix834 is a light grey chert flake located in **REDACTED**. The find was identified in a dirt road on the far eastern edge of a broad, flat agricultural field. The GSV in the road was 90% and averaged 50% in the adjacent agricultural field. No other cultural material was identified surrounding the isolated find. Given the good GSV in the area, it is unlikely that there are intact cultural deposits without a surface expression. The isolate is recommended *not eligible* for the NRHP, and no additional work or avoidance measures are recommended.

Figure 10: Detail view of Isolated Find 32Wix834.
