**ND SHPO Ref.: 23-0218 CERILON GTL in portions of [T153N R103W Sections 25 and 36] in Williams County, North Dakota**

**Re: ND SHPO Ref.: 23-0218**  
**Revised Class III Cultural Resources Inventory Report – Request for Review and Concurrence**  
**Cerilon GTL Project in Williams County, North Dakota**

**CERILON GTL ND SITE:  
A CLASS III CULTURAL RESOURCE INVENTORY IN  
WILLIAMS COUNTY, NORTH DAKOTA**

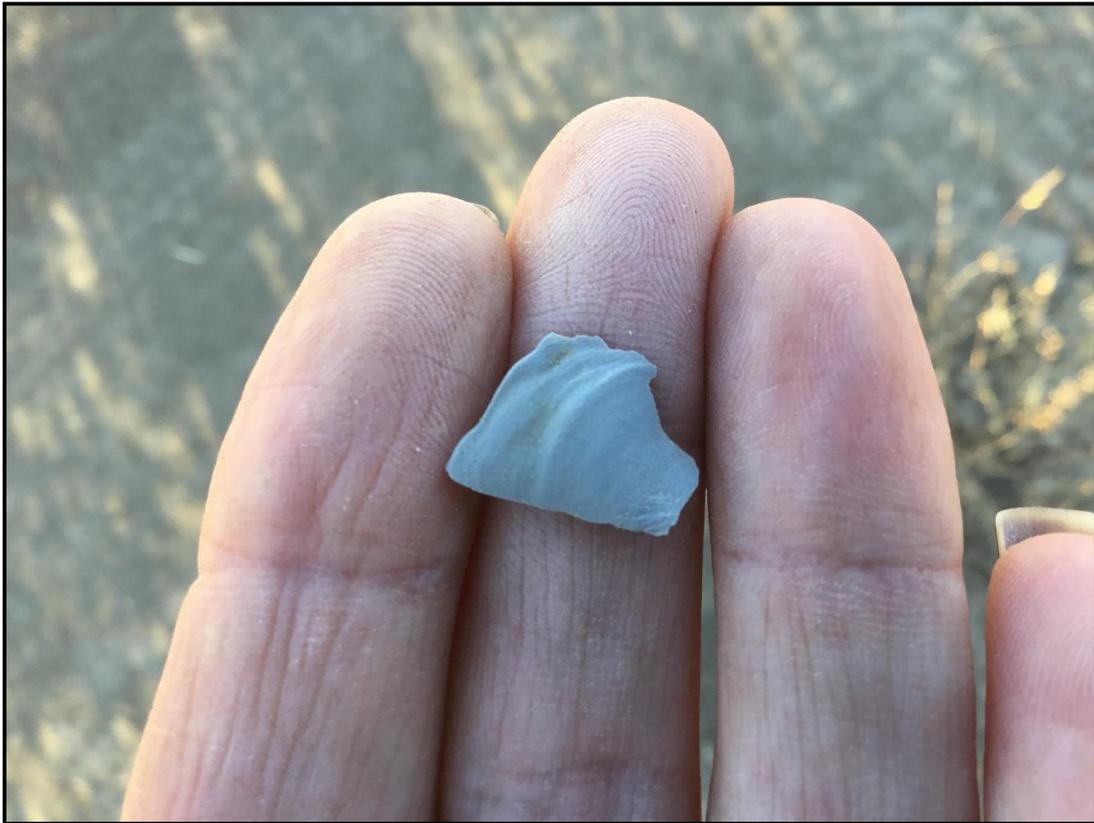
**Figure 10:** Detail view of Isolated Find 32Wix834.

Isolated Find 32Wix834 is a light grey chert flake located in the **REDACTED**. The find was identified in a dirt road on the far eastern edge of a broad, flat agricultural field. The GSV in the road was 90% and averaged 50% in the adjacent agricultural field. No other cultural material was identified surrounding the isolated find. Given the good GSV in the area, it is unlikely that there are intact cultural deposits without a surface expression. The isolate is recommended *Not Significant* for the North Dakota State Historic Sites Registry, and no additional work or avoidance measures are recommended.
