**Flickertail Solar Project  
Flickertail Solar Project, LLC  
Richland County, North Dakota**

**Class II Cultural Resource Inventory  
for Architectural Resources**

**May 27, 2025**

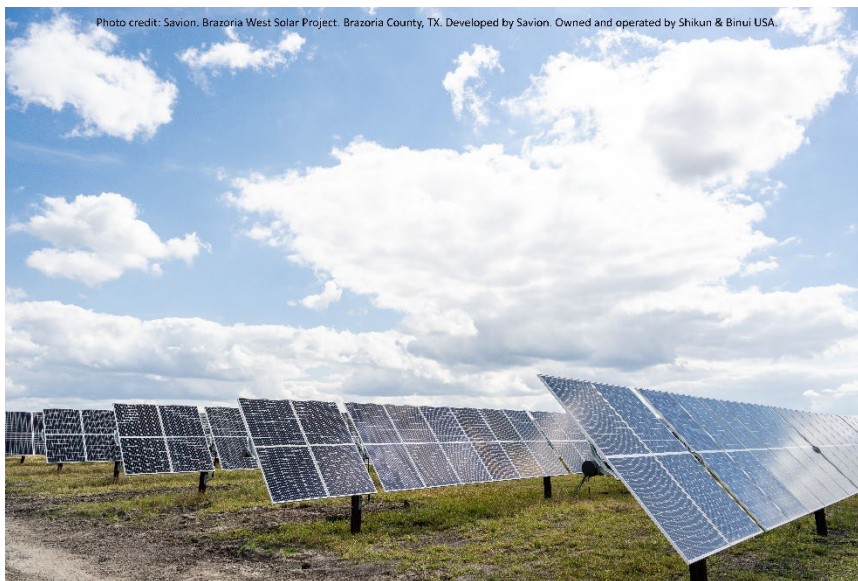
The Project will utilize PV panels with tempered glass varying in size, approximately 8 feet long, 4 feet wide, and 2 inches thick. The panels will be installed on a tracking rack system that utilizes steel and/or aluminum piles for the foundations and a frame with a motor that allows the racking to rotate from east to west throughout the day. The piles will be buried approximately 8 feet below grade. Each tracking rack will contain multiple panels within a fenced perimeter (i.e., a PV array). On the tracking system, panels will be approximately 17 feet in height from the ground to the top of the panels when at a maximum tilt angle and approximately 7 feet when horizontal to the ground. Height may vary due to

**Caption 1.** A typical view of PV panels on a linear axis tracking system.

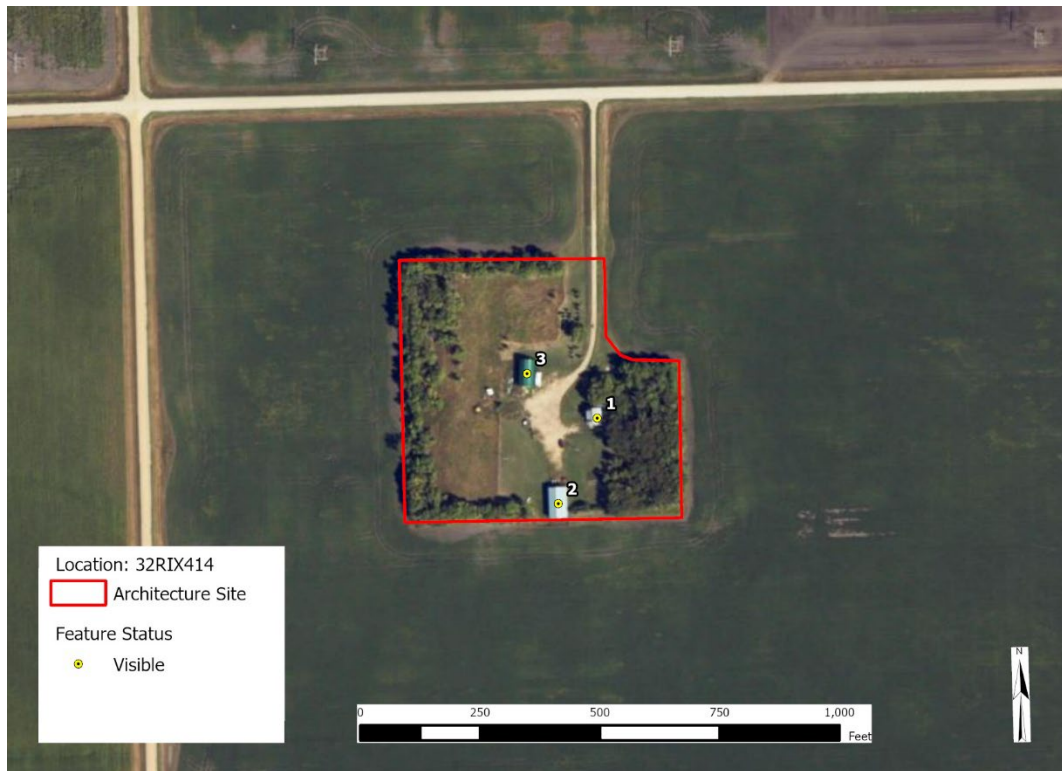
**Map 2.** The location and status of features within 32RIX414 (USDA NAIP 2023).

32RIX414 is a farmstead located at 17320 County Road 6 consisting of three features: a residence built in 1920 (Feature 1), a pole barn constructed between 1952-1961 (Feature 2), and a Quonset hut built between 1969-1978 (Feature 3) (Map 2; Photographs 7 through 11).

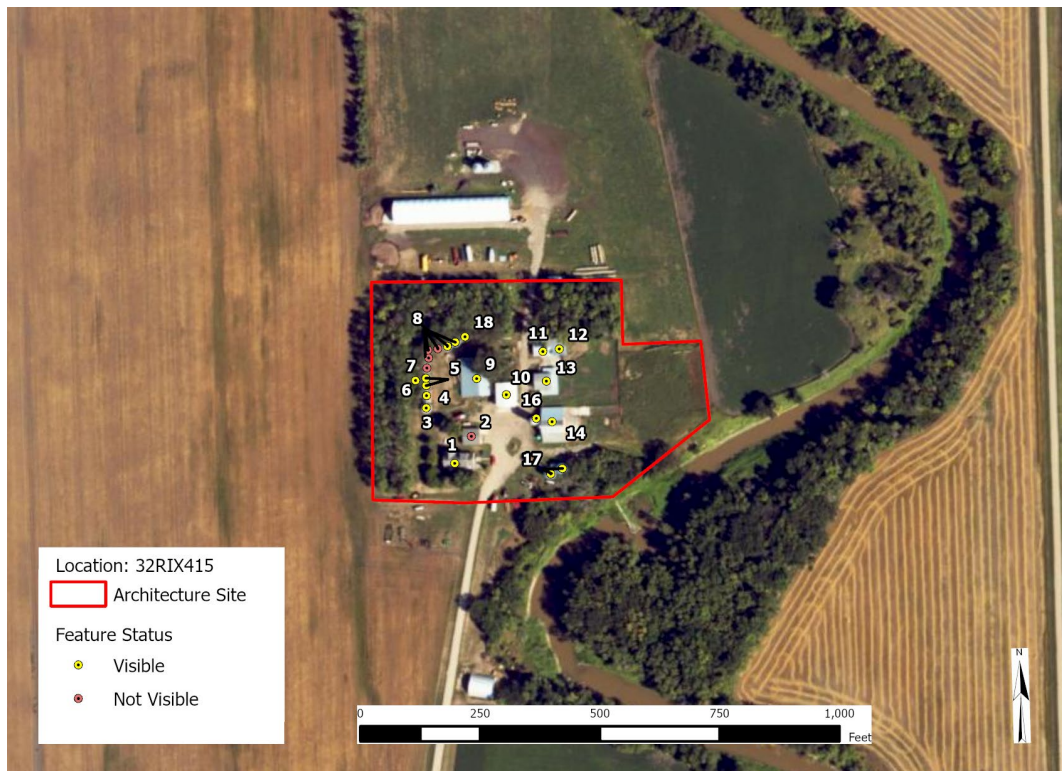
**Map 3.** The location and status of features within 32RIX415 (USDA NAIP 2023).

32RIX415 is a farmstead located at 17375 County Road 6 consisting of 17 features: a residence (Feature 1), a garage (Feature 2), three pole buildings (Features 9, 10, and 13); one barn (Feature 14); 10 metal grain bins (Features 3, 5, 8, and 17); three storage sheds (Features 4, 11, and 12); a silo (Feature 16); and three features that could not be identified (Features 6, 7, and 18). Much of the property was not visible from the right-of-way due to vegetation (Map 3; Photographs 12 through 20).

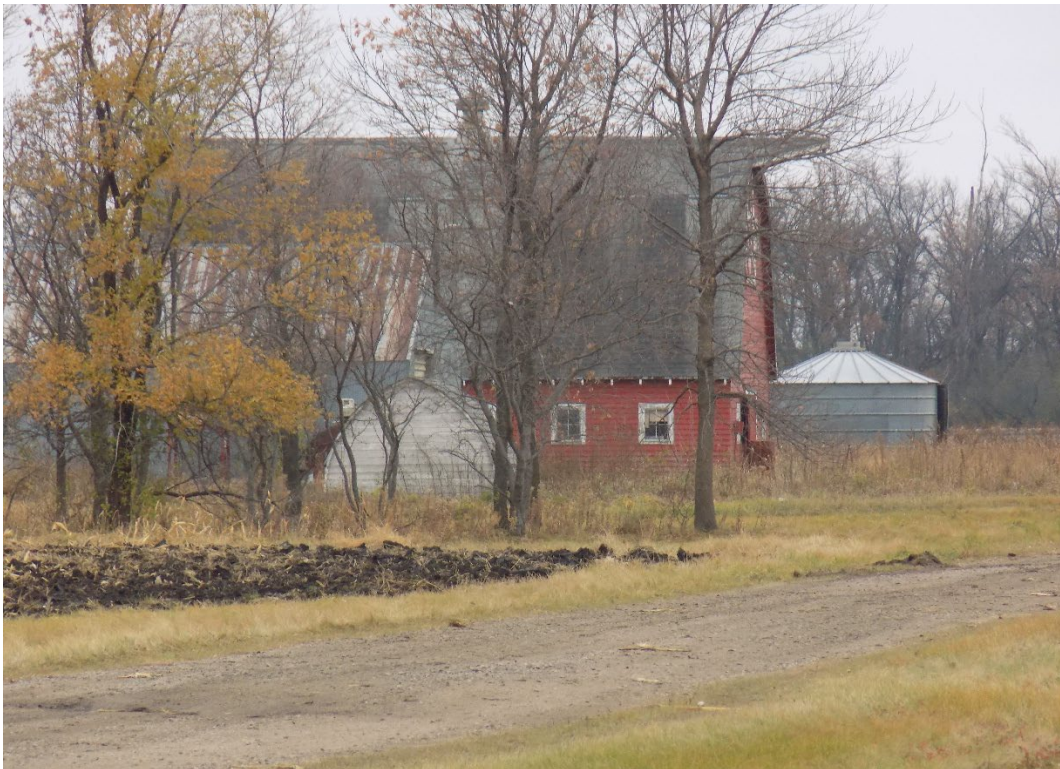
features several fixed for pane windows with wooden sashes, though they are not all visible due to other structures blocking the view from the public road ROW. The barn is clad in red painted horizontal wood siding. The roof is a low extending Dutch-style gambrel roof with exposed rafter tails. The west elevation features a sharply pointed triangular hay hood. There are several barns with similar features in the area. They have similar massing and proportions, extending flared gambrel roofs, the pointed hay hood, and fenestration. This example is the only one with clearly visible rafter tails. These features are not indicative of any widely recognized barn style, though characteristics are shared with Finnish cattle barns and German-Russian barns of the same era. These barns were all built by Norwegian immigrants in the early twentieth century, indicating a potential ethnic or regional barn variation. From the public road ROW, this example appears to retain the most integrity out of similar barns recorded in the Study Area. Feature 4 is associated with farming and meets the guidelines presented in the Multiple Property Documentation Form for Common Farm and Ranch Buildings in North Dakota (SHSND 2022). It also may be associated with Norwegian immigration, though further research is needed (Criterion A). The barn is not associated with any known historically significant individuals (Criterion B). The barn possesses sufficient integrity and a number of character defining features unusual for recognized barn types. More research is needed to see if it is representative of a regional or ethnic style (Criterion C). This barn may yield further information about an ethnic or regional barn type, though more research is needed (Criterion D). Therefore, Feature 4 is recommended eligible under Criteria A and C. More research is needed to determine eligibility under D.

**Caption 2.** Feature 4 (barn) at 32RIX416, camera facing south.

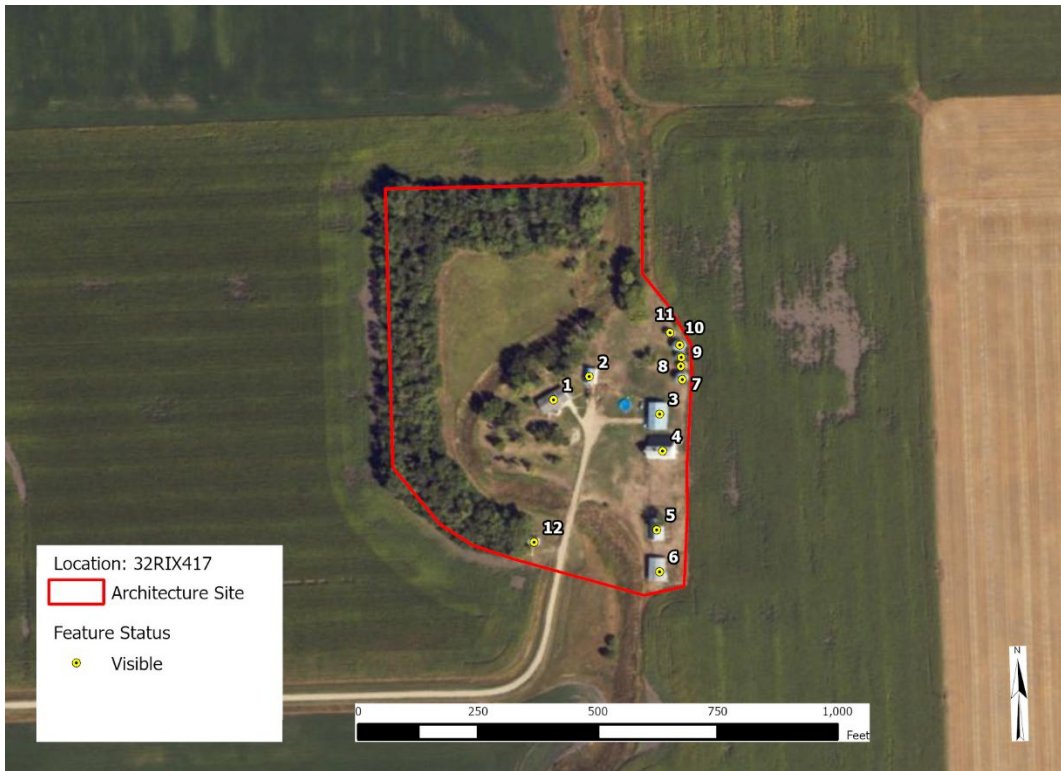
**Map 5.** The location and status of features within 32RIX417 (USDA NAIP 2023).

32RIX417 is a farmstead located at 6670 172nd Avenue SE consisting of 12 features: a raised Ranch style residence (Feature 1) constructed in 1980, two detached garages (Features 2 and 12), a pole barn (Feature 3), a gambrel roof dairy barn (Feature 4), two smaller barns (Features 5 and 6), and five grain bins (Features 7 through 11) (Map 5; Photographs 30 through 37).

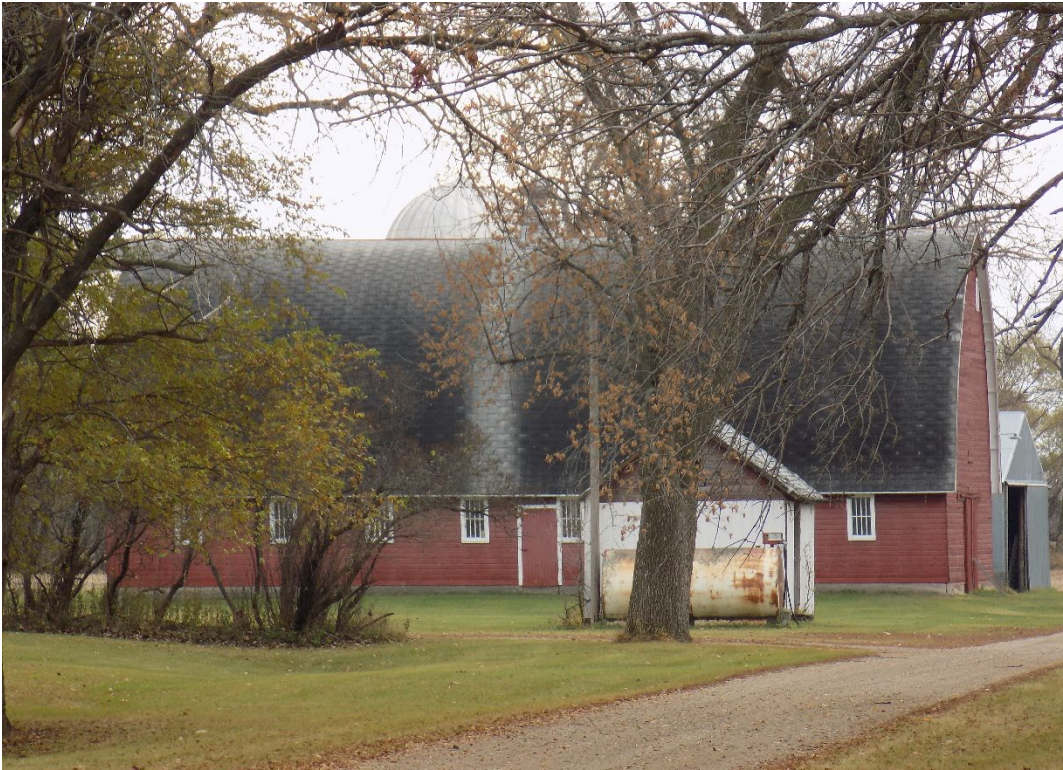
(Criterion C). The barn exhibits no surface level indications of further research potential (Criterion D). Feature 5 is recommended eligible for listing on the NRHP under at least Criterion C for its architectural significance.

**Caption 3.** Feature 5 (middle) at 32RIX418, camera facing south.

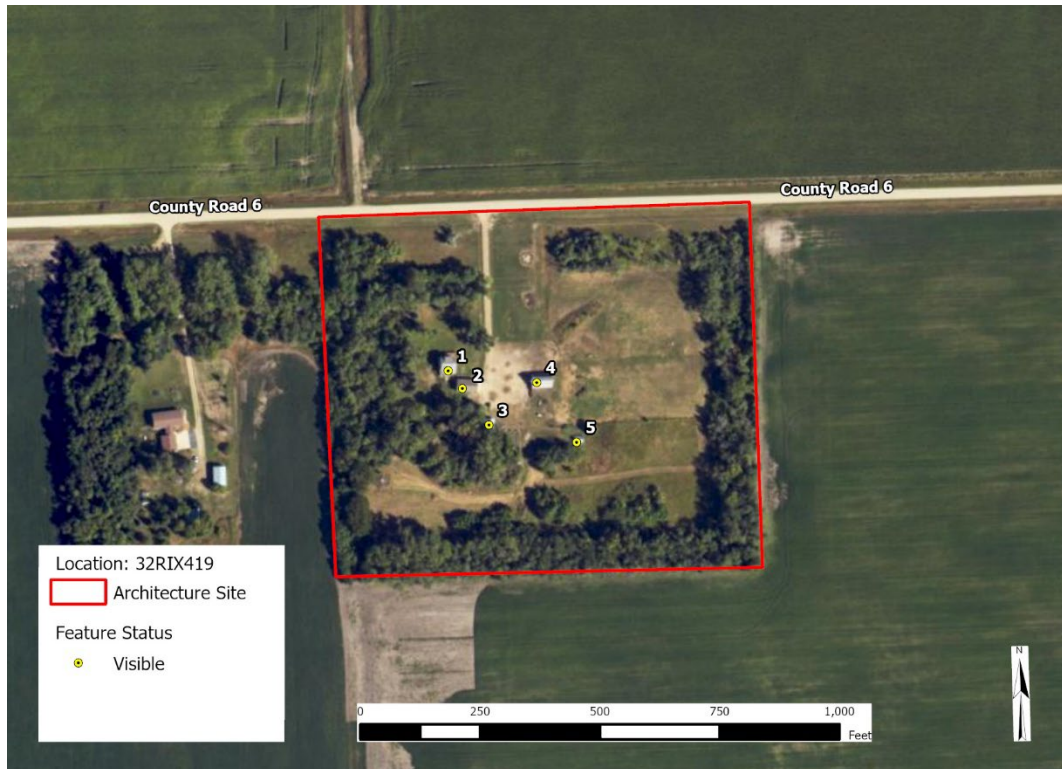
**Map 7.** The location and status of features within 32RIX419 (USDA NAIP 2023).

32RIX419 is a farmstead located at 17070 County Road 6 that consists of five features: a residence (Feature 1), a pole barn (Feature 2), a garage (Feature 3), a dairy barn (Feature 4), and a shed (Feature 5) (Map 7; Photographs 49 through 54).

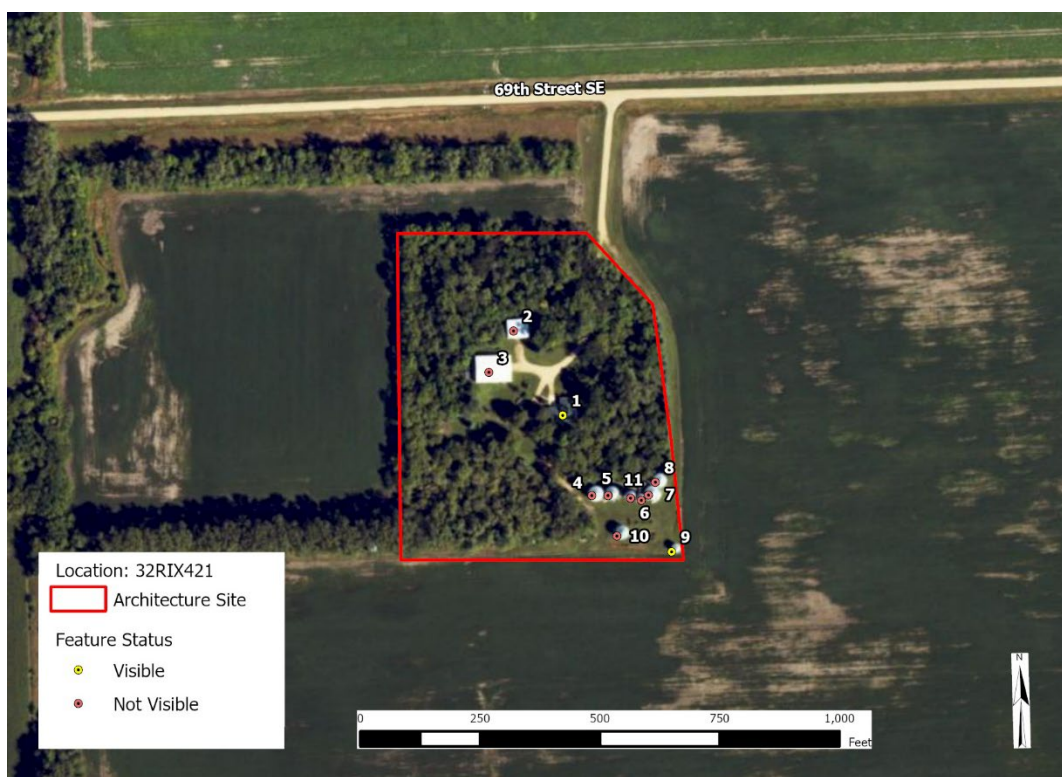
**Map 9.** The location and status of features within 32RIX421 (USDA NAIP 2023).

32RIX421 is a farmstead located at 16890 69<sup>th</sup> Street SE consisting of 11 features: a residence (Feature 1), two pole barns (Features 2 and 3), and eight grain bins (Features 4 through 11) (Map 9; Photographs 60 through 62). Most of the property is ensconced in trees and not visible from the public road ROW.

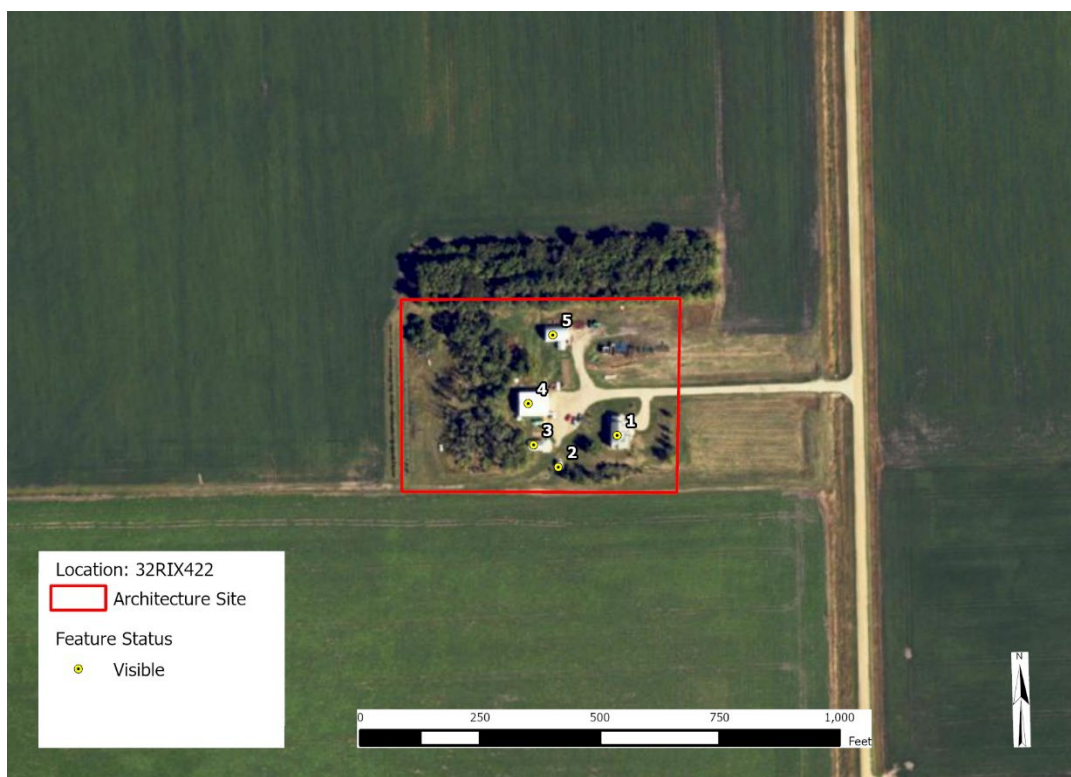
**Map 10.** The location and status of features within 32RIX422 (USDA NAIP 2023).

32RIX422 is a farmstead located at 6845 170<sup>th</sup> Avenue SE consisting of five features: a residence (Feature 1), a shed (Feature 2), a garage (Feature 3), a pole barn (Feature 4), and a Quonset hut (Feature 5) (Map 10; Photographs 63 through 69).

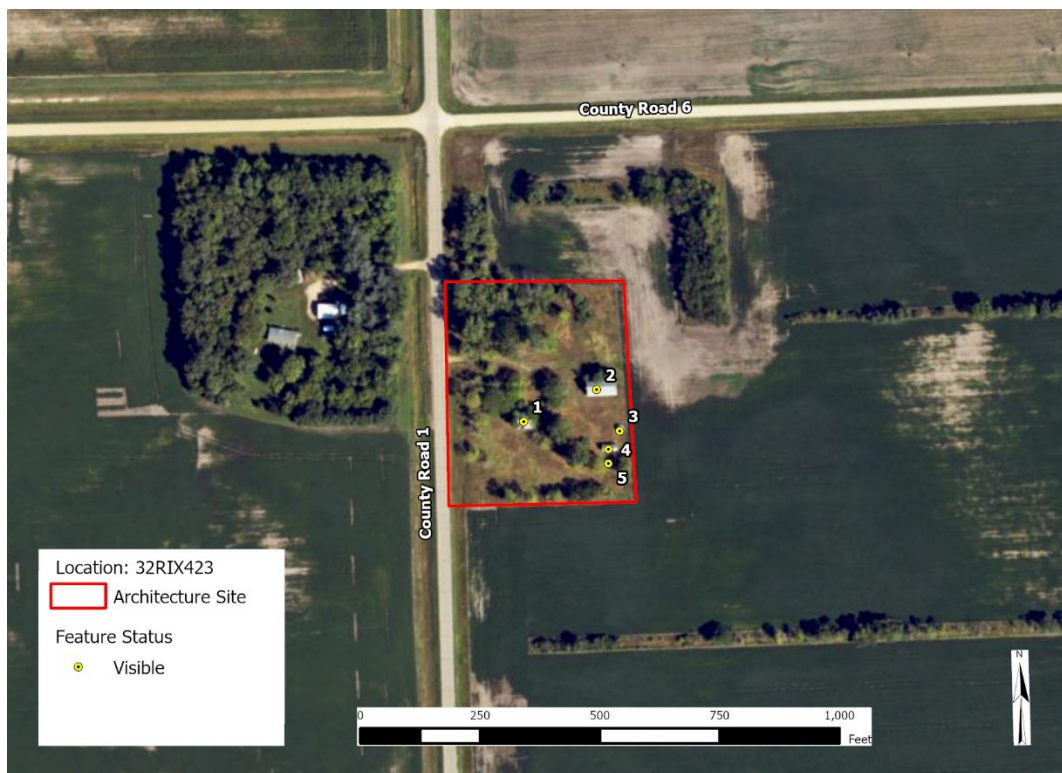
**Map 11.** The location and status of features within 32RIX423 (USDA NAIP 2023).

32RIX423 is a farmstead located at 6810 County Road 1 consisting of five features: a residence (Feature 1), a barn (Feature 2), a grain bin (Feature 3), and two sheds (Features 4 and 5) (Map 11; Photographs 70 through 74).

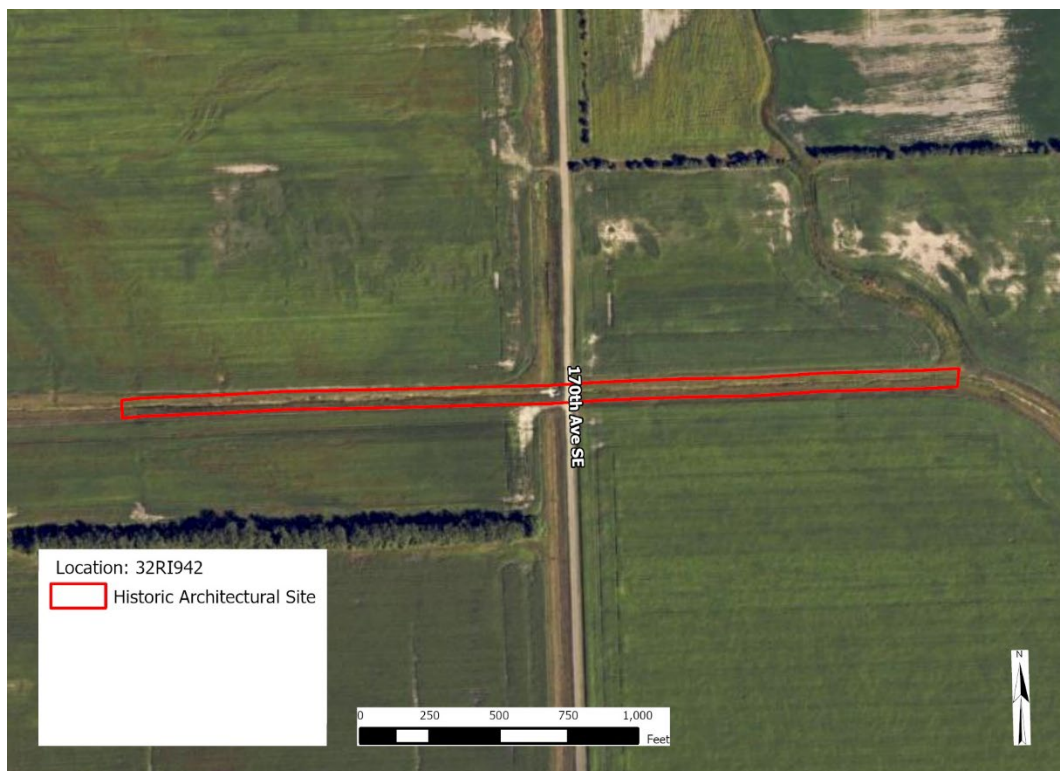
**Map 13.** The location of 32RI942 (USDA NAIP 2023).

32RI942 is a drainage ditch carrying a segment of Pitcairn Creek (Drain 72) intersecting 170<sup>th</sup> Avenue SE between 67<sup>th</sup> Street SE and County Road 6 that was initially excavated at least 50 years ago (Map 13, Photographs 88 and 89). Pitcairn Creek was illustrated on the 1910 Alden Publishing Co. plat meandering through sections 8 and 9 of Township 134 North, Range 49 West (Alden Publishing Co. 1910). The creek did not appear to be channelized in 1910. Pitcairn Creek was not illustrated on the 1922 H.E. Wilson atlas (H.E. Wilson and Company 1922). A review of 1952 aerial photography revealed that Pitcairn Creek had been channelized within 32RI942; 170<sup>th</sup> Avenue SE was not present at this time (AMS 1952). At this time, the ditch was approximately 11 meters wide. 170<sup>th</sup> Avenue SE was constructed across in the ditch between 1952 and 1978 (AMS 1952; USGS 1978). Between 1978 and 1990, portions of the ditch to the east of 170<sup>th</sup> Avenue SE were widened from roughly 11 meters to 25 meters; portions of the ditch to the west of 170<sup>th</sup> Avenue were widened between 1990 and the early 2000s.

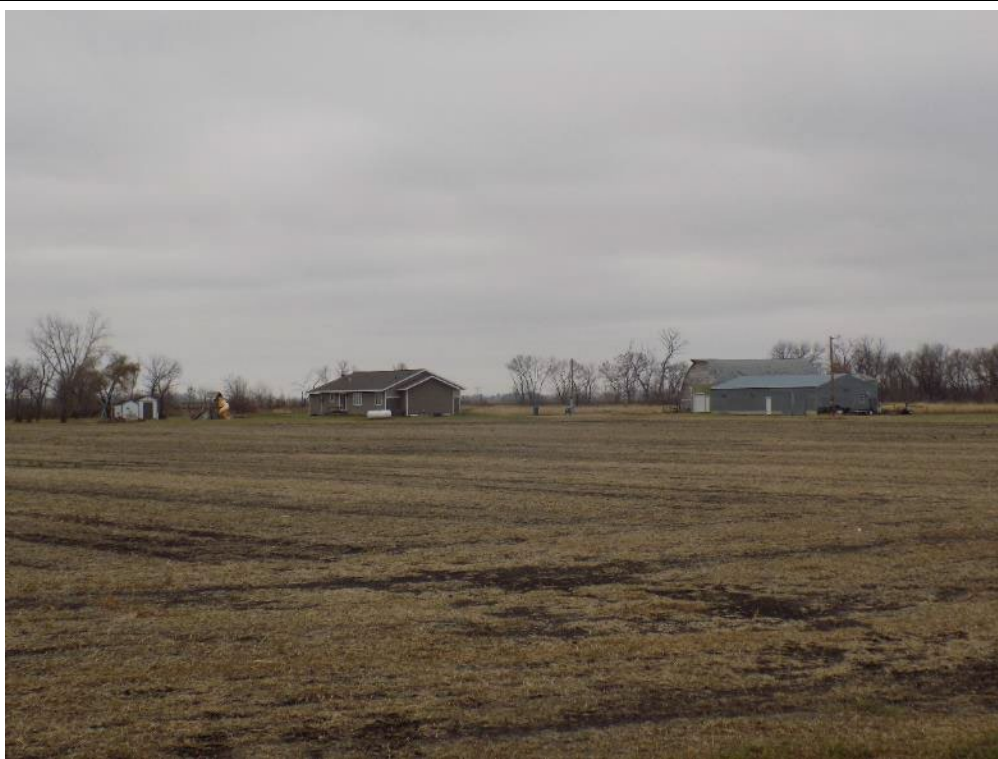
**Photograph: 2**

**Description:** An overview of Location 32RIX413 from the 173<sup>rd</sup> Avenue SE ROW.

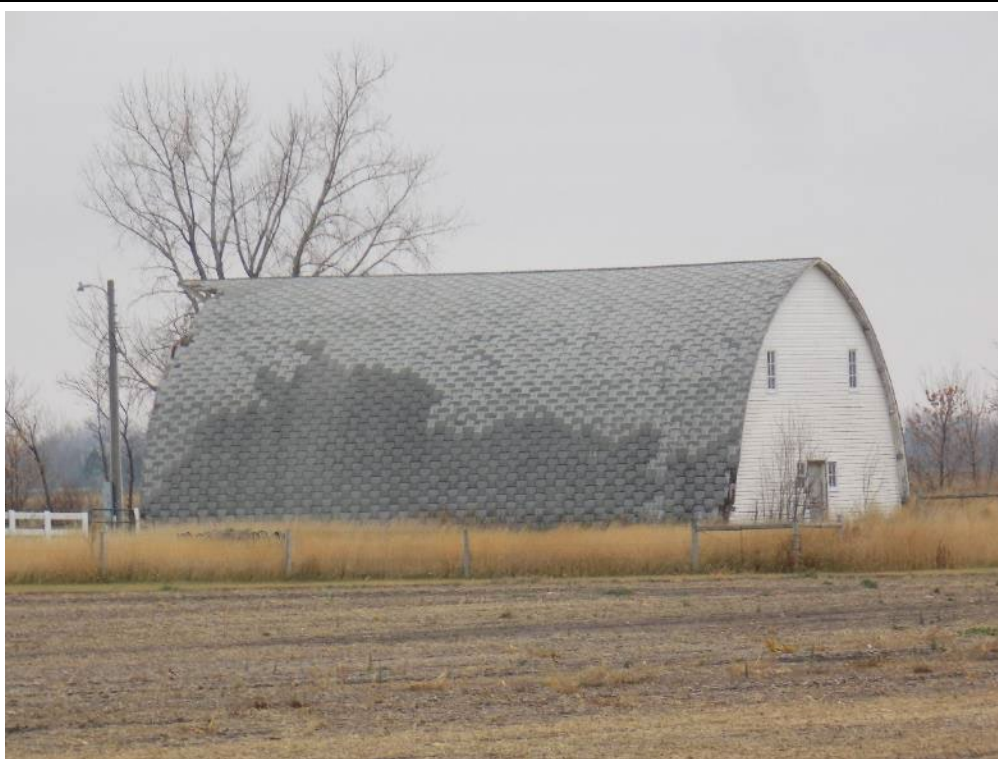
**Photograph: 4**

Feature 2 is the only historic-age building currently on the property (Photograph 4). It is a Quonset hut style barn with a rectangular footprint and an arched/Gothic roof that reaches ground level. The roof is clad in asphalt shingles and features a pointed hay hood on the south elevation. Both the north and south elevations are clad in horizontal wood siding. The south elevation features a human scale door and a garage door set into an unknown material. They appear to be replacements. The north elevation features a centered human scale door flanked by two wood framed, four pane windows. Two wood framed, six pane windows are located toward the roof peak, suggesting a second level or loft. Aerial imagery suggests the barn was constructed between 1961-1969.

**Description:** A view of Feature 2 from the 173<sup>rd</sup> Avenue SE ROW.

- Ground Visibility/Snow: Photograph 4 appears to have snow cover. Please discuss the levels of snow cover and how that may have impacted survey per guidelines (2020, 17-18).

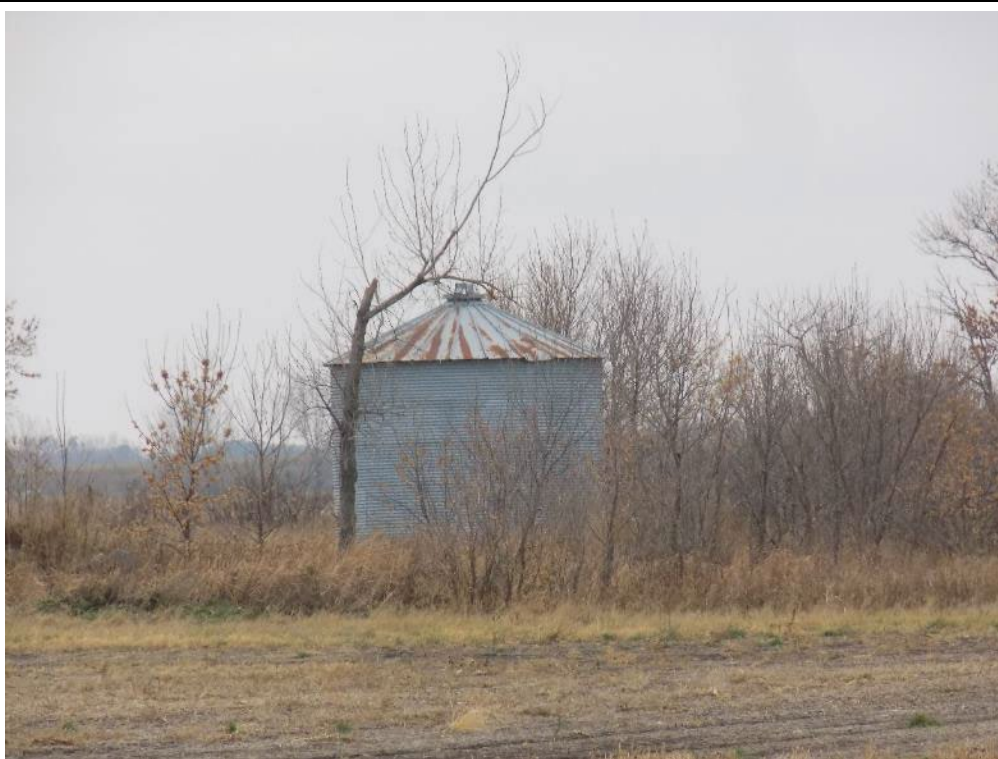
**Photograph: 6**

**Description:** A view of Feature 4 from the 173<sup>rd</sup> Avenue SE ROW.

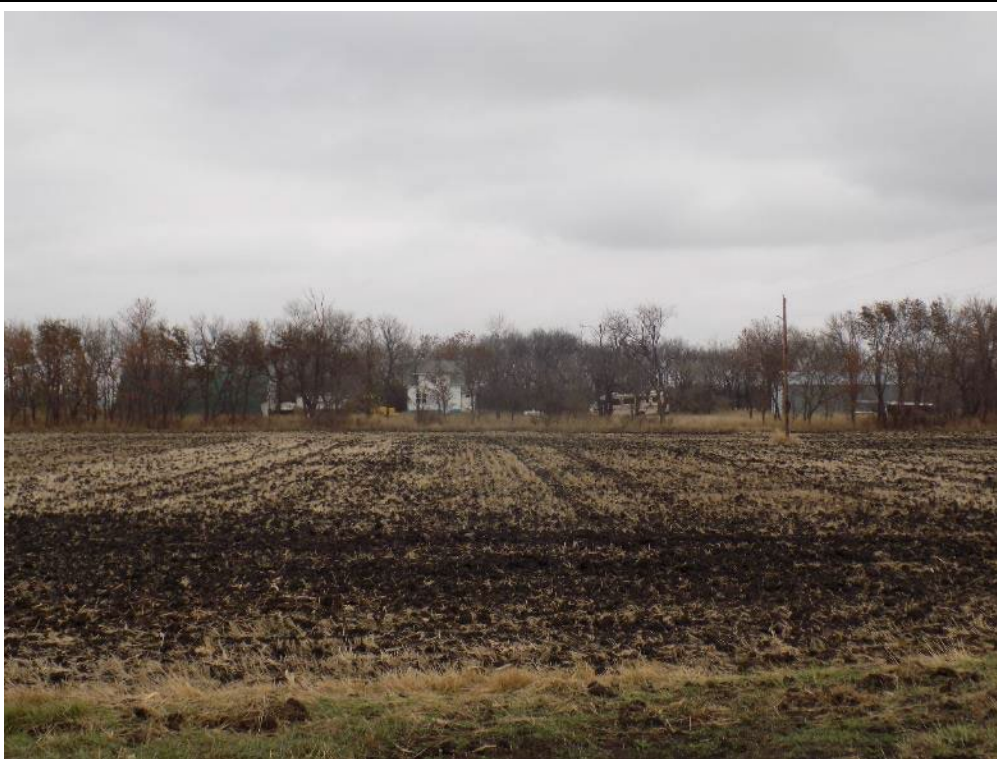
**Photograph: 8**

**Description:** A general overview of Location 32RIX414 from the 173<sup>rd</sup> Avenue SE ROW.

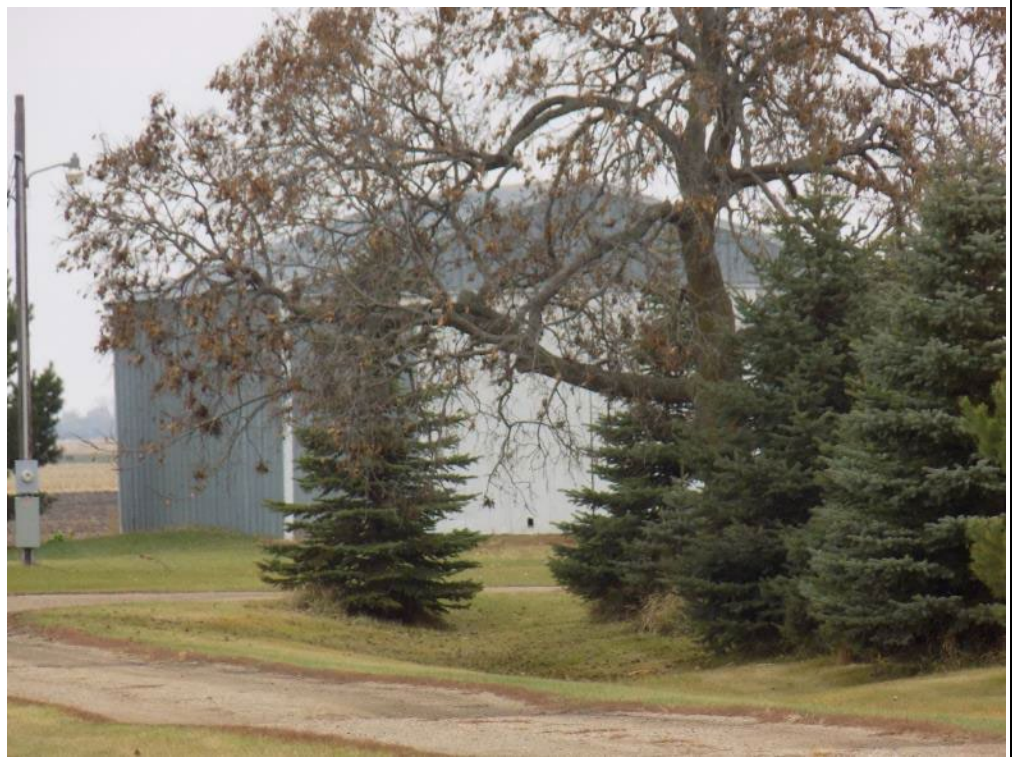
**Photograph: 10**

Feature 2 is a pole barn constructed between 1952-1961 according to aerial imagery (Photograph 10). It has a rectangular footprint and gable roof and is clad in corrugated metal. There appears to be a garage door on the north elevation, though visibility was obscured by vegetation. No other elevations were visible from the public road ROW. Pole buildings like this example proliferated across the United States in the mid-twentieth century and continue to be a commonly constructed building type today. The ubiquity of this building type renders it ineligible for listing on the NRHP under any criteria.

**Description:** A view of Feature 2 from the 68<sup>th</sup> Street SE ROW.

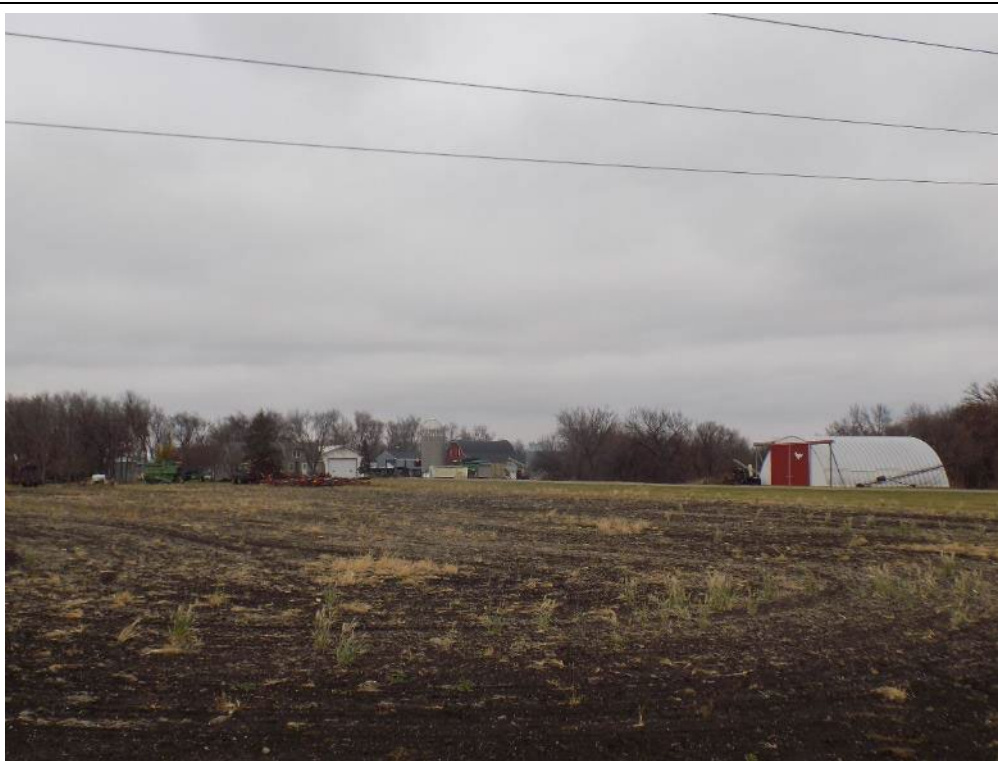
**Photograph: 12**

**Description:** An overview of Location 32RIX415 from the 68<sup>th</sup> Street SE ROW.

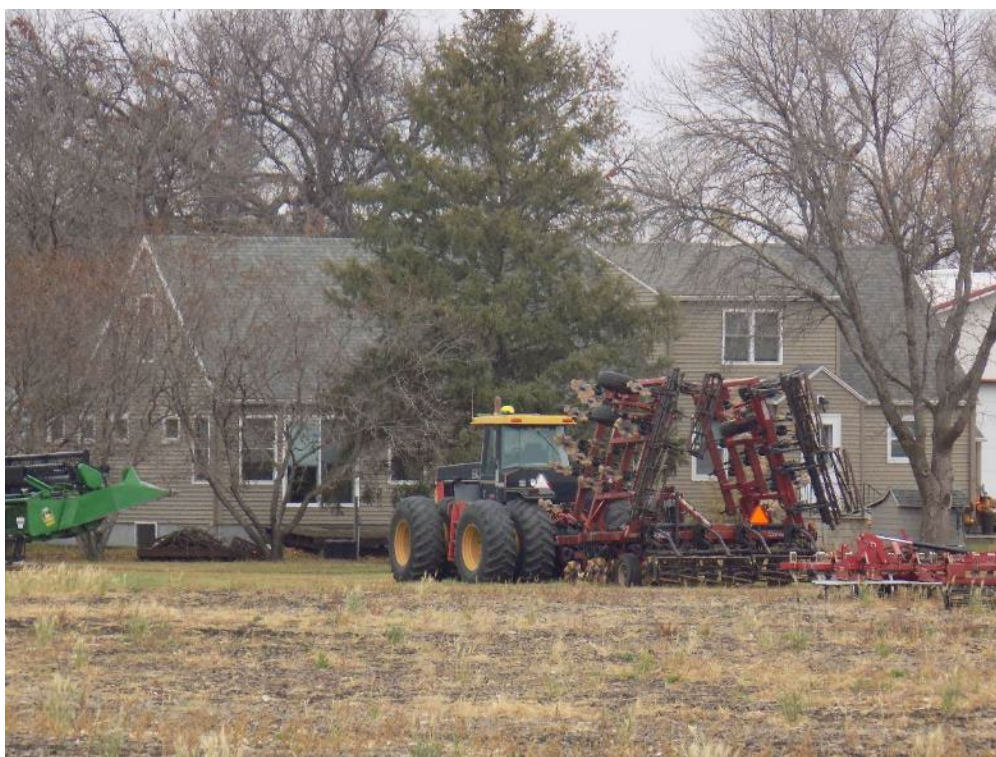
**Photograph: 14**

**Description:** A view of Feature 1 from the 68<sup>th</sup> Street SE ROW.

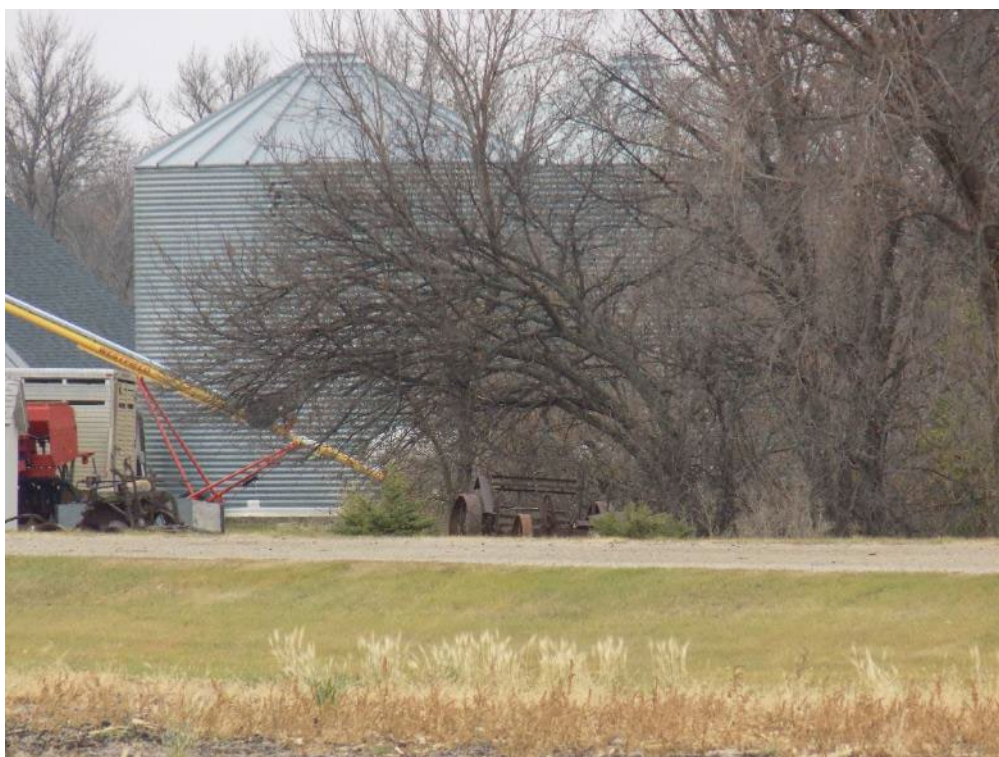
**Photograph: 16**

**Description:** A view of Feature 17 (left silo and right silo) from the 68<sup>th</sup> Street SE ROW.

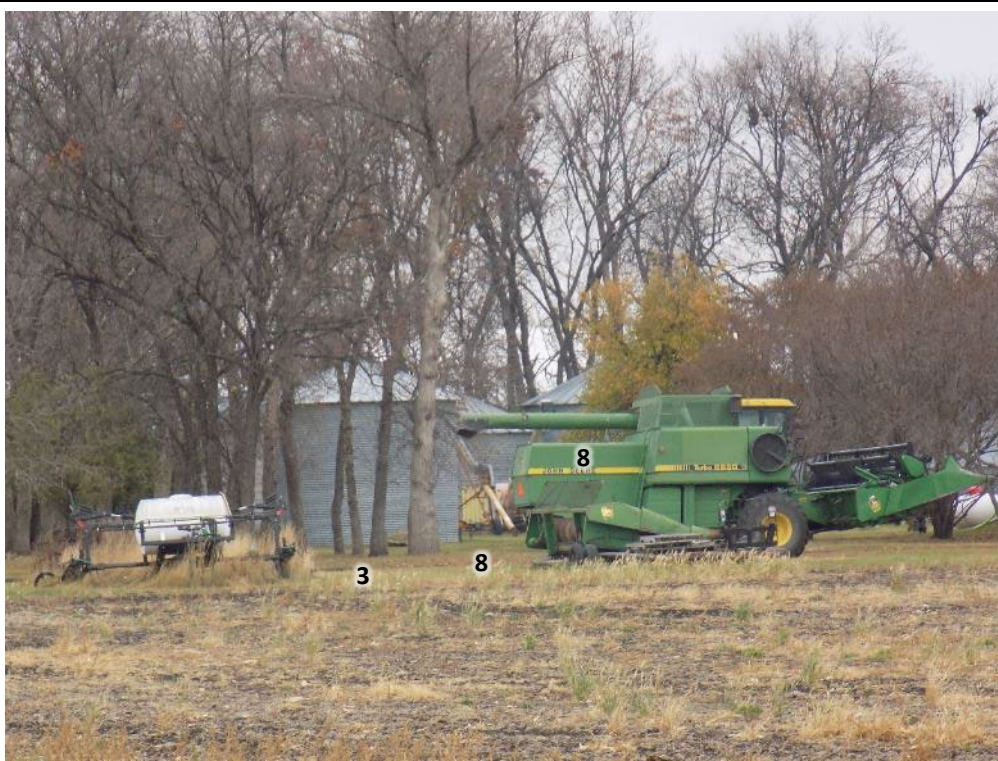
**Photograph: 18**

**Description:** A view of  
Features 3 and 8 from the  
68<sup>th</sup> Street SE ROW.

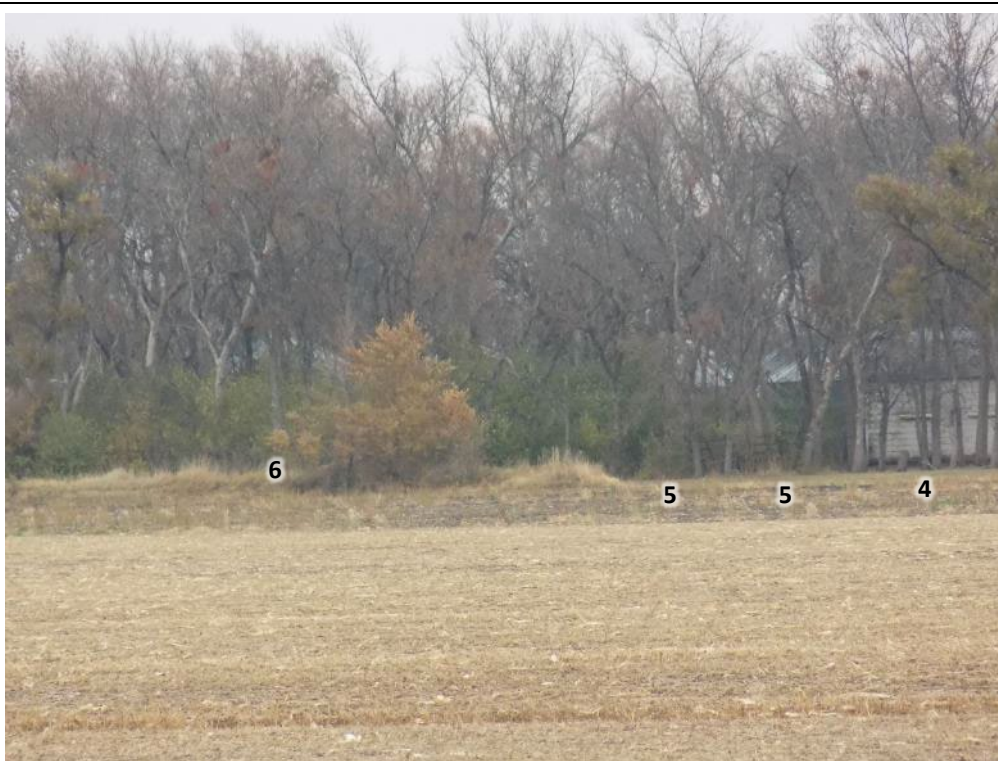
**Photograph: 20**

**Description:** A view of Features 4, 5, and 6 from the 68<sup>th</sup> Street SE ROW.

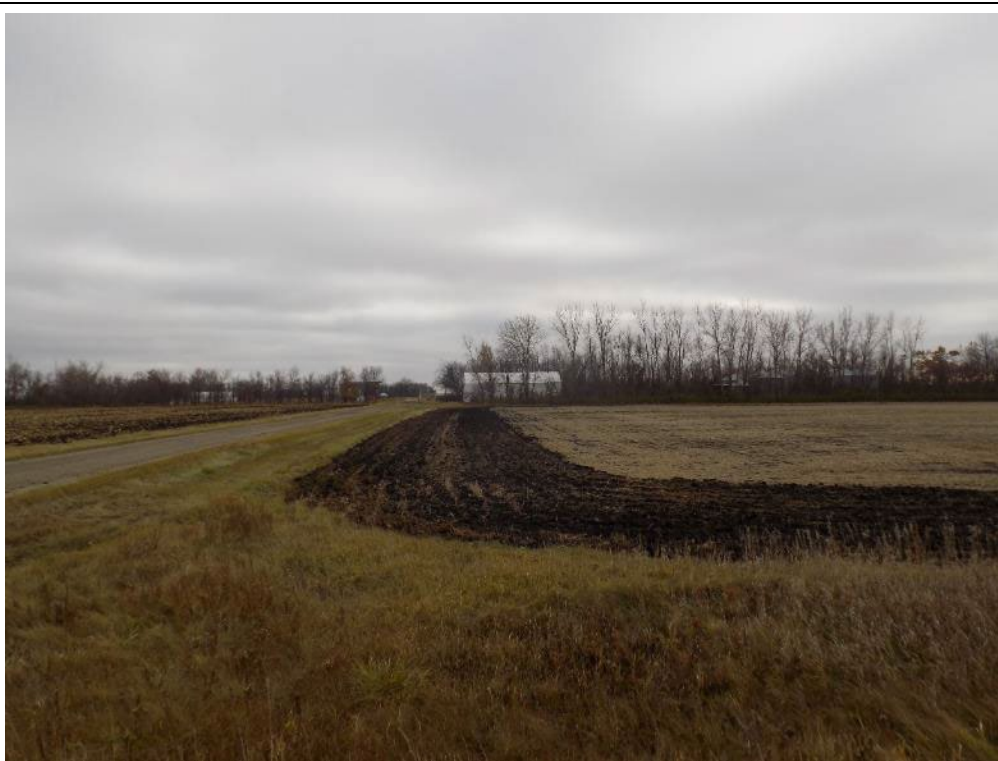
**Photograph: 22**

**Description:** An overview of Location 32RIX416, viewed from the 66<sup>th</sup> Street SE ROW.

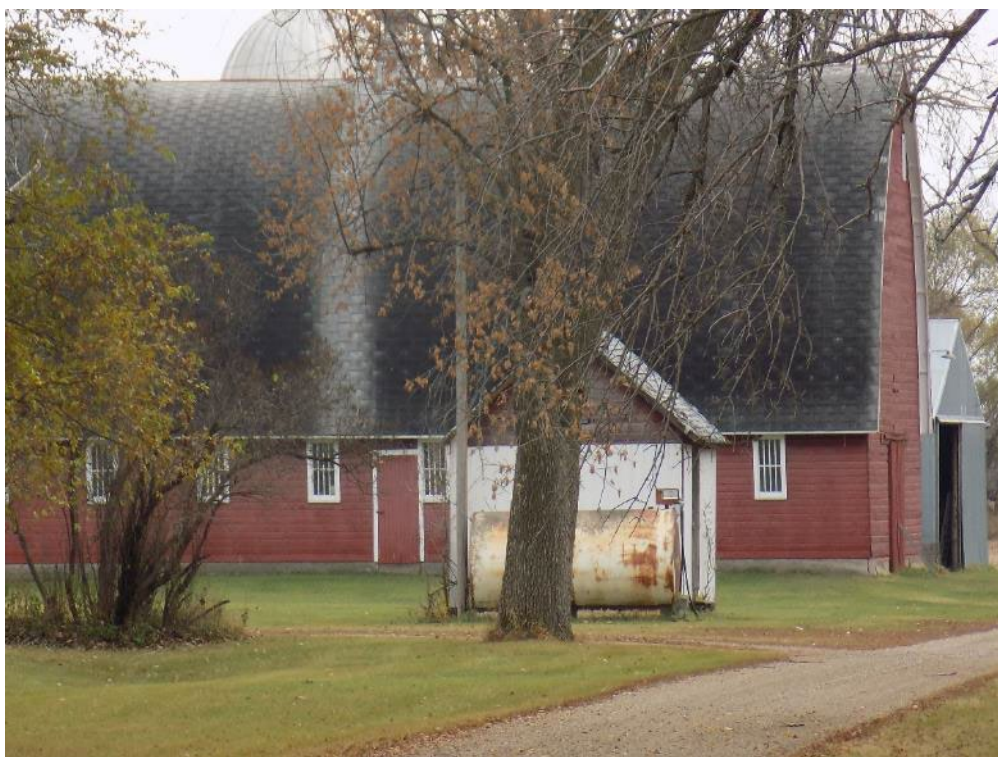
**Description:** A view of the Features 13 (foreground), 5 (middle) and 4 (background) from the 67<sup>th</sup> Street SE ROW.

Feature 4 is a pole barn constructed between 1961-1978 (Photograph 42). It has a rectangular footprint and a gable roof. There is a sliding door on the west elevation. The building is clad in corrugated metal. Pole buildings like this example proliferated across the United States in the mid-twentieth century and continue to be a commonly constructed building type today. The ubiquity of this building type renders it ineligible for listing on the NRHP under any criteria.

Features 6, 7, 8, 9, 13, 16, 17, 18, and 19 were constructed within the last 50 years (Photographs 42, 44, and 48). There is no evidence to suggest that any of these features meet the qualifications for Criteria Consideration G: Properties that Have Achieved Significance Within the Past Fifty Years (NPS 1995). Therefore, they are not recommended eligible for listing on the NRHP under any criteria.

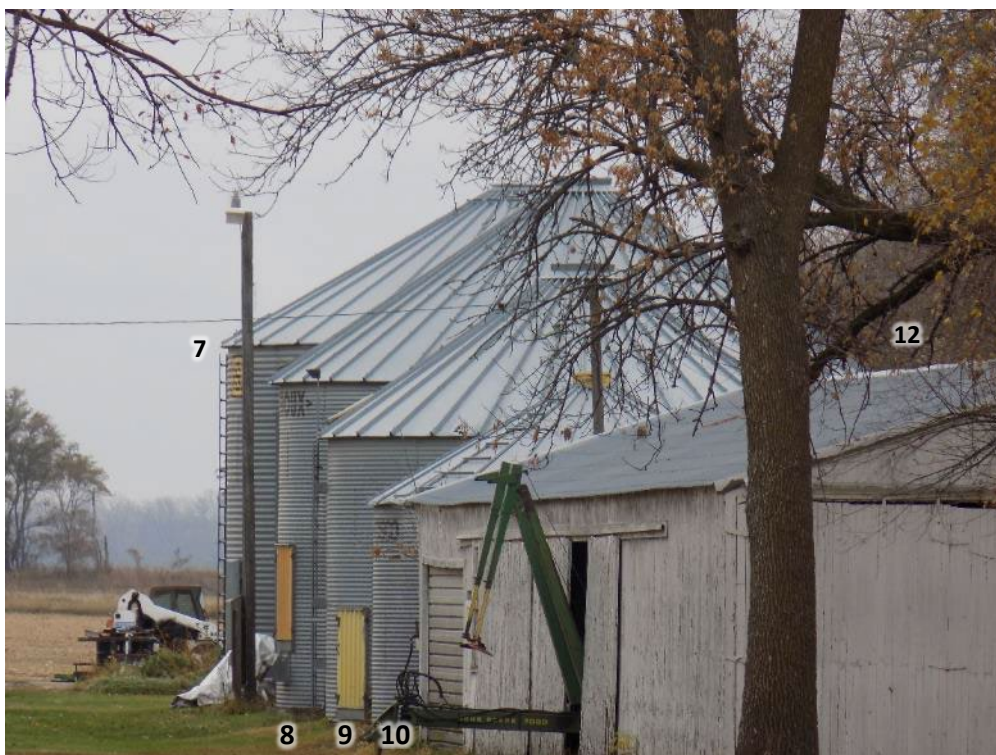
**Description:** A view of Features 7 through 10 and 12 from the 67<sup>th</sup> Street SE ROW.

Feature 10 is the shortest grain bin in a line of four and was constructed between 1961-1978 (Photographs 44 and 45). Metal grain bins like this example are incredibly common structures used for grain storage. They have not had a substantial change in design since they became popular in the mid-twentieth century. Therefore, the feature is not recommended eligible for listing on the NRHP under any criteria.

Feature 12 is a shed with a rectangular footprint and side gabled roof (Photographs 44 and 45). The east elevation appears to have a sliding door and a garage door. The building is clad in wood siding with sheet metal roofing. Farm machinery is sticking out of the door. Although the building is related to farming, it is unlikely to have made any contributions to the theme (Criterion A). The shed does not have any clear associations with any historically significant people (Criterion B). The building is utilitarian and has no distinguishing architectural features (Criterion C). It is unlikely to contribute to further historical or archaeological study (Criterion D). Feature 12 is not recommended for listing on the NRHP under any criteria.
