**Flickertail Solar Project  
Flickertail Solar Project, LLC  
Richland County, North Dakota**

**Class II Cultural Resource Inventory  
for Architectural Resources**

**May 27, 2025**

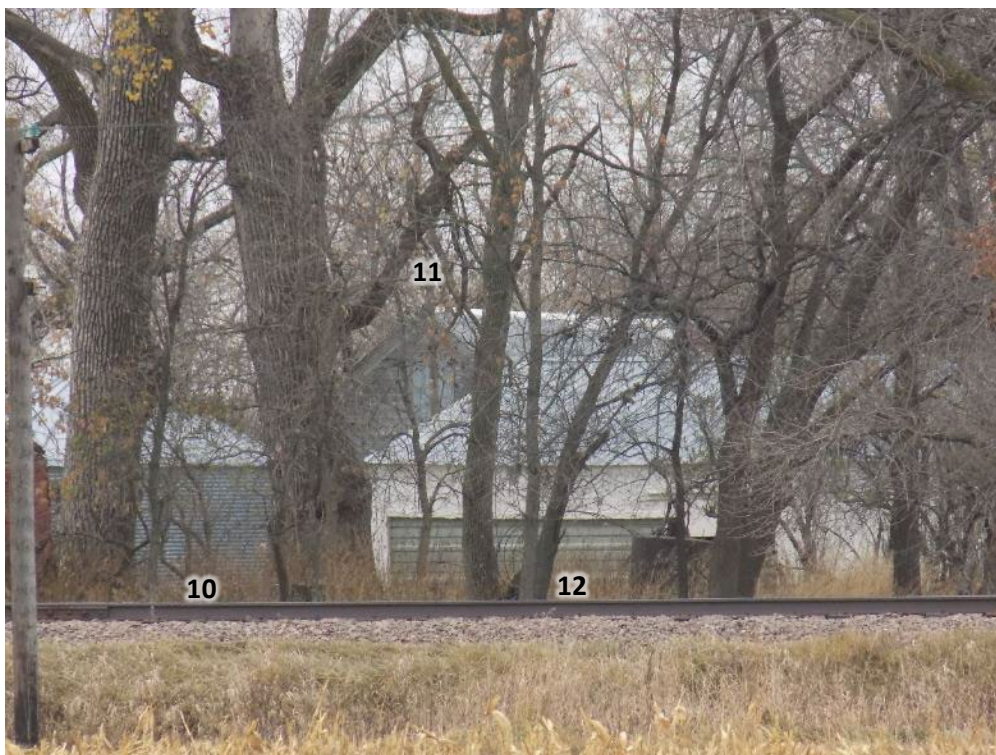
**Description:** A view of Features 10 through 12 from the 67<sup>th</sup> Street SE ROW.

Feature 10 is the shortest grain bin in a line of four and was constructed between 1961-1978 (Photographs 44 and 45). Metal grain bins like this example are incredibly common structures used for grain storage. They have not had a substantial change in design since they became popular in the mid-twentieth century. Therefore, the feature is not recommended eligible for listing on the NRHP under any criteria.

Feature 12 is a shed with a rectangular footprint and side gabled roof (Photographs 44 and 45). The east elevation appears to have a sliding door and a garage door. The building is clad in wood siding with sheet metal roofing. Farm machinery is sticking out of the door. Although the building is related to farming, it is unlikely to have made any contributions to the theme (Criterion A). The shed does not have any clear associations with any historically significant people (Criterion B). The building is utilitarian and has no distinguishing architectural features (Criterion C). It is unlikely to contribute to further historical or archaeological study (Criterion D). Feature 12 is not recommended for listing on the NRHP under any criteria.

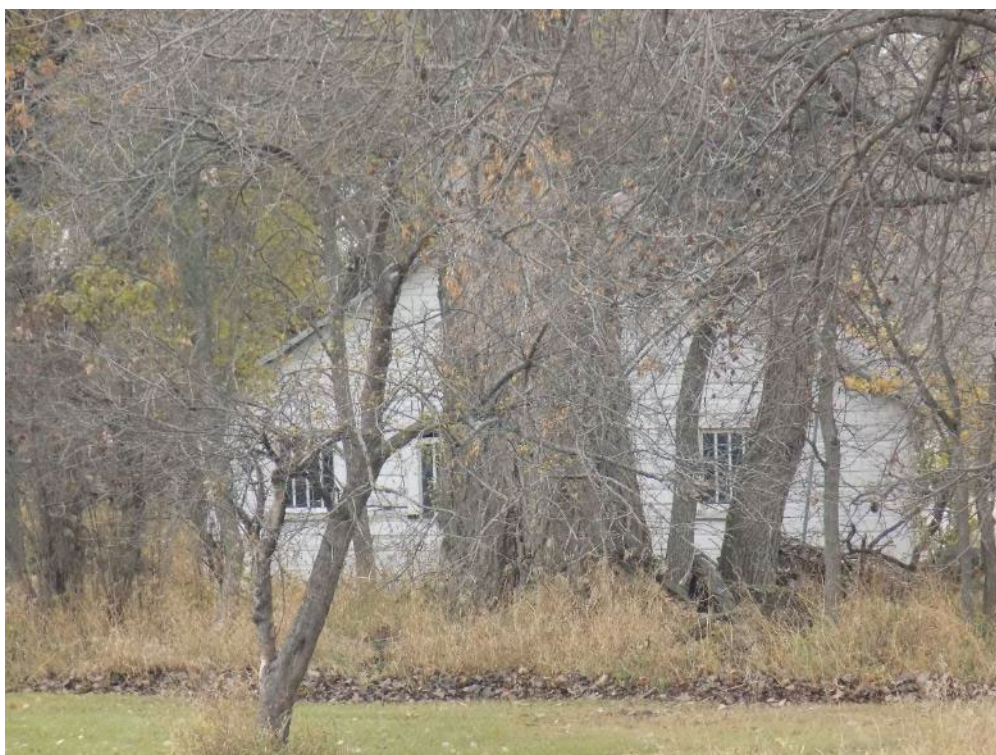
**Description:** A view of Feature 15 from the 67<sup>th</sup> Street SE ROW.

Feature 15 is a storage shed or barn (Photographs 46 and 47). The building has a rectangular footprint and a gable roof. It is clad in horizontal wood siding. The north elevation has at least three fixed narrow four pane wood framed windows. The building is situated in the tree line and is not visible on aerial imagery. Therefore, no definite construction date could be obtained. As the windows are similar to those on Feature 5, it is assumed to be contemporaneous with Feature 5. Without a definitive age or use, and since there is a building on the property that is recommended eligible, there is not enough information to determine NRHP eligibility for Feature 15 and further research is needed.

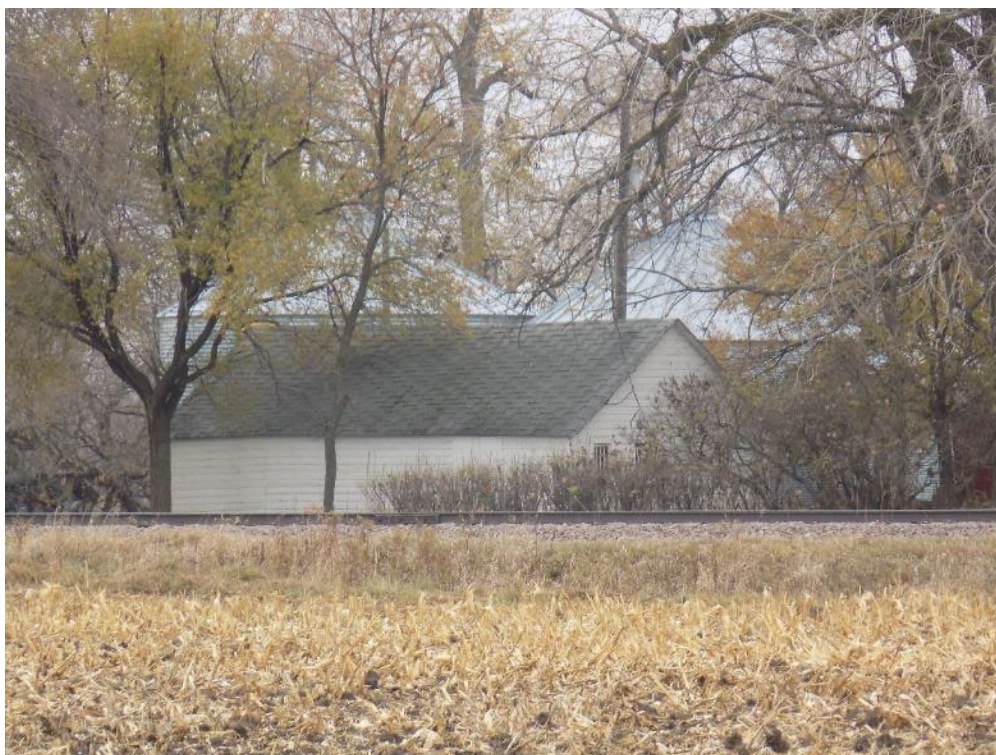
**Description:** A view of Feature 15 from the 67<sup>th</sup> Street SE ROW.

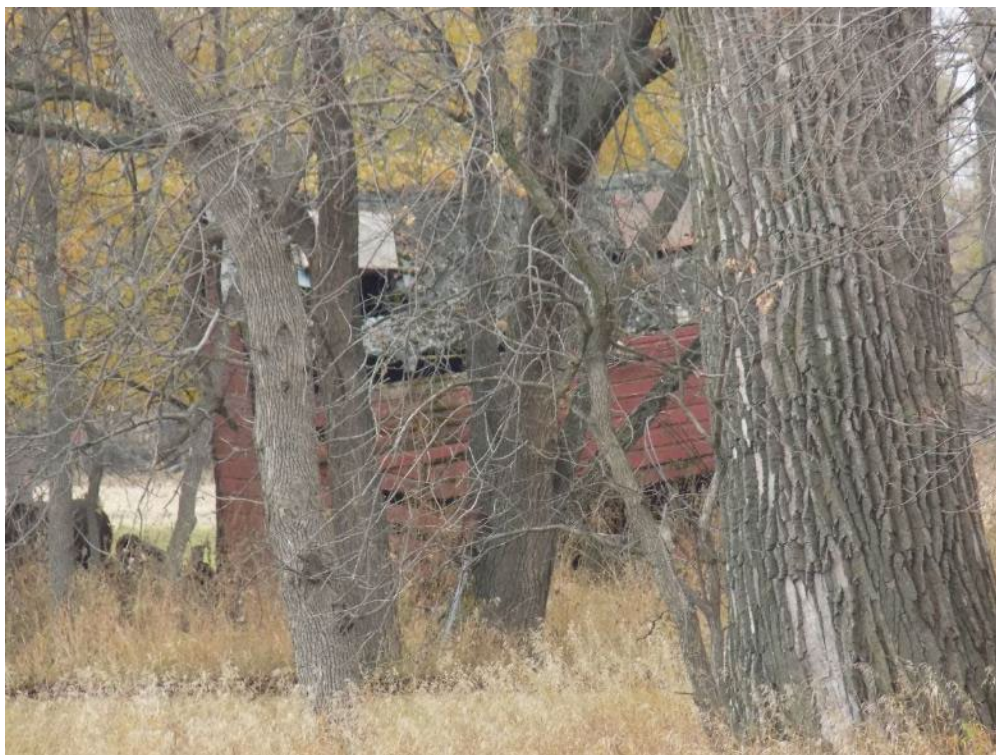
**Description:** A view of Feature 16 from the 67<sup>th</sup> Street SE ROW.

Features 6, 7, 8, 9, 13, 16, 17, 18, and 19 were constructed within the last 50 years (Photographs 42, 44, and 48). There is no evidence to suggest that any of these features meet the qualifications for Criteria Consideration G: Properties that Have Achieved Significance Within the Past Fifty Years (NPS 1995). Therefore, they are not recommended eligible for listing on the NRHP under any criteria.

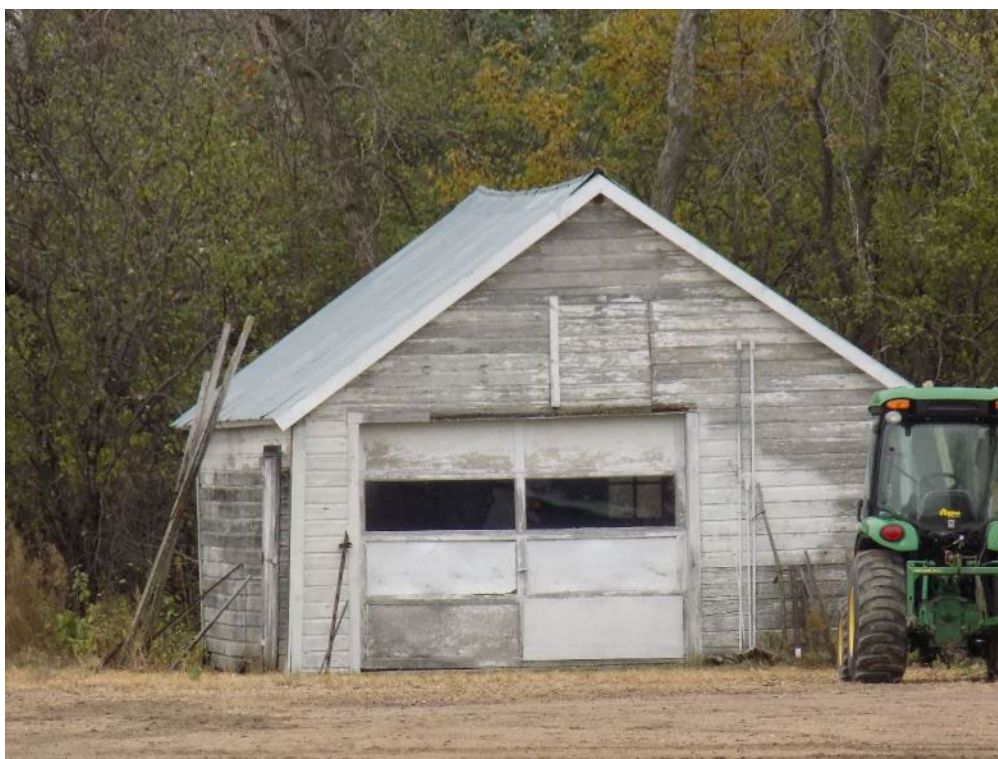
**Photograph: 52**

**Description:** A view of Feature 3 from the 68<sup>th</sup> Street SE ROW.

Feature 3 is a garage built between 1952-1961 (Photograph 52). It has a rectangular footprint and a gable roof. The north elevation has an eight-panel wooden garage door offset to the east. The panels second from the top are glass. There is a square opening in the gable that has been boarded shut. The garage has horizontal tongue-in-groove wood siding. The roof is covered in sheet metal. As a utilitarian building of no specific type, the garage is unlikely to have substantial individual significance that would render it eligible for the NRHP. It is therefore not recommended eligible for listing on the NRHP.

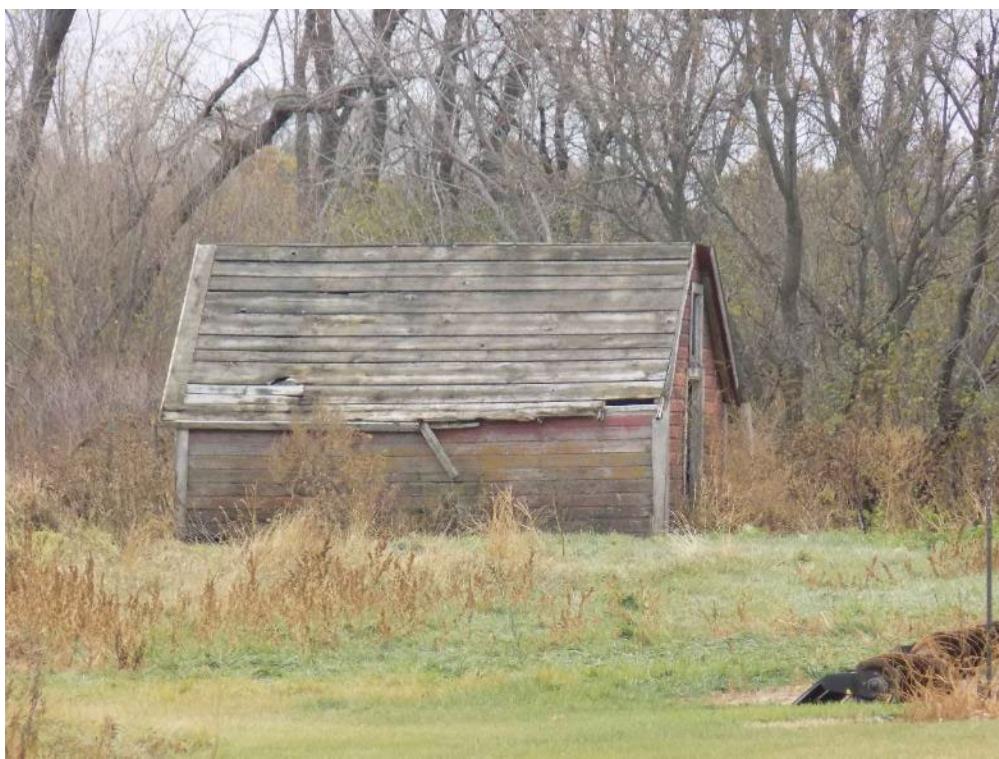
**Photograph: 54**

**Description:** A view of Feature 5 from the 68<sup>th</sup> Street SE ROW.

Feature 5 is a small shed (Photograph 54). The shed has a rectangular footprint and is clad in horizontal wood siding. The east elevation has a wood framed doorway below a rectangular wood framed window of an unknown type. The building has a gable roof that appears flat on top instead of having a typical pointed roof line. The roof is covered in wooden planks. Some of the wood has rotted away. The shed is a utilitarian building. Alone, it is not enough to convey association with historical themes or people (Criteria A and B). Despite the roof line being unusual, it is unlikely that the shed possesses sufficient architectural significance under Criterion C. There are no surface level indications that the shed would be eligible under Criterion D. Therefore, Feature 5 is not recommended eligible for listing on the NRHP under any criteria.

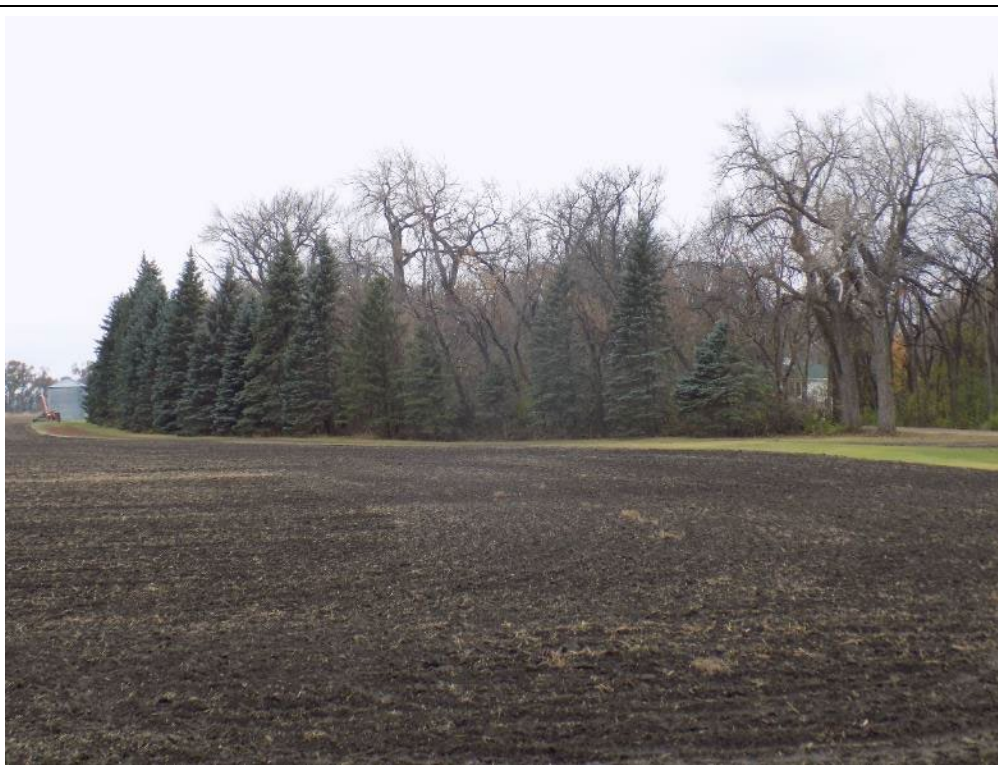
**Photograph: 60**

**Description:** An overview of Location 32RIX421 from the 69<sup>th</sup> Street SE ROW.

32RIX421 is a farmstead located at 16890 69<sup>th</sup> Street SE consisting of 11 features: a residence (Feature 1), two pole barns (Features 2 and 3), and eight grain bins (Features 4 through 11) (Map 9; Photographs 60 through 62). Most of the property is ensconced in trees and not visible from the public road ROW.

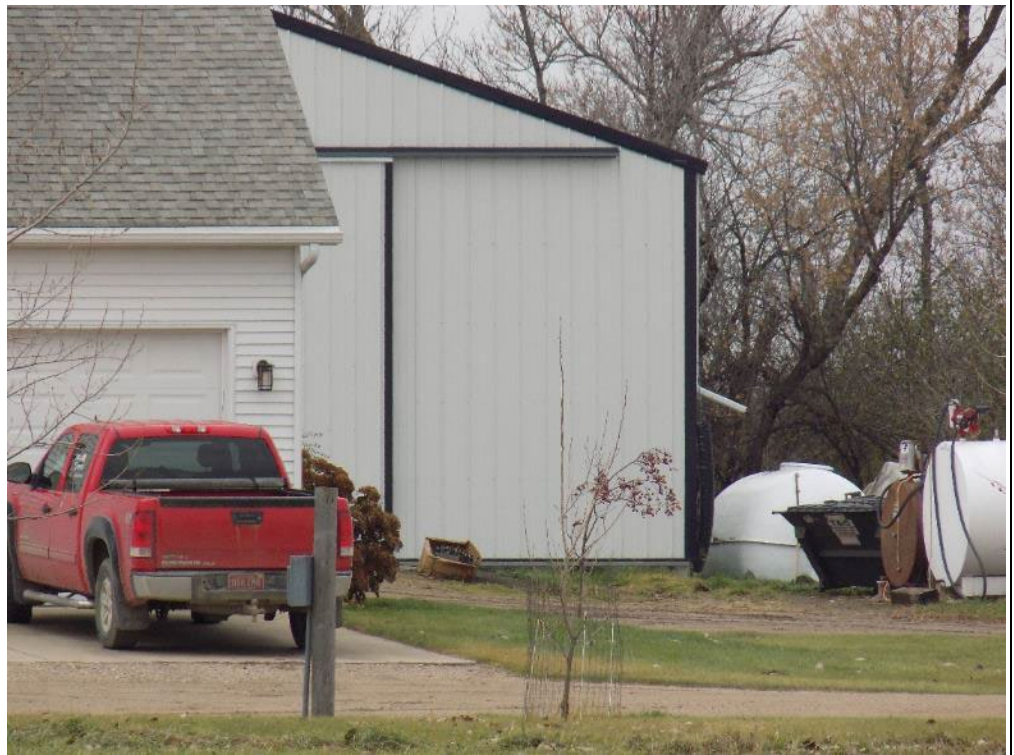
**Photograph: 68**

Feature 4 is a pole barn constructed between 2012-2014 (Photograph 68). There is no evidence to suggest it meets the qualifications for Criteria Consideration G: Properties that Have Achieved Significance Within the Past Fifty Years. It is therefore not recommended eligible for listing on the NRHP.

**Description:** A view of Features 1 (left) and 4 (right) from the 170<sup>th</sup> Avenue SE ROW.

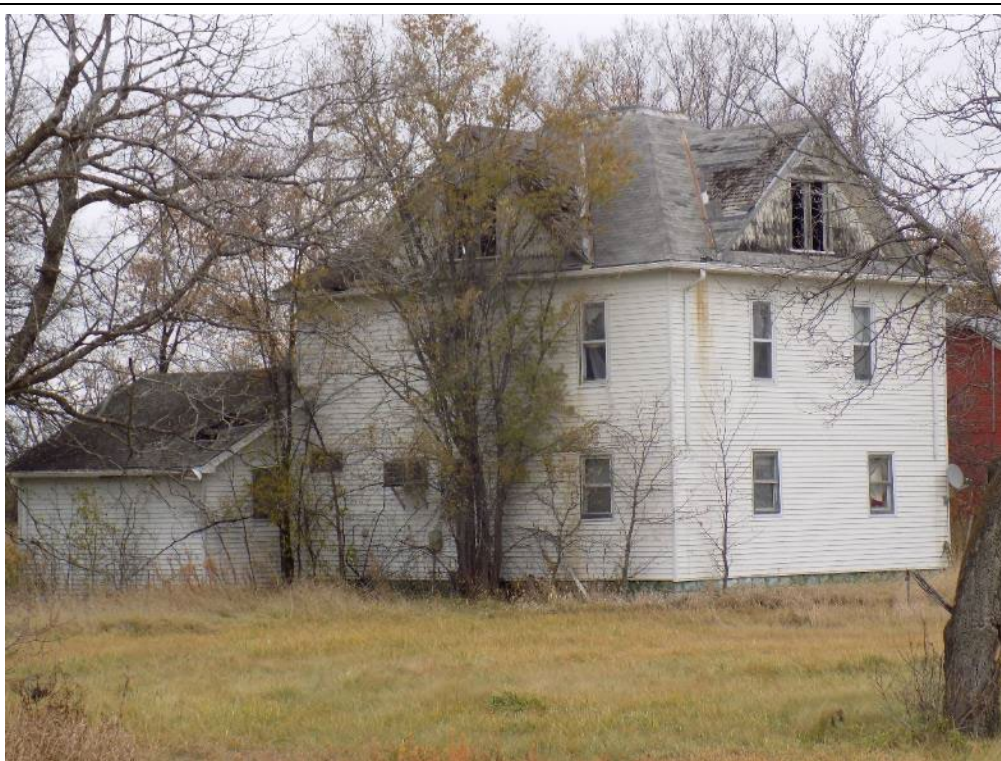
**Description:** A view of  
Feature 1 from the 169<sup>th</sup>  
Avenue SE ROW.

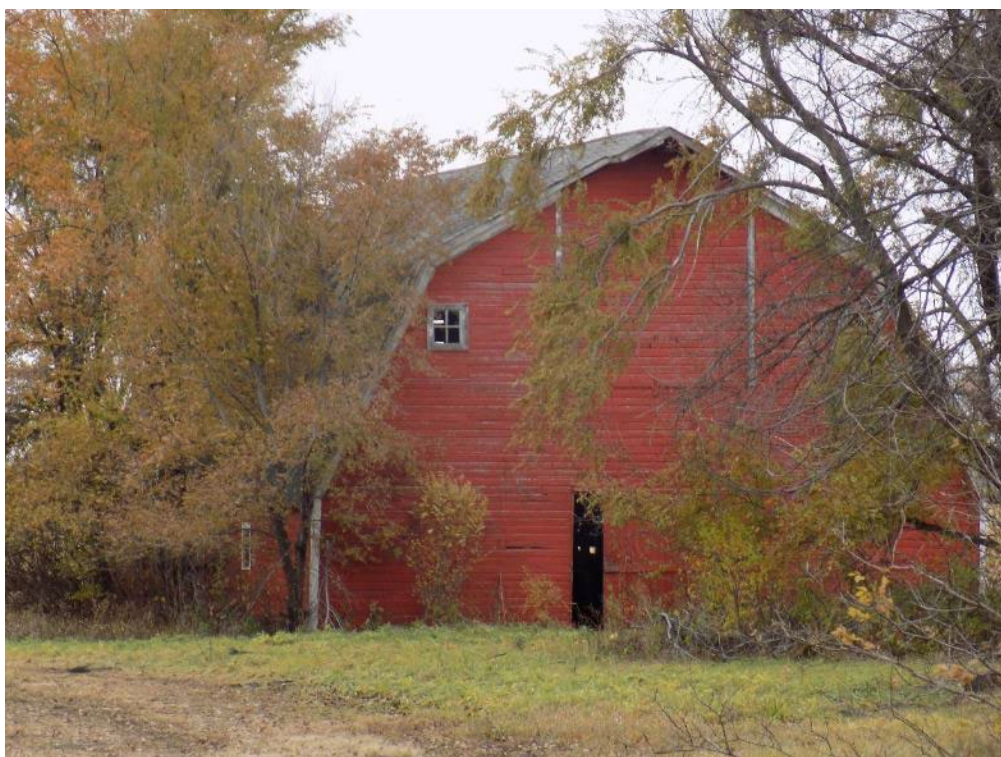
**Photograph: 72**

Feature 2 is a dairy barn featuring a loft, and a wide gambrel roof (Photographs 72 and 73). The barn is clad in horizontal wood siding. The west elevation features a barn door and two four-pane windows with wood sashes on the second level. There is a hay hood located at the roof peak. The south elevation features six four-pane windows with wood sashes, suggesting the building's use specifically as a dairy barn. No other elevations could be seen from the public road ROW. Aerial imagery indicates it was erected between 1952-1961. However, the barn resembles others built in the area by Norwegian immigrants near the turn of the twentieth century. It is possible that the barn is older and has been moved to its current location, as is common with farm buildings. If it has not been moved, the barn is associated with the theme of farming but does not appear to have played any significant role in the development of farming in the area as it was built six decades after farming presumably began on the property (Criterion A). The barn was presumably built by Isabel Mary Fox, but there is no evidence that she played a significant role in the community (Criterion B). The barn is of common construction for the area and is not the best example of its type nearby (Criterion C). There is no evidence the barn would contribute to further research (Criterion D). It is therefore not recommended eligible for listing on the NRHP. If the barn had been moved, the movement would have damaged the integrity of the building and it would not be eligible for listing on the NRHP.

**Description:** A view of  
Feature 2 from the 169<sup>th</sup>  
Avenue SE ROW.

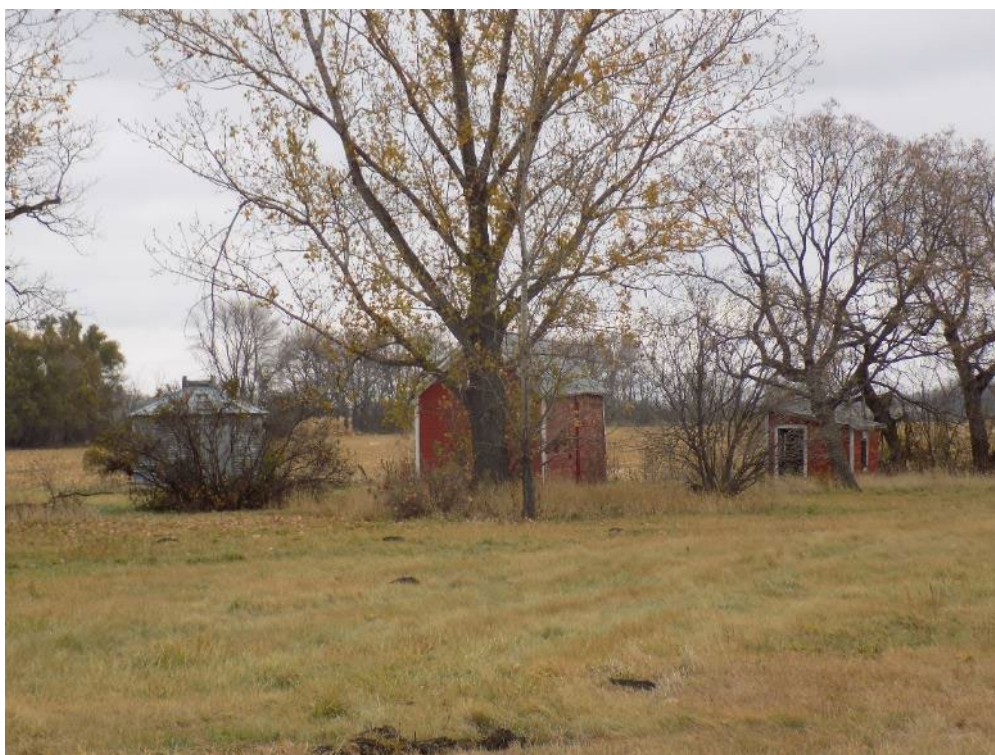
**Photograph: 74**

Feature 3 is a small grain bin constructed between 1984-1990 (Photograph 74). There is no evidence to suggest it meets the qualifications for Criteria Consideration G: Properties that Have Achieved Significance Within the Past Fifty Years. It is therefore not recommended eligible for listing on the NRHP.

Feature 4 is a shed (Photograph 74). It features horizontal wood siding and a gable roof. No further information could be ascertained from the public road ROW. Aerial imagery indicates it was built prior to 1952, and likely dates to the early to mid-twentieth century. Feature 4 is a utilitarian building with no clear associations or distinguishing features and is therefore not recommended for the listing on the NRHP under any criteria.

**Description:** A view of  
Features 3 (left), 4 (center),  
and 5 (right) from the 169<sup>th</sup>  
Avenue SE ROW.

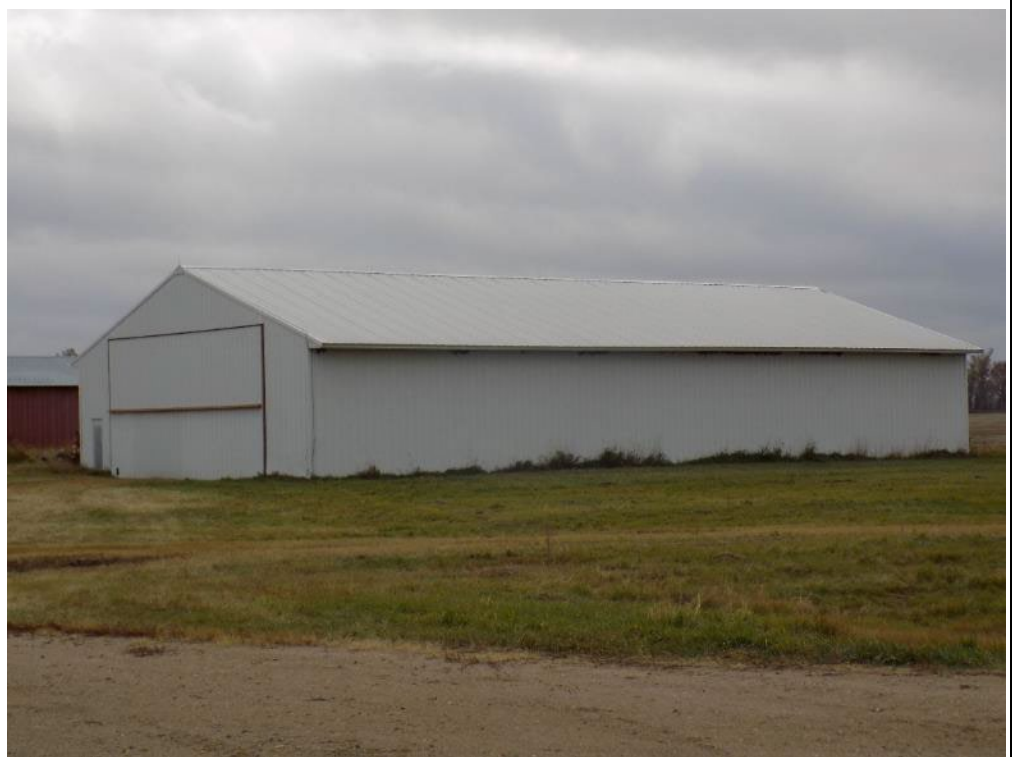
**Photograph: 82**

Feature 1 is a pole barn (Photograph 82). It has a rectangular footprint and gable roof. It is clad in white sheet metal. There is a garage door and a human scale door on the east elevation. It was constructed between 1961 and 1978. Feature 2 is also a pole barn (Photograph 83). It has a rectangular footprint and gable roof. It is clad in both red and unpainted sheet metal. There is an opening on the northeast corner of the building. It was constructed between 1961 and 1978. Pole buildings like these examples proliferated across the United States in the mid-twentieth century and continue to be a commonly constructed building type today. The ubiquity of this building type renders it ineligible for listing on the NRHP under any criteria.

**Description:** A view of Feature 1 from the 67<sup>th</sup> Street SE ROW.

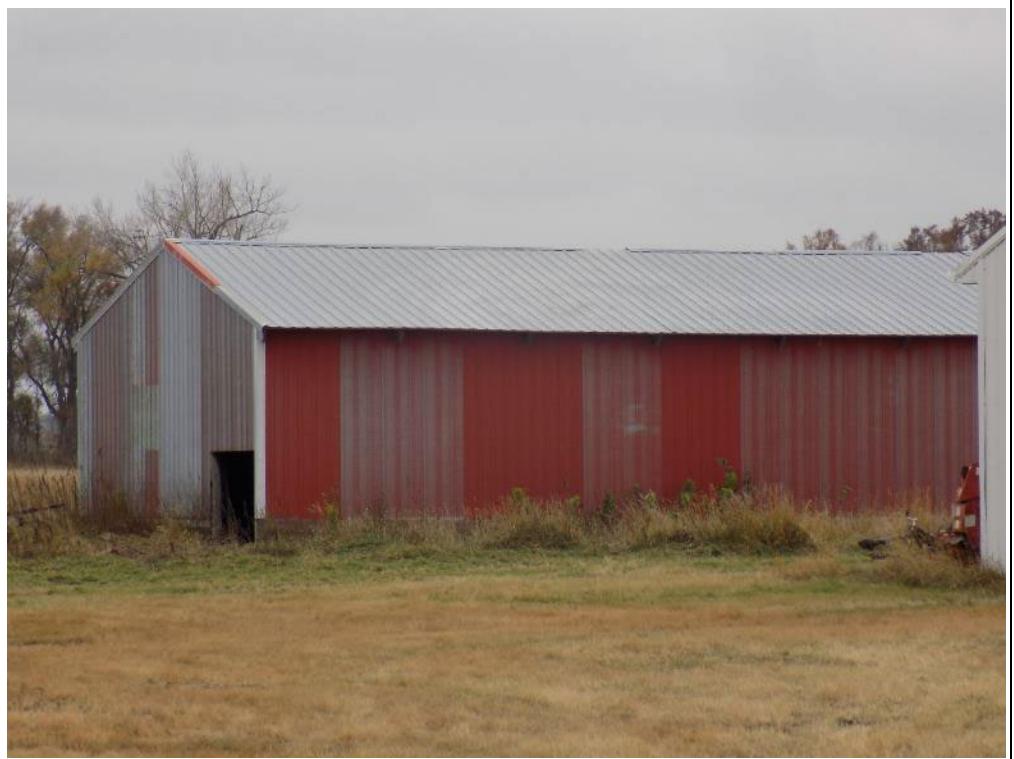
**Description:** A view of Feature 2 from the 67<sup>th</sup> Street SE ROW.

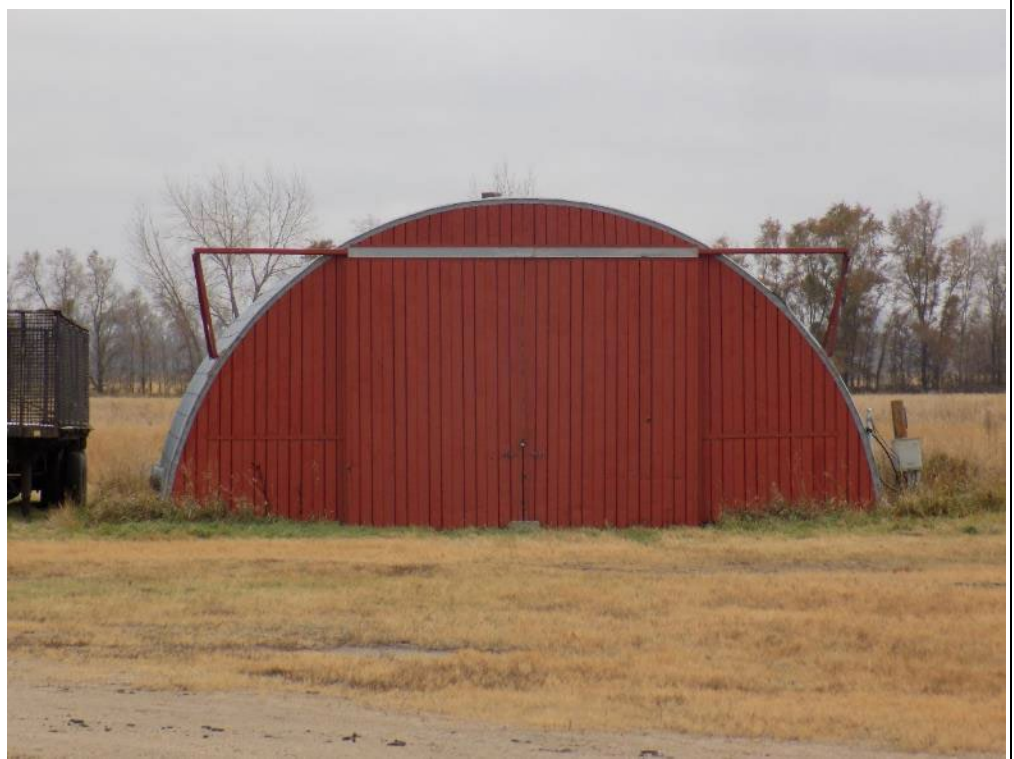
**Photograph: 84**

Feature 3 is a Quonset hut erected between 1952-1961 (Photograph 84). It is clad in red corrugated metal. There is a sliding barn door whose frame is greater than the width of the structure on the north elevation. Feature 4 is another Quonset hut erected between 1952-1961 (Photographs 85 and 86). It is clad in red corrugated metal on

**Description:** A view of Feature 3 from the 67<sup>th</sup> Street SE ROW.

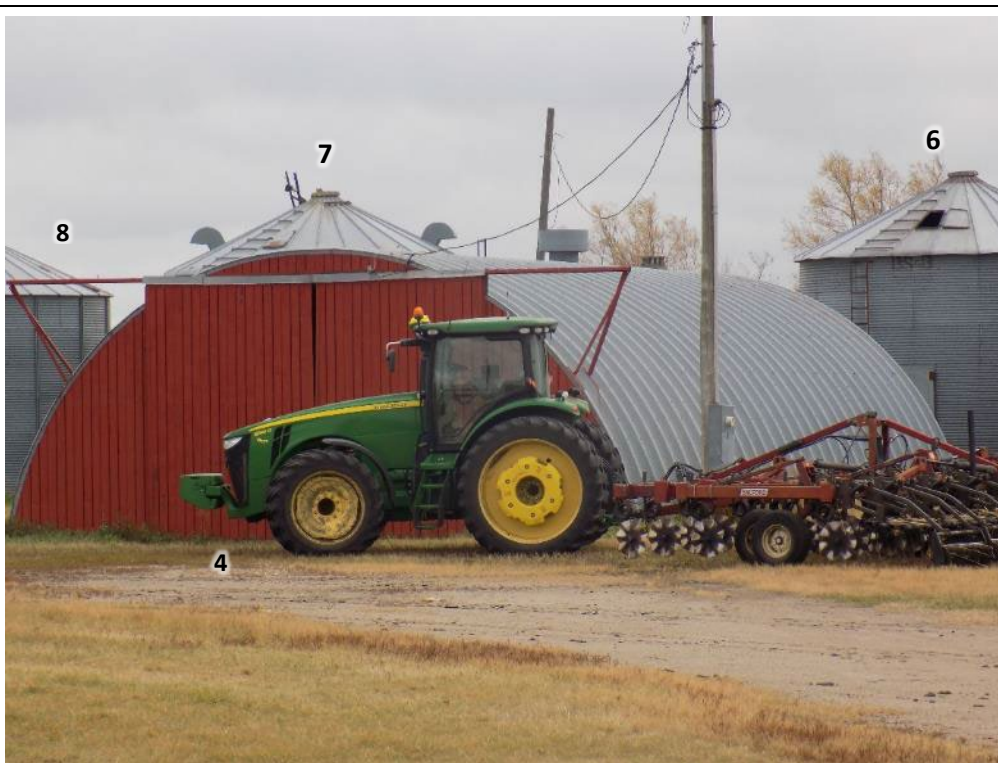
Feature 5 is two identical Butler grain bins erected between 1961-1978 (Photograph 87). They are constructed of corrugated metal and are six rings tall. Feature 6 is a BS&G grain bin erected between 1952-1961 (Photographs 85 and 87). It is clad in corrugated metal and is shorter than Feature 5. Feature 7 is a grain bin that is mostly obscured by other structures (Photograph 85). Only the top was visible from the public road ROW. It was erected between 1961-1978. Feature 8 is a grain bin clad in corrugated metal (Photographs 85 and 86). It is six rings tall and had no visible branding. It was constructed between 1961-1978. Feature 9 is four identical Butler grain bins (Photograph 86). They are clad in corrugated metal and are eight rings tall. They were erected between 1961-1978. Metal grain bins like these examples are incredibly common structures used for grain storage. They have not had a substantial change in design since they became popular in the mid-twentieth century. Therefore, they are not recommended eligible for listing on the NRHP under any criteria.

**Description:** A view of Features 4, 6, 7 (behind 4), and 8 from the 67<sup>th</sup> Street SE ROW.

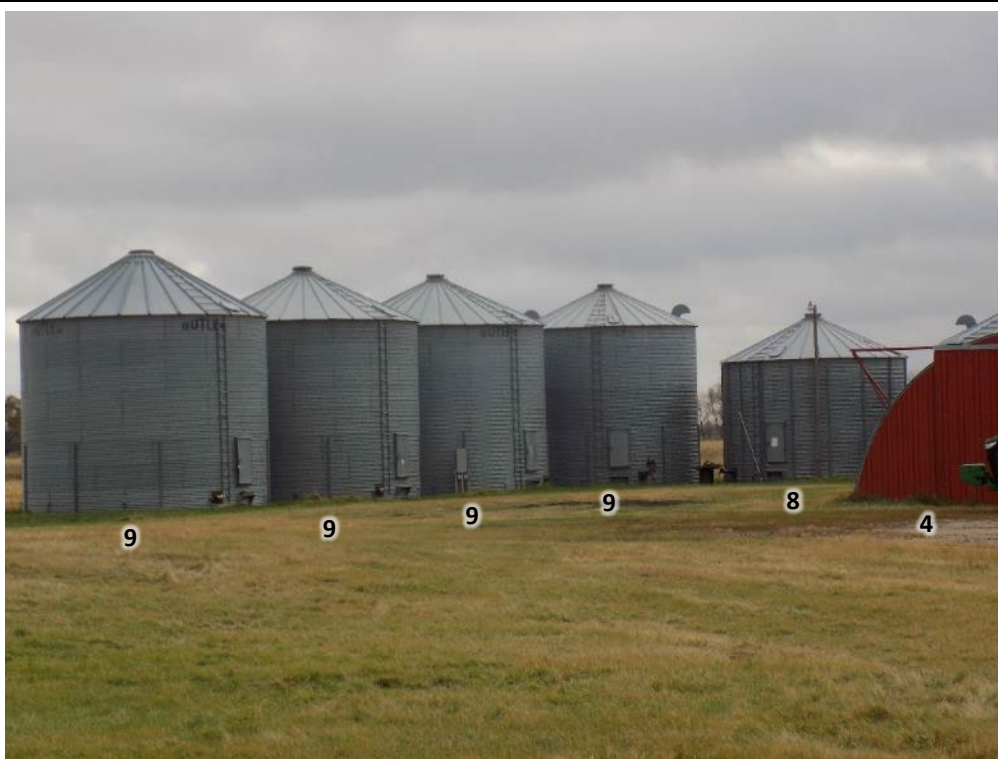
**Photograph: 86**

**Description:** A view of Features 4, 8, and 9 from the 67<sup>th</sup> Street SE ROW.

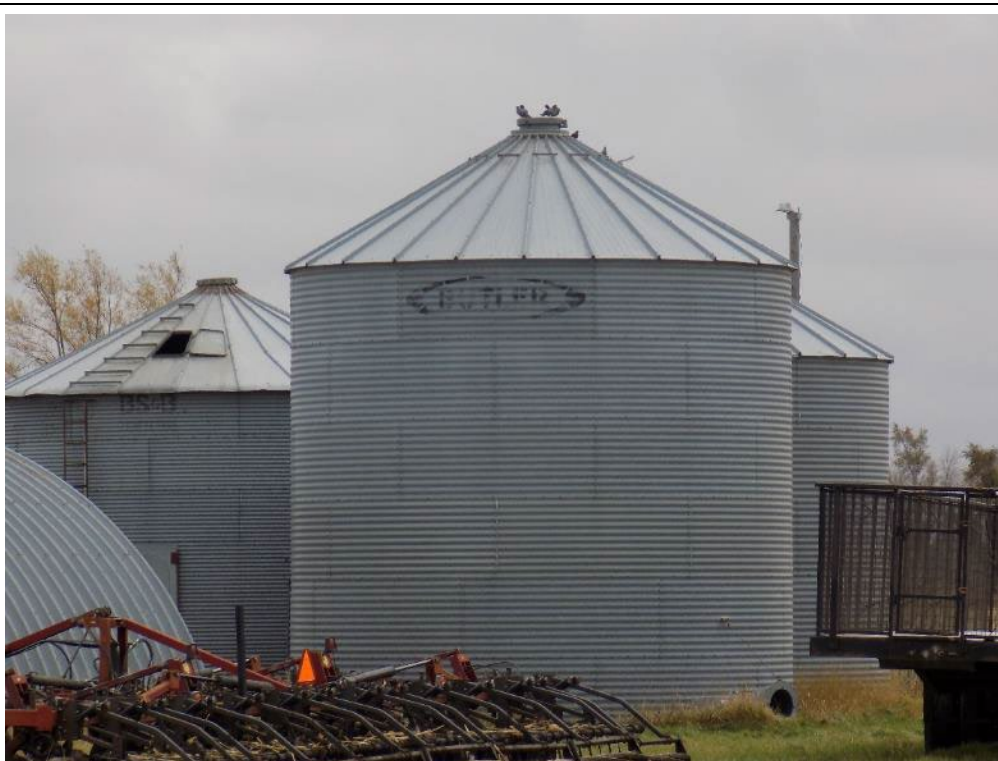
**Description:** A view of Features 6 (left) and 5 (center and right) from the 67<sup>th</sup> Street SE ROW.

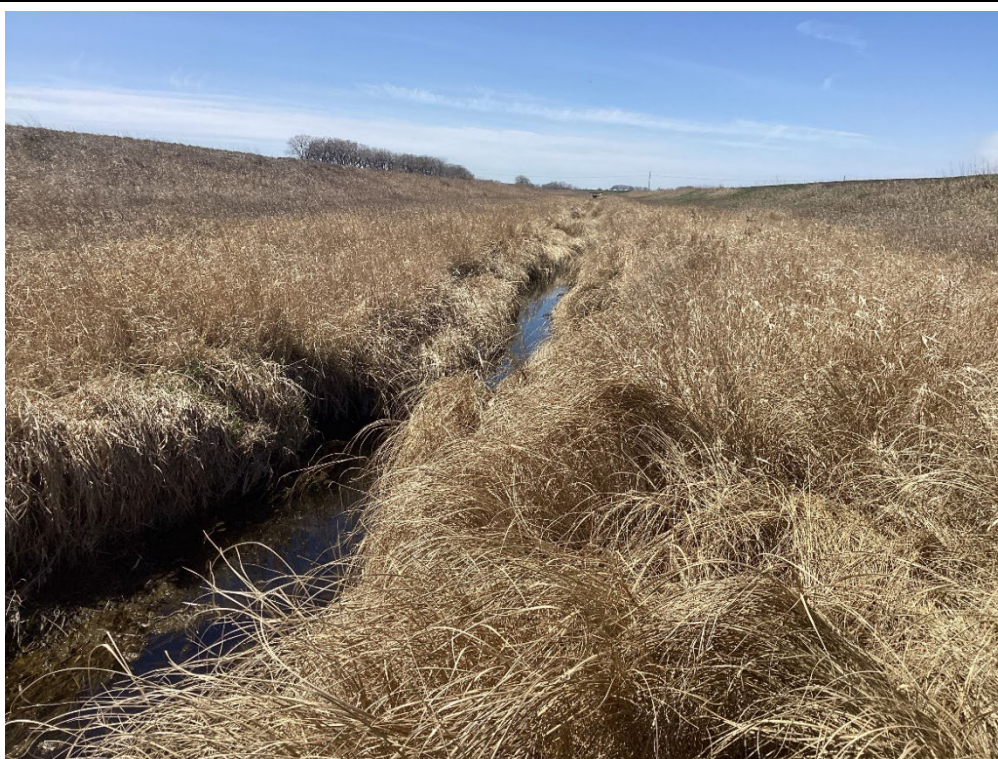
**Photograph: 88**

32RI942 is a drainage ditch carrying a segment of Pitcairn Creek (Drain 72) intersecting 170<sup>th</sup> Avenue SE between 67<sup>th</sup> Street SE and County Road 6 that was initially excavated at least 50 years ago (Map 13, Photographs 88 and 89). Pitcairn Creek was illustrated on the 1910 Alden Publishing Co. plat meandering through sections 8 and 9 of Township 134 North, Range 49 West (Alden Publishing Co. 1910). The creek did not appear to be channelized in 1910. Pitcairn Creek was not illustrated on the 1922 H.E. Wilson atlas (H.E. Wilson and Company 1922). A review of 1952 aerial photography revealed that Pitcairn Creek had been channelized within 32RI942; 170<sup>th</sup> Avenue SE was not present at this time (AMS 1952). At this time, the ditch was approximately 11 meters wide. 170<sup>th</sup> Avenue SE was constructed across in the ditch between 1952 and 1978 (AMS 1952; USGS 1978). Between 1978 and 1990, portions of the ditch to the east of 170<sup>th</sup> Avenue SE were widened from roughly 11 meters to 25 meters; portions of the ditch to the west of 170<sup>th</sup> Avenue were widened between 1990 and the early 2000s.

**Description:** An overview of Site 32RI942. Photograph taken at the eastern boundary of Site 32RI942 on the east side of 170<sup>th</sup> Avenue SE.

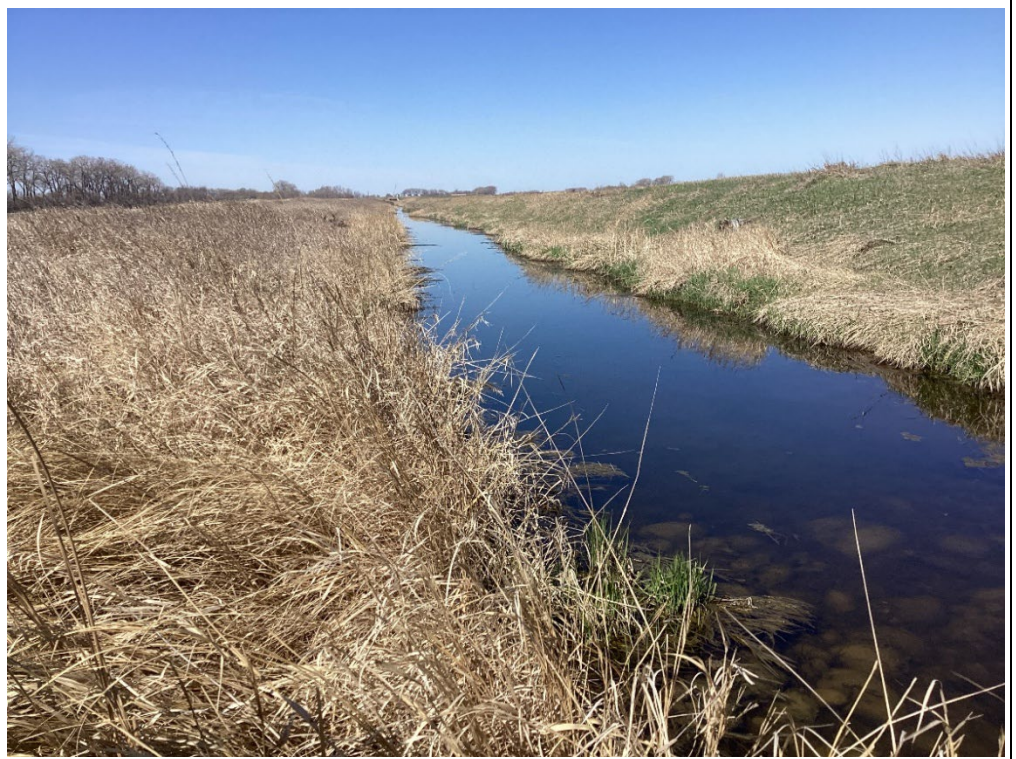
**Description:** An overview of Site 32RI942. Photograph taken on the west side of 170<sup>th</sup> Avenue SE.
