ONEOK Bakken NGL Pipeline

Williams County, North Dakota

Topsoil Inspection Report

Docket Number: PU-25-172

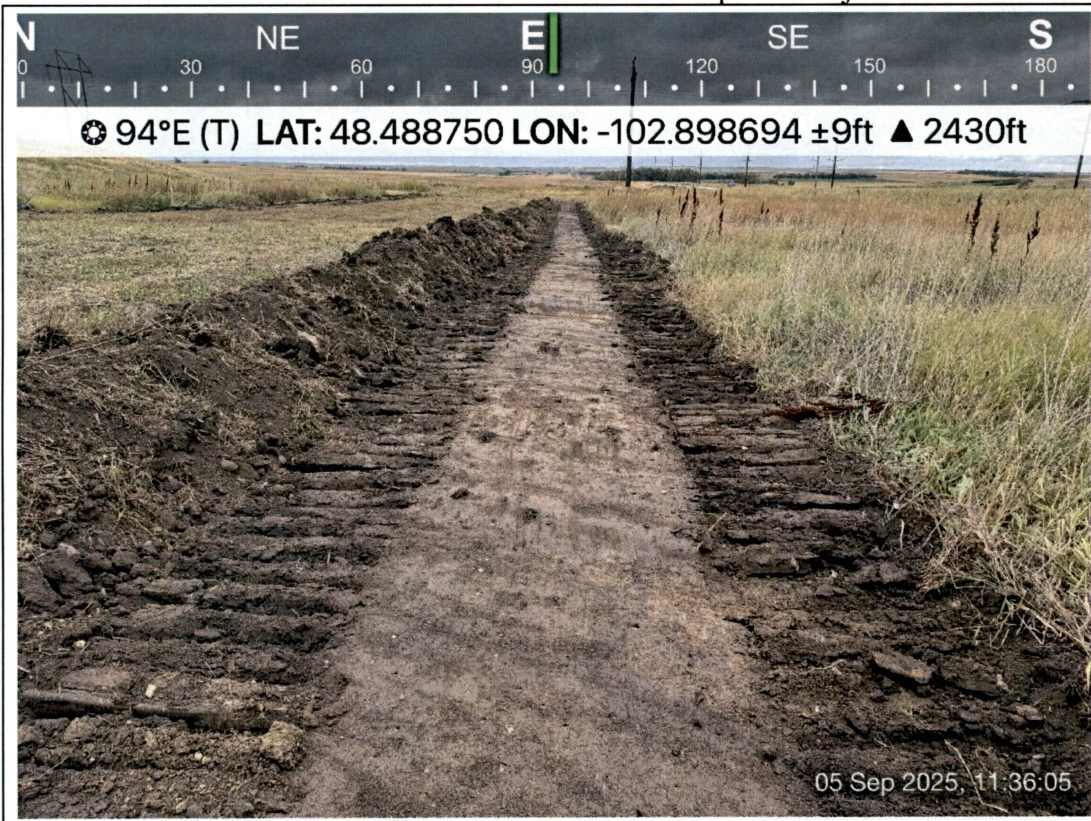
Photo #: 3

Description: Topsoil stripped to depth of color change between topsoil and subsoil.

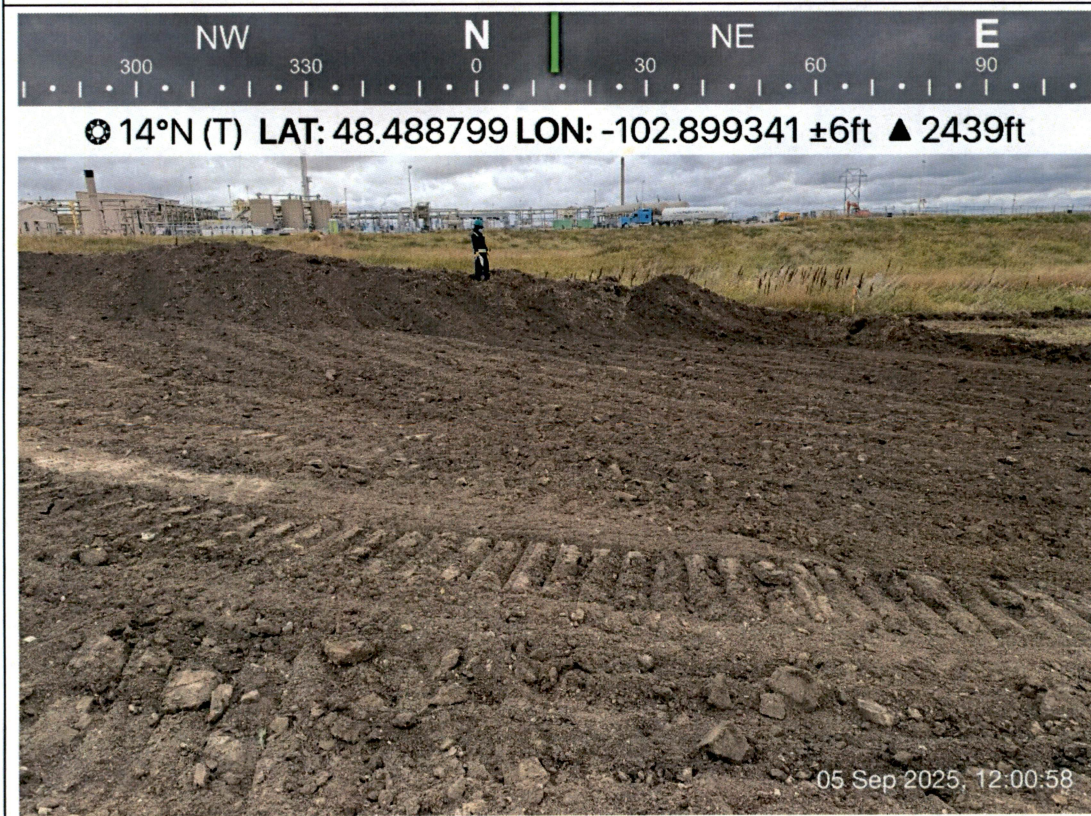
Photo #: 4

Description: Topsoil pile along North side of topsoil inspection area.

Potential Issues	Recommendations
SWPPP/BMPs	Silt fence and straw waddles along the perimeter of the topsoil piles will need to be monitored regularly and replaced when necessary.

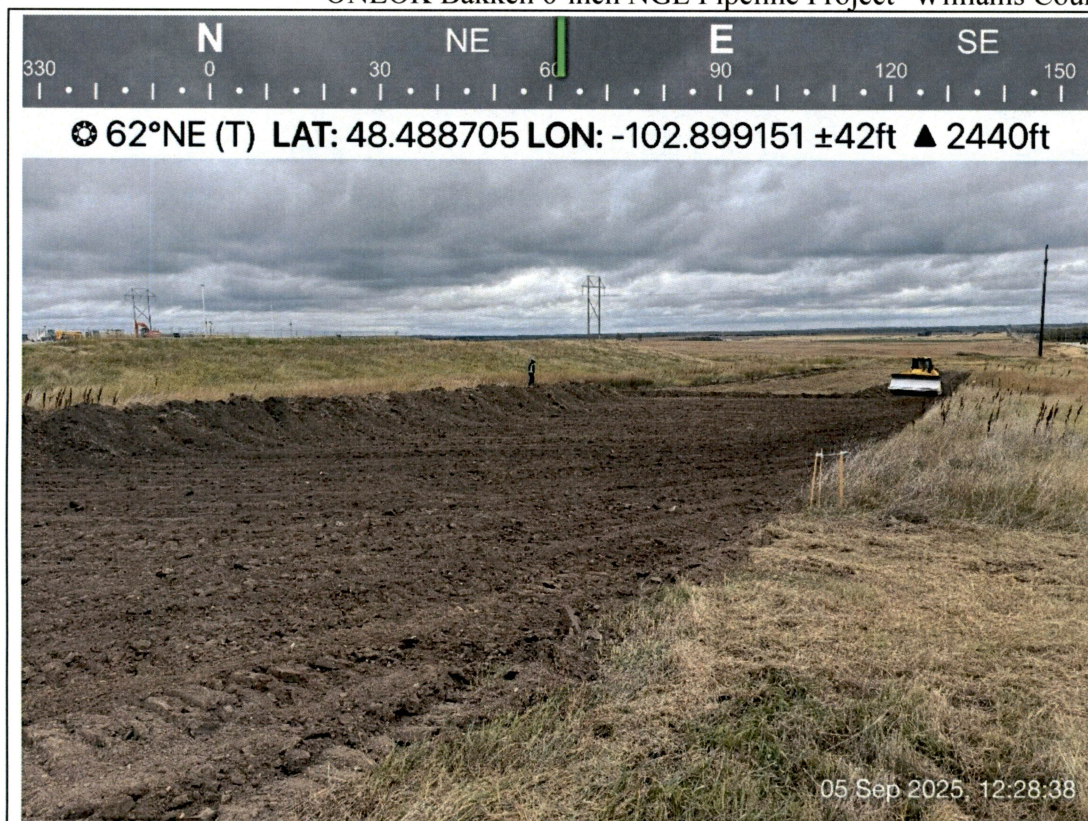
Photo #: 5
Direction: Northeast
Description: Dozer removing topsoil with topsoil pile along North side of construction area in view.
Observer: Zach Peterson
Date: 9/5/2025
Latitude: 48.488705
Longitude: -102.899151

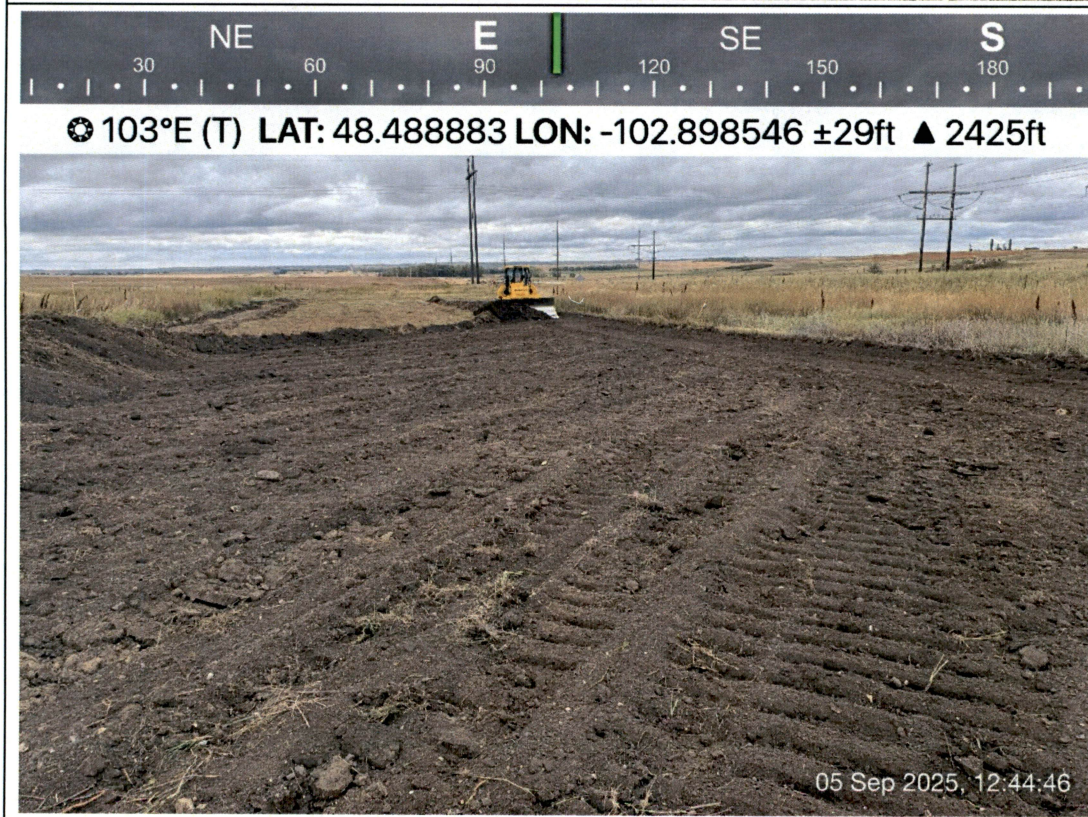
Photo #: 6
Direction: East
Description: Dozer removing topsoil on East end of construction area.
Observer: Zach Peterson
Date: 9/5/2025
Latitude: 48.488883
Longitude: -102.898546

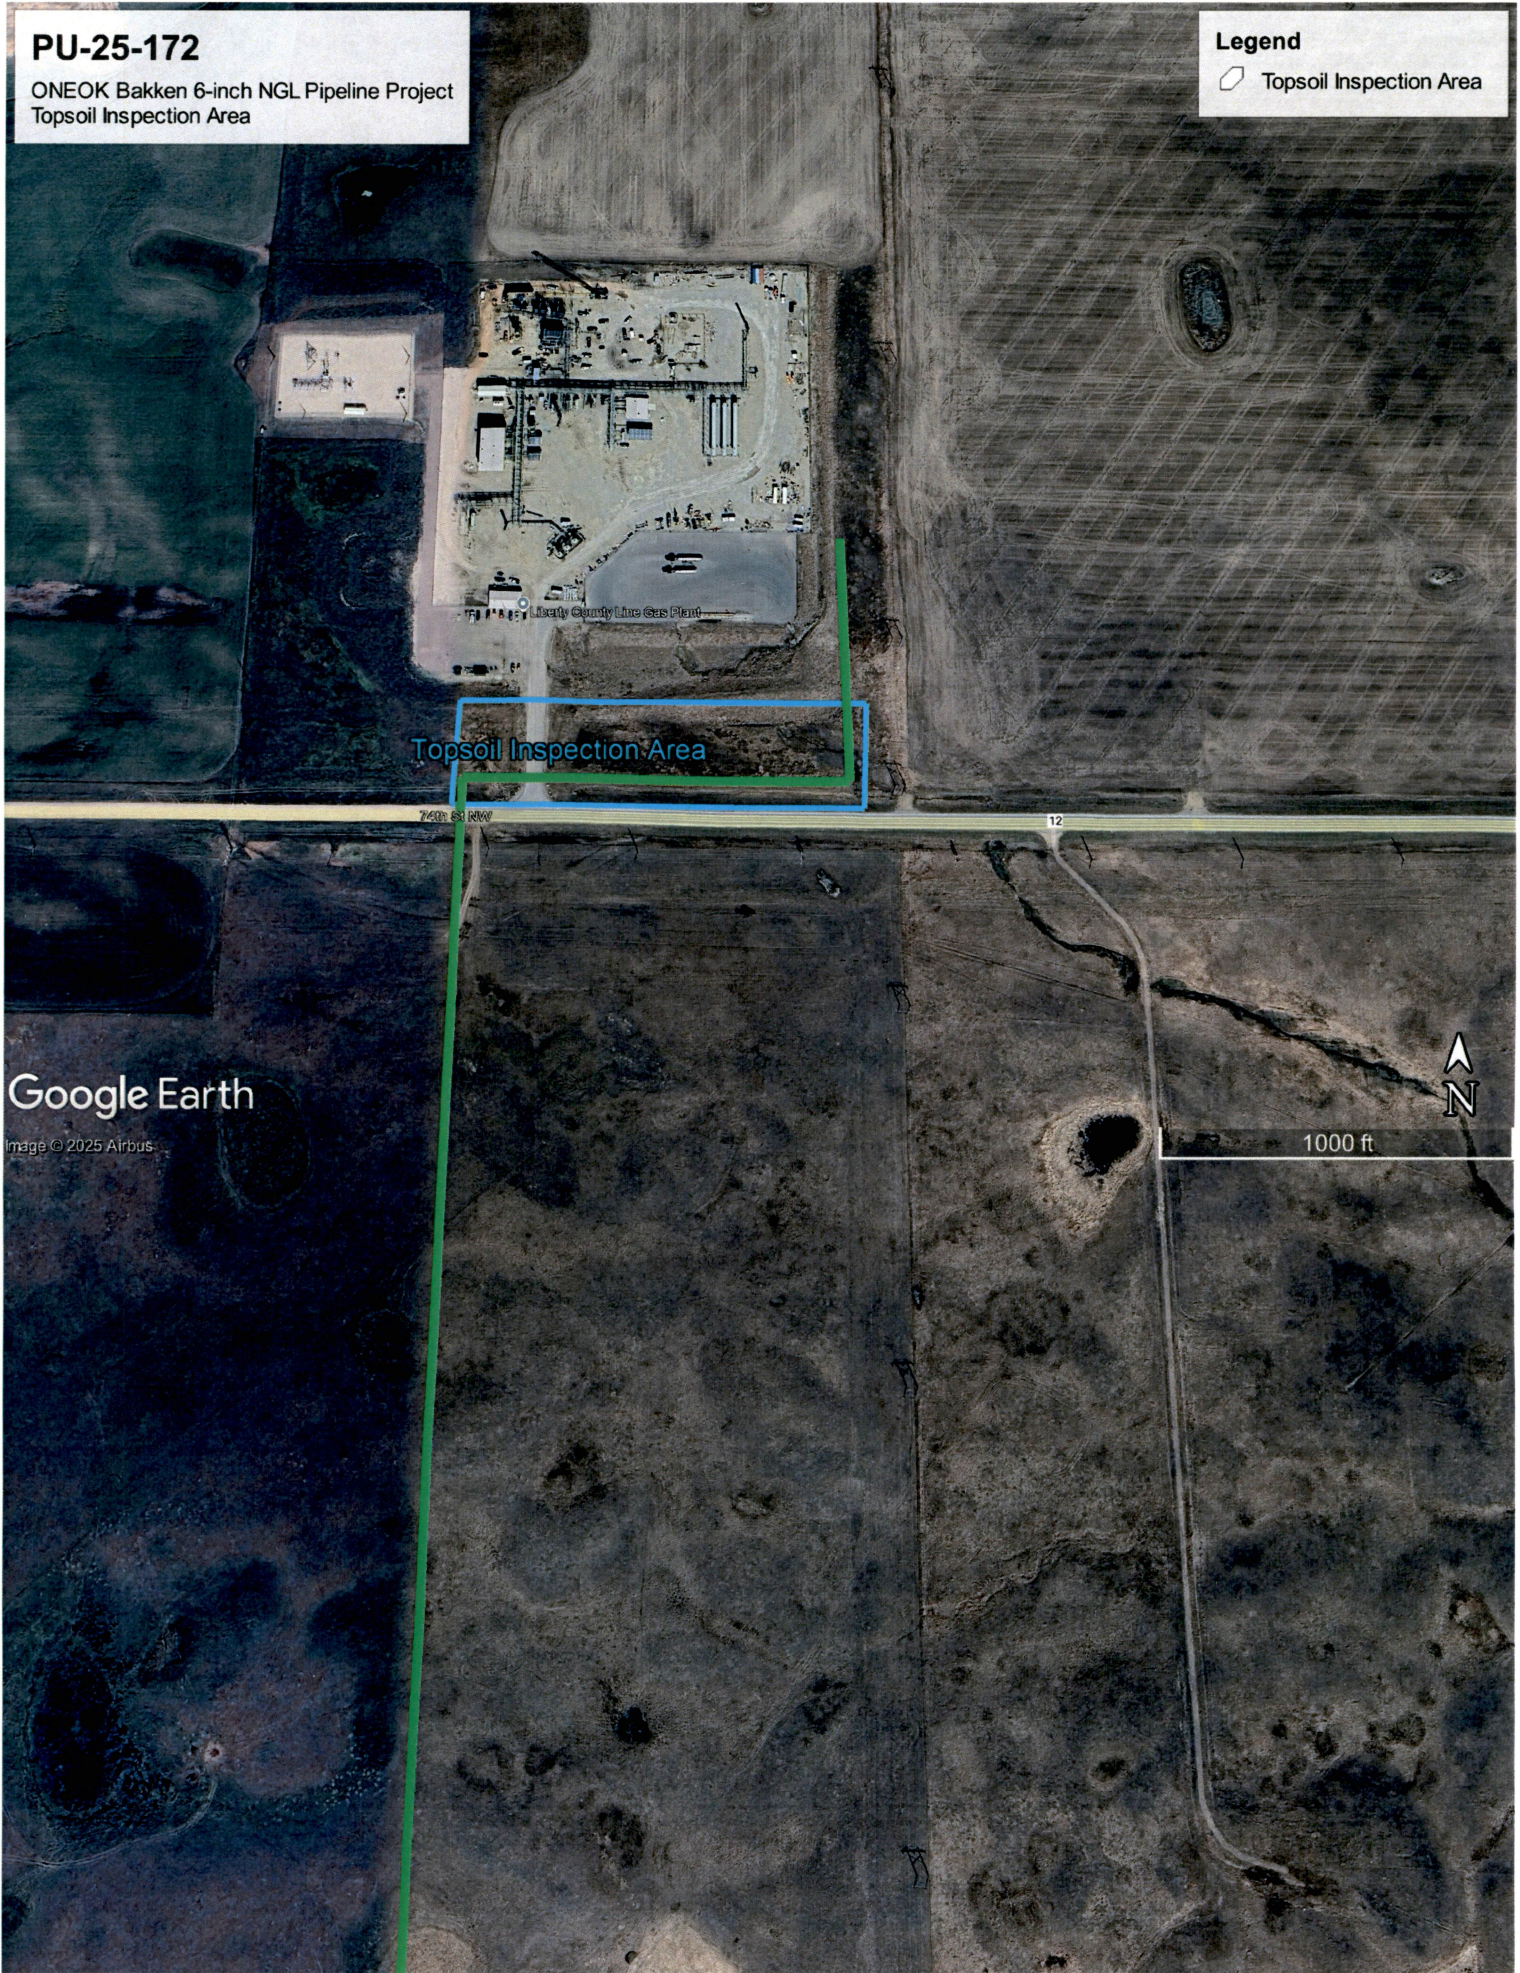
Topsoil Inspection Area

Mr. Peterson met Mr. Gilreath at the County Line Station where construction for the Project was commencing with the removal of topsoil where the pipeline connects with the County Line Station at the northern terminus of the Project in Section 24, T158N, R95W in Williams County, North Dakota. A single bulldozer removed topsoil along the ROW in incremental layers until the subsoil layer began to appear. Topsoil depth ranged from 7 to 10 inches along the differing contours of the Project ROW, with the shallower depth found on the uphill slope and the deeper topsoil in the lowest lying areas. As the topsoil was removed, the equipment operator piled the removed topsoil into an earthen berm running along the north side of the ROW. No subsoil was being removed and the topsoil was properly segregated from the exposed subsoil layer. Silt fence will be placed along the downhill side of the topsoil piles to prevent offsite runoff from the topsoil piles. When the steel pipe is ditched into the ground, the subsoil will be removed and replaced as the pipe is laid along the ROW and will not be mixed with the topsoil piles along the edge of the ROW.
