## DAILY REPORT

| Project: Emmons Logan Energy Storage | Project No.: PU-25-209 |
| Date: 5/5/2026 and 5/6/2026 | Day: Tuesday, Wednesday |

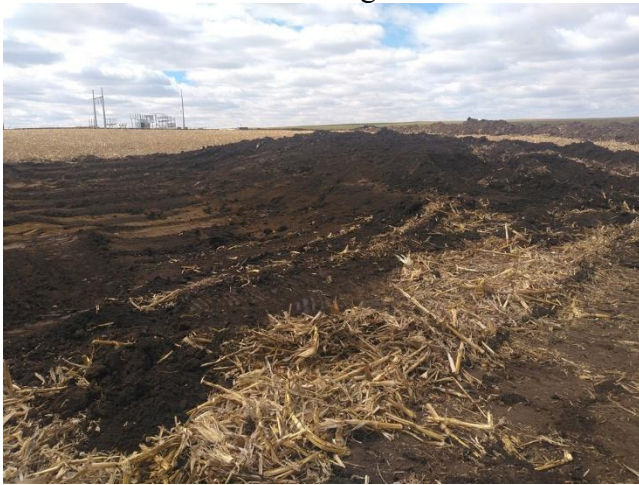
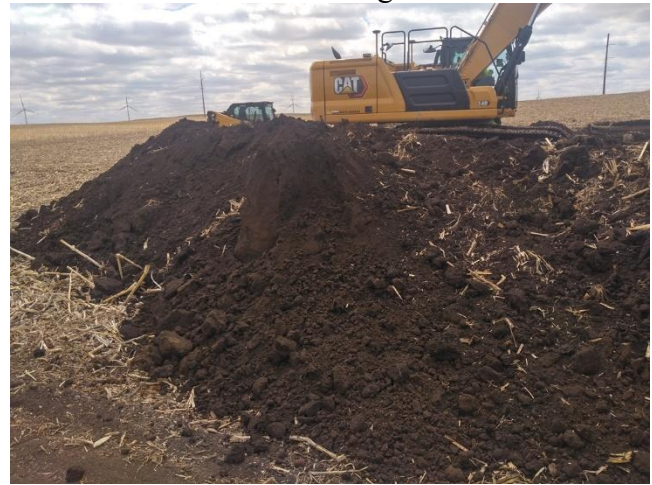
Noted topsoil stripping depth at Site 1 was exceeding the depth necessary and getting into underlying soils. Informed the operator that we did not want to mix subsoils with the topsoil and to exercise care not to get too deep.

Site 1 Looking South

Site 1 Looking East

Discussed stripping depth with onsite Superintendent and the intent to strip to one foot depth or the full cultivated depth, whichever is greater. Reviewed stripping depth at all four sites with Superintendent to ensure compliance with Certification Relating to Order Provisions. Pointed out over depth stripping at site 1 and recommended exercising care to not strip too deeply.
