## DAILY REPORT

| Project: Emmons Logan Energy Storage | Project No.: PU-25-209 |
| Date: 6/11/2026 | Day: Thursday |

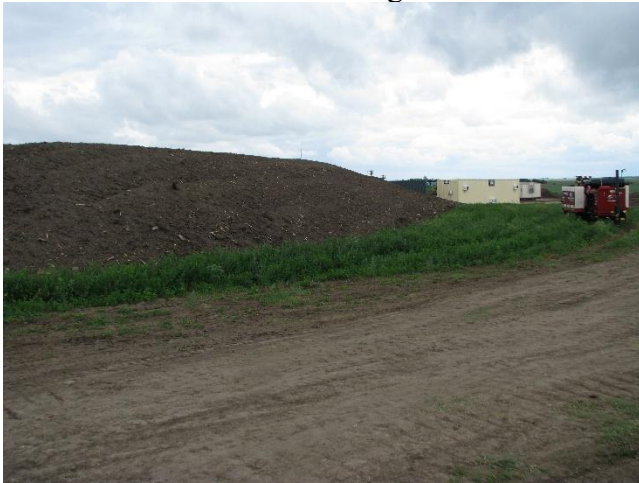
View of Site 1 Looking Northwest

The two topsoil stockpile locations are indicated on the sitemap as Site 1 and Site 2. Photos were taken of the two stockpiles from vantage points facing the stockpile and looking the direction indicated below. Noted vegetative buffer surrounding topsoil pile at site 1 on three sides and silt fence placements to protect natural water course to the north. Noted fiber rolls on the downhill side of the topsoil stockpile at site 2. Did not note any erosion or sediment leaving site.
