# A Class I Review of the Proposed Jamestown to Ellendale Transmission Line Route Corridors

Stutsman, Lamoure, and Dickey Counties, North  
Dakota

March 2024

## **A Class I Review of the Proposed Jamestown to Ellendale Transmission Line Route Corridors**

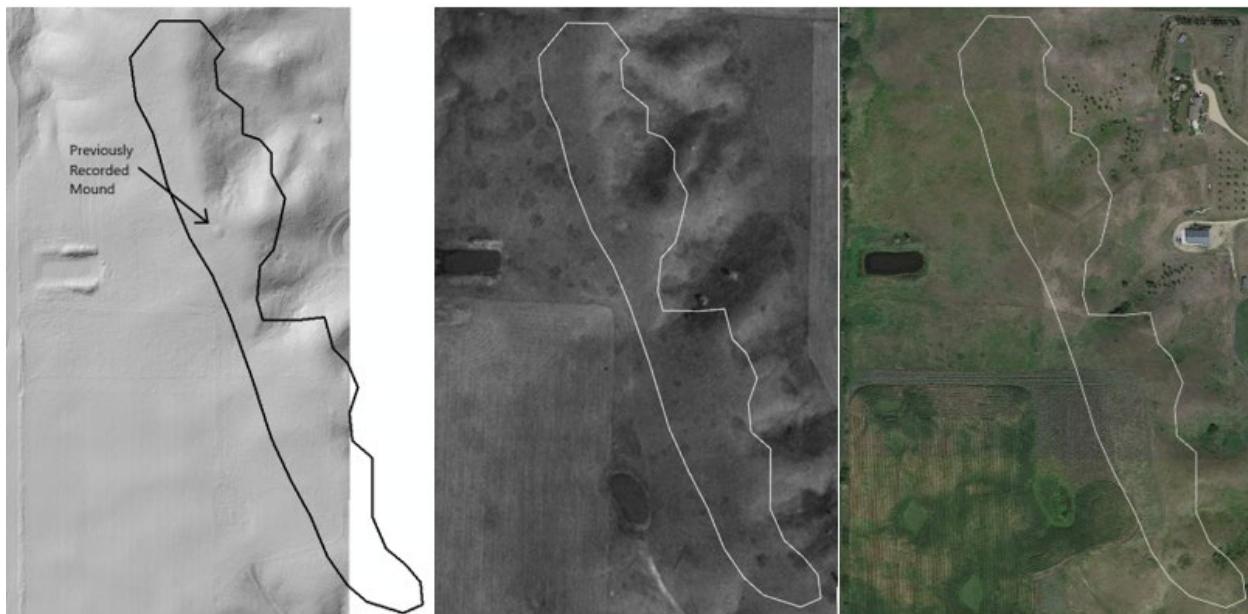
Figure 3. Site 32LM74 lidar and aerial imagery (left: 1997, right: 2022) overview

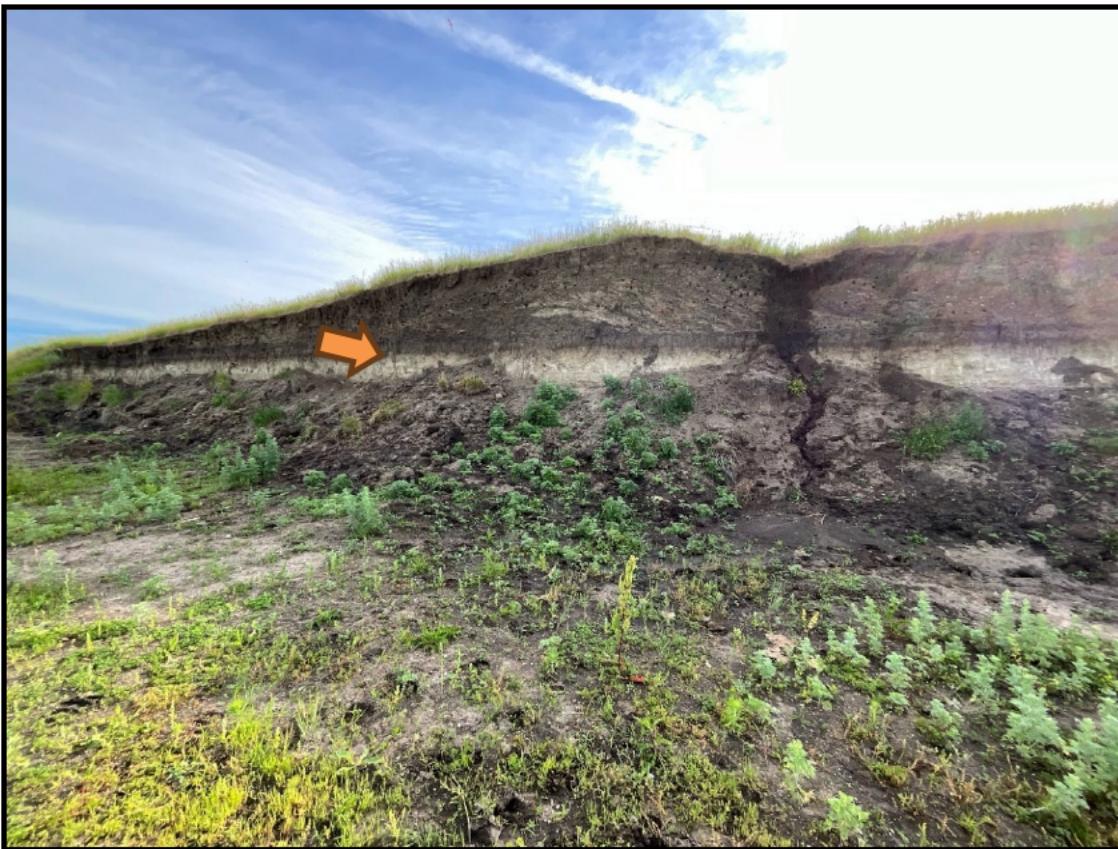
**Figure 28:** Overview of a cutface in gravel pit within Sevenmile Coulee, displaying spoils over the top of the natural ground surface. Orange arrow indicated spoils-buried surface interface.

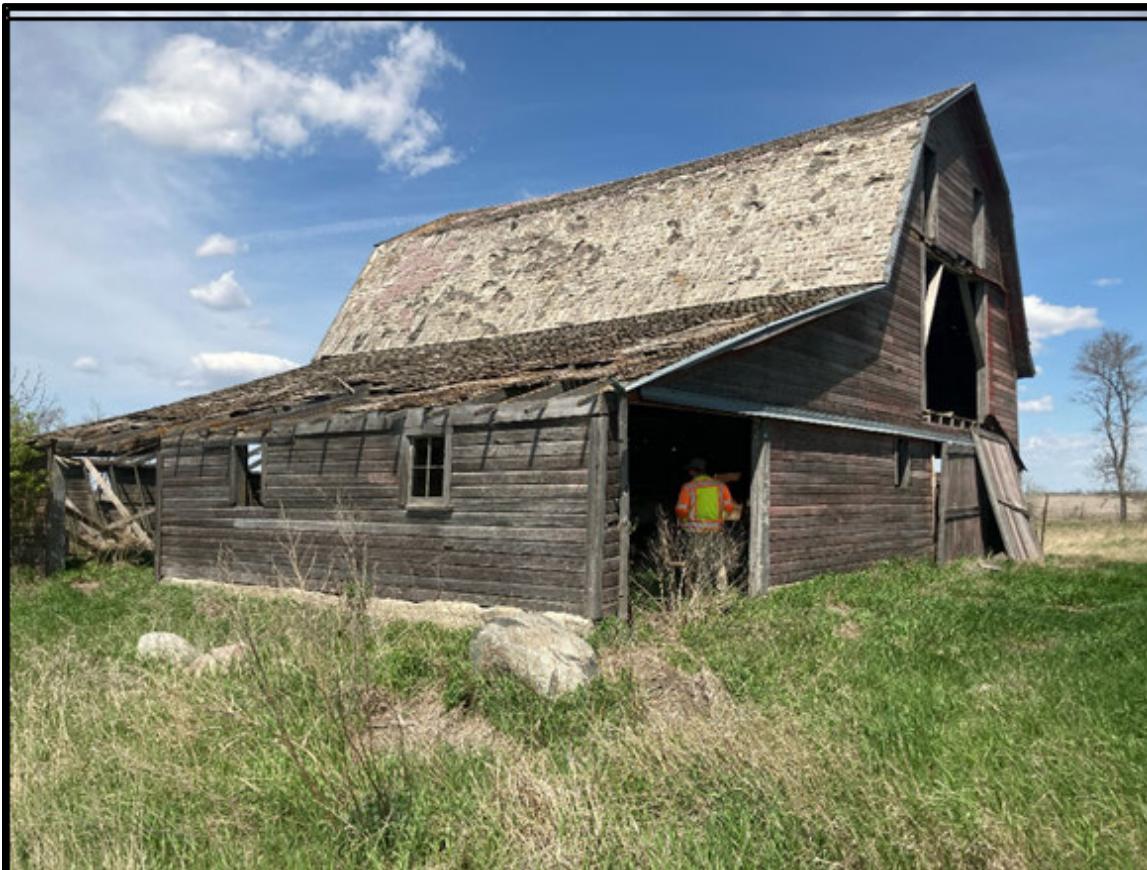
**Figure 33:** Site 32DI543, Feature 5, view facing northwest (JUP 5/10/2024).

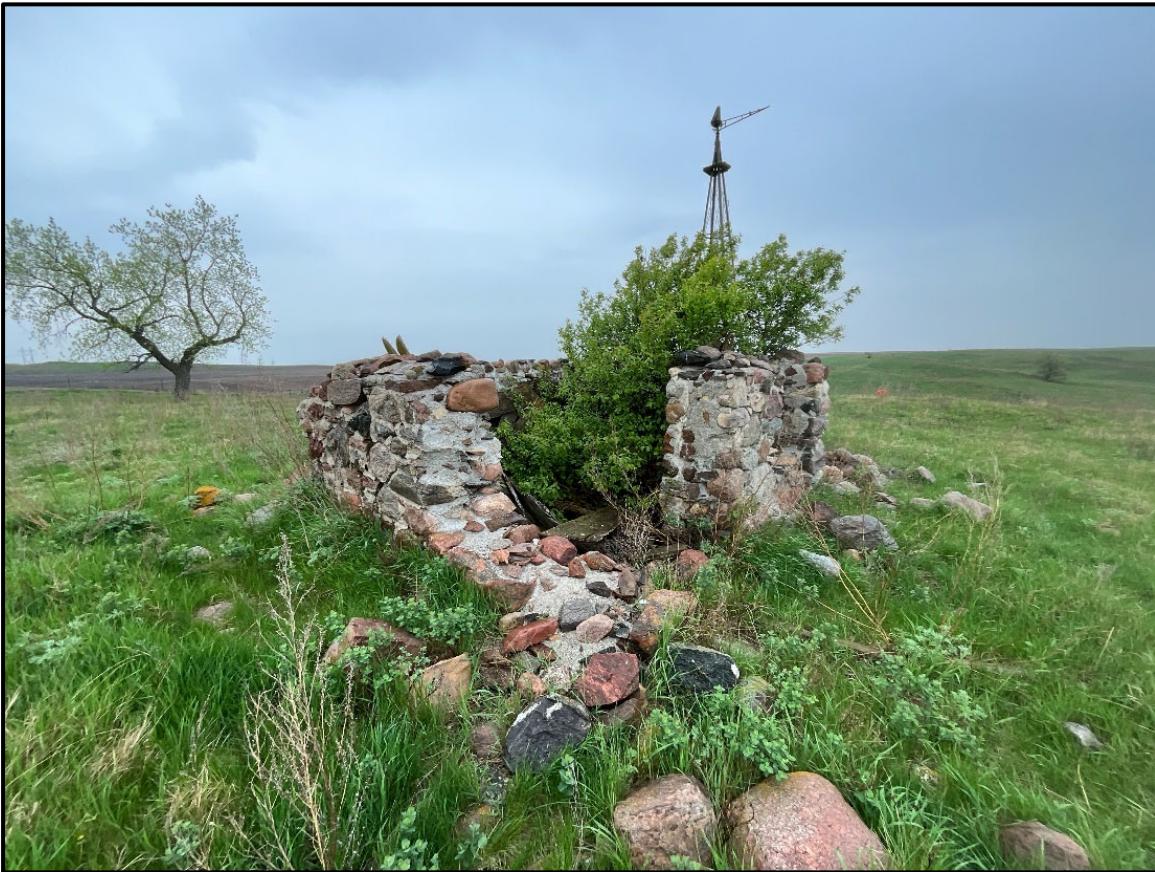
**Figure 37:** 32SN866, Feature 2, view northwest. Feature 1 (windmill frame) visible in background (JUP 5/21/2024).
