Appendix H

Cultural Resources Survey Reports

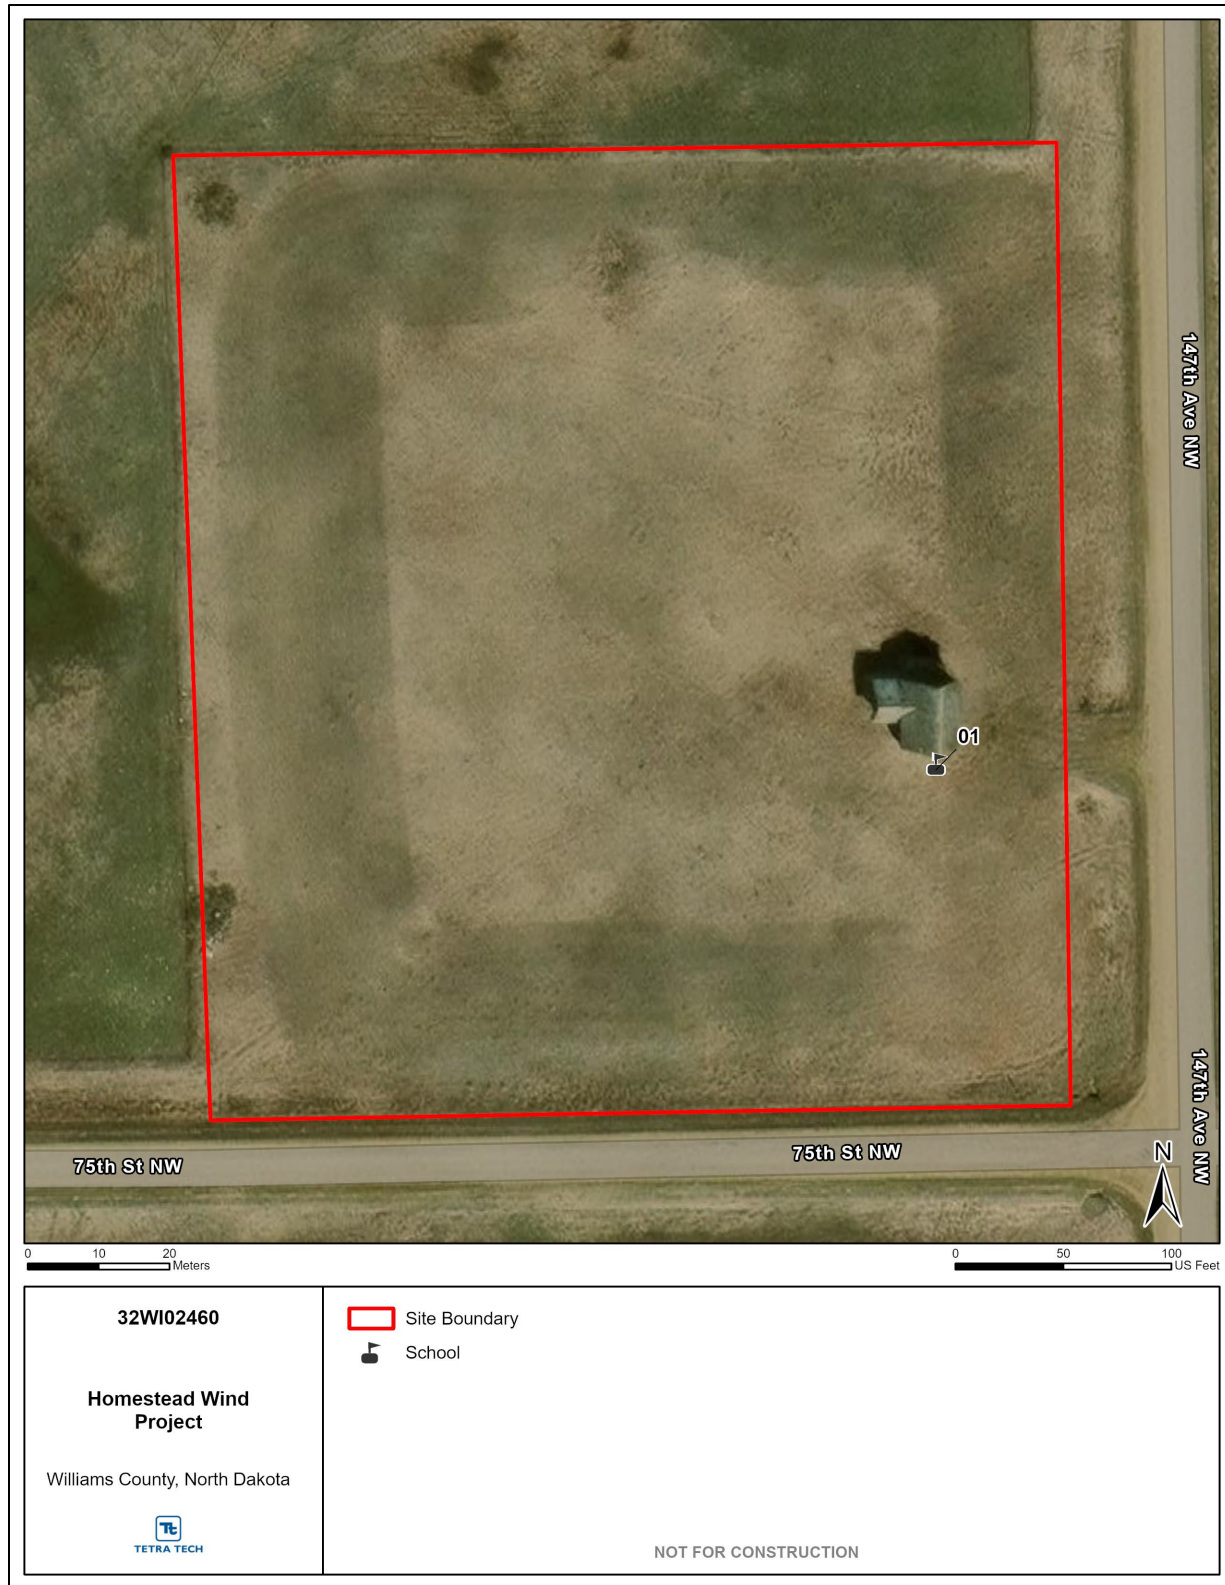
Figure 4-1. The location and status of features within 32WIX2460 (ESRI World Imagery 2024).

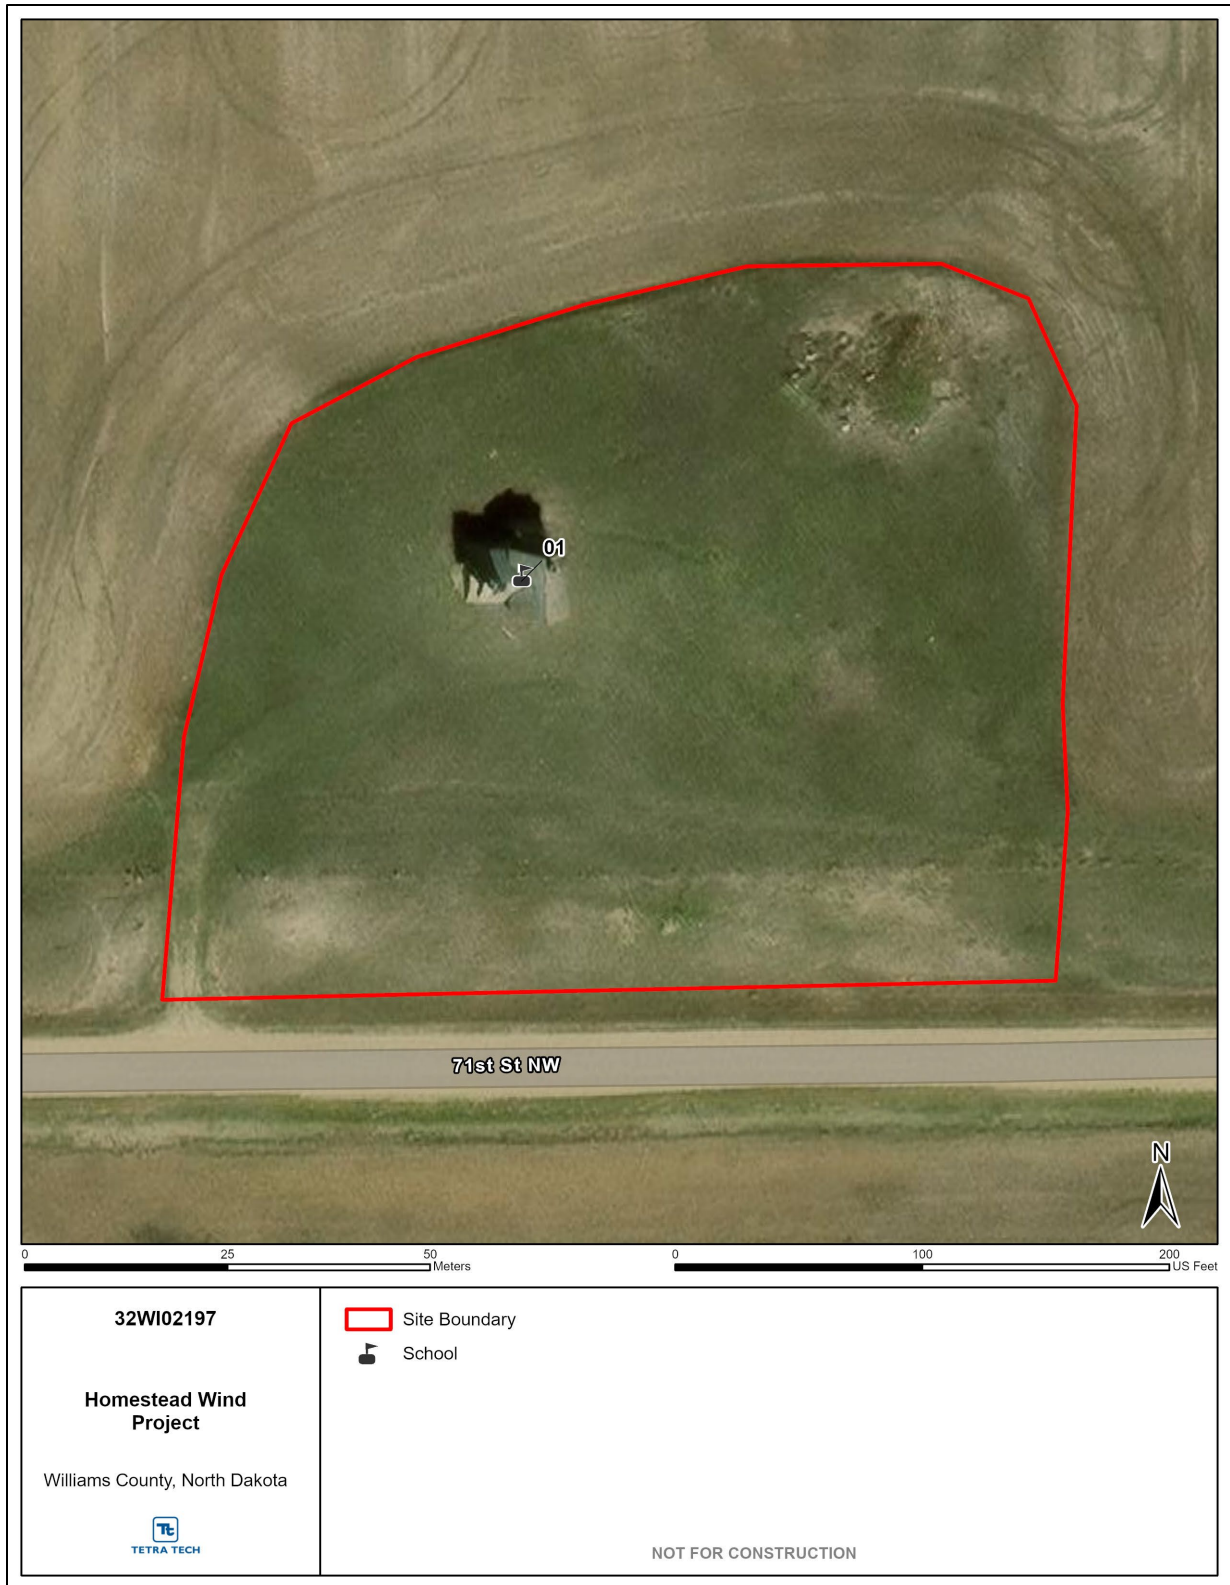
Figure 4-3. The location and status of features within 32WIX2197 (ESRI World Imagery 2024).

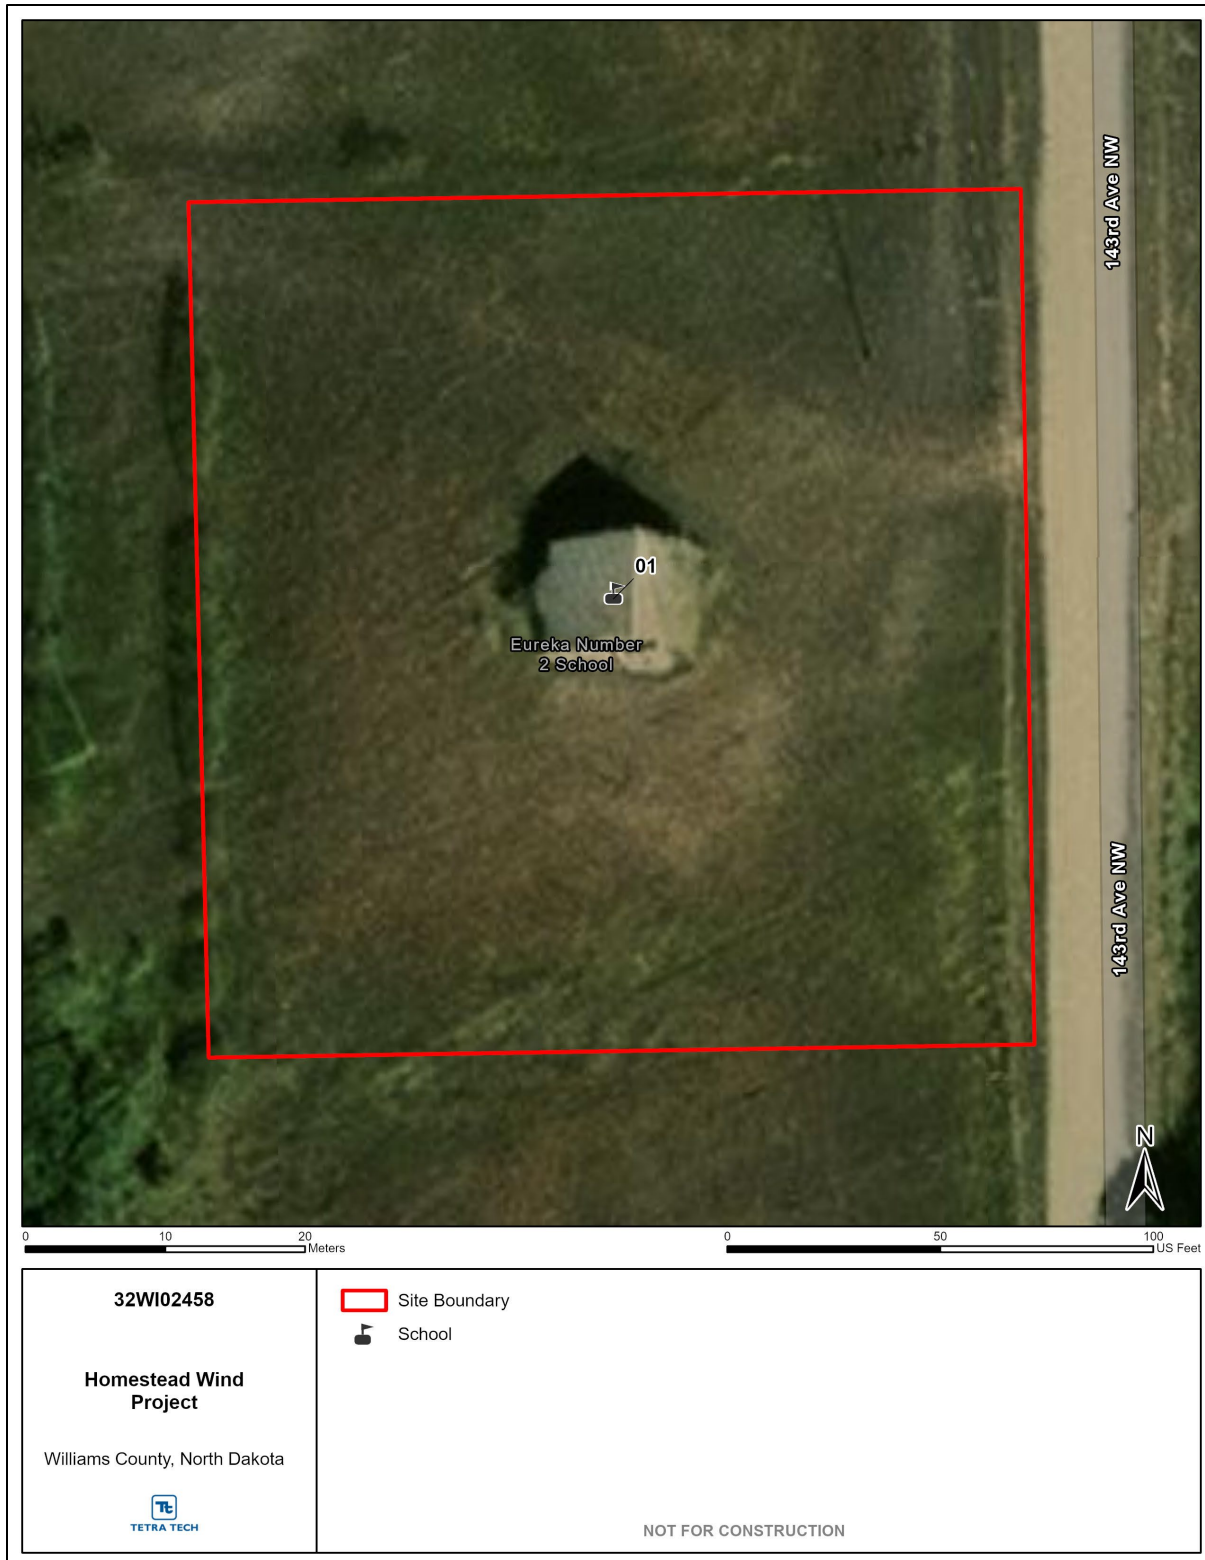
Figure 4-4. The location and status of features within 32WIX2458 (ESRI World Imagery 2024).
