Site/Project Location: Brady Wind Energy Center – Stark County **Date of Inspection:** 26 September 2016

159 PU-15-690 Filed 10/04/2016 Pages: 3
Site inspection trip report - Construction Inspection Report September 26, 2016
Keitu Engineers & Consultants, Inc.

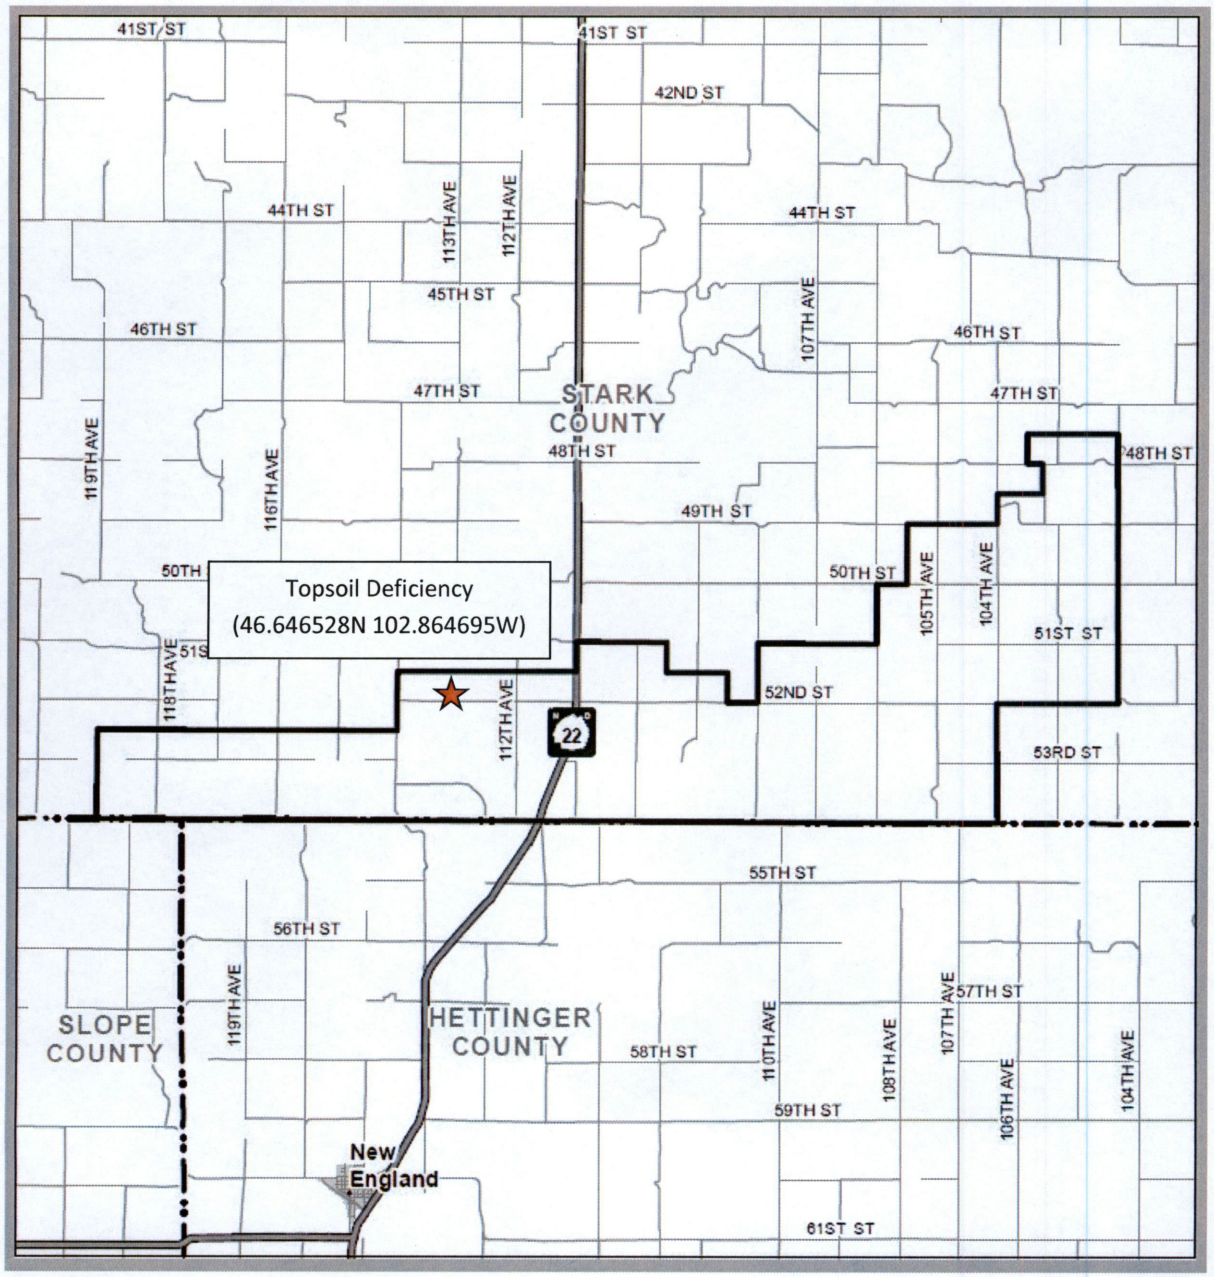
At the time of this inspection there are no new topsoil management issues. However, top soil management issue from previous inspection has not been resolved. The construction crew have shown to be doing an adequate job reclaiming disturbed areas. Turning radius improvements have been implemented on multiple locations. Crew was informed to be cautious during cleanup of gravel in road ditches as they do not want to impact the soil and the roots of vegetation in those areas. Erosion control has been implemented in disturbance areas and heavy slopes. Weather conditions from the weekend have damaged the silt fence at site 29, Kyle McNab stated the issue will be fixed by the end of the day.

Topsoil mixing in subsoil pile issue from previous construction inspection on 8/16/16 had not been resolved at the time of the inspection (9/26/16).

Report Photo #1 "Topsoil Mixing In Subsoil Pile From Previous Inspection"

Report Photo #2 "Damaged Silt Fence At 29"

Blattner Energy crew has been informed to address topsoil management issue. Crew will pull topsoil off of subsoil pile being cautious not to mix during removal. This site will be scheduled for a post-construction inspection check.
