2022 Garrison Phase 5 AML Project Summary

Drilling and Grouting Contract Number: AM-864-22

Location: Along McLean County Highway 15 and other infrastructure located less than one mile south of Garrison. Legal Description: Sections 17, 18, T148N, R84W

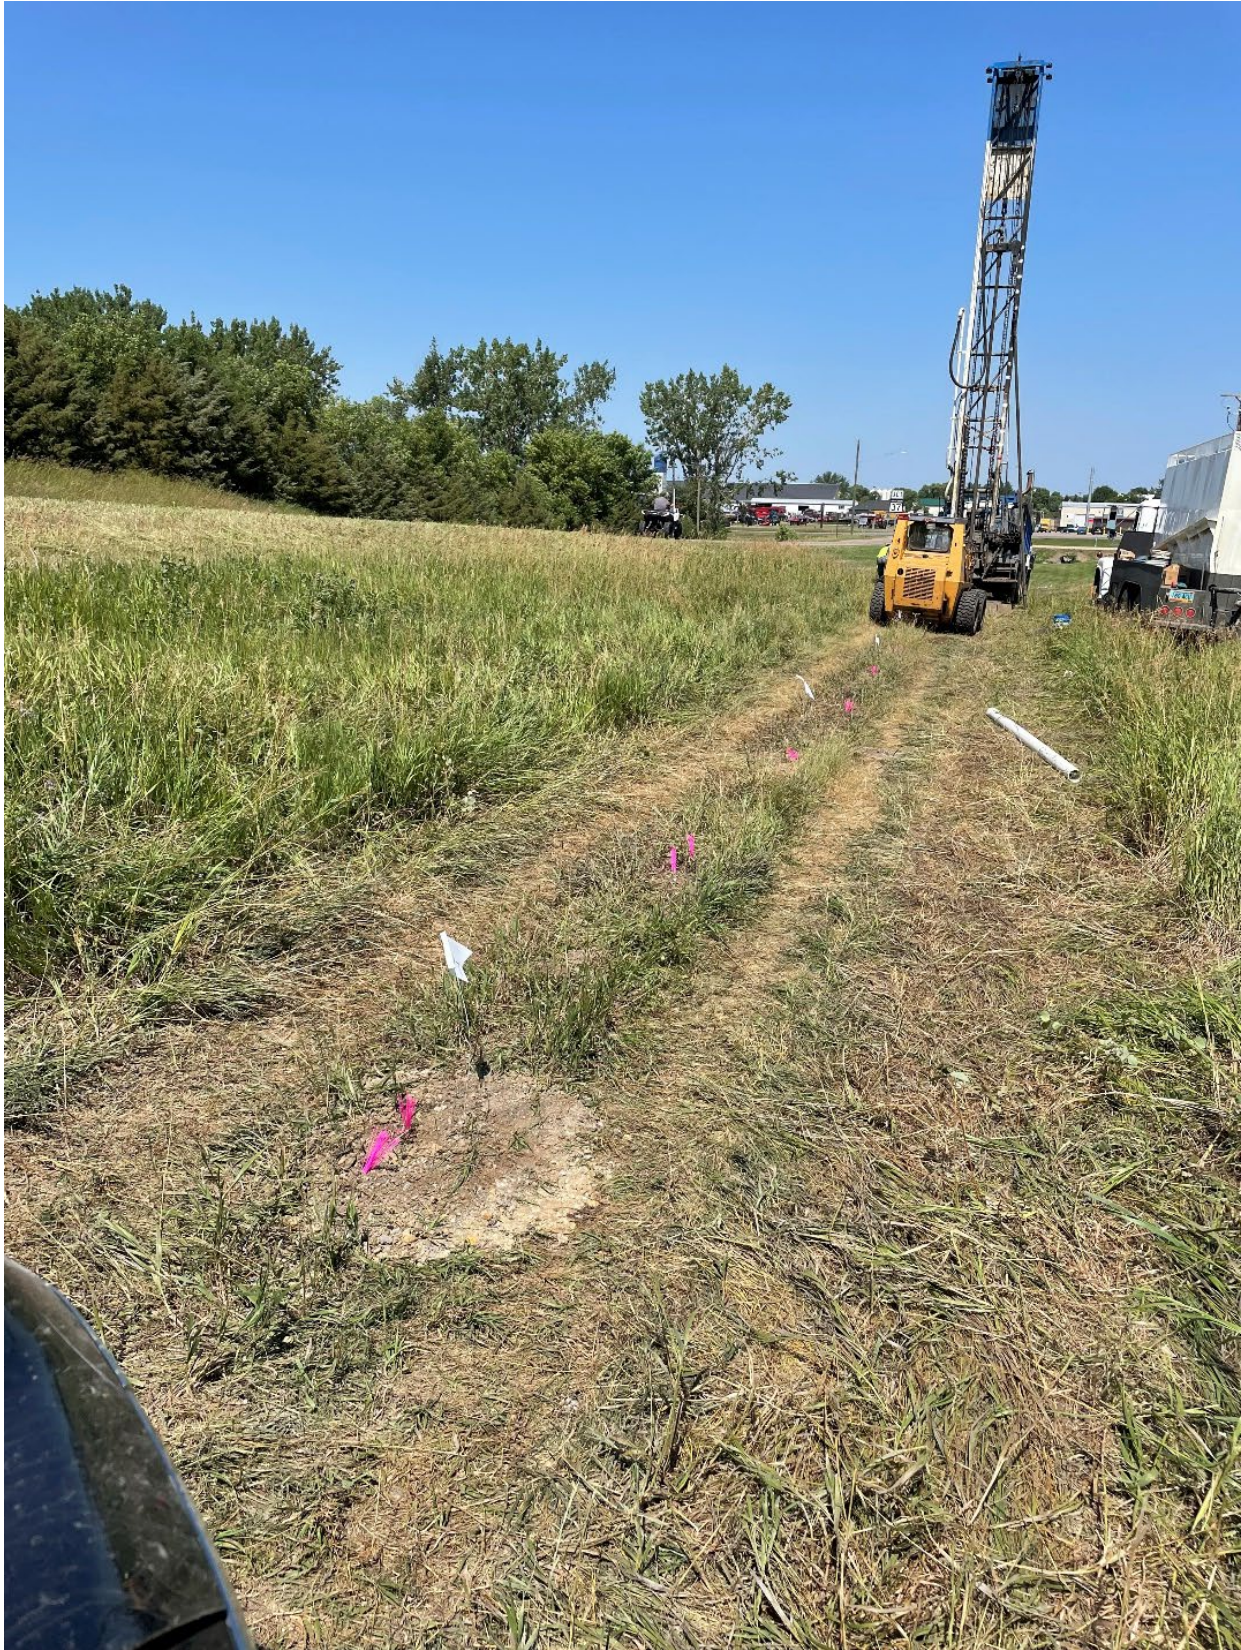
Figure 2: The drilling rig is moving north in the east right of way of McLean County Highway 15 as part of the 2022 Exploratory Drilling AML Project. The pink markers indicate a hole was cased.

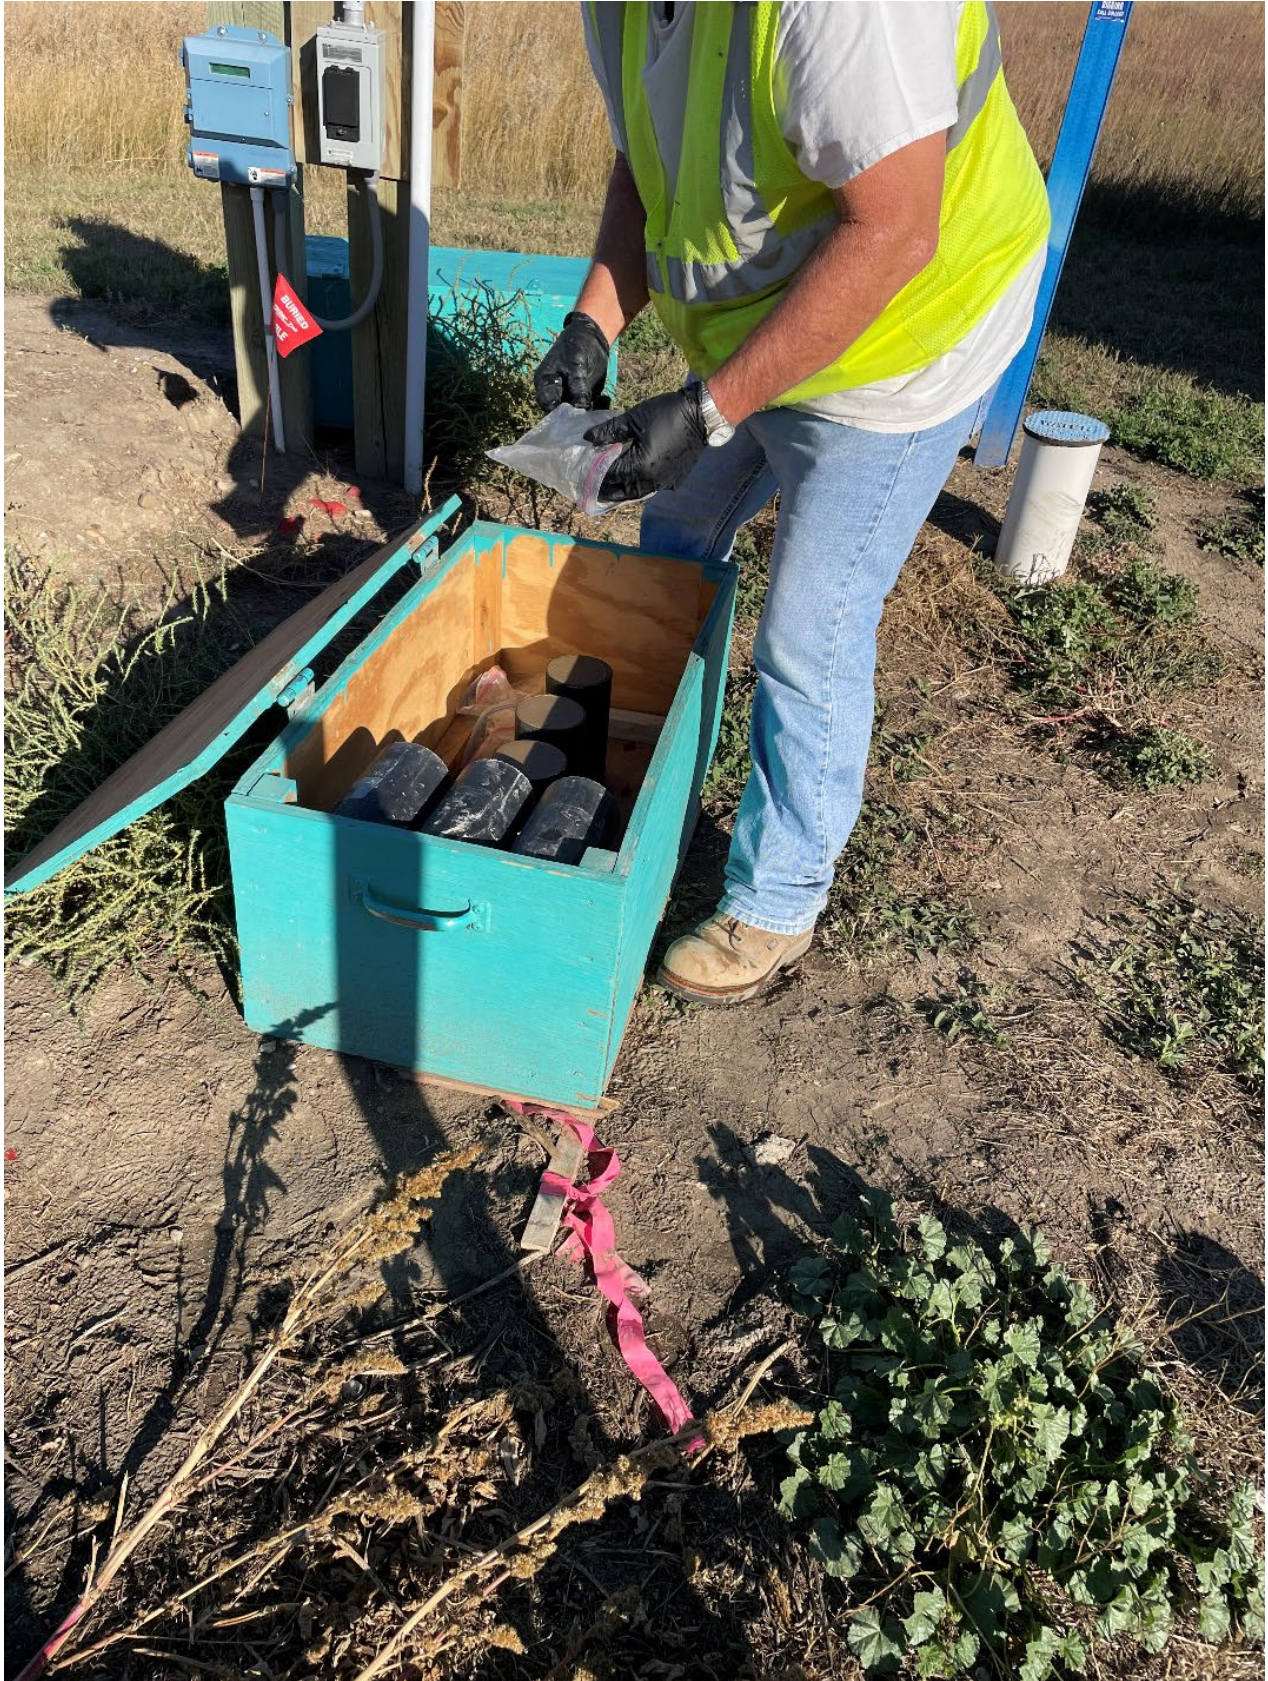
Figure 5: The material tester is storing grout samples for field curing. Once cured, they will be tested for strength.

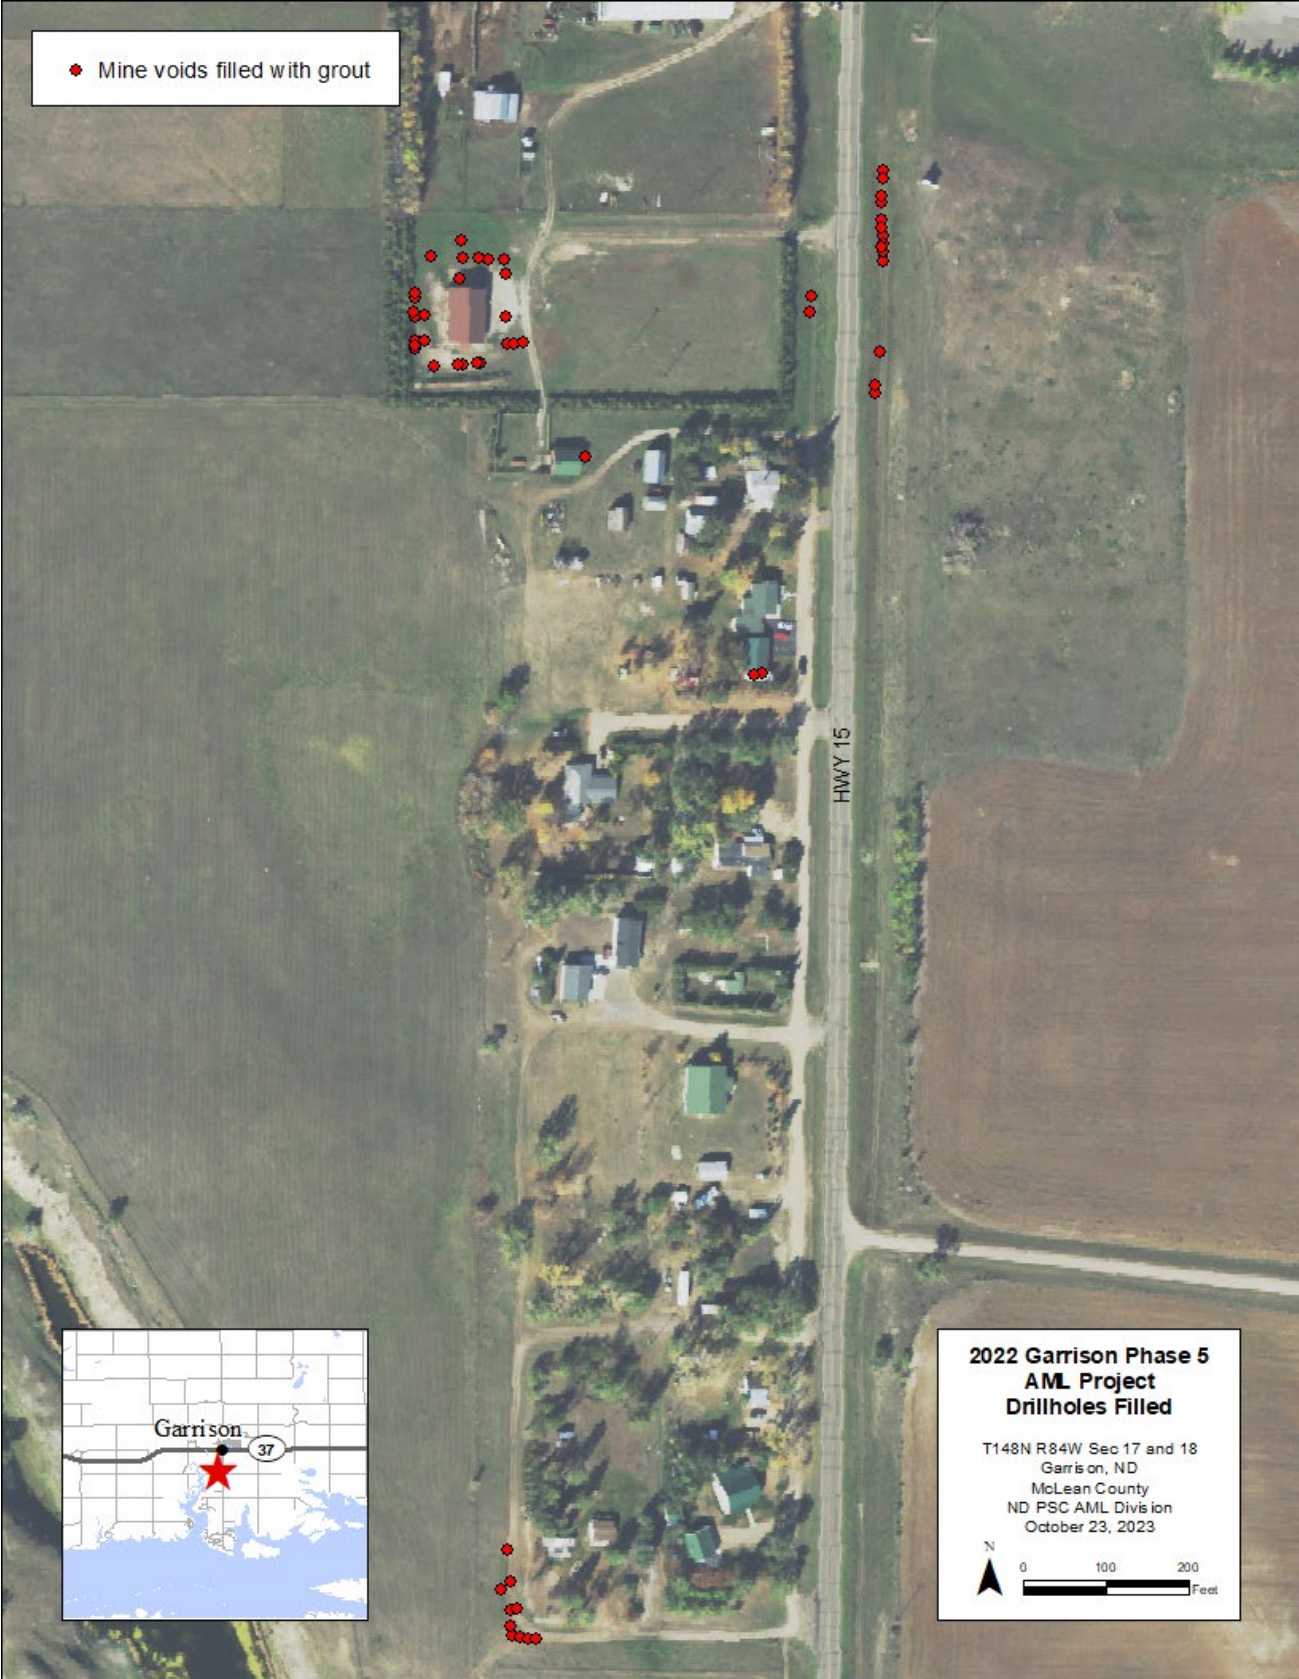
Figure 7: Map showing the 2022 holes that were pumped with grout or filled by adjacent pumping.

The bid quantities for this project included 2,000 cubic yards of grout injection, 5,000 feet of drilling, 1,000 feet of casing, and 50 feet of coring. Grout was first pumped near private residences in the South Garrison Subdivision (**Figure 4**). During this time, the contractor continuously monitored the elevations of the buildings using a laser level to detect any changes in building elevations. Grout is tested by the material testing contractor every 50 cubic yards to ensure it meets contract requirements for flowability and strength (**Figure 5**). After pumping near the homes was complete, the grout pump moved to the McLean County Highway 15 right of way until the end of the project (**Figure 6**). A total of 2,139 cubic yards of grout was pumped at the locations shown on the map (**Figure 7**).
