2020 PROJECT SUMMARIES

March 2021

2020 Projects

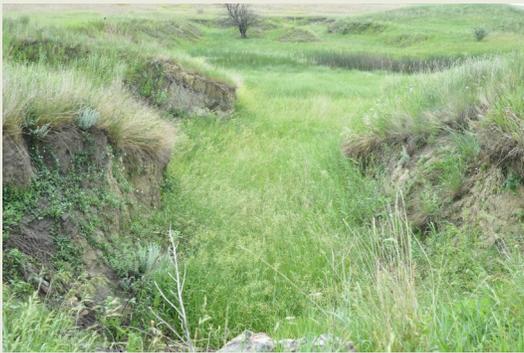
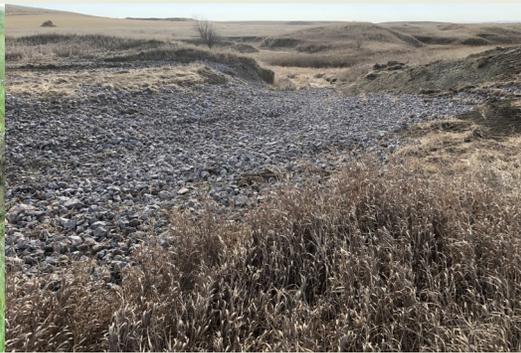
Albrecht

Reclamation involved backsloping about 500 feet of dangerous highwall and excavating on-site spoil material while preserving the pits. The highwall averaged 20 feet in height. The Initial design included backfilling a pit. Once

reclamation began, and plans were alter to keep the pond intact. Years of erosion occurring next to a tilled field was stabilized using a rock rip-rap channel as shown in the photos below.

Reclamation began on September 3 and was completed on October 10. A total of 5,091 cubic yards of material was excavated and 524 cubic yards of topsoil was salvaged and respread. The average slope after reclamation was 12.3%. The site was tilled, fertilized, and seeded with a native grass mix. Areas of the site were deep tilled and prepared for tree planting by the Hettinger County Soil Conservation District. Tree planting is scheduled for Spring 2021.

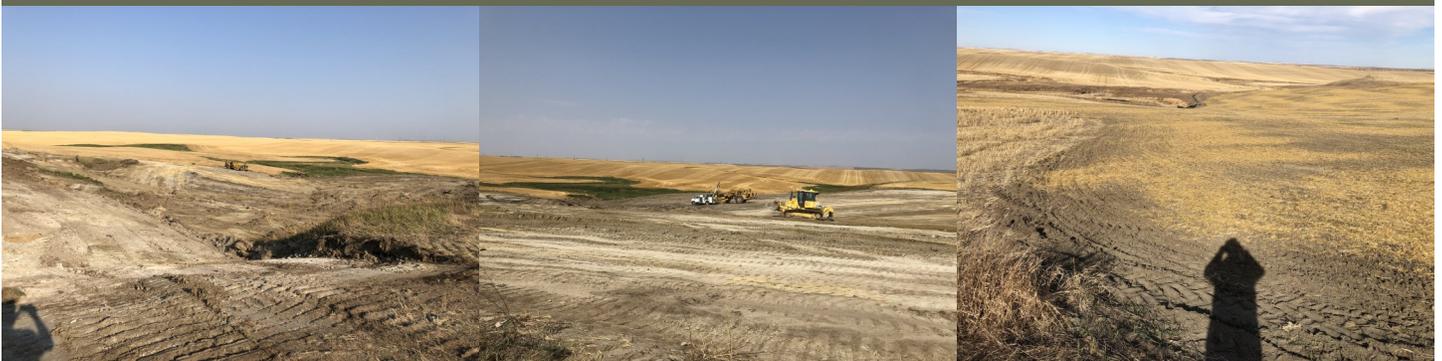
The Weinandy site is located approximately 5 miles northwest of Regent. The site contained a dangerous 360 foot long highwall that averaged a height of 20 feet. The site is situated just south of a natural drainage and is surrounded by cropland. Silt fences were installed to prevent any runoff from the site into the drainage.

erosion control blanket was placed in the drainage after reclamation was complete to minimize erosion until the site could is vegetated.

Reclamation began on August 21 and was complete by September 3. A total of 24,462 cubic yards of spoil material were used as fill material. Over 1,500 cubic yards of topsoil was saved and respread. The average slope after reclamation was 9.6%. The site was tilled, fertilized, and seeded in November with a native grass mix.

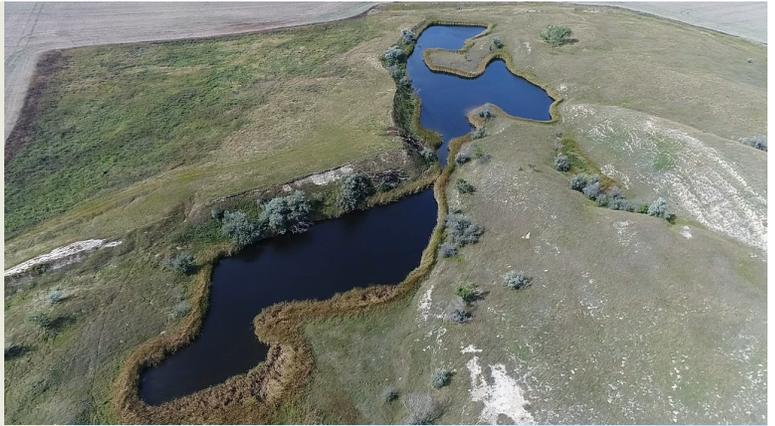
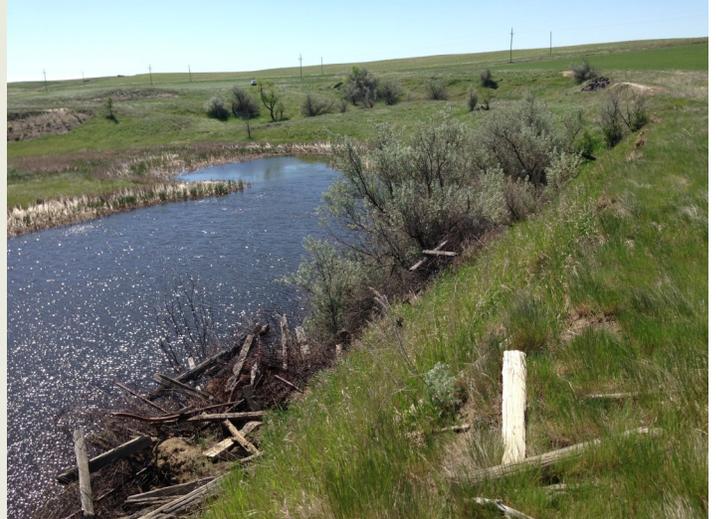
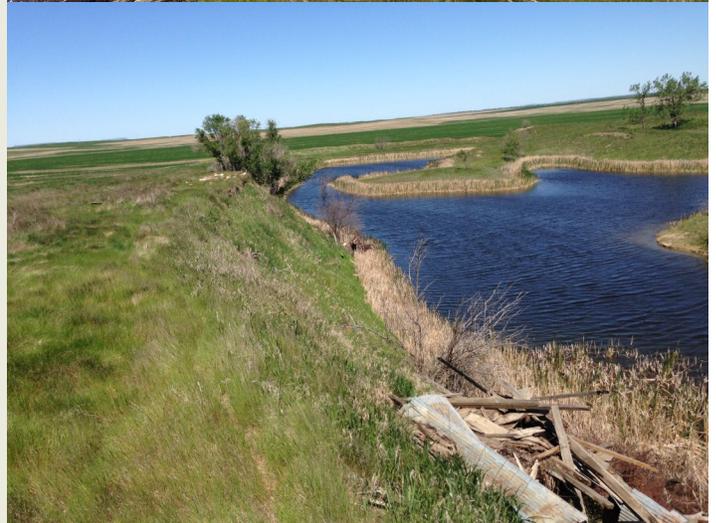
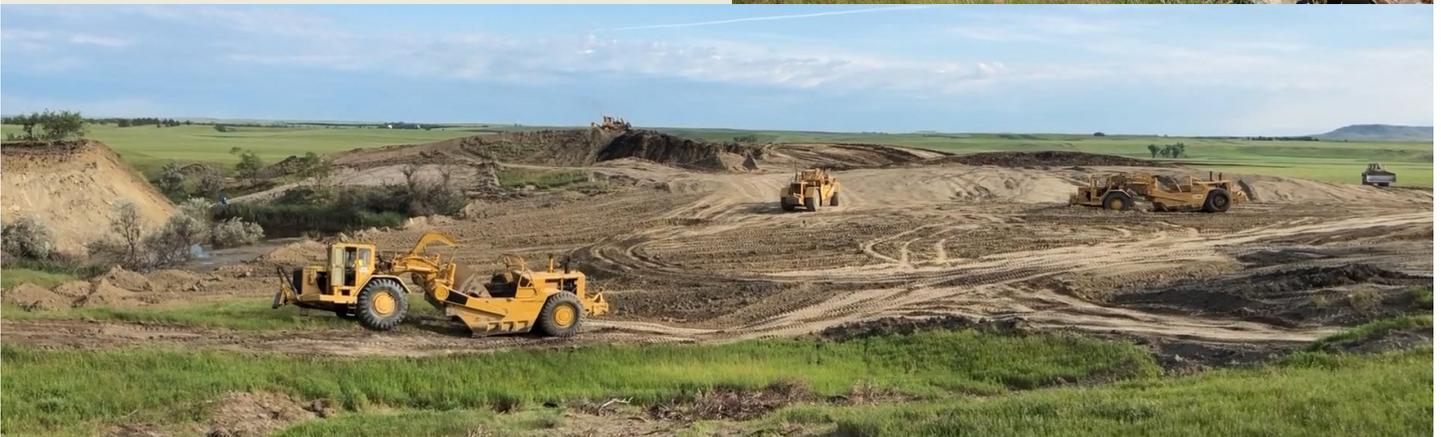
The Regent site was the largest site of the four surface mine sites. The site contained a dangerous highwall that totaled 1,180 feet in length and averaged 50 feet in height and two water filled pits. The land surrounding the mine is cropland. The design consisted of backsloping the northwest highwall and filling in the southern pond. The reclamation of the Regent site began by constructing a dike between the two ponds and pumping about 1.97 million gallons of water from the southeast pond to the northwest pond.

The Regent site proved to be more challenging as reclamation progressed. As the contractor began backsloping the northwest highwall, a rock ledge was exposed. This slowed down the progress of the site because the CAT 637C scrapers were unable to continue working in the area. The contractor brought in a CAT D9 dozer to rip up the rock ledge and push the rocks into the fill area in the southeast part of the site. The southwest portion of the site was a wet area before reclamation began due to the presence of a natural spring. Once the rock ledge was removed along the northwest highwall, the area became too wet for the scrapers to effectively excavate the area. The contractor constructed a series of drainage channels in this area so the spring could drain into the northwest pond. Two Komatsu 61PXi low ground pressure dozers were utilized in the southwest portion of the site to excavate the remaining material and to spread topsoil.

The landowner requested the northwest pond and spoil piles remain untouched and left as a wildlife area. The reclamation of the site involved moving 149,740 yd³ of material. The average slope after reclamation was 5.6%. The site was tilled, fertilized, and seeded in November and December with a native grass mix. Areas for tree planting were prepped and deep tilled. Trees will be planted in 2021 by the Hettinger County Soil Conservation District.

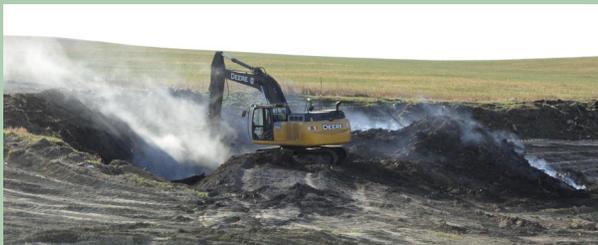
In 2019 the landowner of the 4 acre abandoned mine at the Buresh site contacted the PSC AML Division regarding reclamation. Hidden neatly behind a hilltop and near Dickinson city limits, the site had been used as an illegal dumpsite for many years. Discarded liquor bottles and bullet holes suggest that it was also used as a hang out. The mine site also had a 500-foot dangerous highwall greater than 20 feet high.

All sorts of wood, household waste, appliances, furniture and tires made up the bulk of the garbage as shown in the composite photo below. Before addressing the hazardous highwall, the waste needed to be sorted and hauled to a local landfill. The contractor utilized a John Deere 250G excavator to sort and two side dump semi-trucks to haul the waste. The waste was sorted into piles onsite by type. The type of piles included were tires, recyclable metal, wood, and waste for the landfill. The contractor began sorting and hauling the waste July 1 and finished on July 30. Even as the contractor was hauling trash, newly dumped trash would appear overnight. Forty-six loads of waste were hauled which included 26 loads of metal, 12 loads of trash, and 8 loads of tires. The total amount of waste removed was over 900 tons.

Once the waste was hauled offsite, the remaining wood and trees were burned onsite and the ash hauled away. Due to the dry conditions of the area, several partially

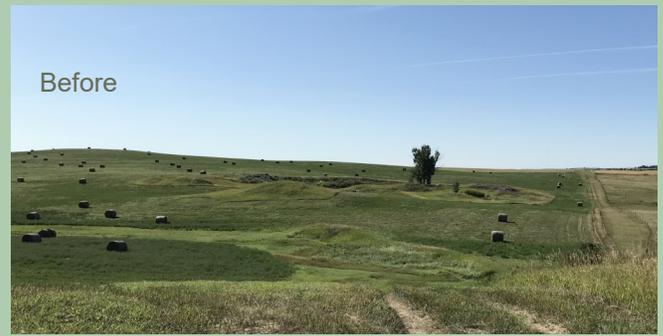
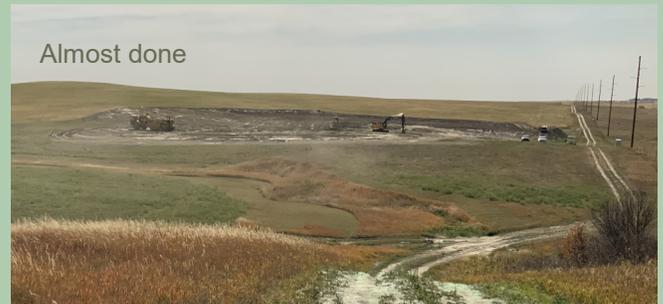
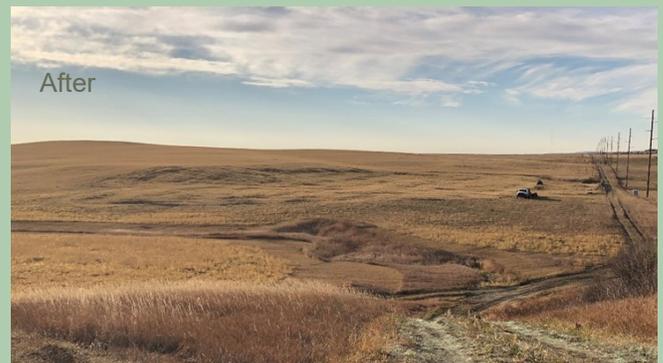
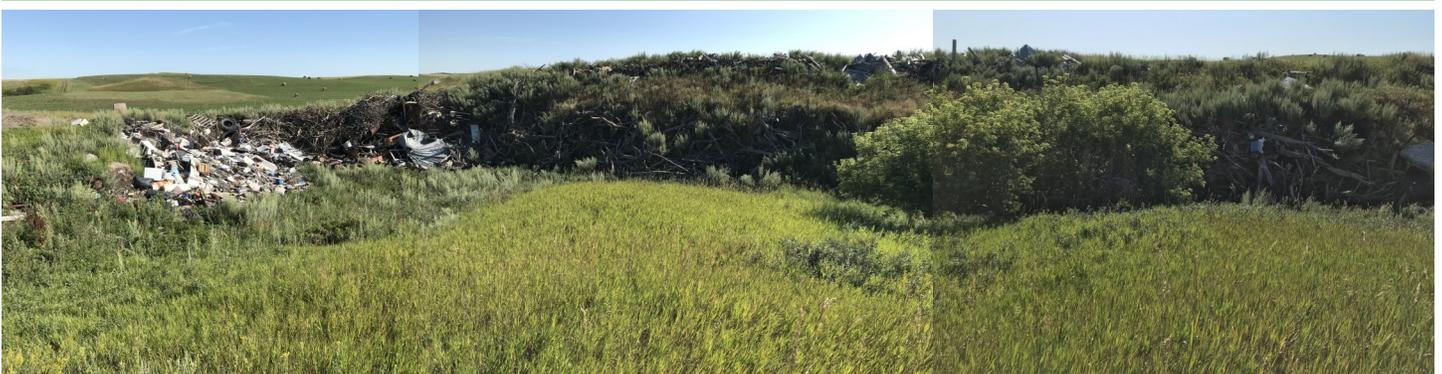
buried trees continued to burn underground for approximately a month. The smoldering trees were excavated and transferred to an existing pit and buried. Spoil mate-

rial onsite was used to bury any existing residual inert waste that was left at the surface.

Reclamation of the site was complete on October 8. A total of 14,519 cubic yards of spoil material were excavated onsite and 1,055 cubic yards of topsoil were salvaged and respread. The average slope after reclamation was 6.5%. The site was tilled, fertilized, and seeded in November with a native grass mix. It is hoped this reclamation will prevent further illegal dumping at the site.

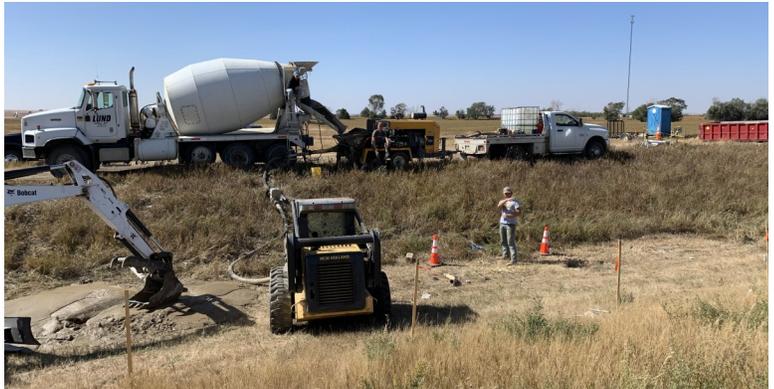
This project included pumping grout on Divide County Highway 21. About 678 cubic yards of cementitious grout were pumped into holes drilled and cased in 2017 in the ditch on the west side of Highway 21 across from the land fill. While pumping, we observed ground cracking up the roadside of the ditch indicating that the voids potentially extended under the road.

Grout pumping along Divide County Highway 21.

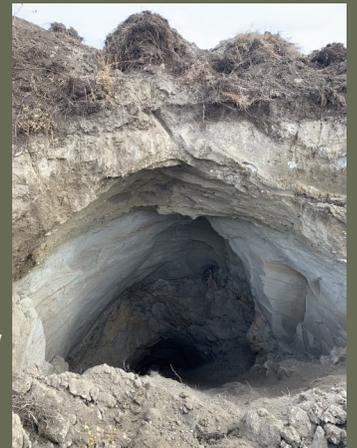
Another 75 holes were filled at Beulah both on privately owned land and North Dakota Game and Fish properties. For safety reasons access to some of the North Dakota Game and Fish property is closed to public. The sinkholes there can be large and deep and occur without warning like the one in the photo below. As the contractor removed topsoil in preparation of filling the hole, it became evident that the hole was much larger than it initially appeared. Although 76 holes were filled at Beulah, hundreds of sinkholes remain. New sinkholes will likely appear as the ground thaws in the spring.

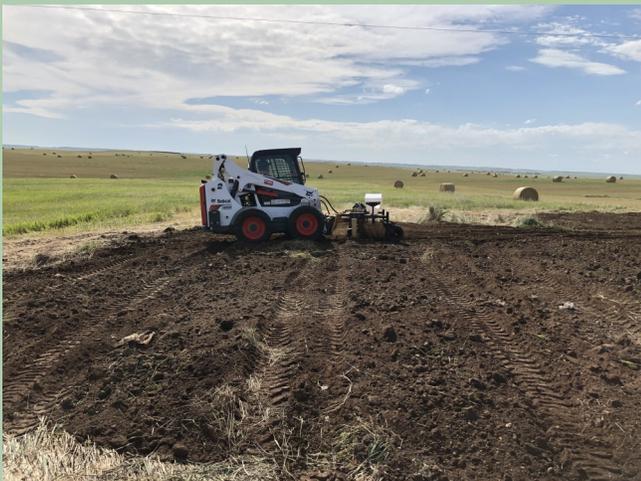
Bowman

Sinkholes continue to form at the location of the historic Halleck Mine. A 2015 drilling and grouting project pumped over 2,000 cubic yards of grout into the mine to protect the roads, but not the field. Mining removed over 20 feet of the 30 foot thick coal seam in some places. Below the contractor is seeding the filled sinkhole using a Harley rake on his skid steer.

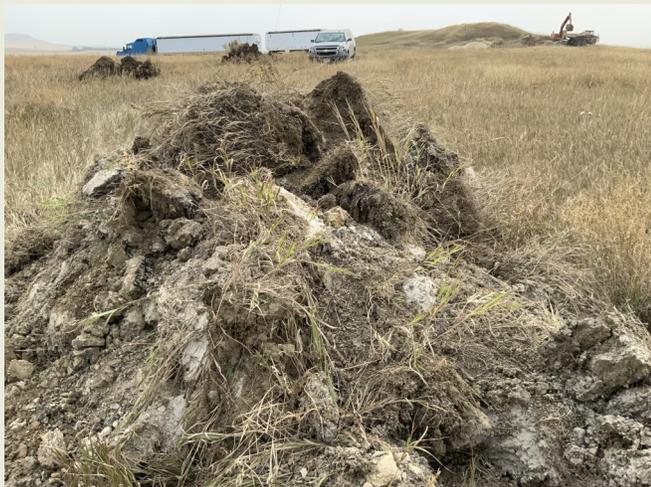
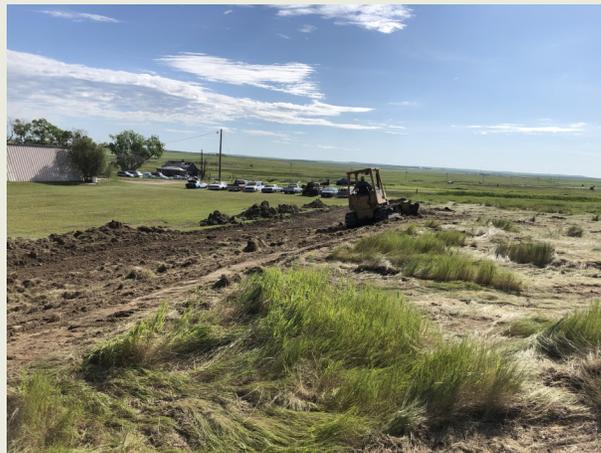
SW Hebron and Lefor

This was the first time the PSC AML Division filled sinkholes in these locations. Ten sinkholes were filled at SW Hebron and seven at Lefor. Both sites are on private land. The SW Hebron is pasture. The Lefor site is used as hayland and for storing semi-trailers. The photo below shows stock piled topsoil at Lefor. Visible in the background are a semi-tractor/trailer and the contractor's excavator near the borrow site.

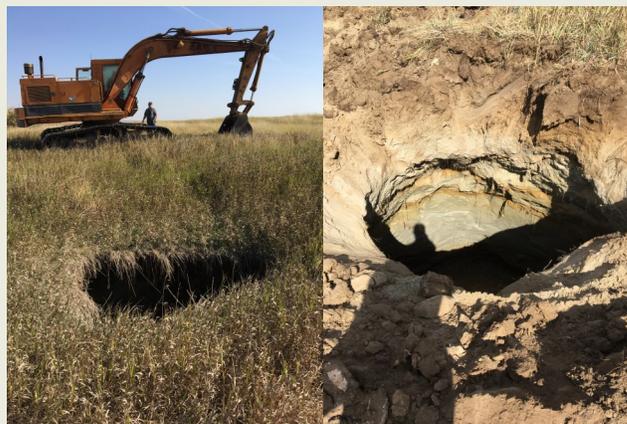
The PSC AML Division refers to the area between Regent and New England as Havelock. This area is home to many abandoned surface and underground mines. While the town of Havelock no longer exists, abandoned mines in the area still cause sinkholes. A landowner on his UTV veered just in time to miss the sinkhole shown below. The same sinkhole is shown in both photos. This sinkhole was well outside where sinkholes normally appear in his field.

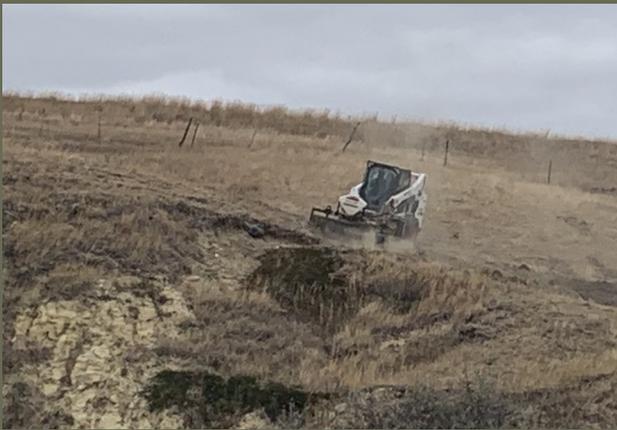
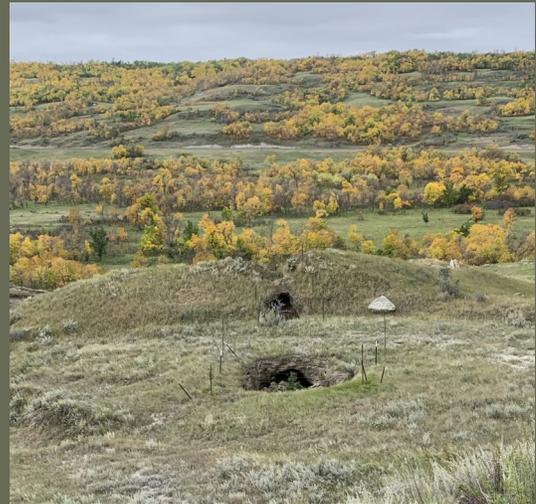
SW Tioga

Several sinkholes were located in two separate areas at a farmstead. Three abandoned underground mines and one surface mine is within 1,000 feet of the home.

Below the contractor is using a Harley box rake to finish tilling and seeding the filled sinkhole. About 10 sinkholes were filled at this site. This work was completed on October 1st.

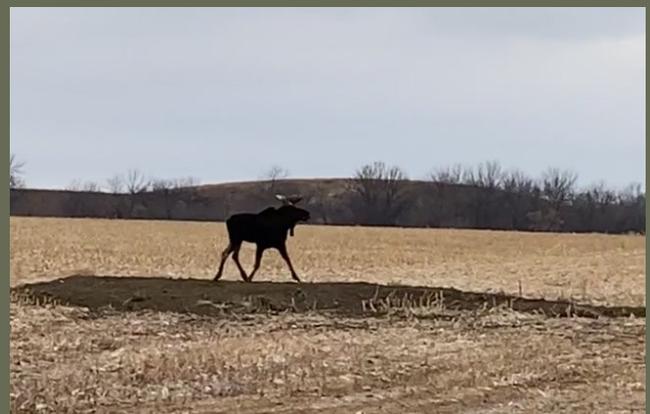
A bull moose surprised AML staff when it was seen running through the field near sinkhole filling activities. The picture below shows the moose trotting over a just filled sinkhole. Sinkholes can be dangerous to wildlife as well as humans and livestock.

The sinkholes in Velva were in a cultivated field. As noted at New Salem, even small sinkholes can pose significant hazards to farmers and equipment when they occur in cultivated fields.

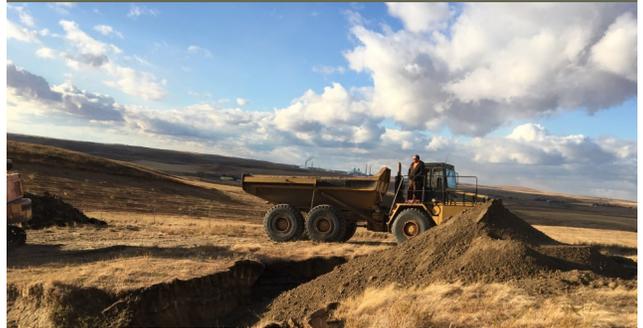
Bowman: When the sinkhole above was reported to the AML Division, it was less than 6 feet in diameter, but over 30 feet deep. Below is the same hole. The contractor is stripping the topsoil around the hole to save for spreading on the top of the filled hole. The hole was enlarged to create a ramp into the hole to allow equipment to compact fill in the bottom of the hole.

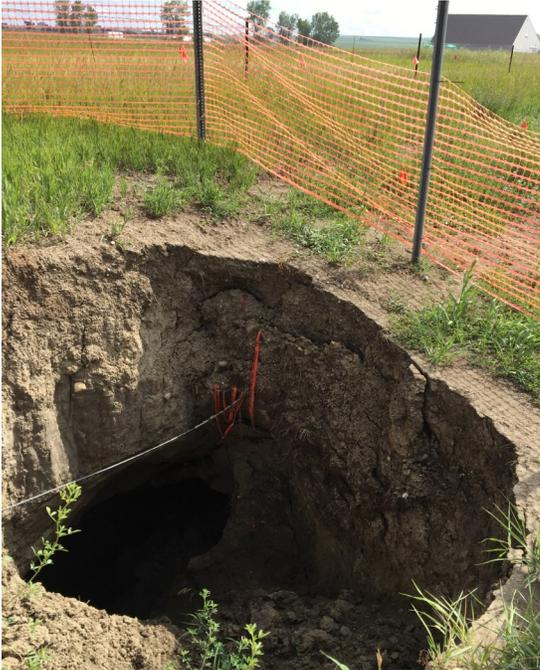
This sinkhole was in the ditch of U.S. Highway 200 near Beulah. A fiber optic line can be seen running across the hole. The PSC AML Division responds quickly to reports of sinkholes in ditches.
