PSC CASE NUMBER: PU-06-421

DAILY REPORT

Job Site: North SPREAD

Date: January 27, 2009

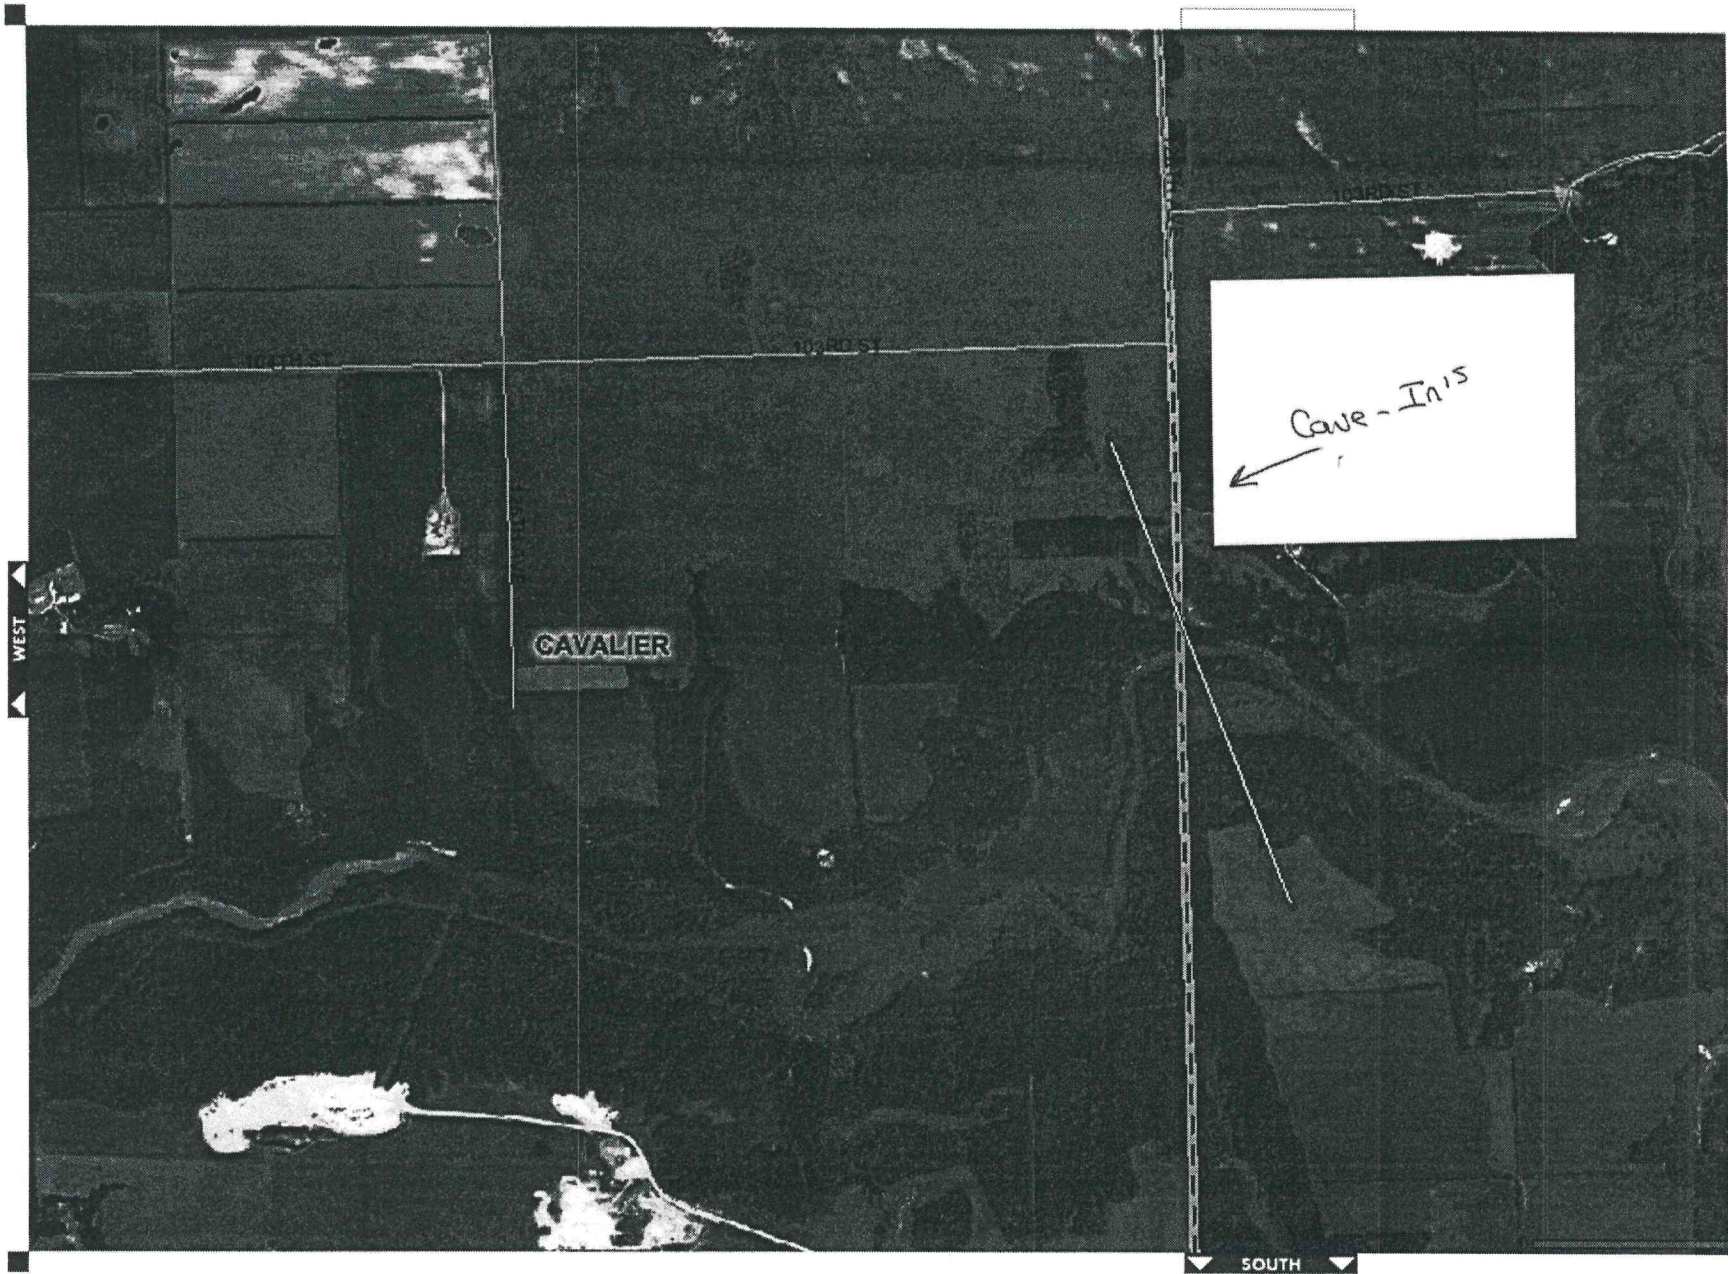
Here are Dennis' reports for 1-27 and 2-2-09. Also attached are 2 pictures of the sink holes that have developed over the pipeline where the bore took place. I will have more pictures that I will put on a CD and send to you.

Please note Dennis' suggestion of contacting the ND State Forest Service to verify they are satisfied with the immediate plans the contractor has and their proposal to repair the sink holes in the spring.
