TRANSCANADA KEYSTONE PIPELINE PROJECT

Pembina River Directional Drill Crossing

Sink Hole Remediation Approach DRAFT

Pembina Sinkhole Remediation Plan

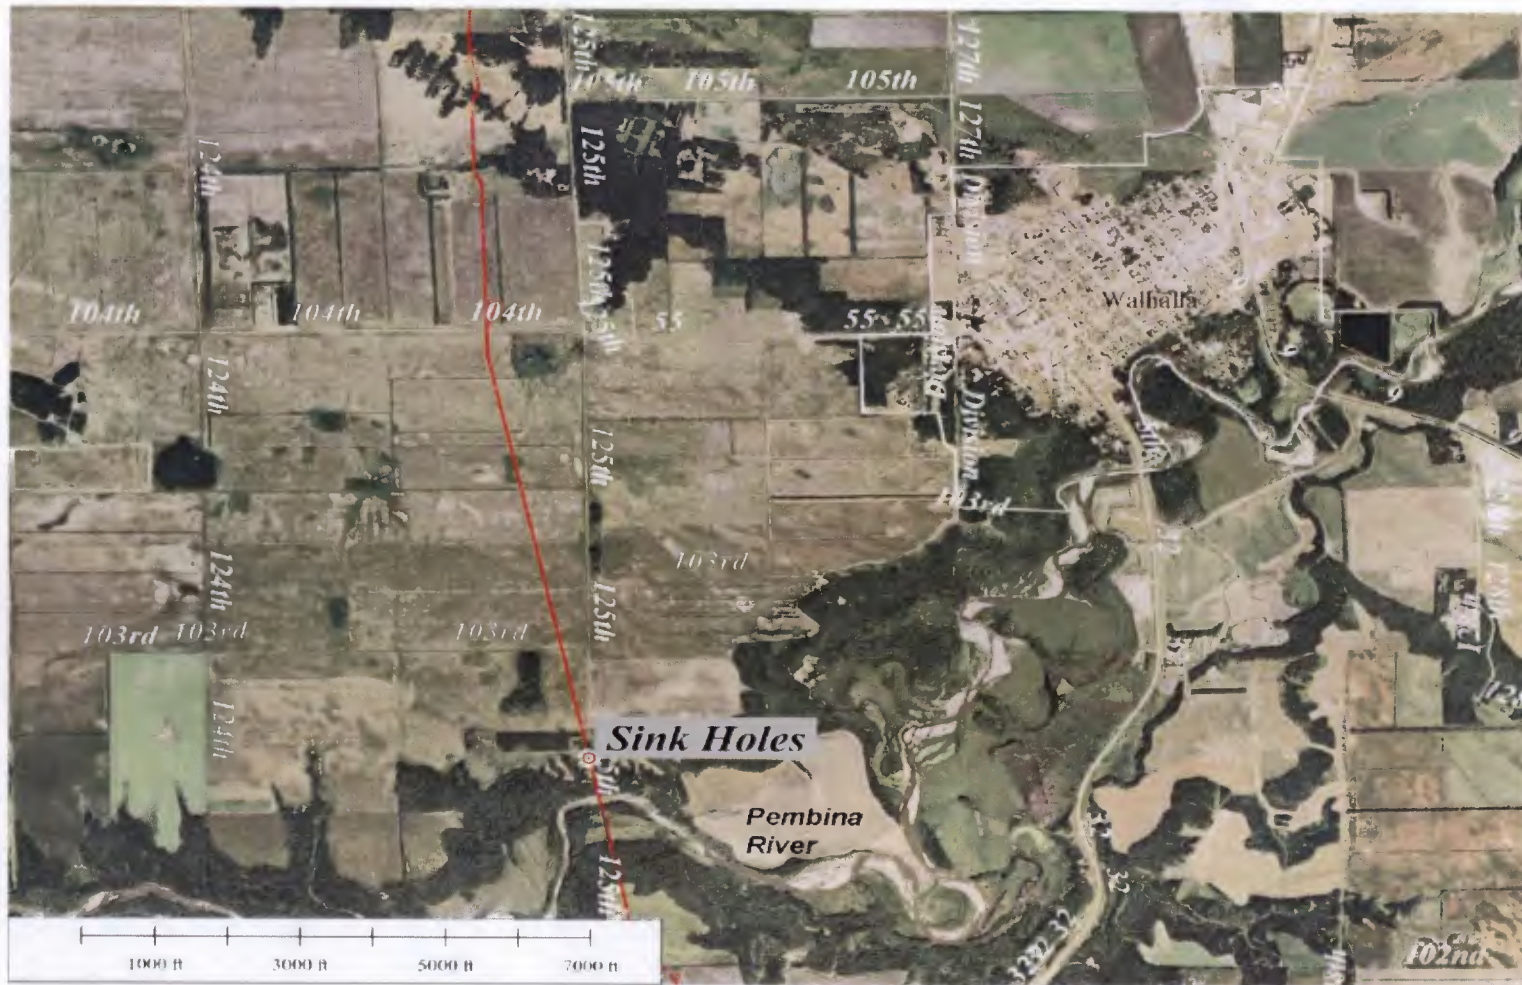
Appearance of Sinkholes

Probable Causes Of Subsidence

- Swab passes that attempted to clear the hole were continually obstructed approximately 600-feet from the drill exit point which is coincident with the area of eventual subsidence
- Drilling mud circulation was absent for extended period of time, indicating a loss of drilling mud into the subsurface formation
- Due to geotechnical conditions of the crossing profile, the installation required drilling through both soils and bedrock
- Reamers were repeatedly lodged in the vicinity of the eventual subsidence during reaming passes
