Alberta Clipper Pipeline **Construction Inspection Report**

Enbridge Energy Co., Inc.

**NORTH DAKOTA
PUBLIC SERVICE COMMISSION**
600 E. Boulevard Avenue
Bismarck, ND 58505-0480

December 2011

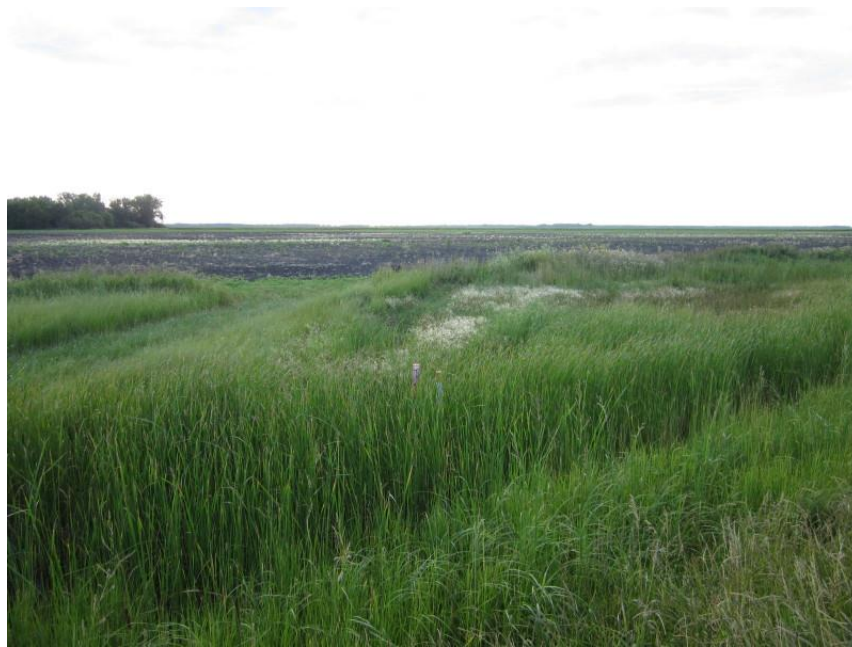
Photo 3. Direction: Southeast. Ditch and field to the southeast of gravel frontage road at Mile 795.2. Markers denote pipeline routes, which were barely visible in wetland vegetation. The bore would have ended within the field in the distance. There was no settling observed in the field along the route.

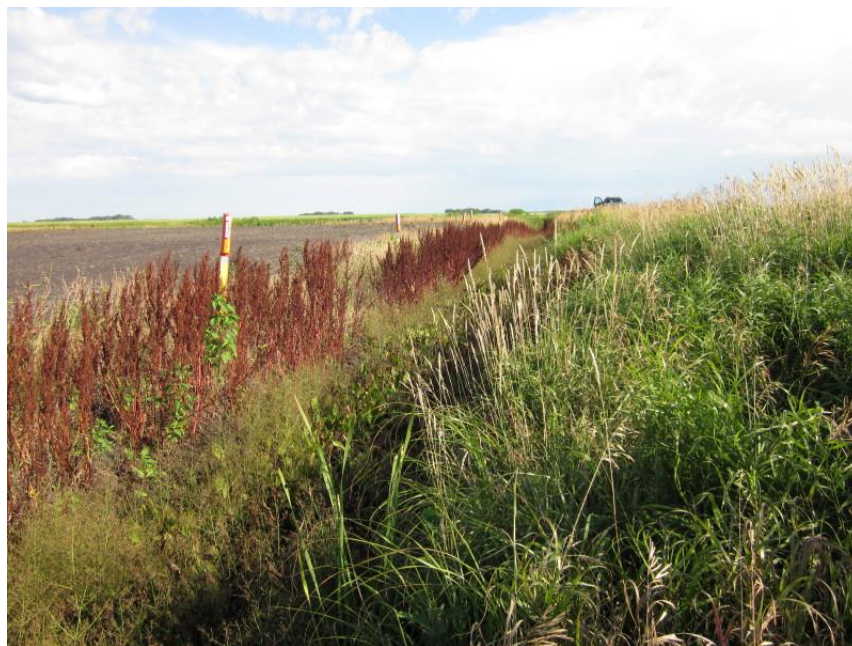
Photo 10. Direction: North. West ditch of 161st Ave NE which was open cut. Pipeline markers are visible on edge of field. Revegetation of the ditch appeared to be successful. Dominant species included smooth brome (*Bromus inermis*), reed canarygrass (*Phalaris arundinacea*), curly dock (*Rumex crispus*), and arrowhead (*Sagittaria cuneata*). The crop to the southeast of this crossing showed no impacts.

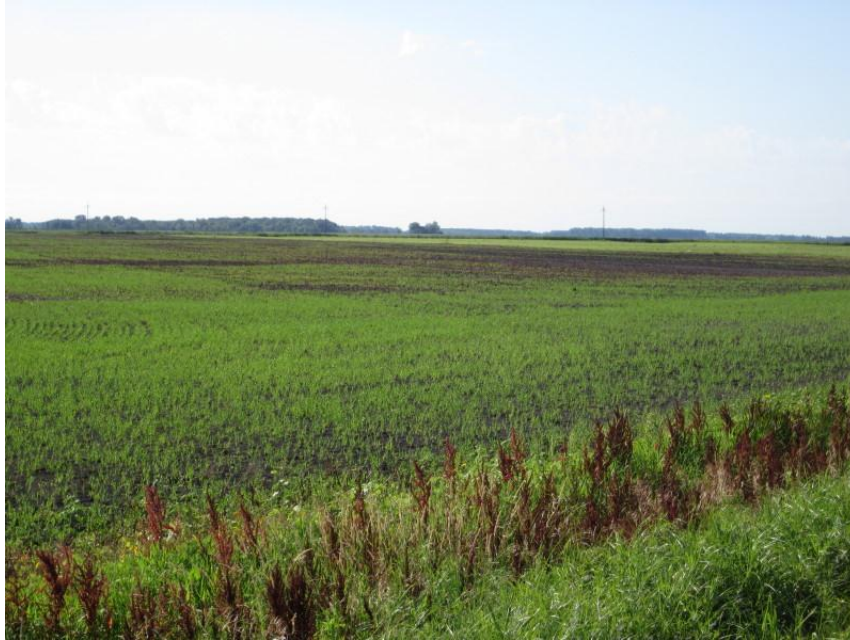
Photo 13. Direction: Southeast. View of pipeline right-of-way marked as conservation easement, showing the wheatgrass or crop that was planted.

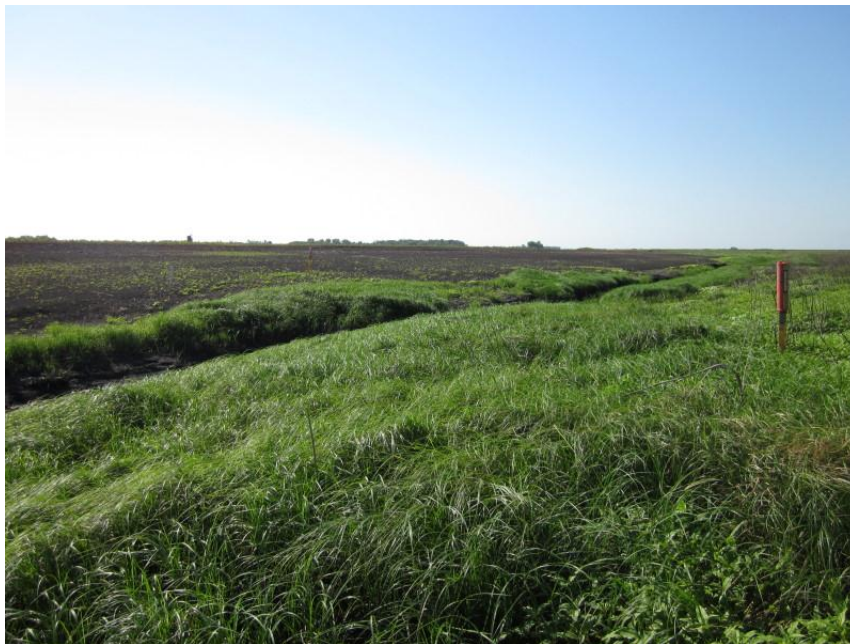
Photo 14. Direction: South. View of County Ditch 66-1 to the south, which diverges from the Red River within 0.5 miles north of this point. The crossing of the pipeline is indicated by the marker posts on either bank, and is just to the northwest of Mile 801. This crossing was directionally drilled underneath the ditch. There were no indications of vegetation disturbance or erosion problems.

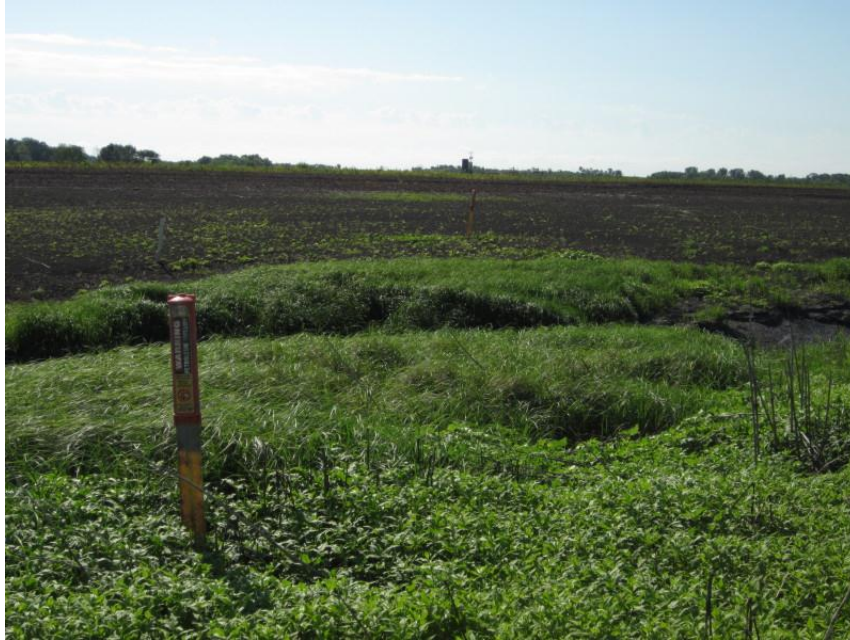
Photo 15. Direction: Southeast. Another view of the County Ditch 66-1 crossing, indicated by the pipeline markers on either side. In the distance slightly right of center the above-ground Mainline Valve site is visible. The trees in the distance indicate the woodland on the east side of the Red River, which marks the end of the pipeline in North Dakota. The Red River and cultural site 32PB0161, which were scattered materials on the west bank, were avoided by a directional drill underneath them.

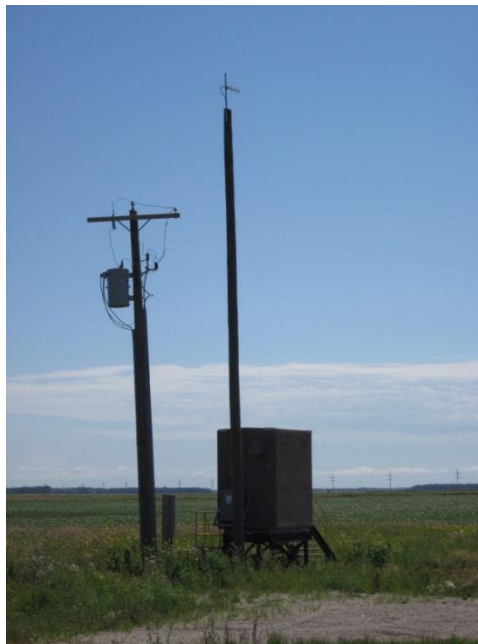
Photo 24. Direction: Southeast. Densitometer next to the valve system, which measures the density of the oil flowing through the pipeline. Information on the line served was not available at the time of the survey.

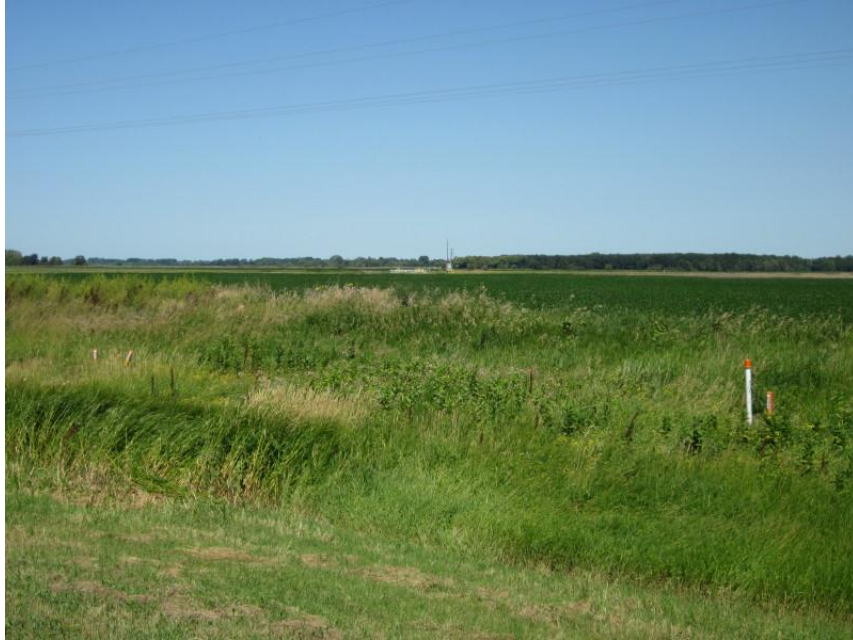
Photo 25. Direction: Northwest. Looking back across field to valves in the distance, with the road ditch of 107th St NE (County Hwy 55) in the foreground. This road had been bored underneath. The crop appeared to be in good condition.

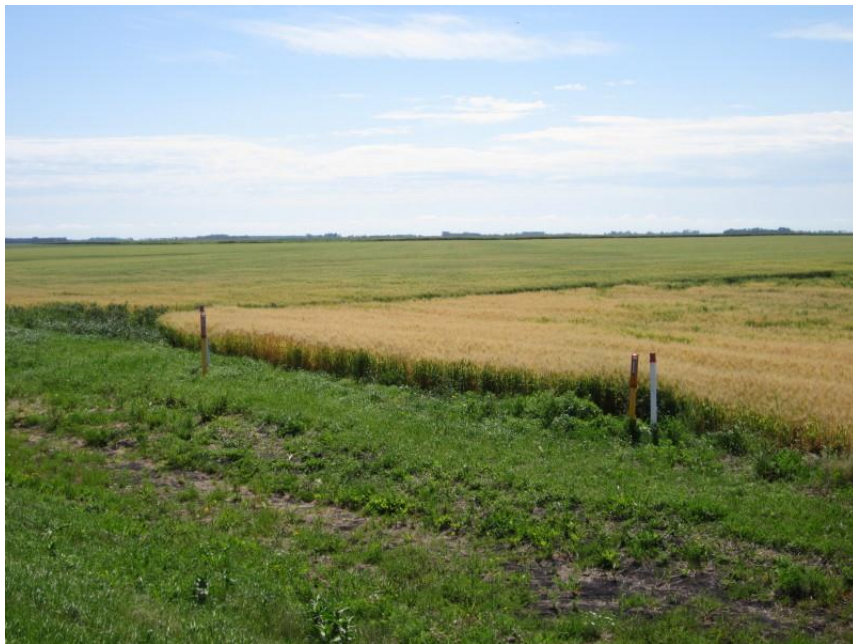
Photo 26. Direction: Southeast. To the southeast of 107th St NE (County Hwy 55) along the pipeline route. The crops appeared to be in good condition, with no differences within versus outside the pipeline route. Markers were in place in the ditch.

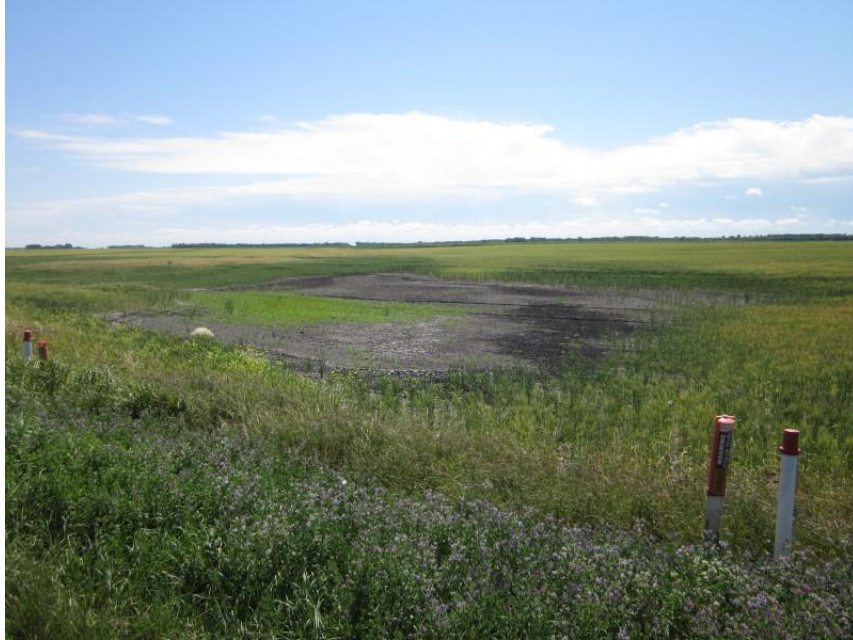
Photo 33. Direction: Southeast. Field southeast of 102nd St NE at Mile 784 had a restored wetland depression (based on aerial imagery) within the pipeline route. Road had been bored underneath and all markers were in place.

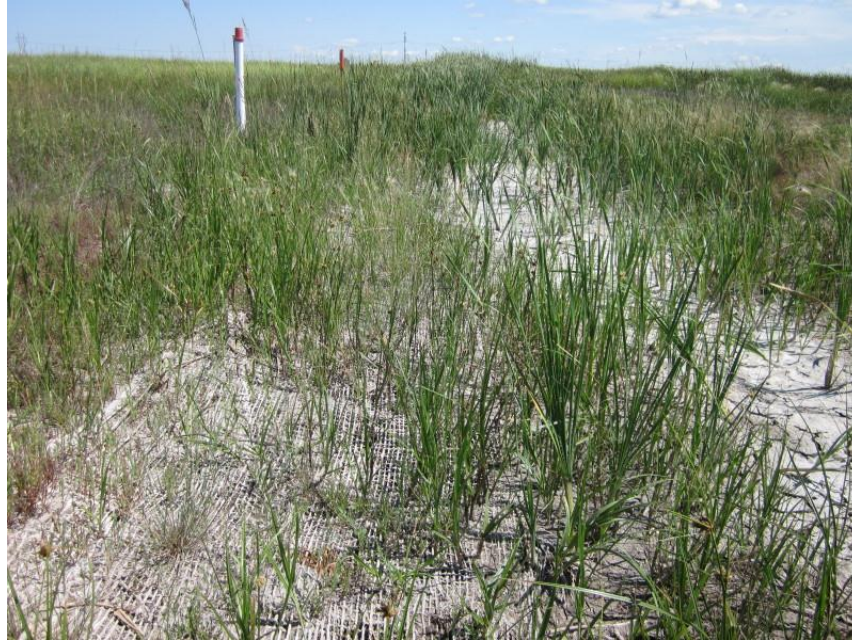
Photo 37. Direction: East. Ditch along minimum maintenance portion of 97th St NE between Miles 790 and 791, within the wetlands surrounding Juhl National WMA. Pipeline route is marked by the posts on the left. Jute netting was in place in the ditch to stabilize soils and was functioning well. New vegetation was growing through the netting, including many native species such as prairie cordgrass (*Spartina pectinata*) and cattails (*Typha* sp.) and the non-native but common grass quackgrass (*Agropyron repens*).

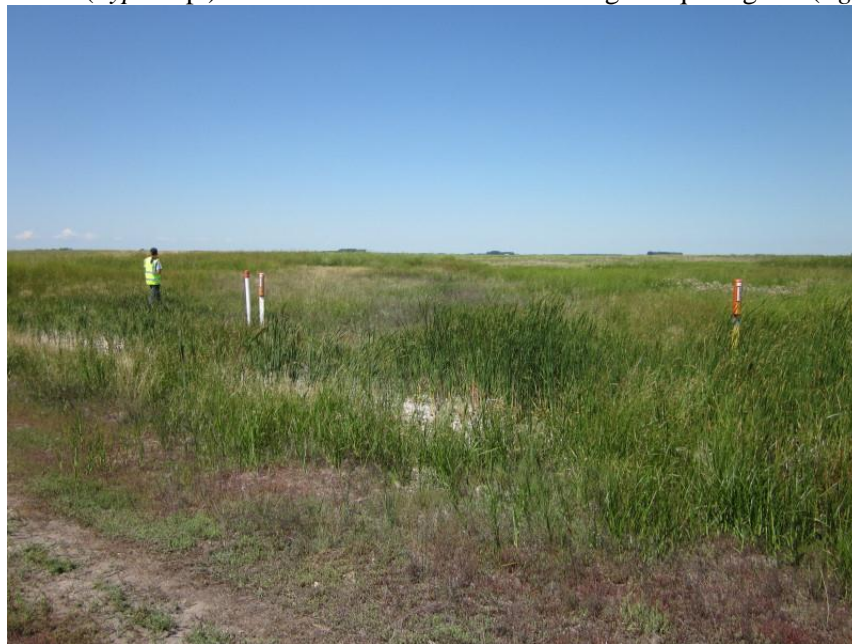
Photo 38. Direction: Northwest. On 97th St NE in the same location as above but showing the view of the pipeline route to the northwest. The plant composition was different within the pipeline route and the vegetation was not as tall or dense compared to outside of the route, however the species within the route were typical early successional native plants and regrowth of the vegetation should continue on its own with no problems.

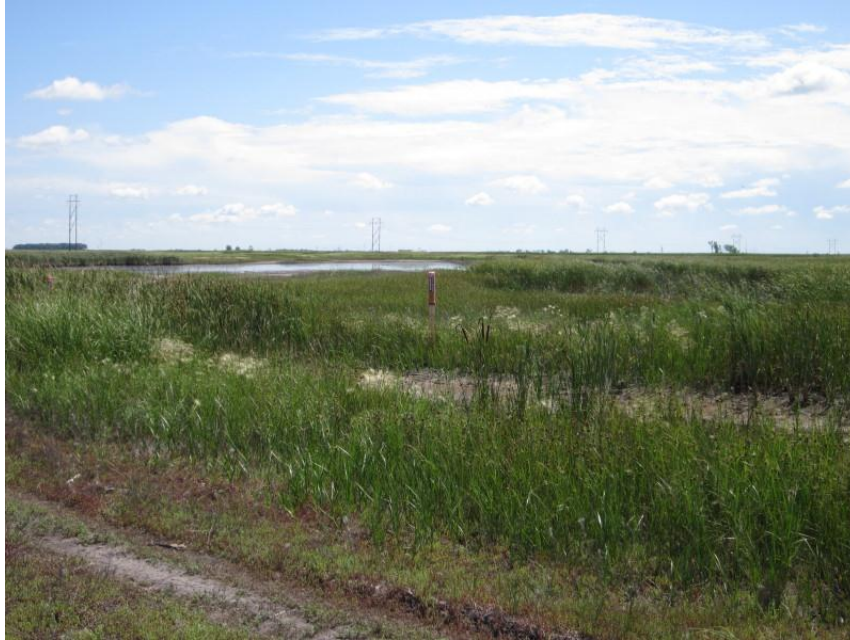
Photo 39. Direction: Southeast. Also on 97th St NE but showing the pipeline route on the other side of the road, which went through an extensive wetland area to the southeast. The Juhl National WMA intersects the pipeline route about 0.5 miles to the southeast of this point. The Joliette pumping station is just over one mile to the southeast.

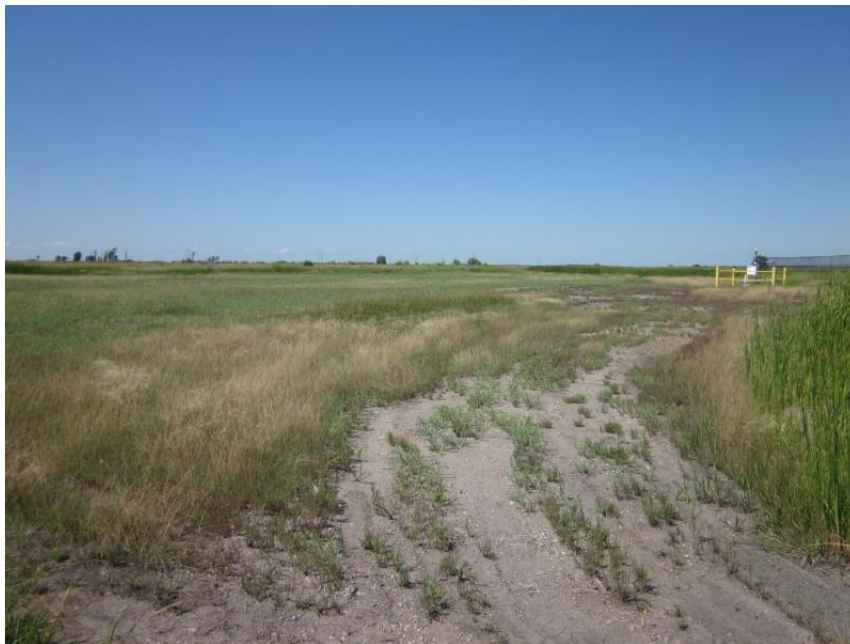
Photo 40. Direction: Northwest. West side of Joliette pumping station grounds near Mile 792 where the pipeline veers south to cross State Highway 5. Pipeline runs to the south of above-ground valve visible on right.
