CRT LABORATORIES, INC.

LWR NO.: 17936 DATE: April 29, 2009

Product ID: Fargo Gas Riser with approximately 3ft pigtail with an in-line PE coupling fused to Century PE tan tubing

RE: Plastic welds
Laboratory Work Request 17936

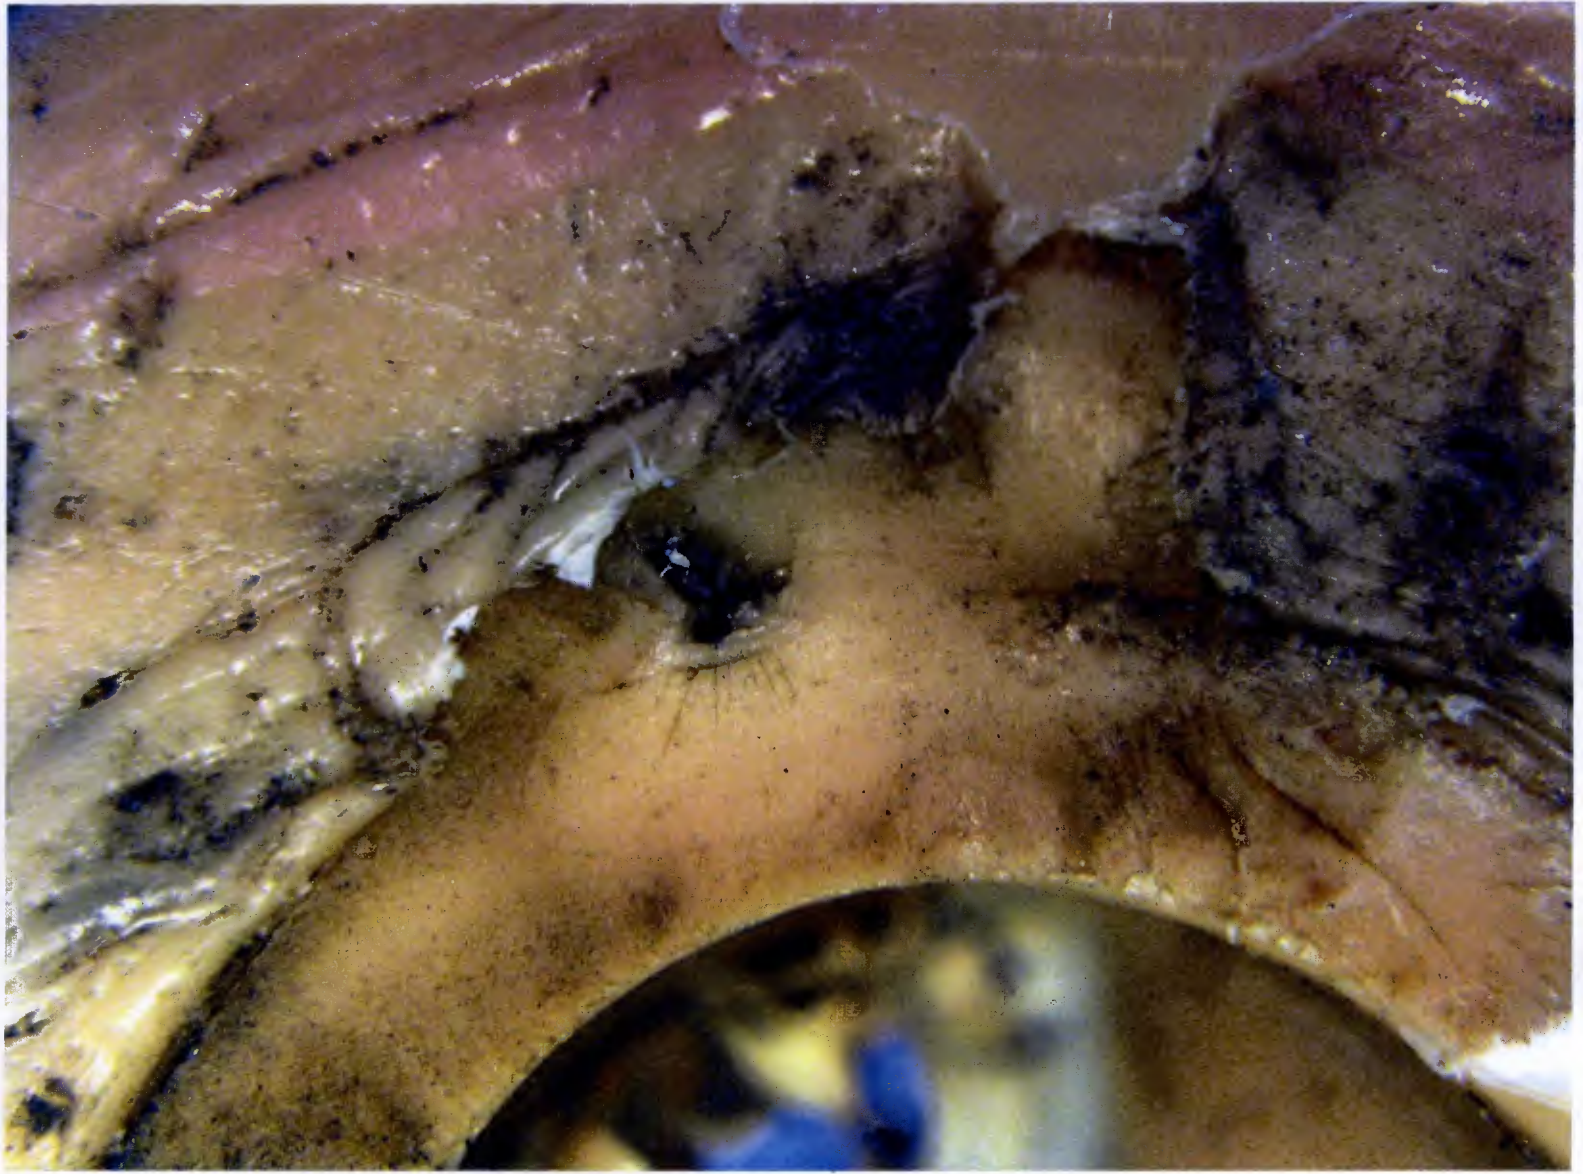
The failure of the cracked tube was attributed to the combination of a cavity formed by debris entrapped at the time of welding that served as a stress concentrator and a relatively high bending load at the time of failure.

Sand grains inclusion at origin of fracture
