PU-08-932/PU-19-144

**Merricourt Wind Power Project
Reclamation Inspection Report**

July 2022

Stantec Consulting Services Inc.
3303 Fiechtner Drive, Suite 100
Fargo, ND 58103

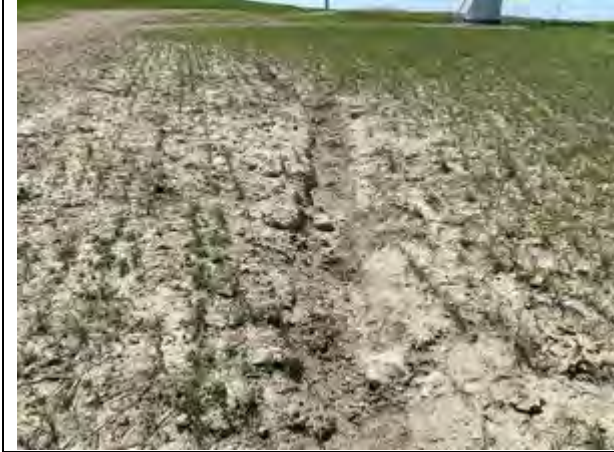
Observation Point: 1

Photo Description: Minor washout near T-49

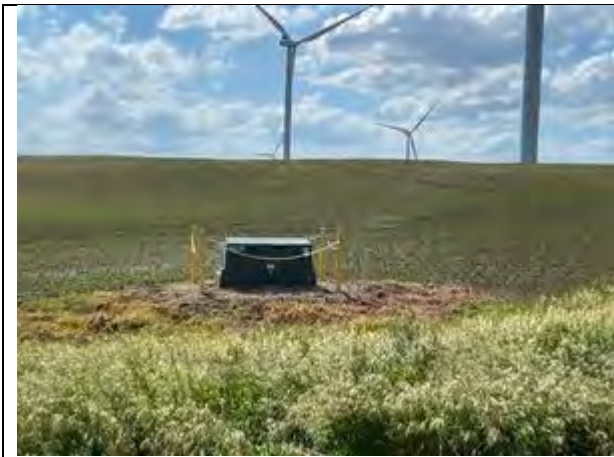
Observation Point: 2

Photo Description: Topography matches surrounding land around utility box

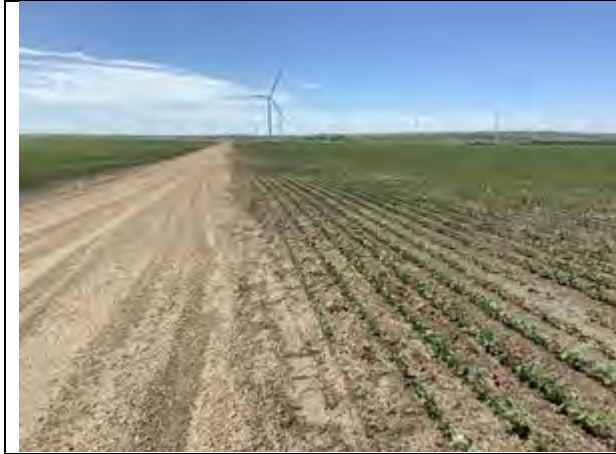
Observation Point: 4

Photo Description: Reclamation along access road is appropriate and matches surrounding field.

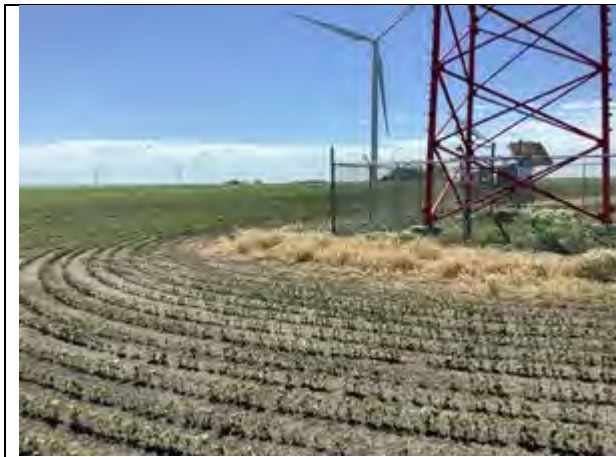
Observation Point: 5

Photo Description: Healthy soybeans, With no noxious weeds on MET tower pad.

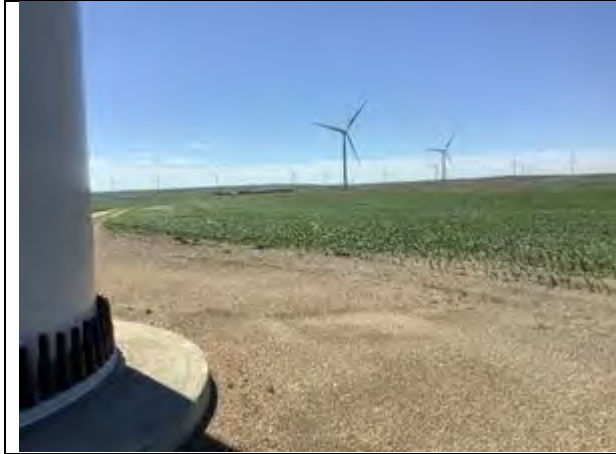
Observation Point: 7

Photo Description: Minimal erosion on T-27 pad. Corn growth is consistent across reclaimed and undisturbed area.

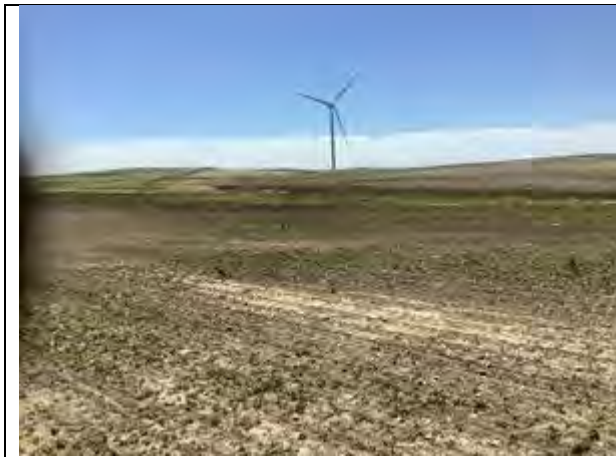
Observation Point: 17

The Project components cross numerous acres of cropland via access roads, turbine pads, meteorological evaluation towers (MET), and transmission lines. Cropland was observed to be under soybean and corn production or were recently sprayed and not planted. No visual yield estimate or stand height comparisons were made, however, the stand density and physical characteristics were consistent to the surrounding, undisturbed cropland (**Appendix B; Observation Points 2, 4, 5, 7, 17, 27, 30, 35, 37, 38, 47, 50, 51, 52, 53, 55, 56**). Soybeans that were seeded directly adjacent to reclaimed areas were observed to be stressed compared to undisturbed cropland (**Appendix B; Observation Points 3, 8, 14, 40, 41**), and may warrant additional Best Management Practices (BMP's) or action. Most visible impacts were at **Observation Point 40**, where the T-46 access road was constructed along a cut slope which was observed to be severely eroding into crops. Lastly, the fields observed to be void of any cultivated species in the undisturbed and reclaimed areas appear to be sprayed out by producers and were unrelated to the reclamation (**Observation Points 17, 39**).

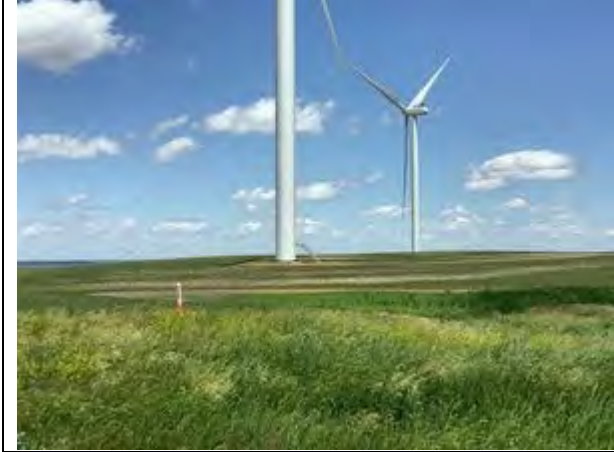
Observation Point: 27

Photo Description: Reseeding slope recommended. Road to east eroding. Other areas road right-of-way has acceptable vegetative cover.

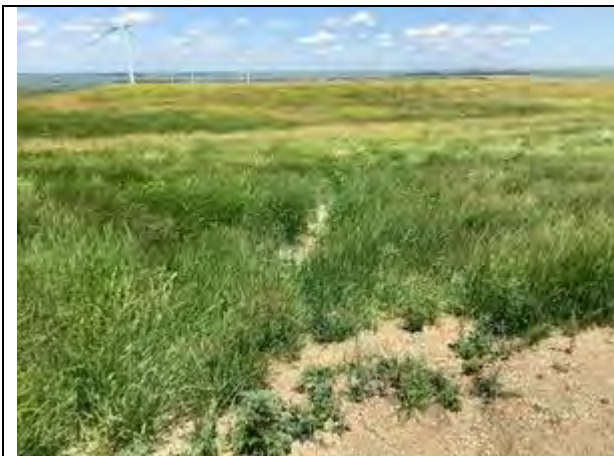
Observation Point: 29

Photo Description: Road wash out impacting pasture and seeded vegetation. Overall plant cover is appropriate and matches surrounding areas. Unclear if seeded.

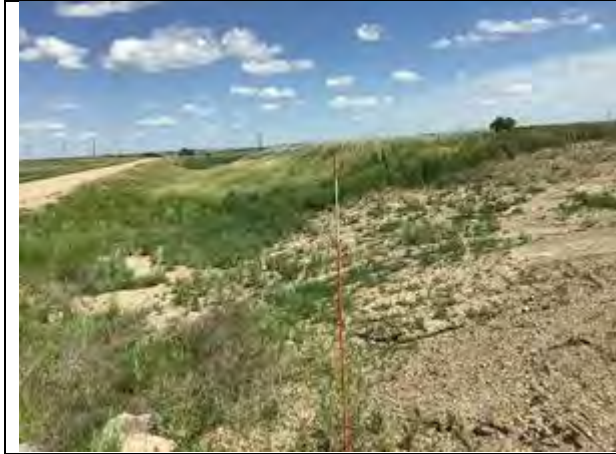
Observation Point: 36

Photo Description: Unaddressed area of soil erosion.

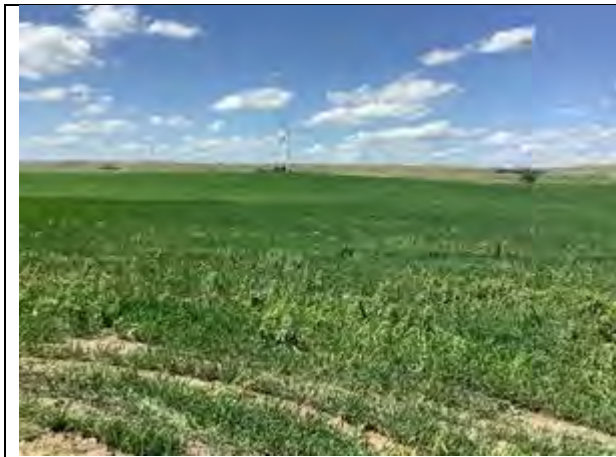
Observation Point: 37

Photo Description: Collection line and planted crops are comparable to undisturbed area around T-45.

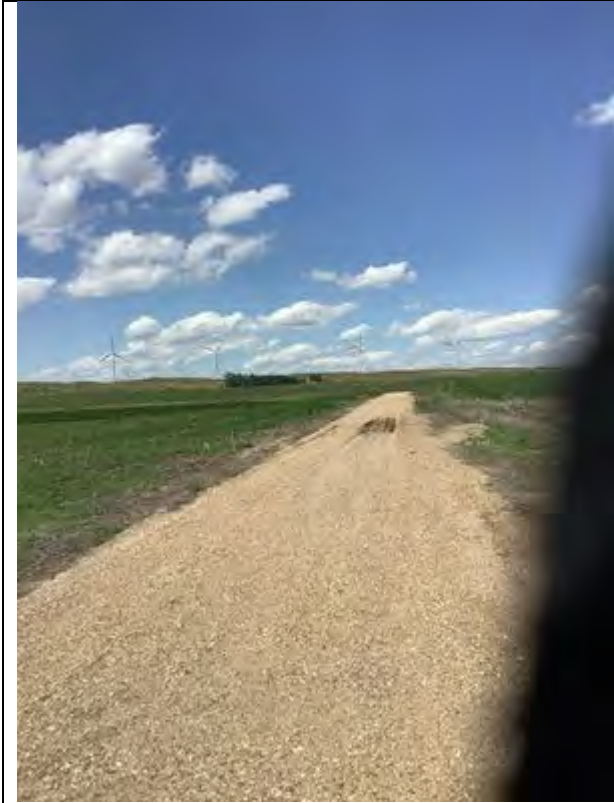
Observation Point: 39

Photo Description: Cropland unseeded. Grading is adequate with minimal erosion around T-46.

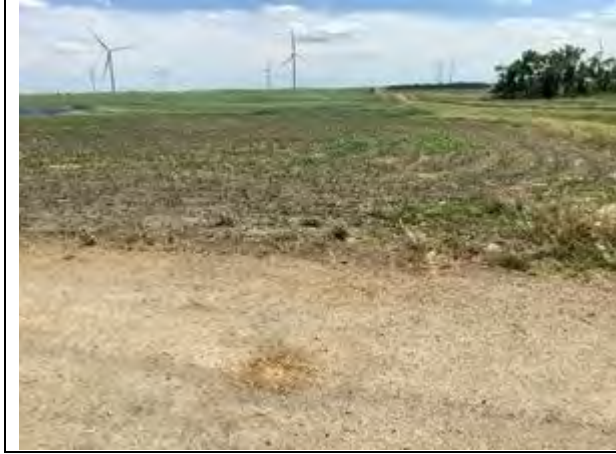
Observation Point: 41

Photo Description: Planted soybeans are growing well. Closest rows to access road are slightly stressed.
