# Public Service Commission

### INSPECTION REPORT

PERMITTEE - MINE: Falkirk Mining Company - Falkirk Mine

Sediment Pond P-E13-01, Permit NAFK-8405, and drainageway below the pond

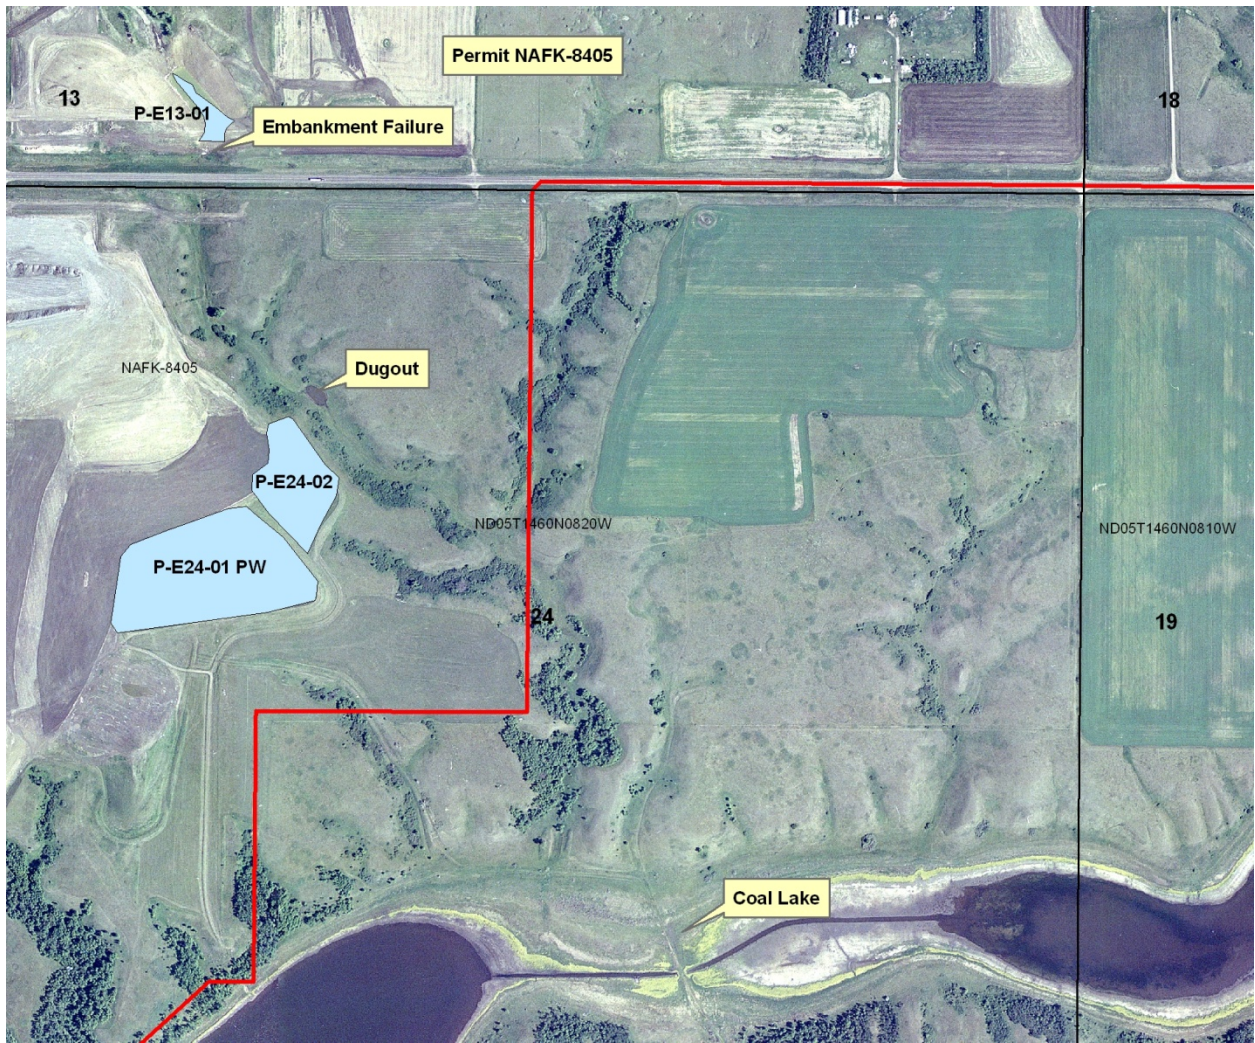
The purpose of this inspection was to evaluate sediment Pond P-E13-01. Falkirk staff called the PSC on Friday, March 20<sup>th</sup> and reported that this pond had failed and that water was channeling through the embankment along the barrel principal spillway.

There was a thin (approximately 1/8" thick) layer of sediment deposited on the bottom of the drainageway where the discharge water from the pond had passed. In a few small areas, less than 100 square feet in size, it appeared that deposition of materials was greater than 1" but less than 2" in depth. A thin layer of sediment also was noted on the snow drifts in the drainageway where water had accumulated while breaking a path through the snow. A dugout pond is located in the undisturbed drainage channel approximately 1350 feet downstream from Pond P-E13-01. There was also a deposition of sediment on the ice of this pond. A head cut in the drainage immediately above the dugout pond is not attributed to the pond discharge, but it may have been enlarged from high flows. The downstream drainage channel was inspected to a distance of approximately 200 yards beyond the dugout.
